## **SECTION 12A APPLICATION**

**To rezone the Application Site from “Other Specified Uses” annotated “Business” to  
“Residential (Group E) 2” at Lot 316 in D.D. 444 and Kwai Chung Town Lot (KTCL) 146,  
97-107 Wo Yi Hop Road, New Territories**

### **Land Contamination Review**

July 2025

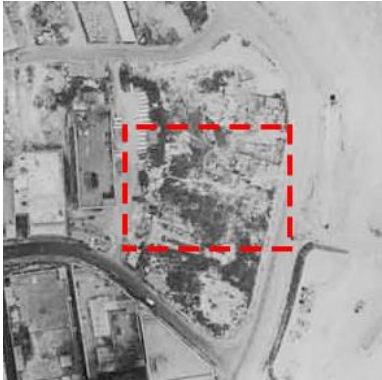
<p><b>1967</b></p>

Year	Height (feet)	Reference No.	Observations
1967	3900	1967-5285	Flat and Vacant Land
1973	2400	04477	Under Construction
<b>1974</b>	<b>12500</b>	<b>09781</b>	<b>Park Sun Building</b>
1976	4000	13221	Land use was the same as in 1974.
1981	2000	38382	Land use was the same as in 1974.
1985	5000	CN00900	Land use was the same as in 1974.
1990	4000	A23543	Land use was the same as in 1974.
1995	3500	CN11105	Land use was the same as in 1974.
2000	6000	CN28060	Land use was the same as in 1974.
2005	4000	CW65348	Land use was the same as in 1974.
2010	6000	CS29194	Land use was the same as in 1974.
2015	6000	CS57485	Land use was the same as in 1974.
2020	6900	E110065C	Land use was the same as in 1974.
2023	6900	E193914C	Land use was the same as in 1974.

2.2.2. Based on the aerial photographs reviewed, the **Subject Site** was vacant until 1973 that sign of construction was found in 1973. The Park Sun Building has been in operation no later than 1974 until now.
