**GEOTECHNICAL PLANNING REVIEW REPORT (GPRR)**

**APPLICATION FOR AMENDMENT OF PLAN**

**PROPOSED RESIDENTIAL DEVELOPMENT AT**

**PAK WAI, SAI KUNG**

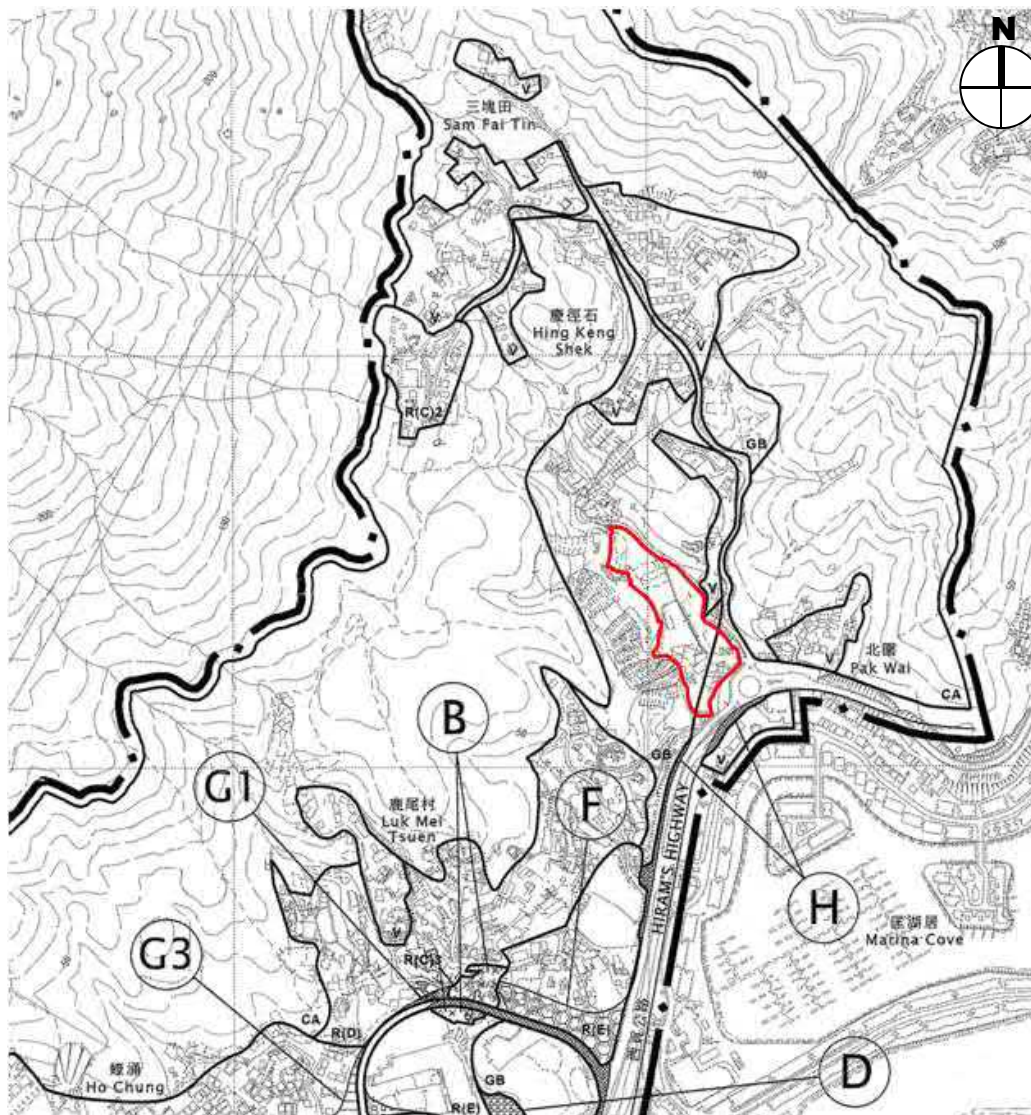
Figure 1

## Site Location Plan

(Extracted from Draft Ho Chung Outline Zoning Plan No. S/SK-HC/12)

The captioned site locates in a valley opposing Pak Wai in Sai Kung, The total area of the site is about 12,692m<sup>2</sup>. The elevation of the site is about +4.5 – 7.5mPD. A site location plan is attached in Figure 1.

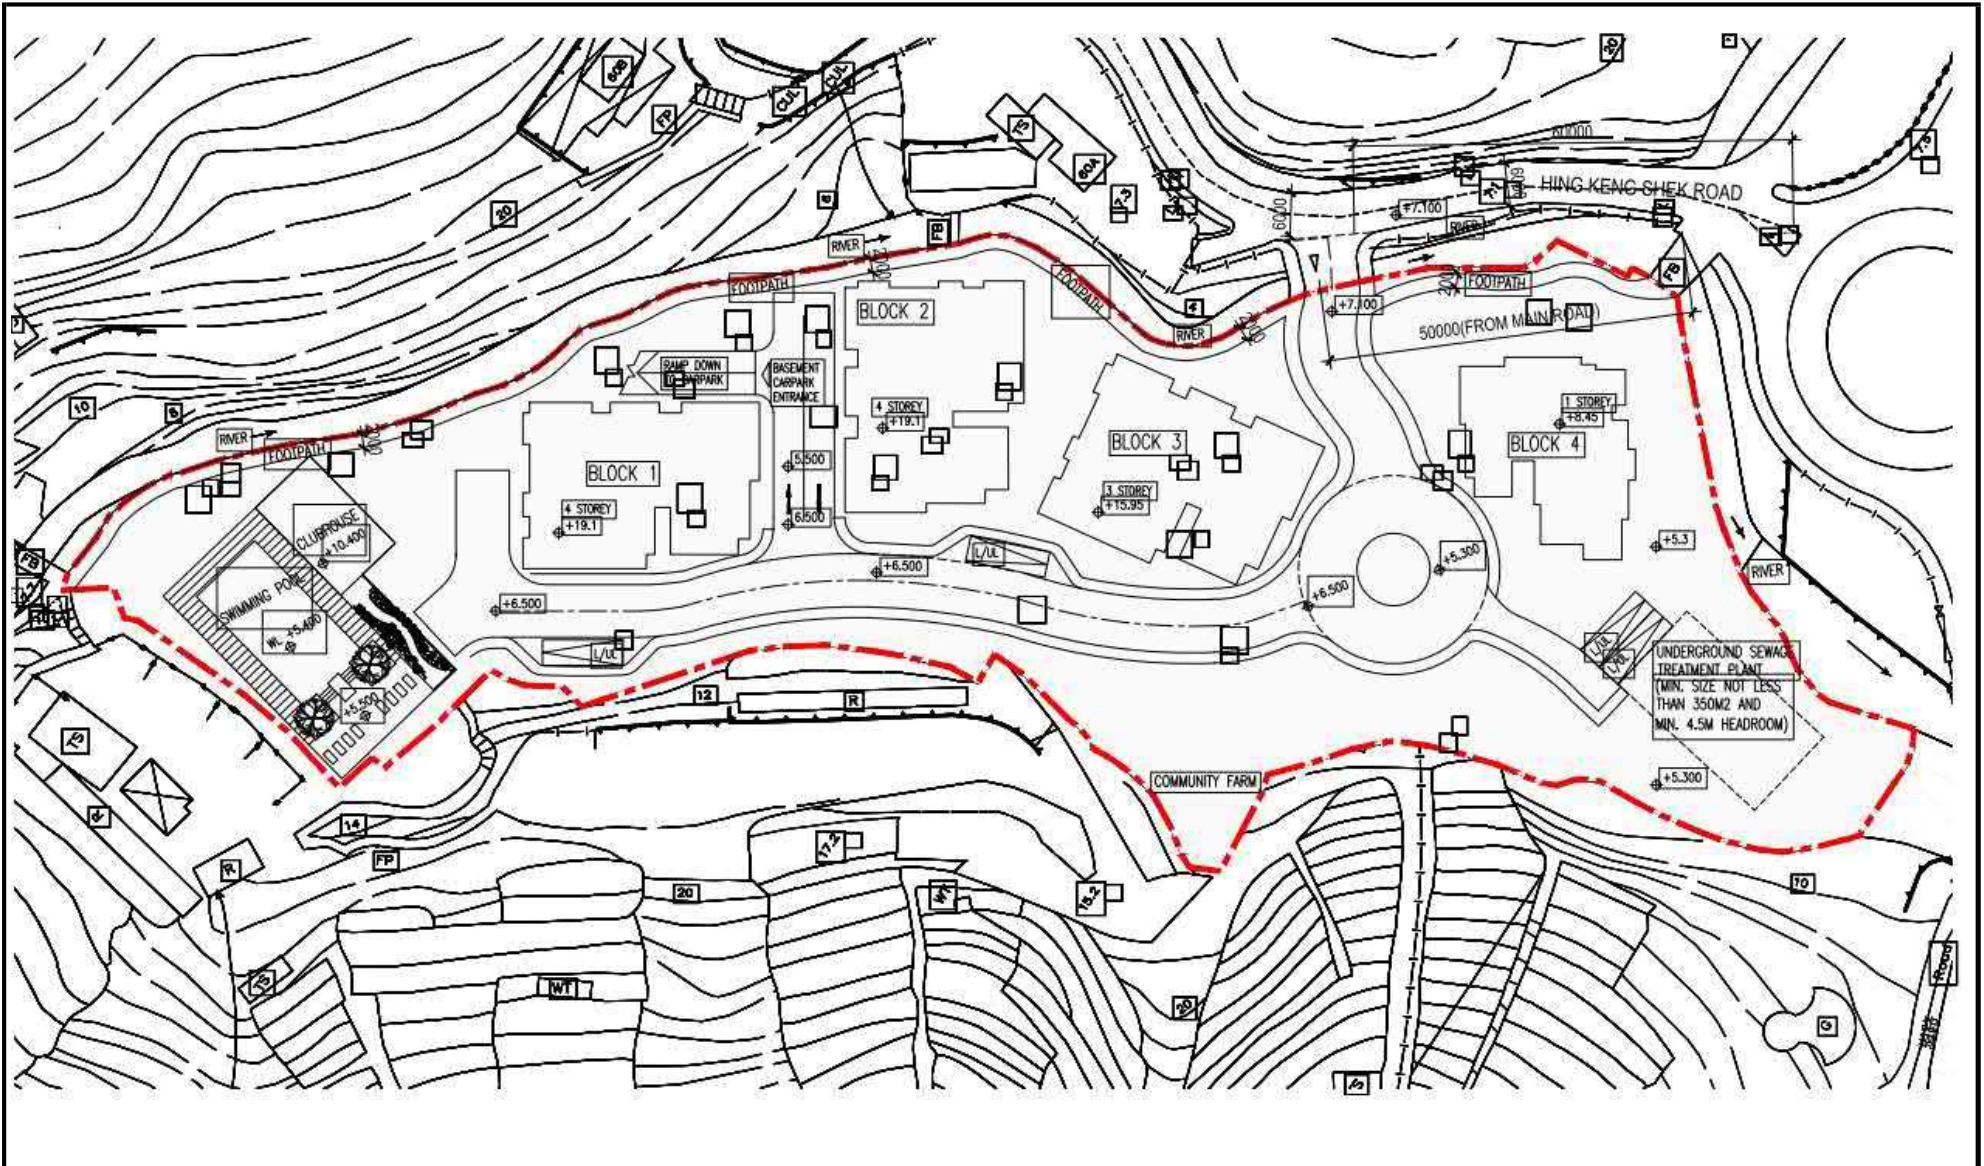
Master Layout Plan

The development involved the construction of residential development of four blocks of 1 to 4 storey residential building with one-level basement carpark. The schematic master layout plan and diagrammatic section of the proposed new building are given in Figure 2 and Figure 3.

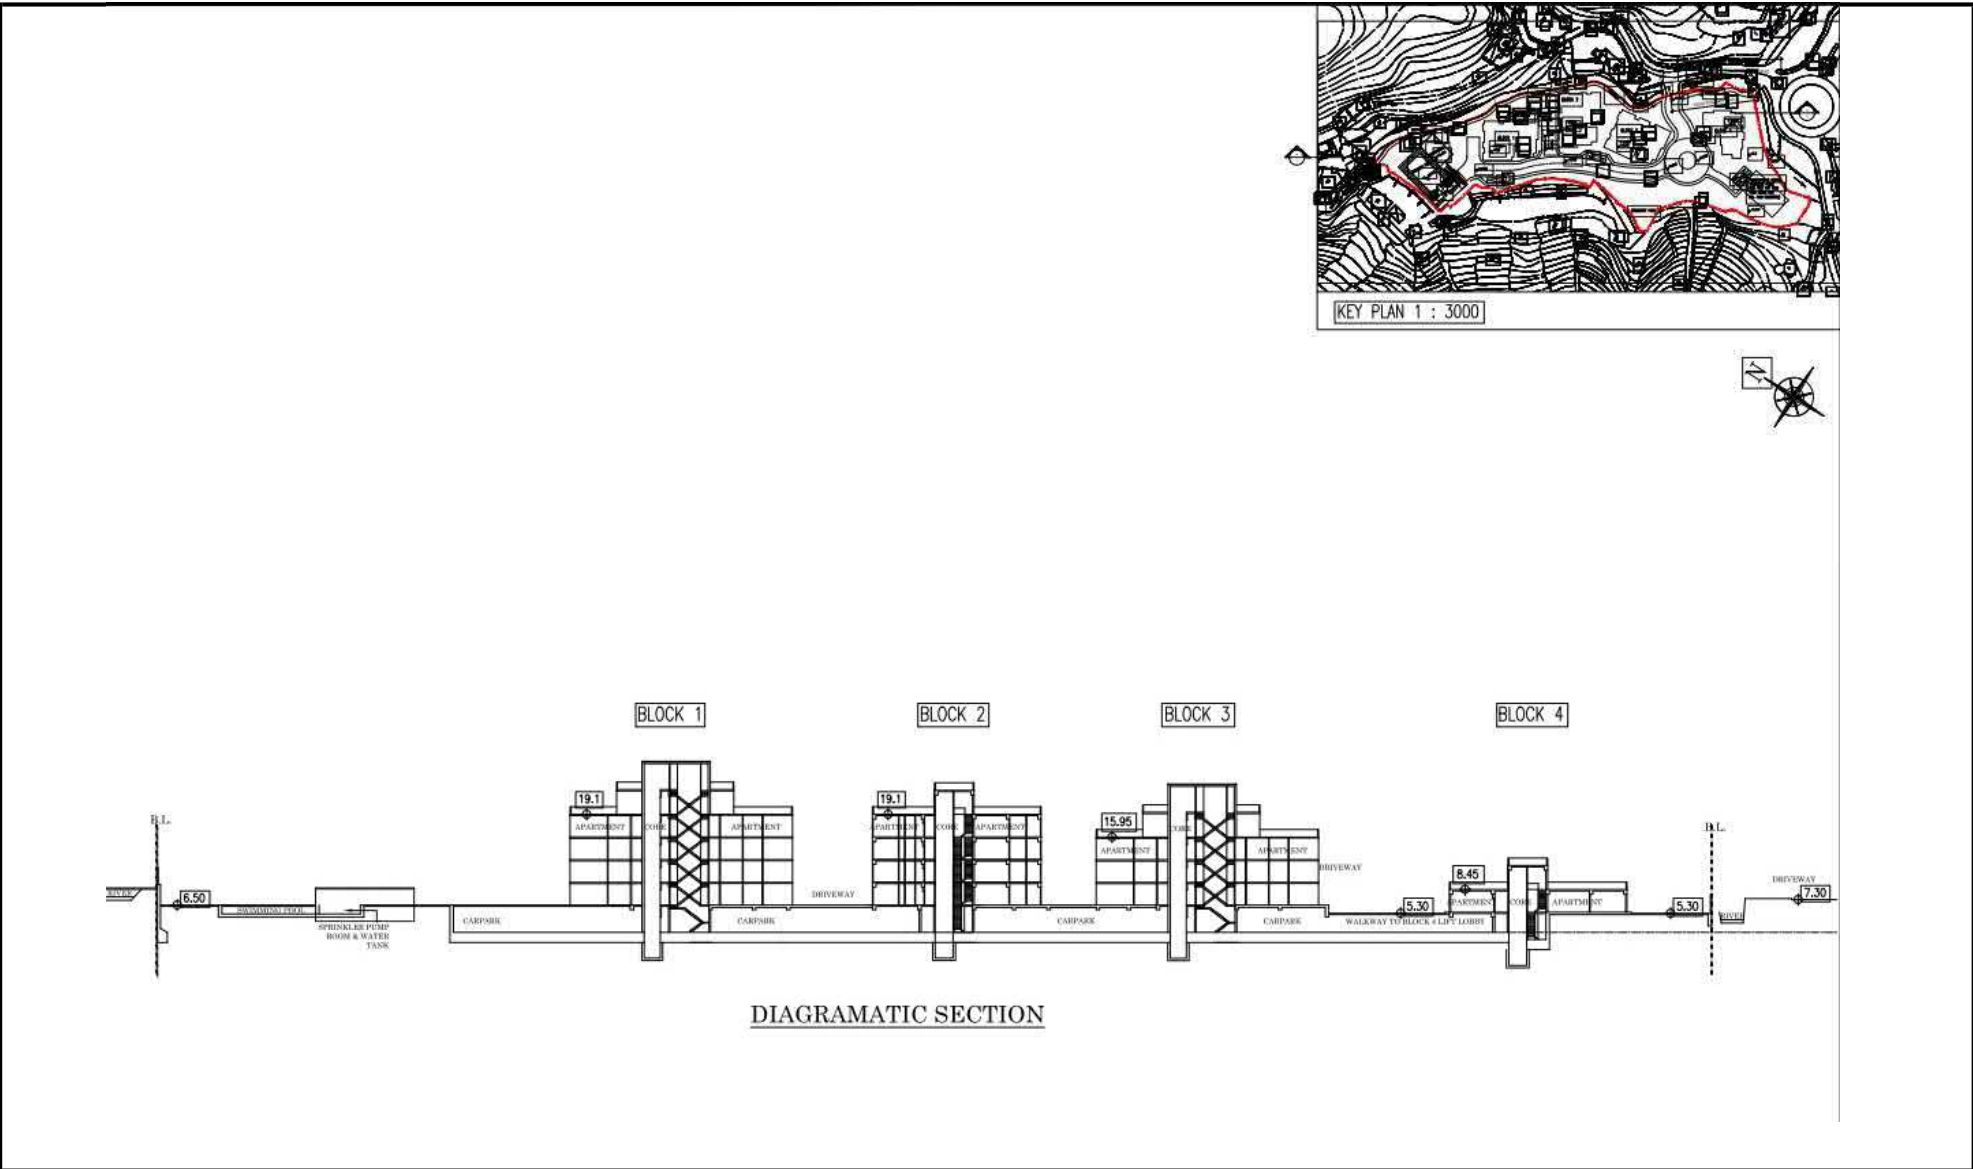
Figure 3

Diagrammatic Section

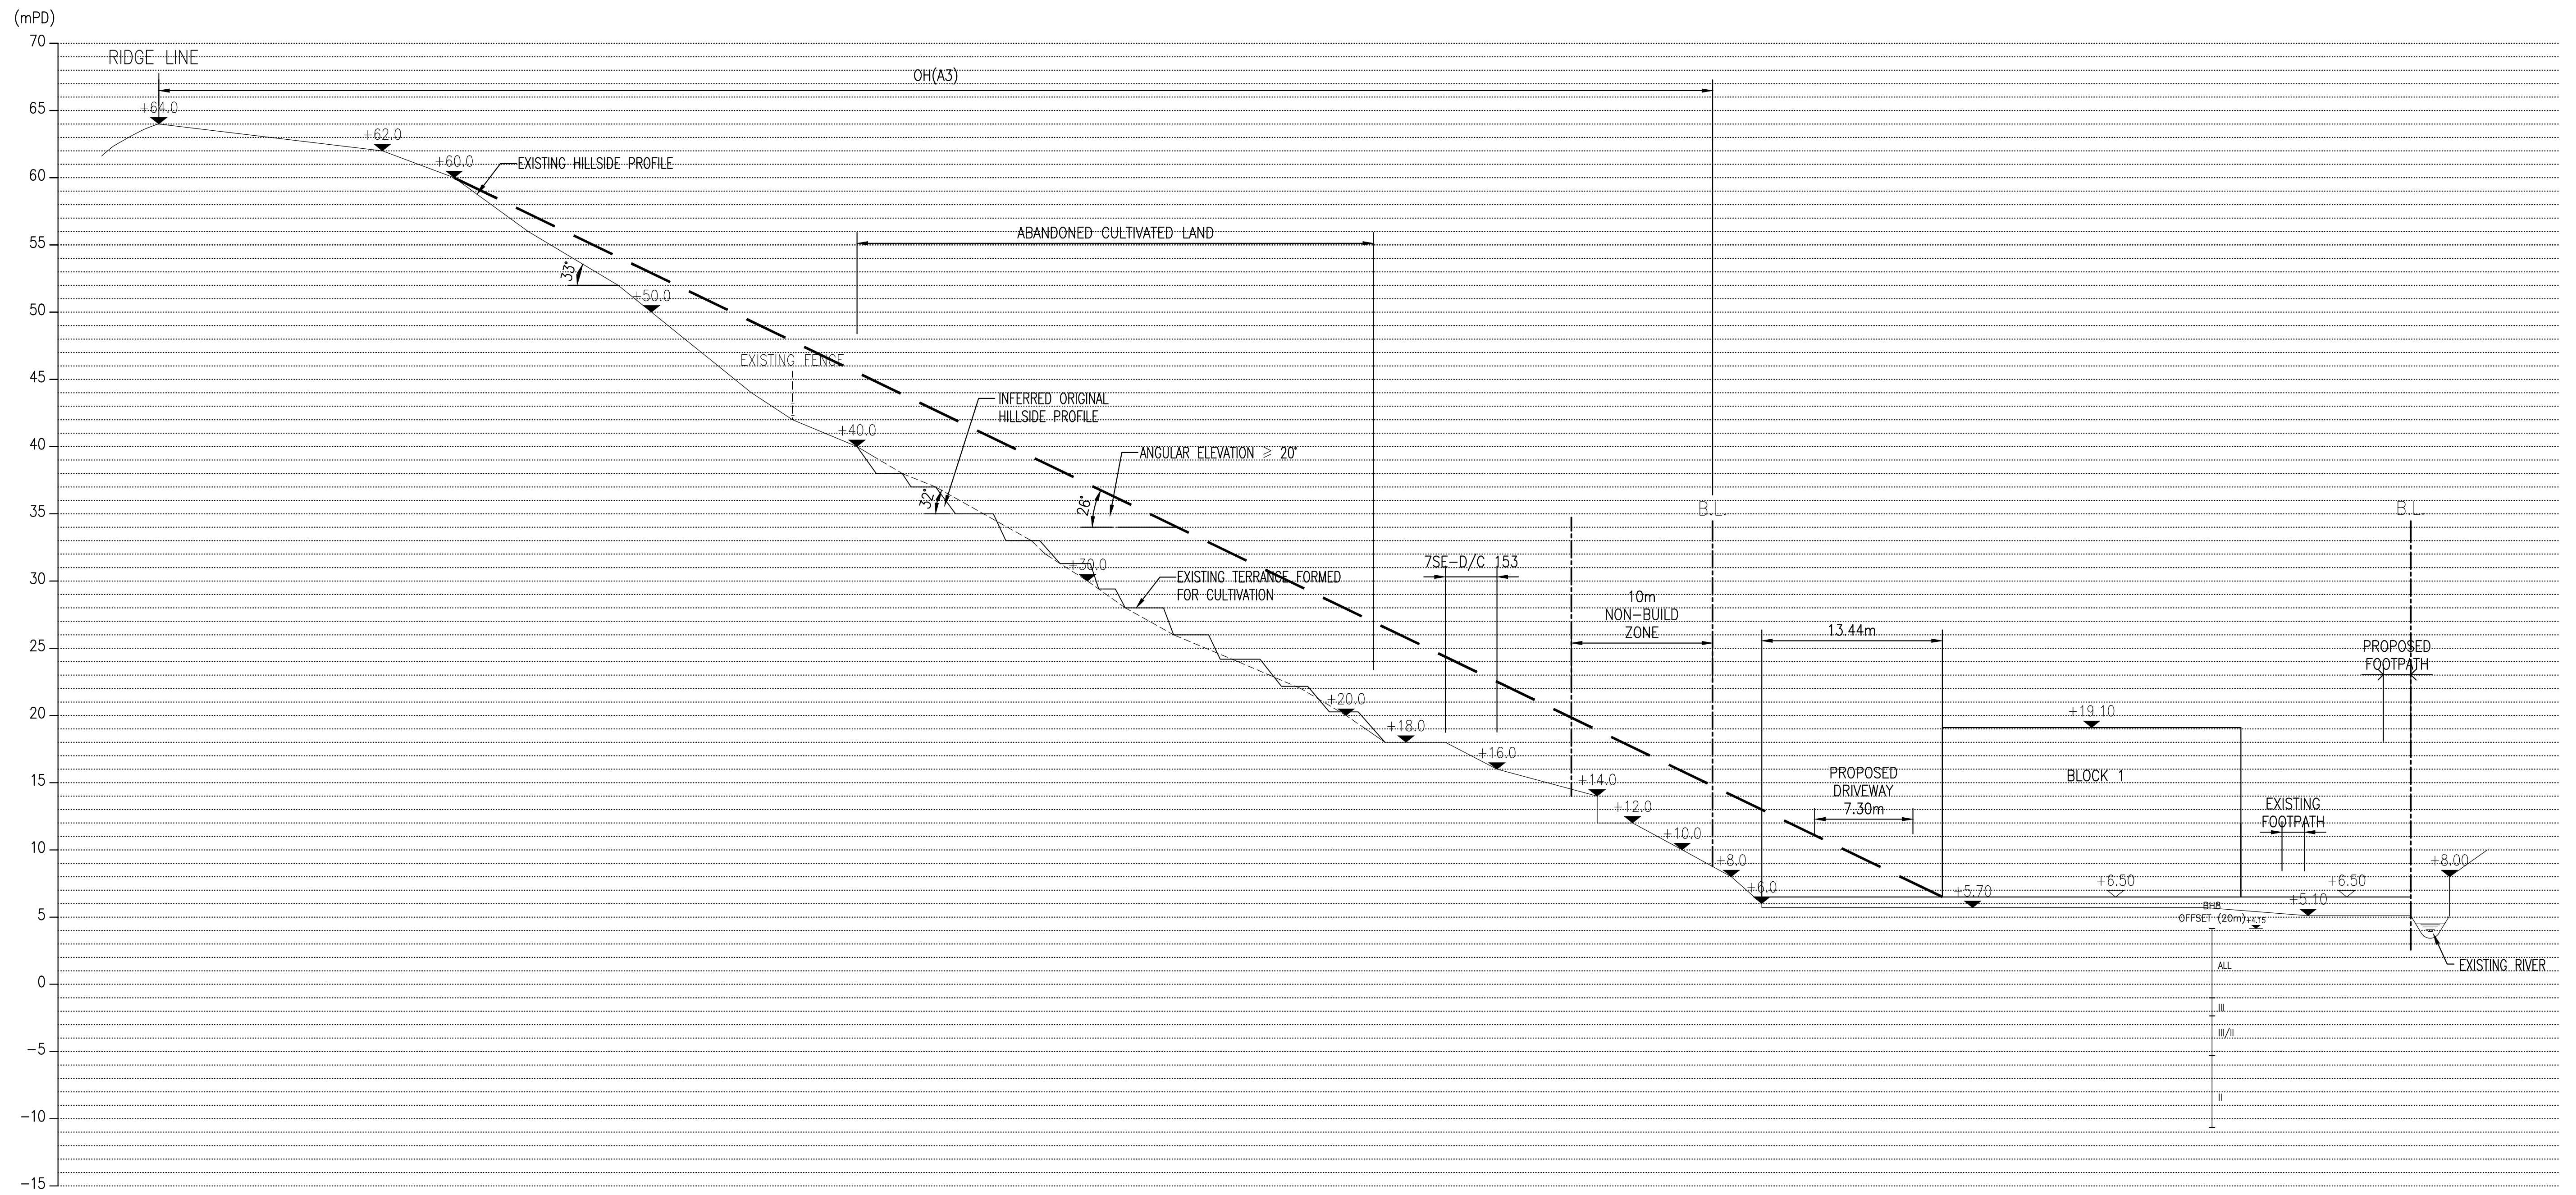
FIGURE 5

SECTION A-A  
1 : 500

Based on available topographic maps No. 7SE-25A, 7SE-25B, 7SE-25C and 7SE-25D of Hong Kong from the Survey & Mapping Office (SMO) of the Lands Department, the hillside catchment of proposed Redevelopment understudy are described below, and presented as Figure 4, with relevant cross-sections of the catchment presented as Figure 5 to 13.

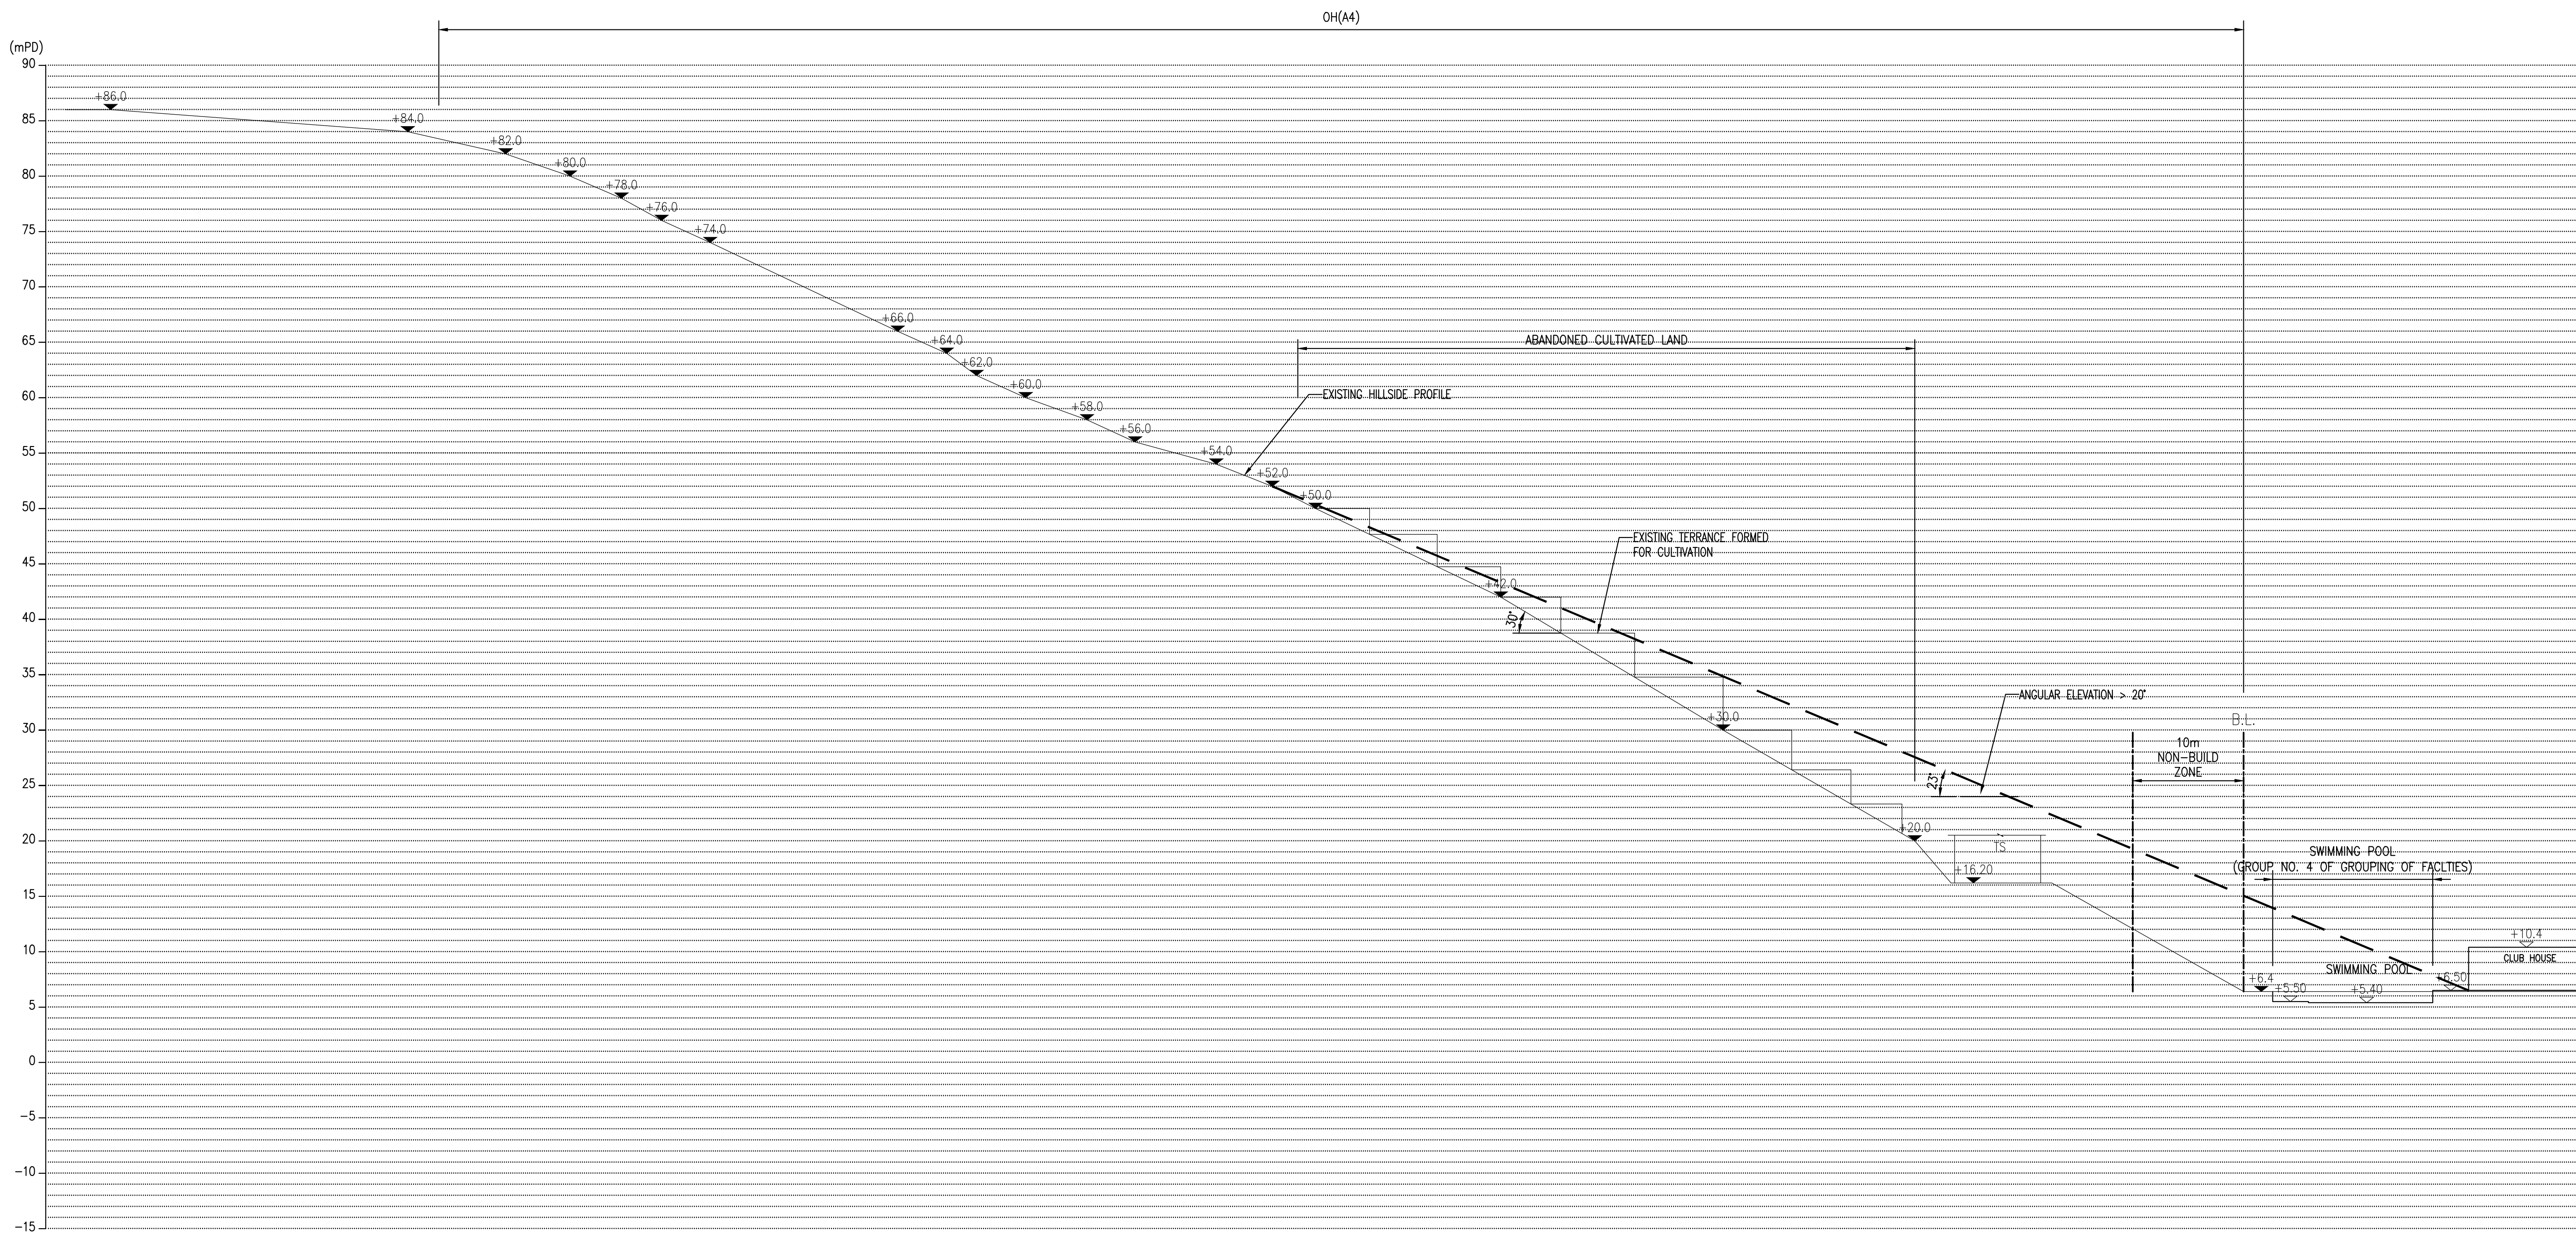
FIGURE 8

SECTION D-D  
1 : 500

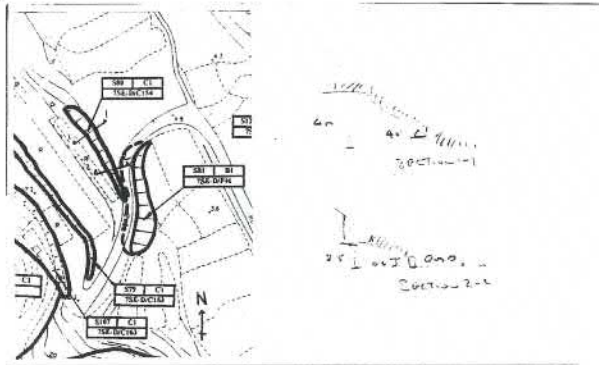
Section No: 1-1  
 Height(m): H1 : 4 , H2 : 0  
 Type of Toe Facility: Remote area or abandoned facilities  
 Distance from Toe(m): 0  
 Type of Crest Facility: Remote area or abandoned facilities  
 Distance from Crest(m): 0  
 Consequence Category: 3  
 Engineering Judgement: U  
 Section No: 2-2  
 Type of Toe Facility: N/A  
 Distance from Toe(m): 0  
 Type of Crest Facility: N/A  
 Distance from Crest(m): 0  
 Consequence Category: 3  
 Engineering Judgement: U  
 Sign of Seepage: Slope : No signs of seepage  
 Wall : N/A  
 Criterion A satisfied: N  
 Sign of Distress: Slope : Minor (mid-portion)  
 Wall : N/A  
 Criterion D satisfied: N  
 Non-routine maintenance required: N  
 Note: N/A  
 Masonry wall/Masonry facing: N  
 Note: N/A  
 Consequence category (for critical section): 3  
 Observations: N/A

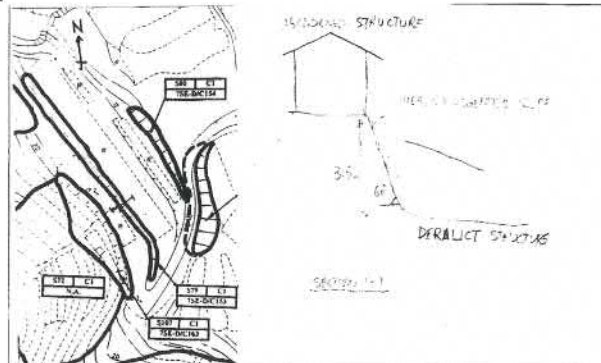
Section No: 1-1  
 Height(m): H1 : 4 , H2 : 0  
 Type of Toe Facility: Remote area or abandoned facilities  
 Distance from Toe(m): 0  
 Type of Crest Facility: Remote area or abandoned facilities  
 Distance from Crest(m): 0  
 Consequence Category: 3  
 Engineering Judgement: P  
 Section No: 2-2  
 Type of Toe Facility: N/A  
 Distance from Toe(m): 0  
 Type of Crest Facility: N/A  
 Distance from Crest(m): 0  
 Consequence Category: 3  
 Engineering Judgement: P  
 Sign of Seepage: Slope : No signs of seepage  
 Wall : N/A  
 Criterion A satisfied: N  
 Sign of Distress: Slope : Reasonable (mid-portion)  
 Wall : N/A  
 Criterion D satisfied: N  
 Non-routine maintenance required: N  
 Note: N/A  
 Masonry wall/Masonry facing: N  
 Note: N/A  
 Consequence category (for critical section): 3  
 Observations: N/A  
 Emergency Action Required: N  
 Action By: N/A

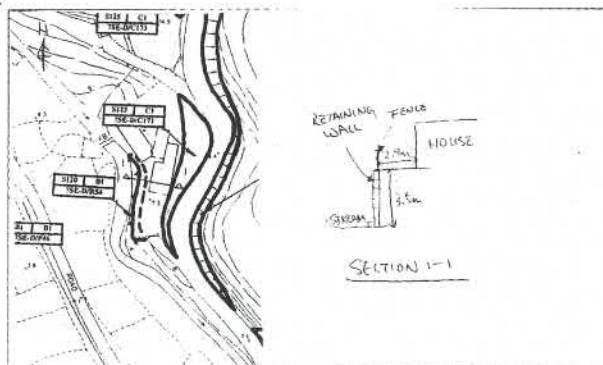
Section No: 1-1  
 Height(m): H1 : 4 , H2 : 4  
 Type of Toe Facility: Catchwater w/consequence on Group 5 facilities  
 Distance from Toe(m): 0  
 Type of Crest Facility: Cottage, licensed and squatter area  
 Distance from Crest(m): 3  
 Consequence Category: 1  
 Engineering Judgement: P  
 Section No: 2-2  
 Type of Toe Facility:  
 Distance from Toe(m):  
 Type of Crest Facility:  
 Distance from Crest(m):  
 Consequence Category: 1  
 Engineering Judgement: P  
 Sign of Seepage: Slope : N/A  
 Wall : Signs of seepage  
 Criterion A satisfied: N  
 Sign of Distress: Slope : N/A  
 Wall : Moderate(mid-portion, at toe)  
 Criterion D satisfied: N  
 Non-routine maintenance required: N  
 Note: N/A  
 Masonry wall/Masonry facing: Y  
 Note: N/A  
 Consequence category (for critical section): 1  
 Observations: N/A  
 Emergency Action Required: N  
 Action By: N/A

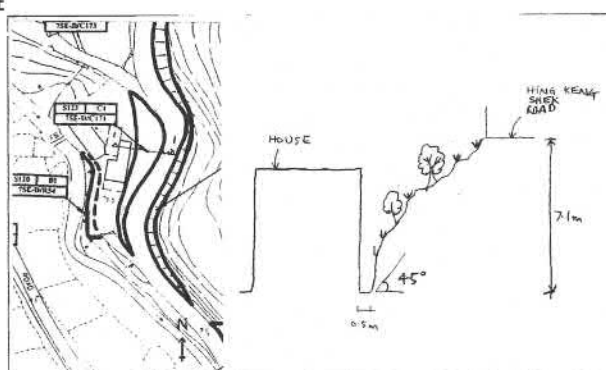
Section No: 1-1  
Height (m): N/A  
Type of Toe Facility: Cottage, licensed and squatter area  
Distance from Toe (m): 0.5  
Type of Crest Facility: Road/footpath with low traffic density  
Distance from Crest (m): 0  
Consequence Category: 1  
Engineering Judgement: P  
Section No: 2-2  
Type of Toe Facility: N/A  
Distance from Toe (m): 0  
Type of Crest Facility: N/A  
Distance from Crest (m): 0  
Consequence Category: 1  
Engineering Judgement: P  
Sign of Seepage: Slope : Signs of seepage  
Wall : N/A  
Criterion A satisfied: N  
Sign of Distress: Slope : Reasonable (near crest, mid-portion)  
Wall : N/A  
Criterion D satisfied: N  
Non-routine maintenance required: N  
Note: N/A

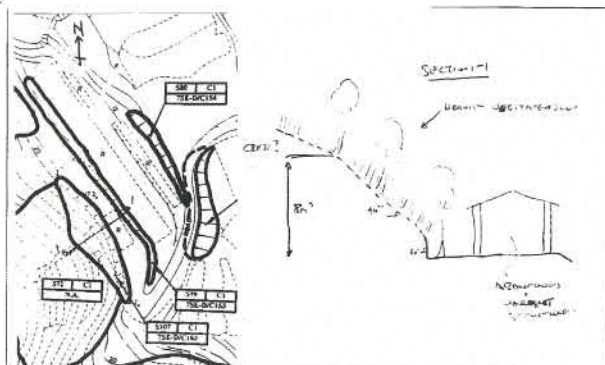
Section No: 1-1  
 Height(m): H1 : 8 , H2 : 0  
 Type of Toe Facility: Lightly-used playground  
 Distance from Toe(m): 1  
 Type of Crest Facility: Undeveloped green belt  
 Distance from Crest(m): 0  
 Consequence Category: 1  
 Engineering Judgement: P  
 Section No: 2-2  
 Type of Toe Facility: N/A  
 Distance from Toe(m): 0  
 Type of Crest Facility: N/A  
 Distance from Crest(m): 0  
 Consequence Category: 1  
 Engineering Judgement: P  
 Sign of Seepage: Slope : No signs of seepage  
 Wall : N/A  
 Criterion A satisfied: N  
 Sign of Distress: Slope : Minor (mid-portion)  
 Wall : N/A  
 Criterion D satisfied: N  
 Non-routine maintenance required: N  
 Note: N/A  
 Masonry wall/Masonry facing: N  
 Note: N/A  
 Consequence category (for critical section): 1  
 Observations: TGN 15 case - provided by SP Division (31 MAR 2004)  
 Emergency Action Required: N  
 Action By: N/A

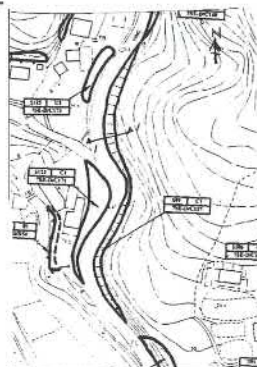
Section No: 1-1  
 Height (m): N/A  
 Type of Toe Facility: Road/footpath with low traffic density  
 Distance from Toe (m): 0  
 Type of Crest Facility: Undeveloped green belt  
 Distance from Crest (m): 0  
 Consequence Category: 3  
 Engineering Judgement: P  
 Section No: 2-2  
 Type of Toe Facility: N/A  
 Distance from Toe (m): 0  
 Type of Crest Facility: N/A  
 Distance from Crest (m): 0  
 Consequence Category: 3  
 Engineering Judgement: P  
 Sign of Seepage: Slope : No signs of seepage  
 Wall : N/A  
 Criterion A satisfied: N  
 Sign of Distress: Slope : Minor (mid-portion, at toe)  
 Wall : N/A  
 Criterion D satisfied: N  
 Non-routine maintenance required: N  
 Note: N/A  
 Masonry wall / Masonry facing: N

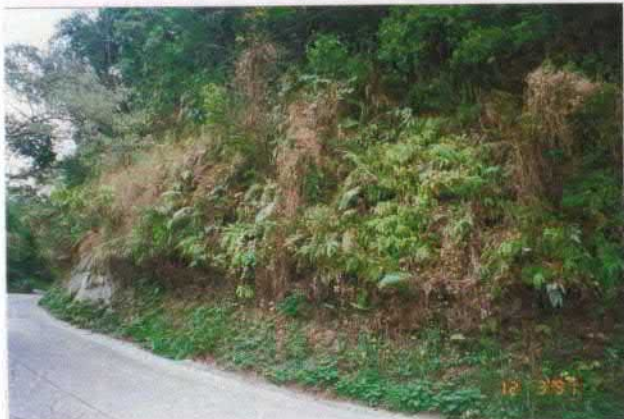
7SE-D/C157

General View

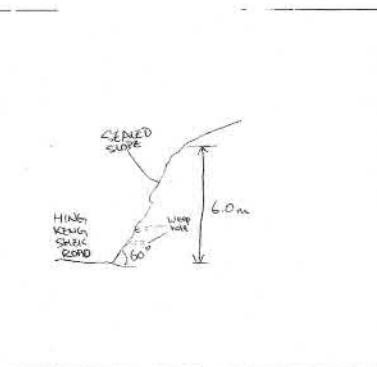
Section No: 1-1  
 Height (m): N/A  
 Type of Toe Facility: Road/footpath with very low traffic density  
 Distance from Toe (m): 0  
 Type of Crest Facility: Undeveloped green belt  
 Distance from Crest (m): 0  
 Consequence Category: 3  
 Engineering Judgement: P  
 Section No: 2-2  
 Type of Toe Facility: N/A  
 Distance from Toe (m): 0  
 Type of Crest Facility: N/A  
 Distance from Crest (m): 0  
 Consequence Category: 3  
 Engineering Judgement: P  
 Sign of Seepage: Slope : No signs of seepage  
 Wall : N/A  
 Criterion A satisfied: N  
 Sign of Distress: Slope : N/A  
 Wall : N/A  
 Criterion D satisfied: N  
 Non-routine maintenance required: N  
 Note: N/A  
 Masonry wall / Masonry facing: N

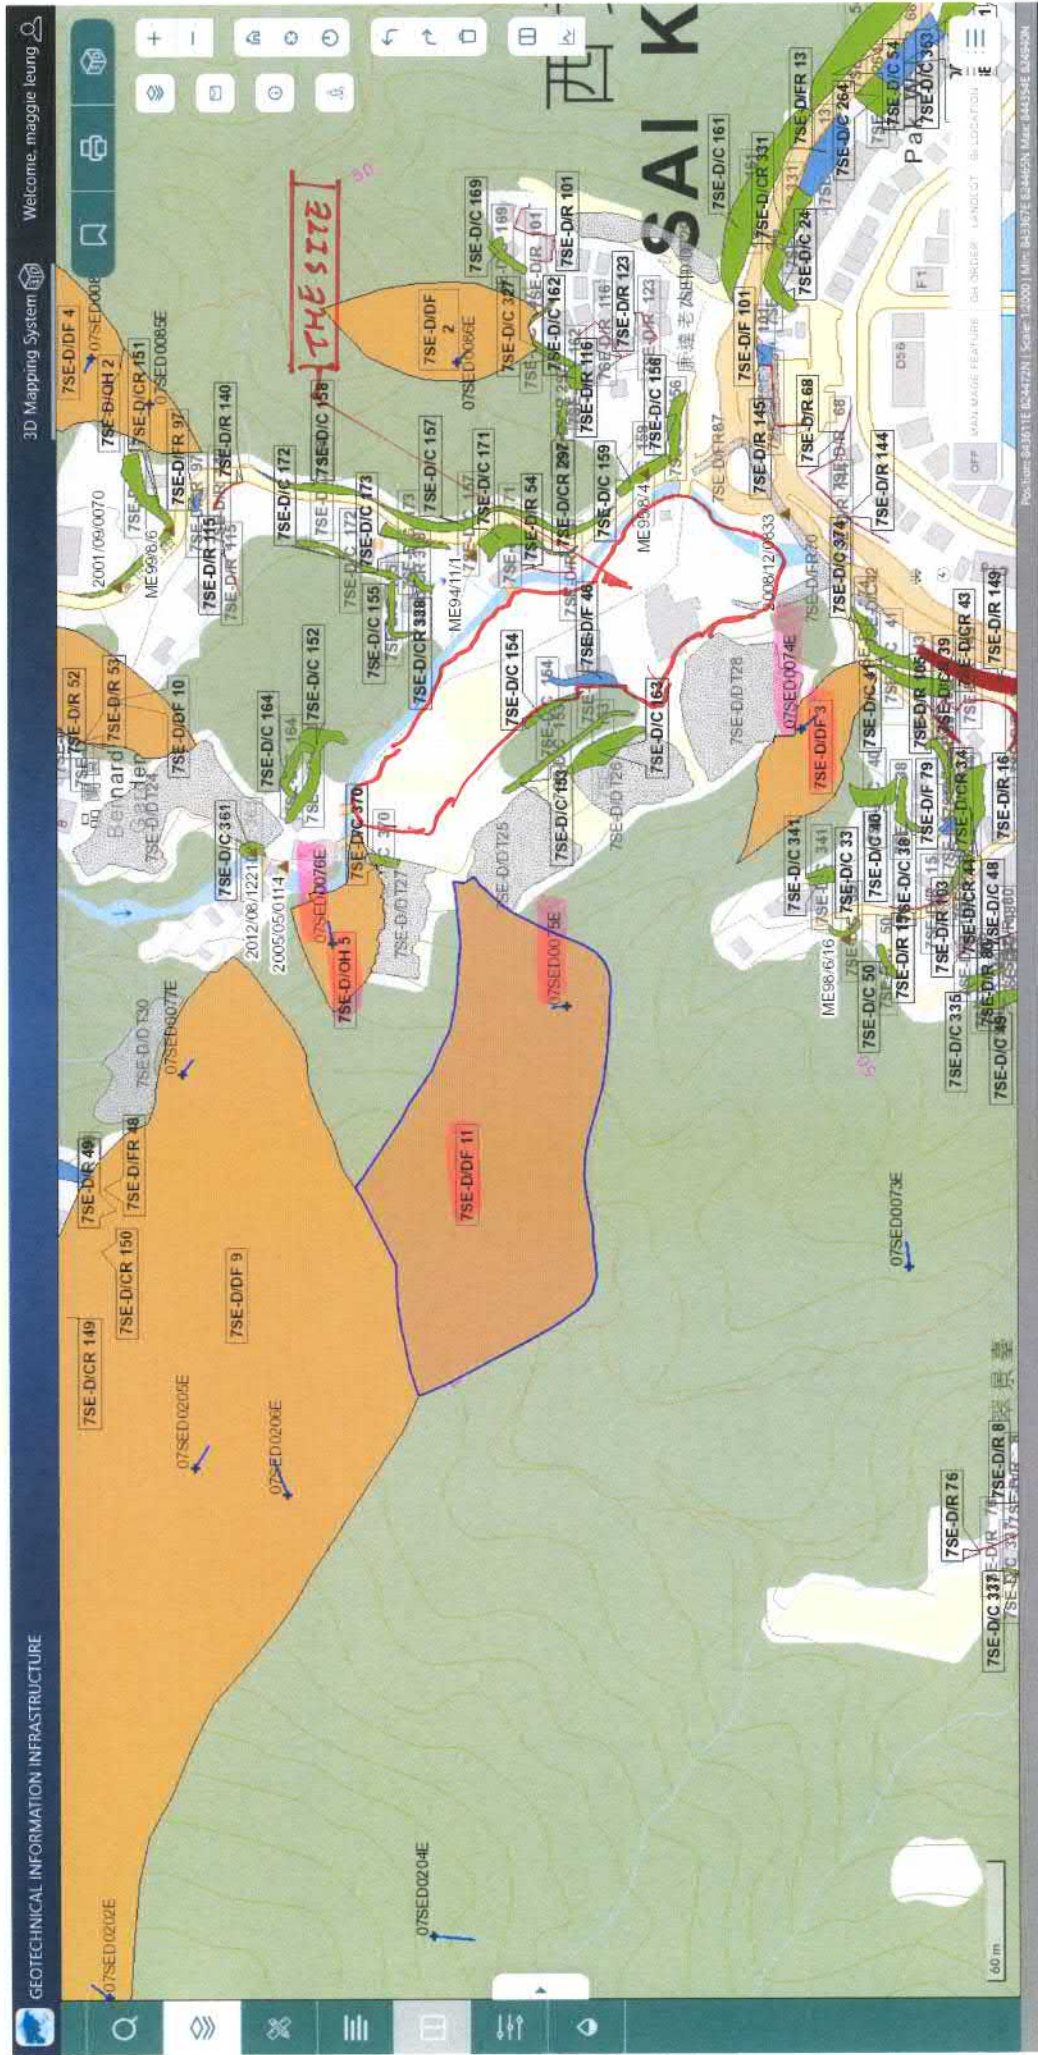
ENTLI & HLC

Historical Landslide Catchment

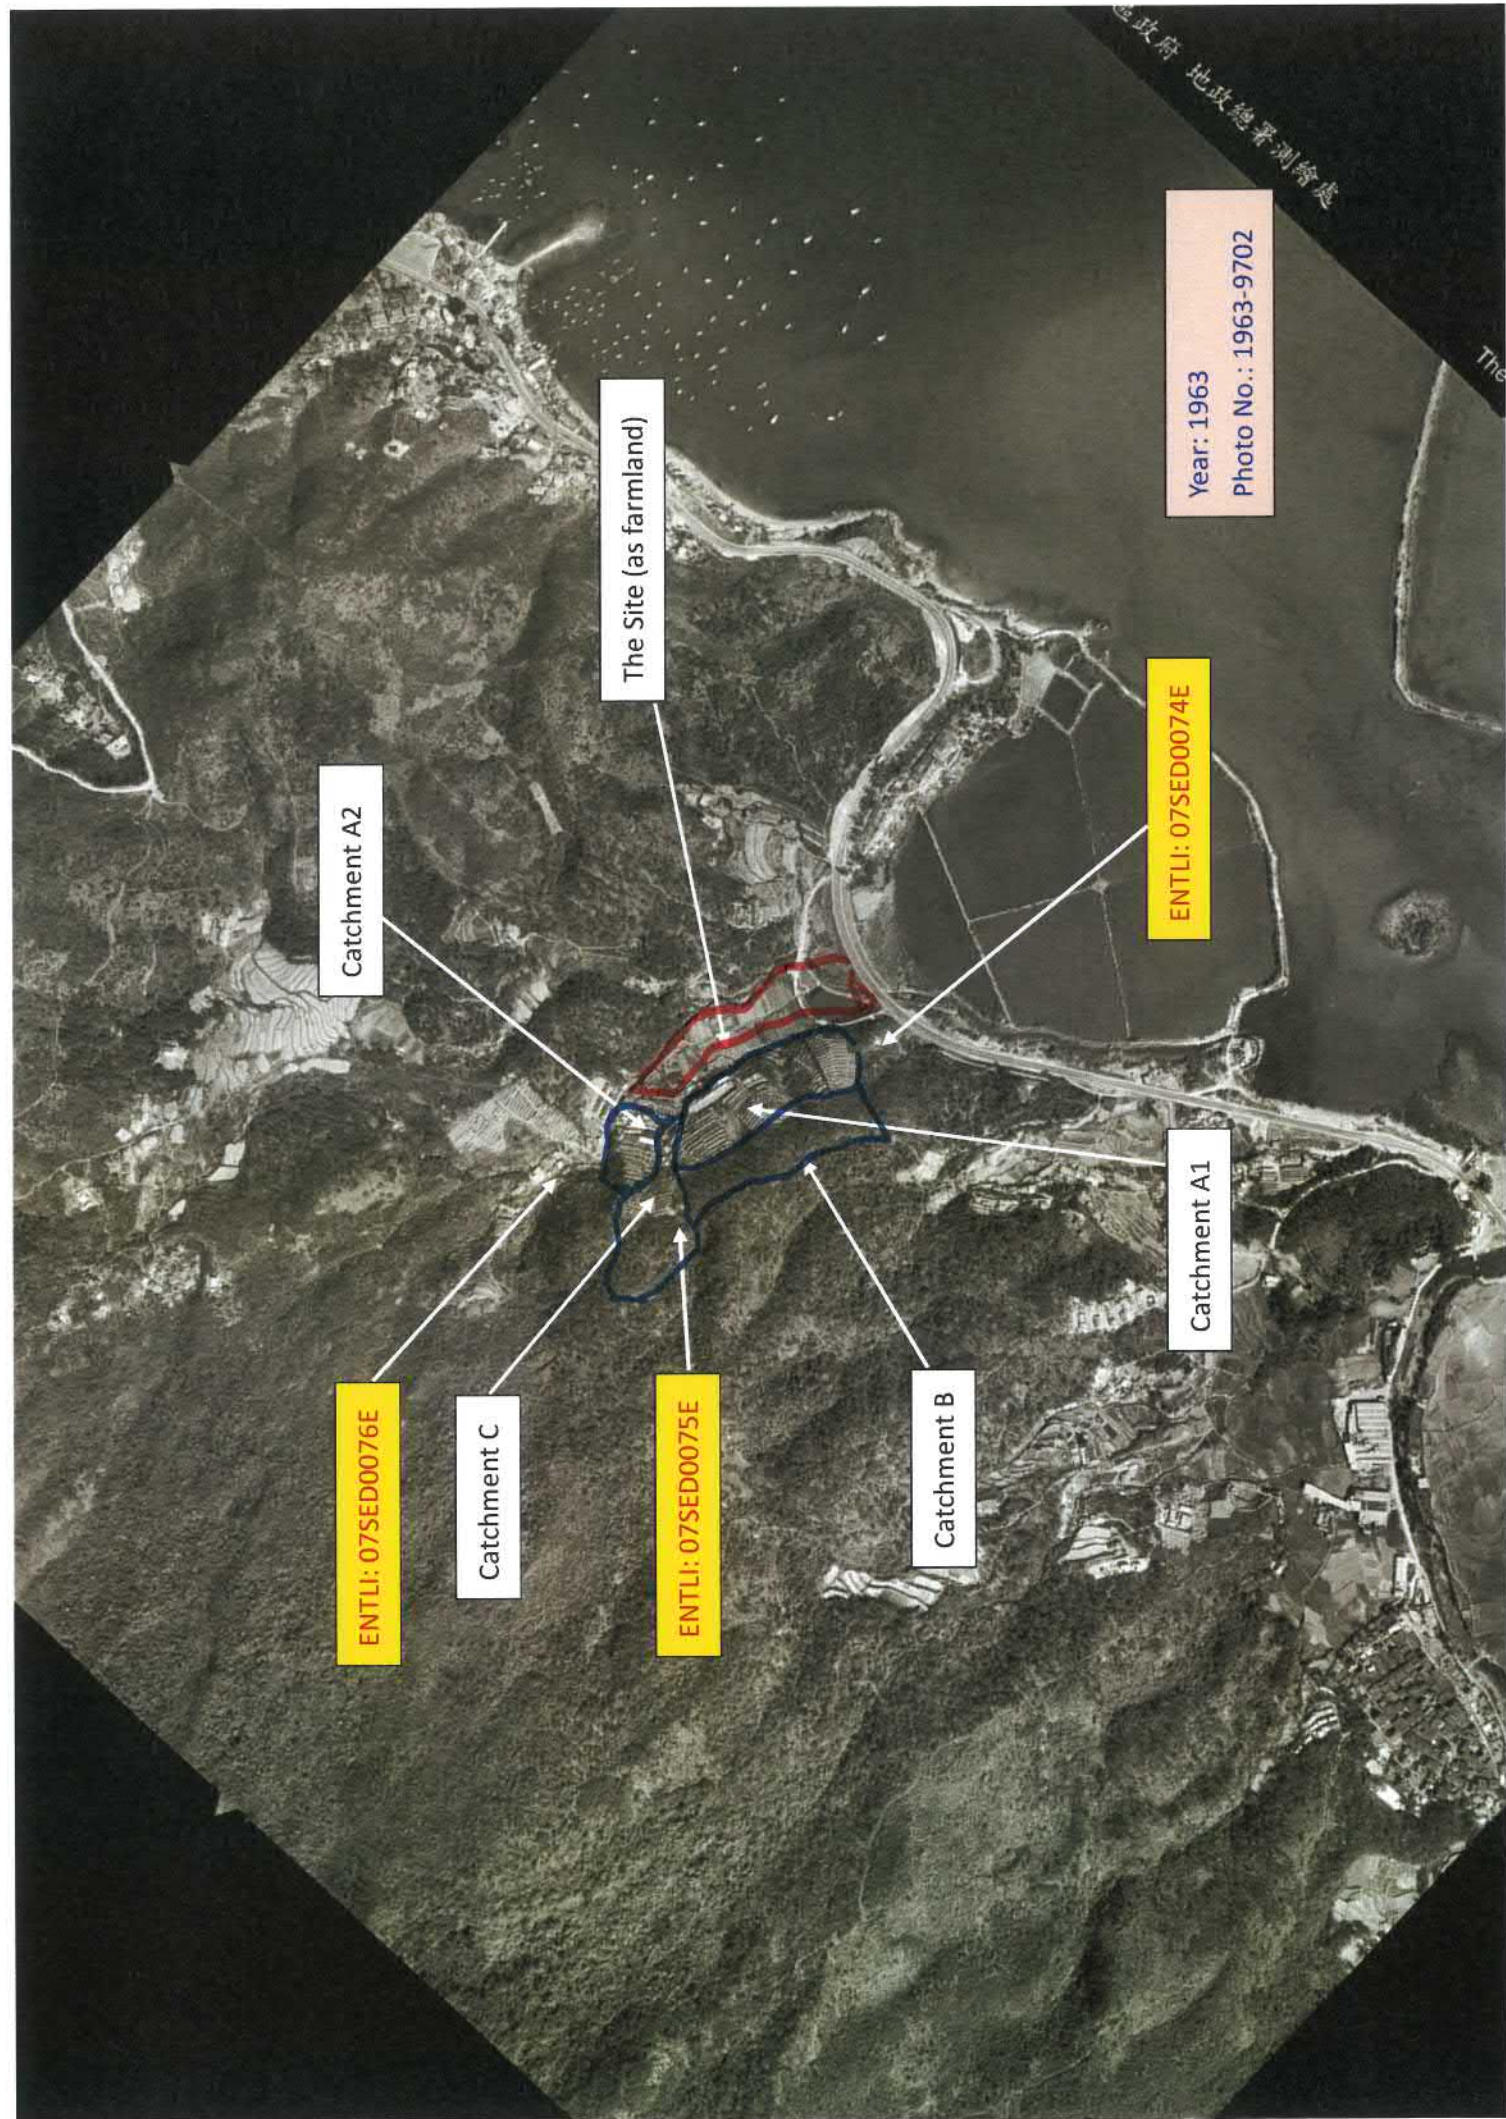
Year: 1963  
Photo No.: 1963-9702

ENTLI: 07SED0075E

Catchment B

| Year | Photographic Reference no. | Activities | Observations |
|---|---|---|---|
| 1963 | 1963-9701<br>1963-9702 | 3900 | The usage of land in the Site is farmland. Catchment A1 & A2 are also farmland. 3 nos. of Enhanced Natural Terrain Landslide Inventory (ENTLI) with Historical Landslide Catchment (HLC) are found from Ginfo. |
