**GEOTECHNICAL PLANNING REVIEW REPORT (GPRR)**

**APPLICATION FOR AMENDMENT OF PLAN**

**PROPOSED RESIDENTIAL DEVELOPMENT AT**

**PAK WAI, SAI KUNG**

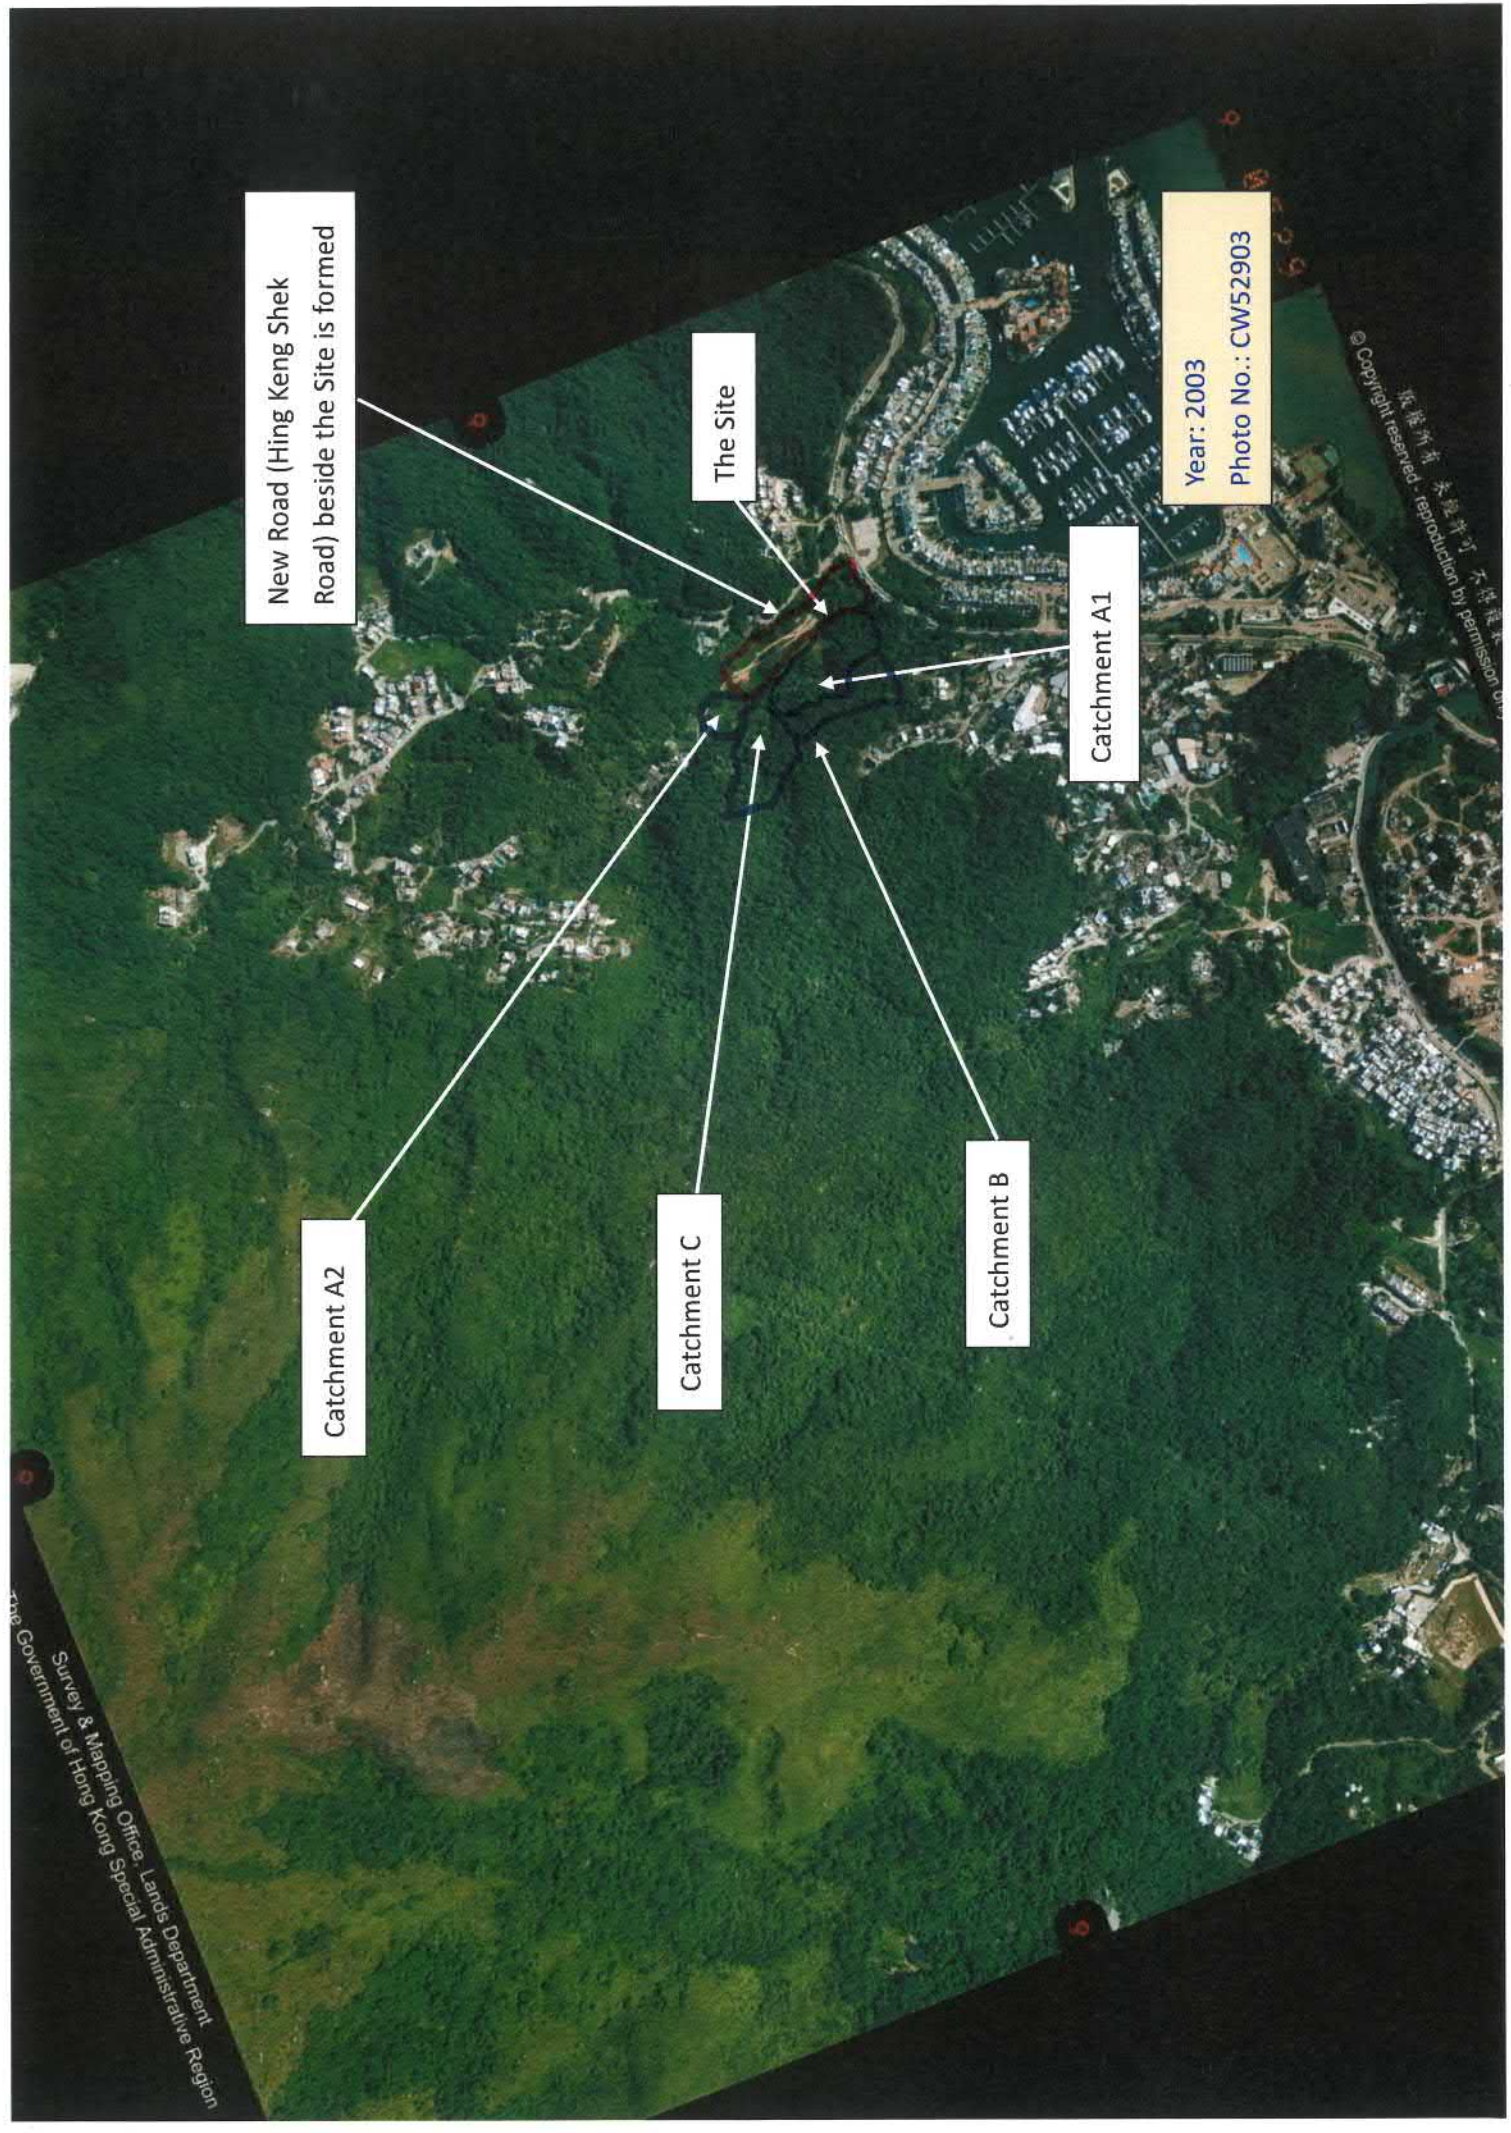
New Road (Hing Keng Shek Road) beside the Site is formed

The Site

Catchment C

Catchment A2

| Year | Photographic Reference no. | Activities | Observations |
|---|---|---|---|
| 2003 | CW52903 | 4000 | New Road (Hing Keng Shek Road) beside the Site is formed<br>Some squatters found in the Site.<br>Catchments under study were fully covered by vegetation. |
