VARIOUS LOTS IN DD185, SHEUNG WO CHE NO. 198 SAI LAM TEMPLE, SHATIN, NEW TERRITORIES

GEOTECHNICAL PLANNING REVIEW REPORT (AMENDMENT 1)

APRIL 2025

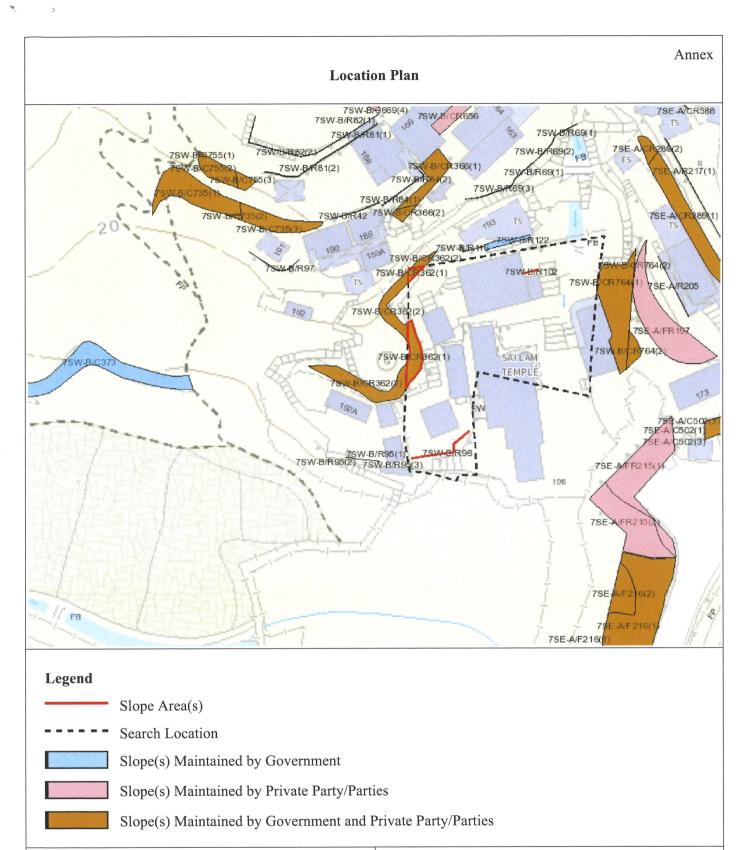
Search Criteria: DD185 Lot 296

This Plan is **NOT TO SCALE** and intended for **IDENTIFICATION** only. All information shown on this plan **MUST** be verified by field survey.
