Appendix A
Conservation Management Plan

Conservation Management Plan with Implementation Proposal for the Proposed Hotel Development with Adaptive Reuse of Ng Yuen at Shing Mun River, Sha Tin

2026 June

Prepared by Substance Lab Limited

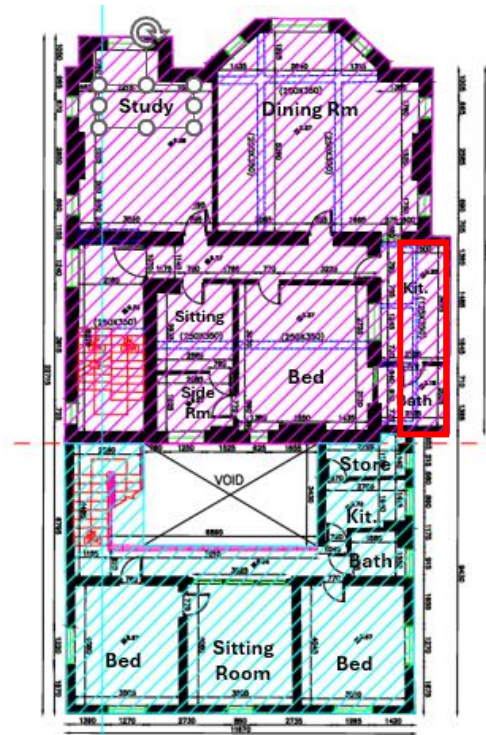
B1.3 – Plan showing MB 1/F (hatched in pink) and SB 2/F (hatched in cyan) of Ng Yuen. The area demarcated in red is not covered by the historic building boundary. It covers part of 1/F kitchen and bathroom at MB that were later expanded. Floor plans of better legibility are presented on P.20 and 21. (Source: The Applicant, 2026)

NY is composed of Main Building (MB), Sub Building (SB), and the lightwell sandwiched between MB and SB. The grading boundary with a recessed portion on the east side excludes the existing kitchen and bathroom on the 1/F of Main Building, and includes the lightwell sandwiched between the Main and Sub Buildings.

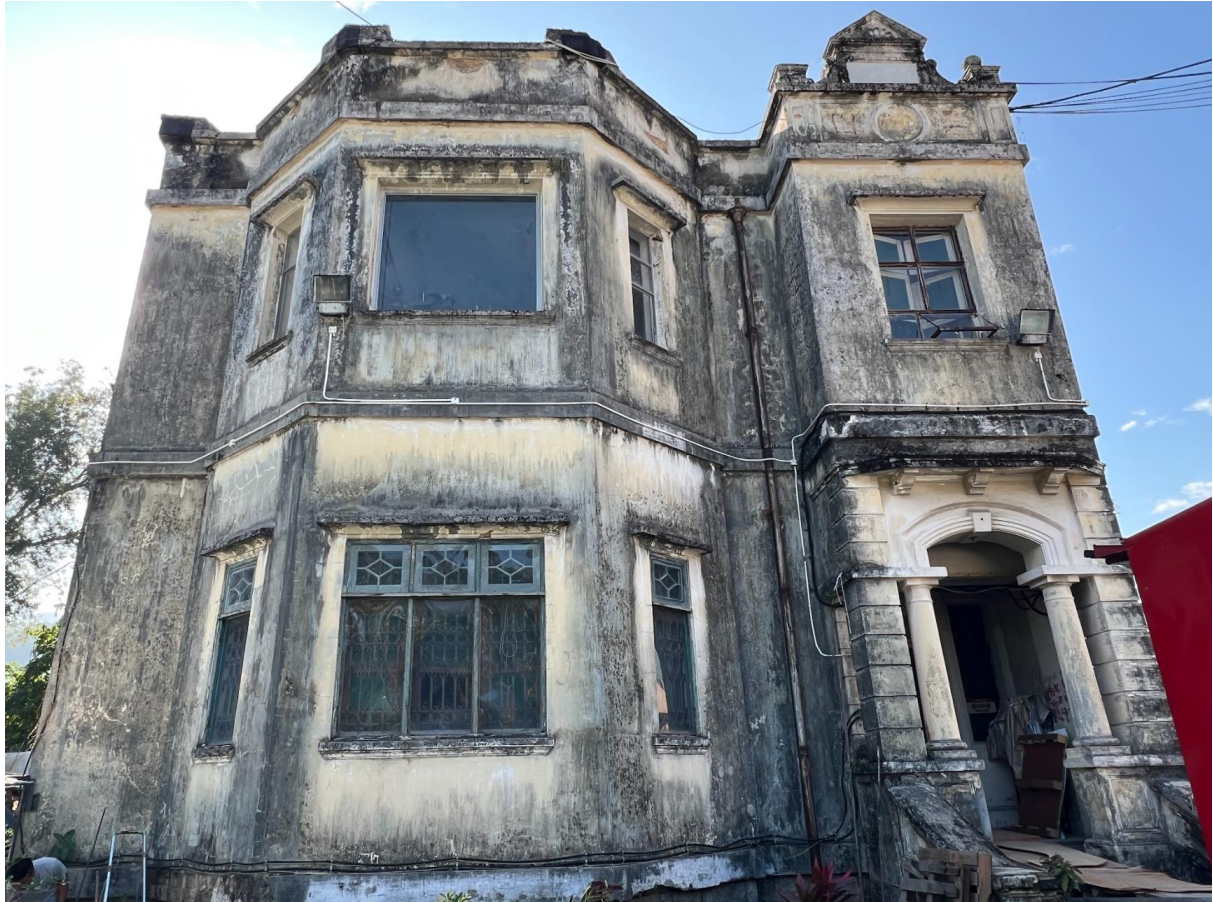
B4.1.1 – The main entrance is located at the west side of the main facade.

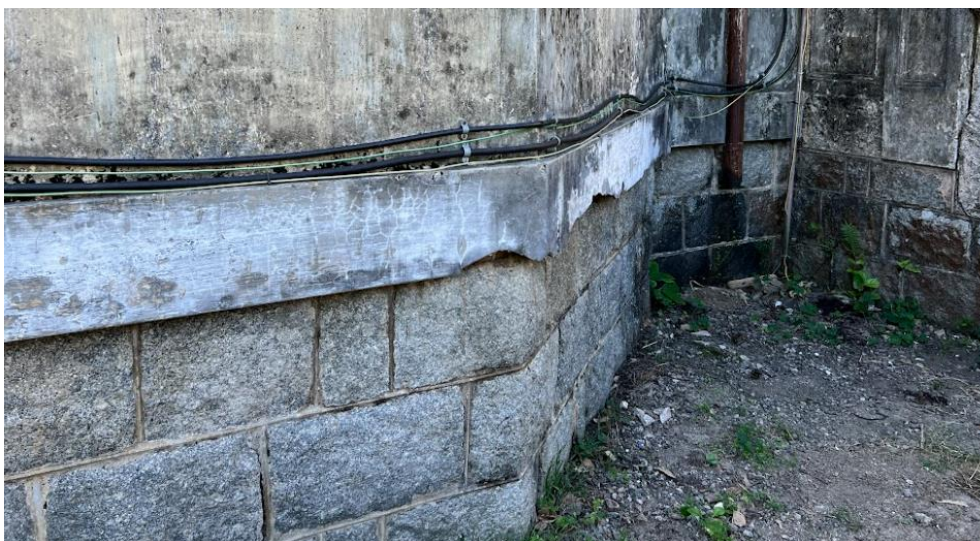
B4.1.3 – Granite to the base of the Main Building which raises the level of its G/F.

It is composed of two portions, namely the Main Building and Sub Building. The former is raised from the ground with a base faced with granite blocks of about 1.29m high. Such arrangement creates grandeur and minimizes moisture of the ground from entering the interior, similar to bungalow. The Main Building is accessible by ascending a short flight of steps from the main entrance positioned on west side of the main facade. It has 2 storeys that sandwich a mezzanine of limited footprint right above the G/F kitchen and bathroom.

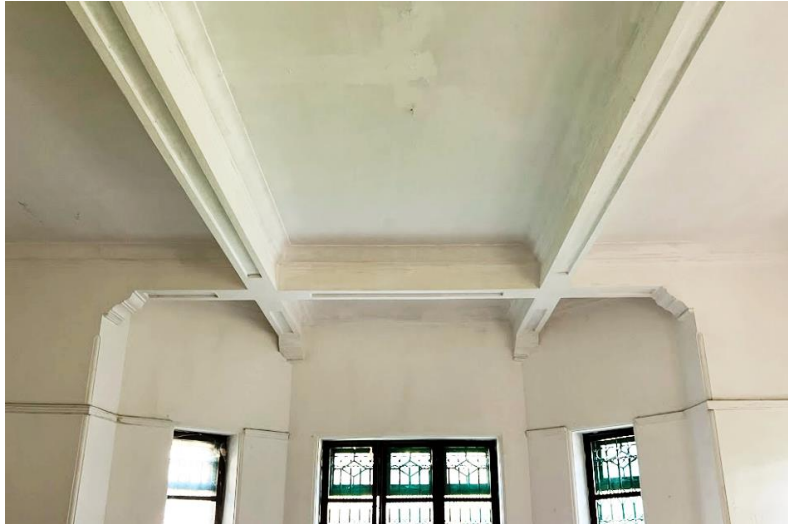
B4.1.4 – Structure with reinforced concrete structural beams at Main Building.

NY is in reinforced concrete, but the Main and Sub Buildings are built in different manner. In the 1920s, inserting timber strips—often called "sleepers" or "nailing strips"—into reinforced concrete floor slabs was a common practice designed to facilitate the installation of wood flooring in residential buildings, as the case of Main Building which is substantially finished with timber flooring. As construction shifted from traditional timber joists to more durable, fire-resistant reinforced concrete, the need to attach wooden finishes (like hardwood floors) remained, necessitating a hybrid approach. Sub Building was added in the 1960s to 1970s whose concrete floor slab has no timber strips. Its internal floors are finished mainly by terrazzo.

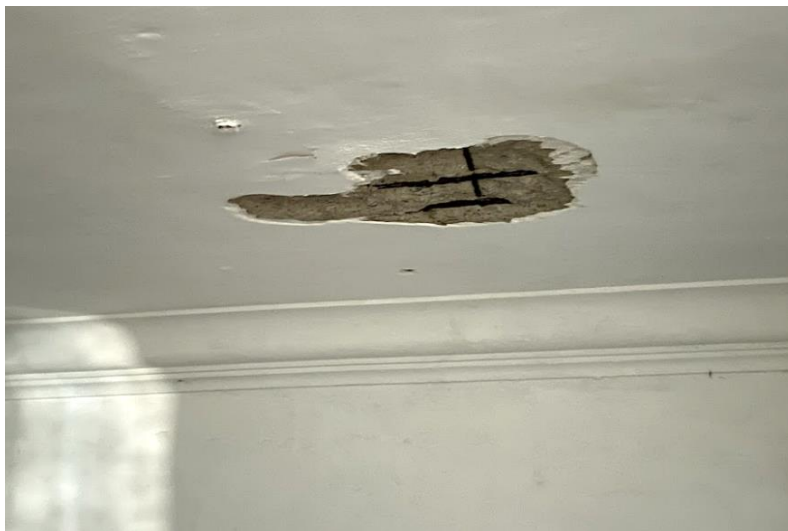
B4.1.5 – Structure with reinforced concrete slabs at Main Building.

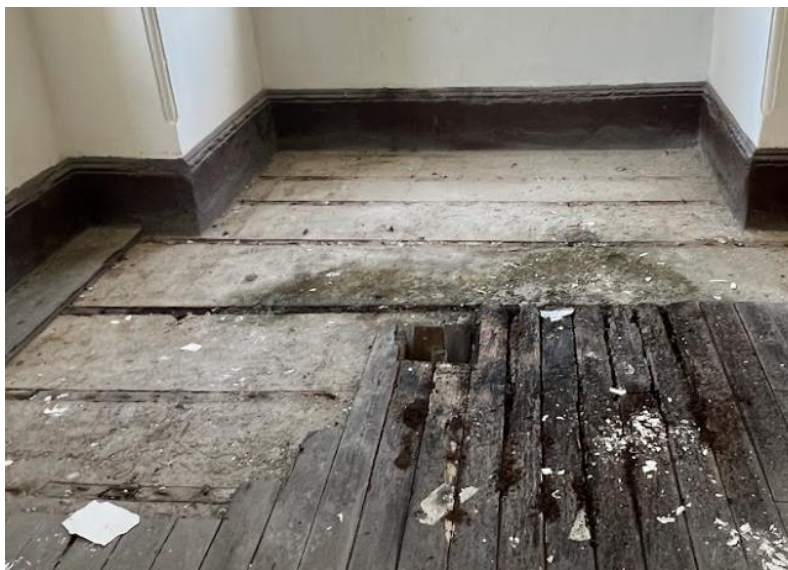
B4.1.6 – Slabs composed of reinforced concrete structural slab blocks inserted with timber strips.

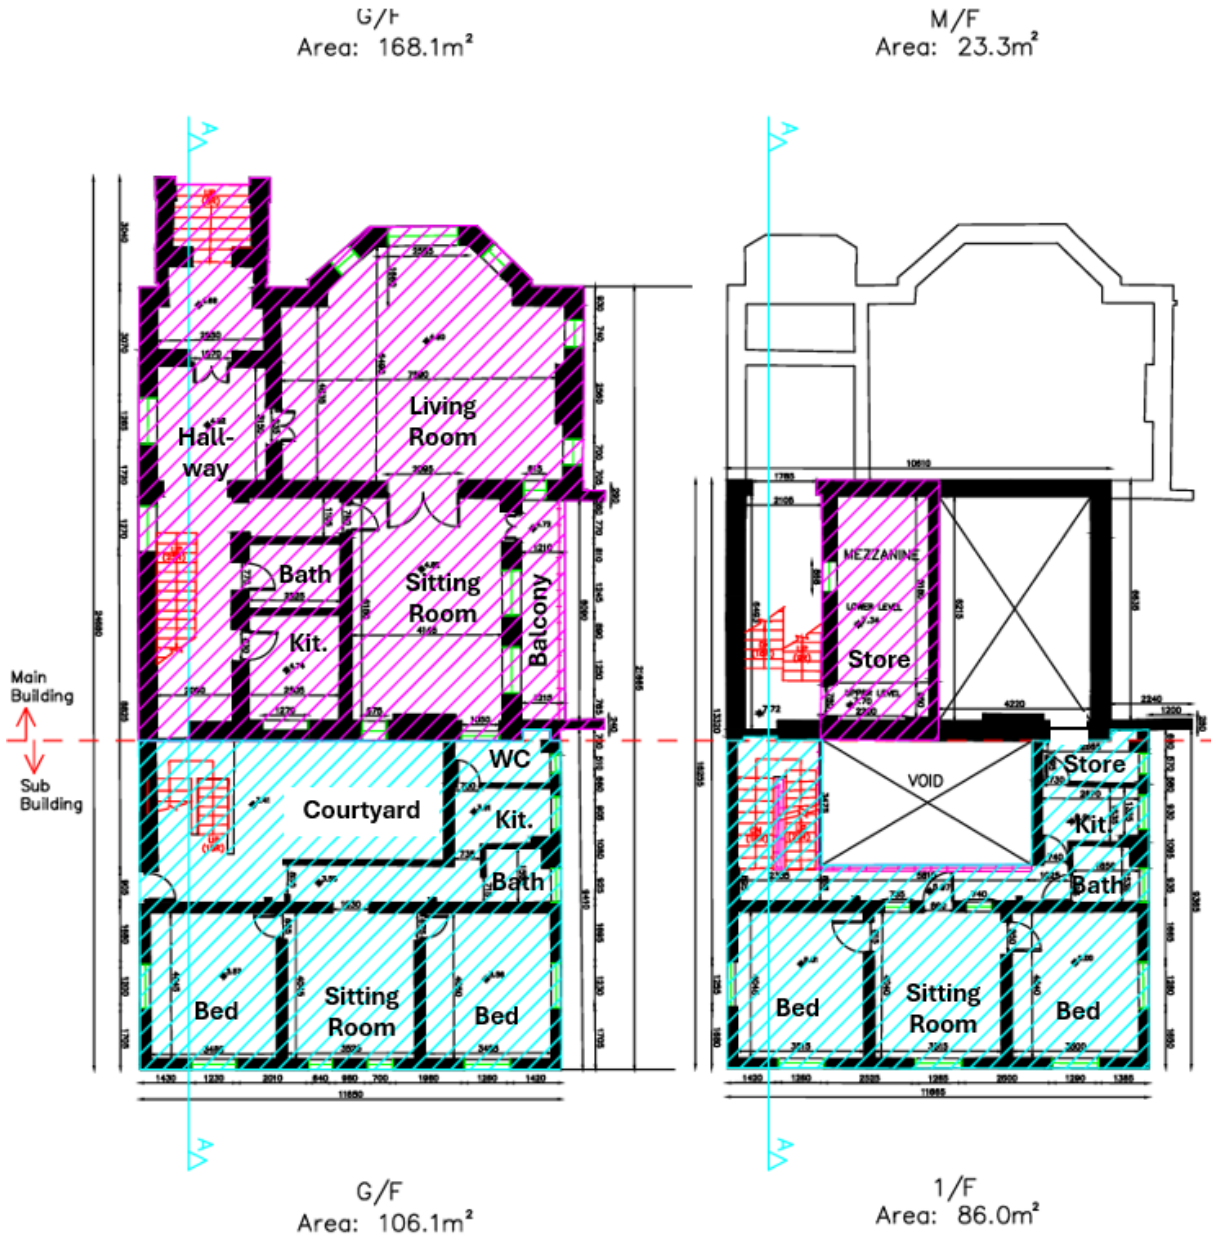
B4.2.1a – Floor plans of the Main Building (cross hatched in pink) and Sub Building (cross hatched in cyan) of Ng Yuen. (Source: THE APPLICANT, 2025)

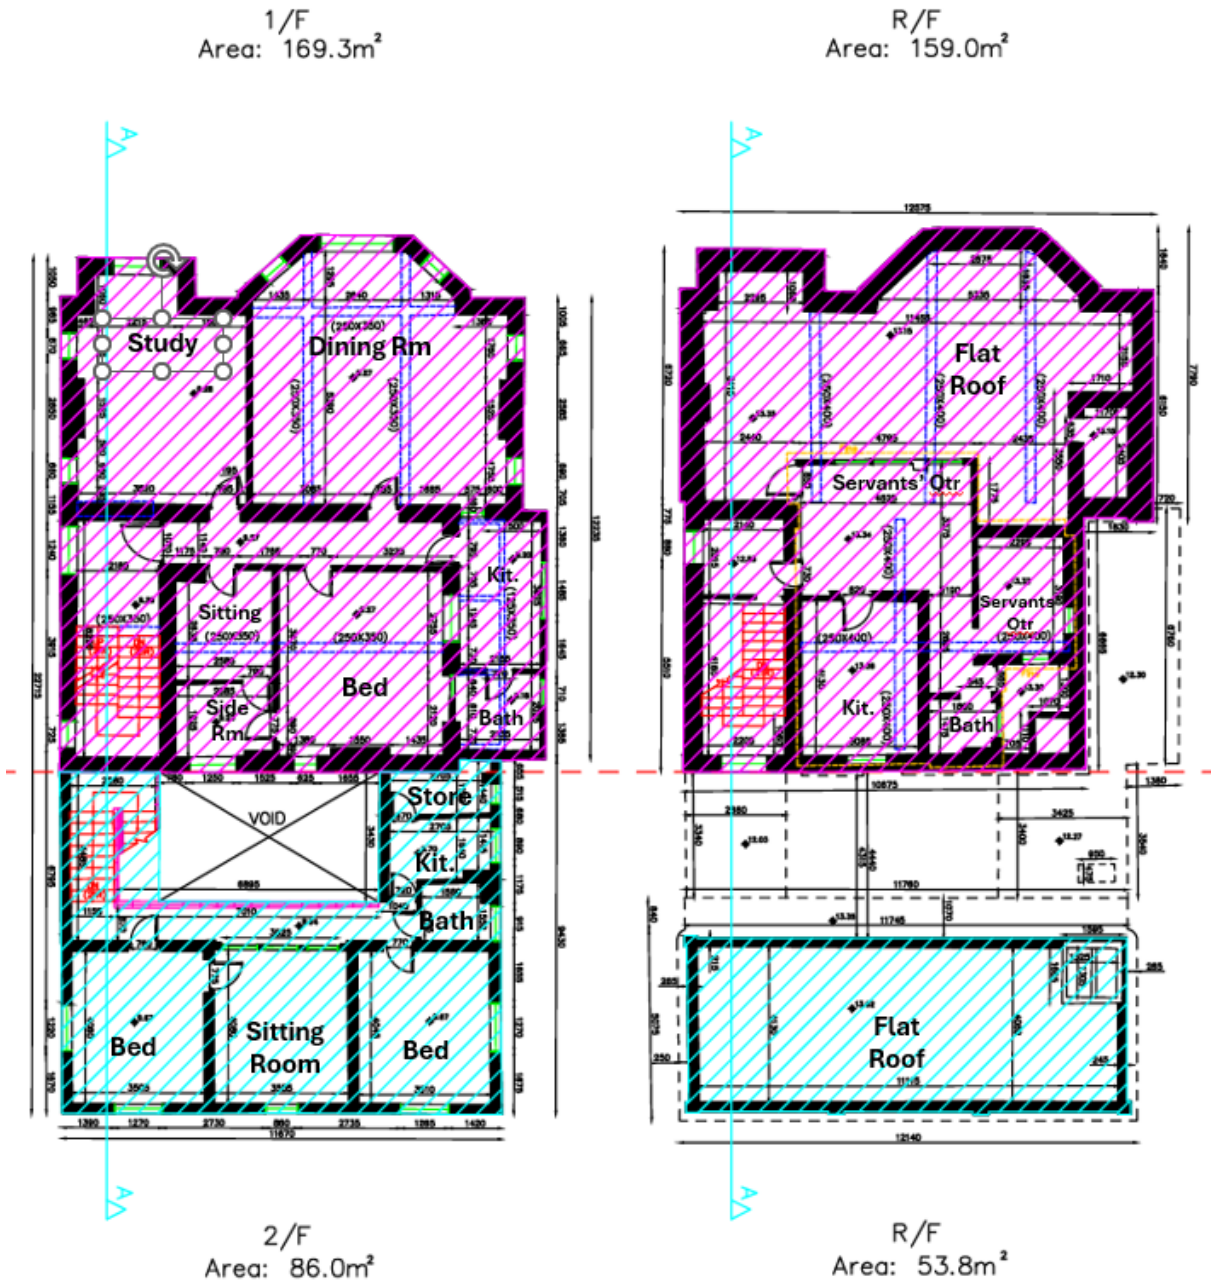
B4.2.1b – Floor plans of the Main Building (cross hatched in pink) and Sub Building (cross hatched in cyan) of Ng Yuen. (Source: THE APPLICANT, 2025)

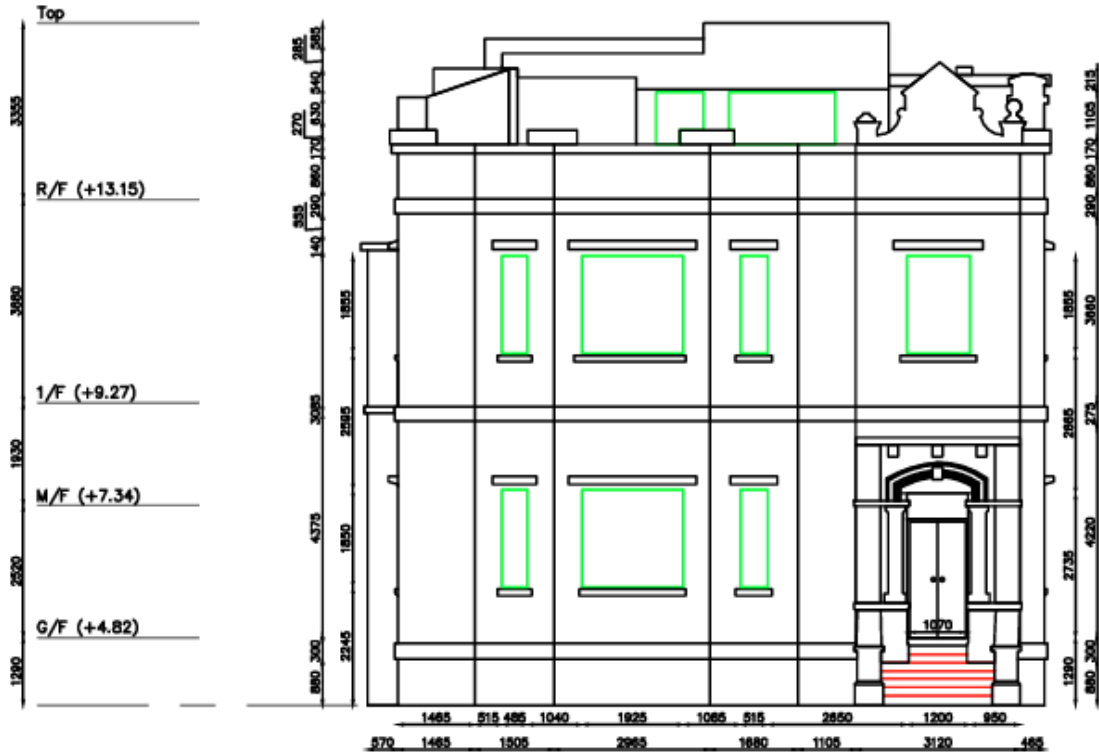
B4.2.2 – Front (north) elevation of NY Main Building (Source: THE APPLICANT, 2026)

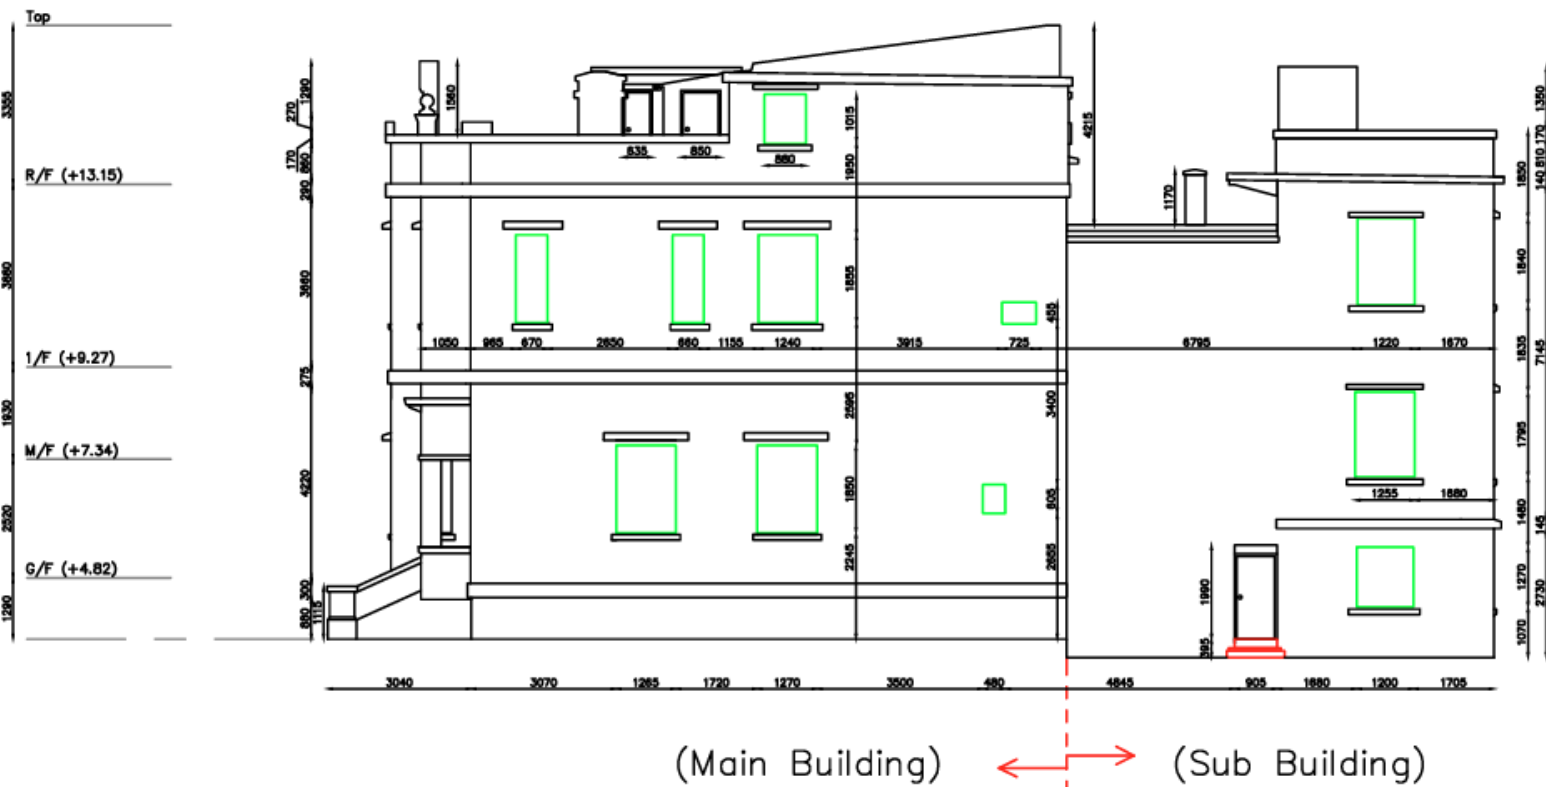
B4.2.5 – Side (west) elevation of NY (Source: THE APPLICANT, 2026)

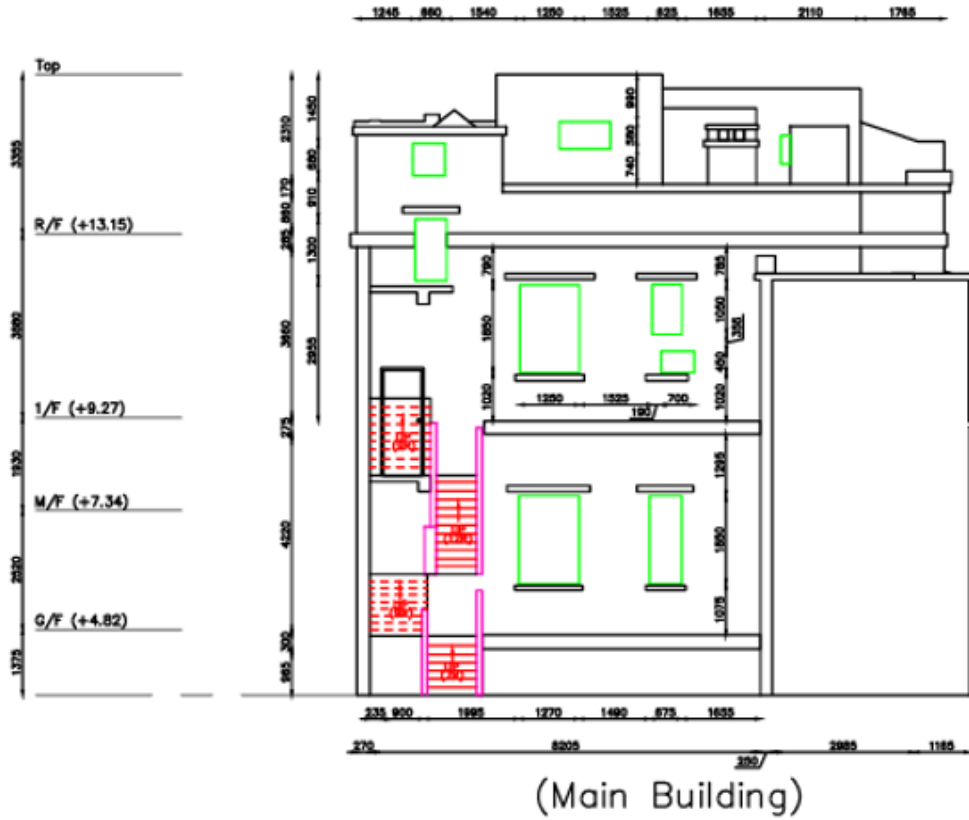
B4.2.6 – South elevation of NY Main Building (elevation to the north of lightwell) (Source: THE APPLICANT, 2026)

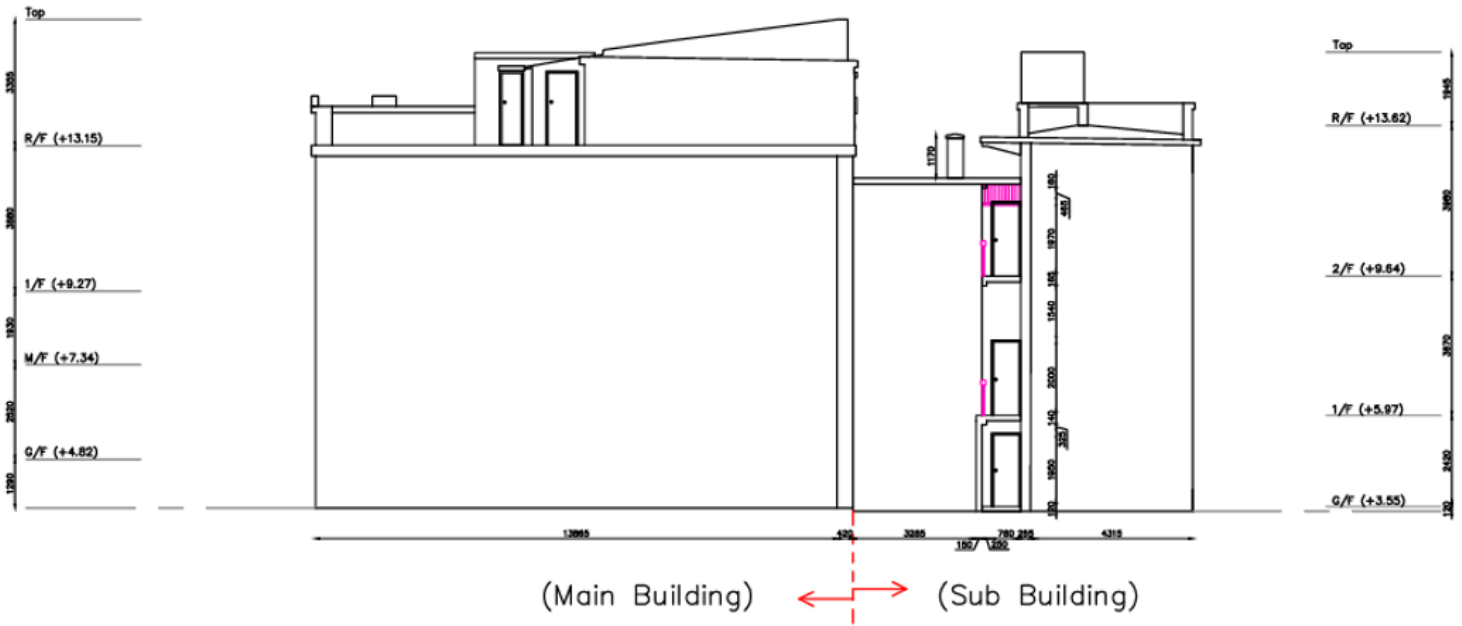
B4.2.8 – Elevation to the east of lightwell (Source: THE APPLICANT, 2026)

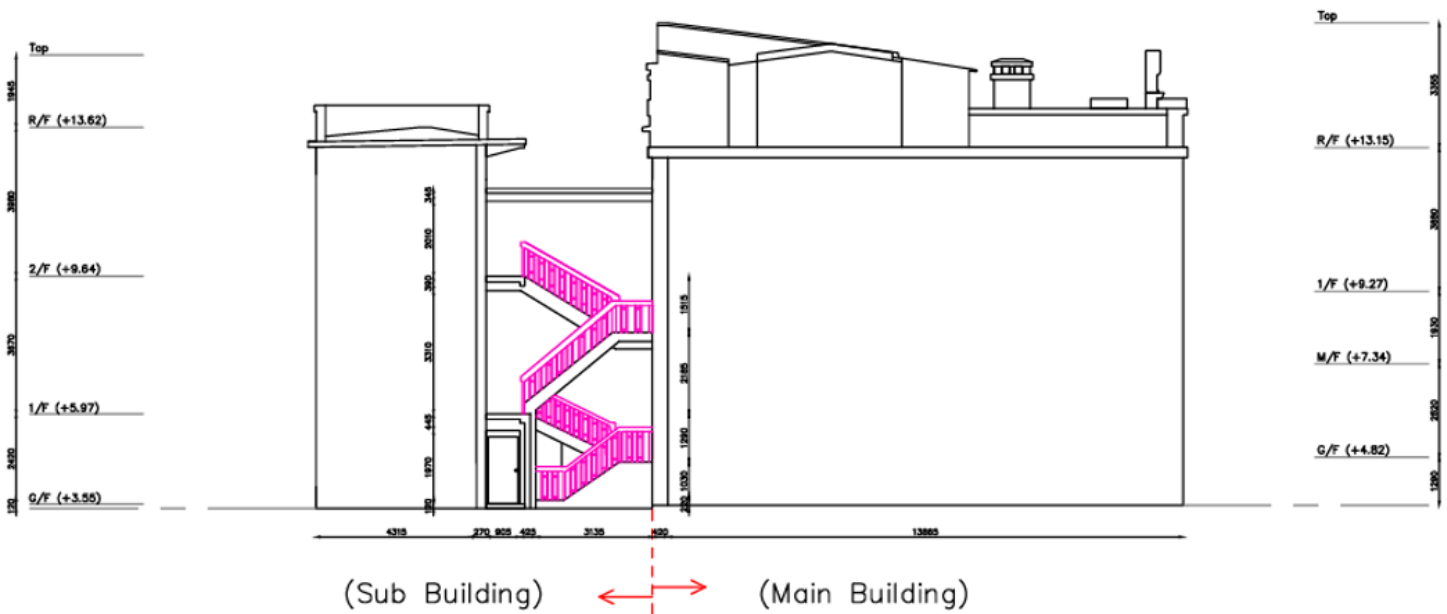
B4.2.9 – Elevation to the west of lightwell (Source: THE APPLICANT, 2026)

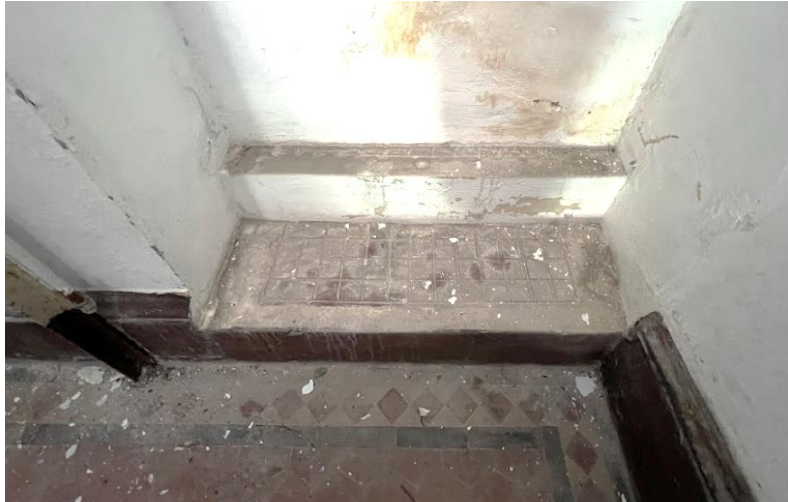
B4.2.12 – The skirting at the staircase landing on the mezzanine level of Main Building was modified for the introduction of a steps that reach the level of the landing between 1/F and 2/f of the staircase at lightwell.

The Main and Sub Buildings are built at different times. Firstly, it is noted that the skirting at the staircase landing at the mezzanine level of Main Building was modified awkwardly to allow the introduction of a step that extended to the landing of the staircase at lightwell between the 1/F and 2/F of Sub Building. Such alteration advises that Sub Building was a later addition. Such connection is now blinded by a full height wall (Fig. B4.2.12).

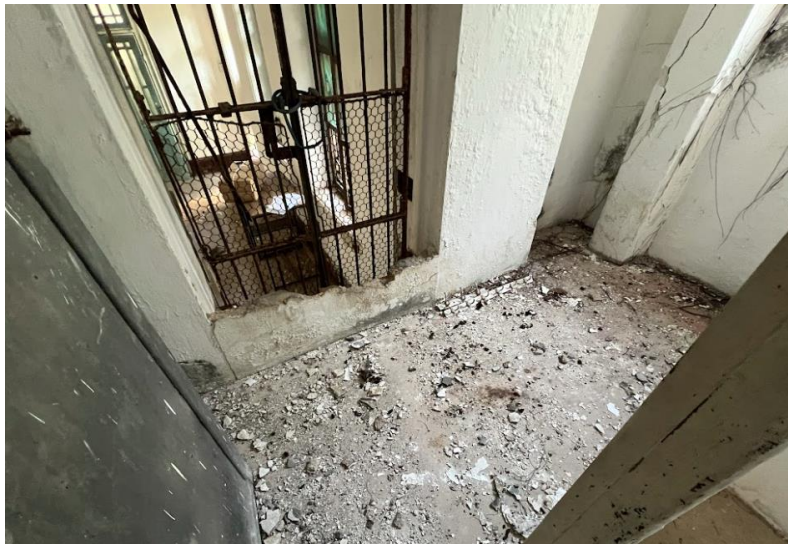
B4.2.13 – View of 1/F store of Sub Building. Original rear entrance with metal fence of NY at the south east of Main Building G/F sitting room is half blocked.

Secondly, at the southeast corner of the G/F sitting room of Main Building, there is a metal fence which is believed to be the security measure of the original rear door of NY. Due to the level difference, its bottom half is currently blocked by the north wall of the G/F WC of Sub Building, and is now providing merely a visual access to the 1/F store of Sub Building. Such situation reinforces the fact that the service core at the east of Sub Building was later added. Sub Building was not designed and not constructed at the same time as Main Building (Fig. B4.2.13).

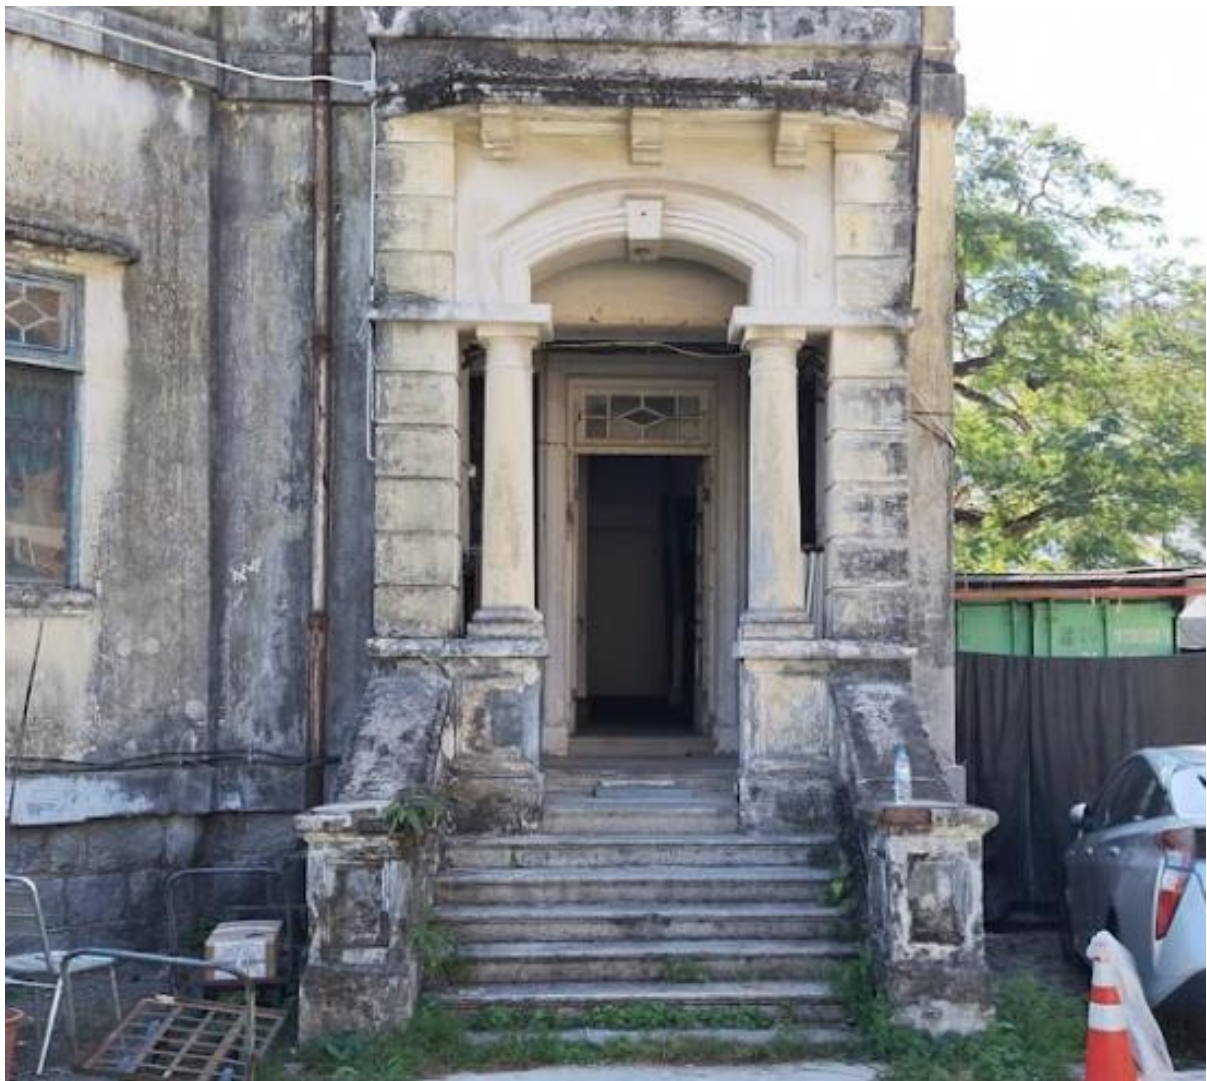
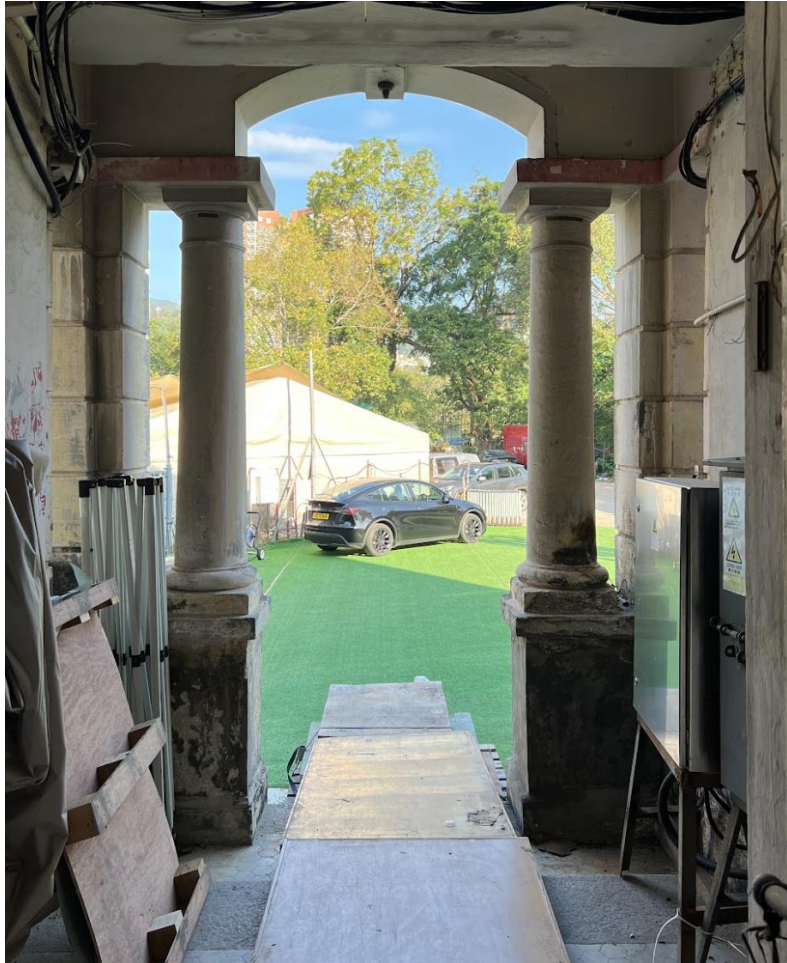
B4.3.1 – Entrance arch porch, Main Building.

B4.3.2 – Entrance arch porch, Main Building.

Externally, the entrance arch porch with columns of Doric orders at front are the dominant features of the building.

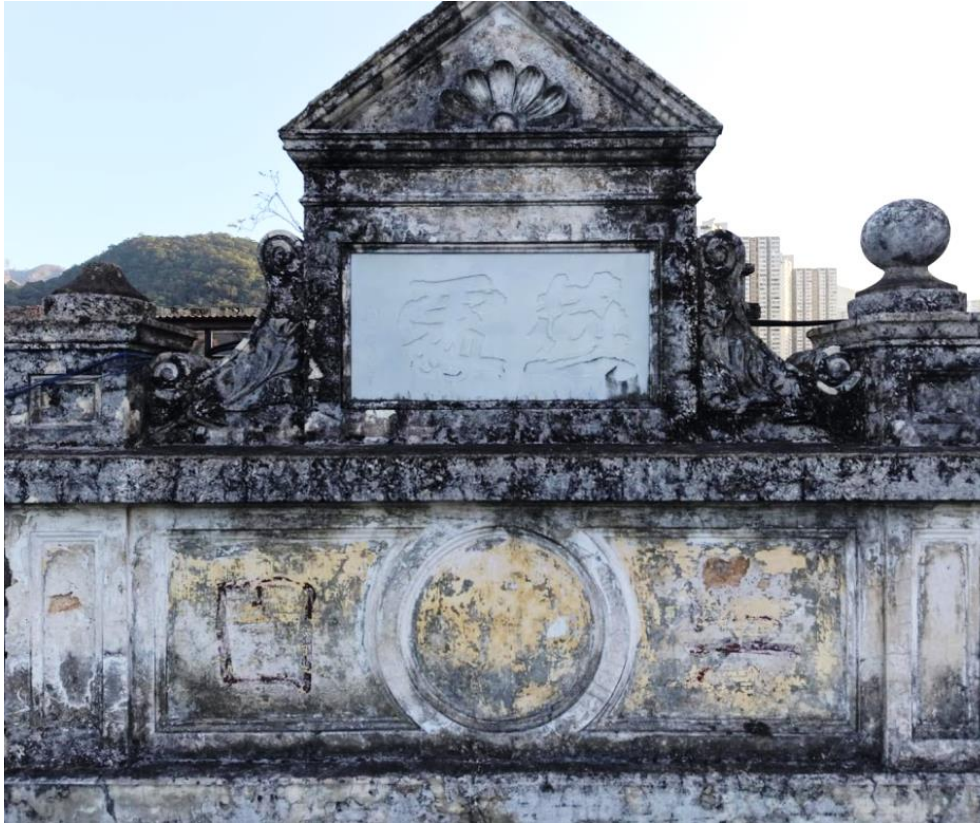
B4.3.3 – Ornate balustrade wall with upstand pediment inscribed with the name and nickname of the residence, Main Building.

The entrance porch is topped at the roof level with the parapet wall enriched with an upstand pediment with scroll ornamentations featuring floral and leave motives on top. The Chinese name of the residence 「吳園」 has been inscribed on the roof parapet wall directly above the entrance porch. The inscribed Chinese characters 「燕處」 signifying the residence as the place of retirement or rest for the owner are found on the rectangular panel at the pediment. Note that the Chinese character 「處」 here is presented by way of replace the top portion of 「處」 by 「雨」 (such approach is also known as 「雲頭」¹⁰, “head of cloud”).

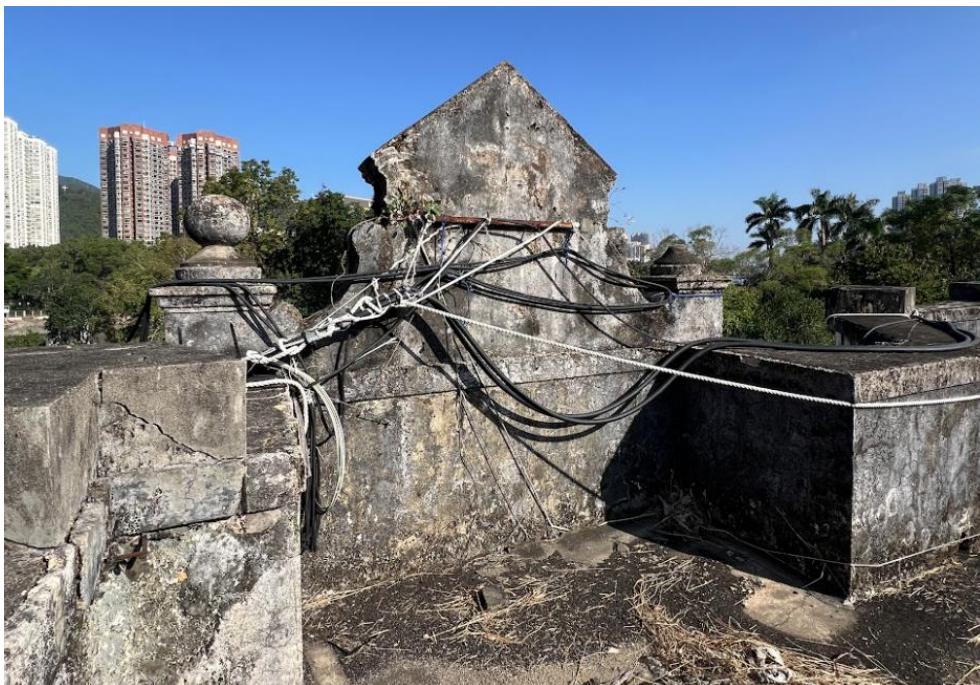
B4.3.4 – Ornate balustrade wall with upstand as observed from the roof level, Main Building.

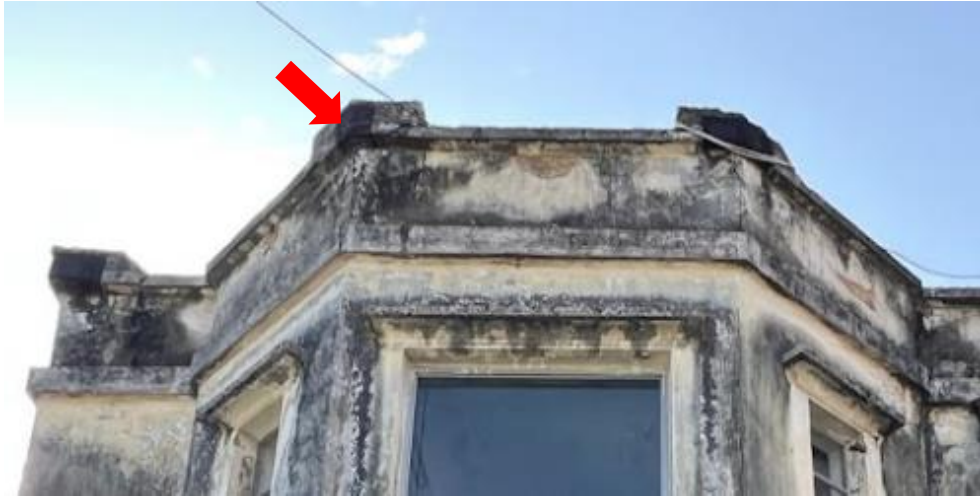
B4.3.5 – Roof crenellation features as observed from street level, Main Building.

Another significant feature at the roof balustrade walls is the presence of concrete masses resembling teeth-like battlement or crenellation, emphasizing the defensive gesture of the residence.

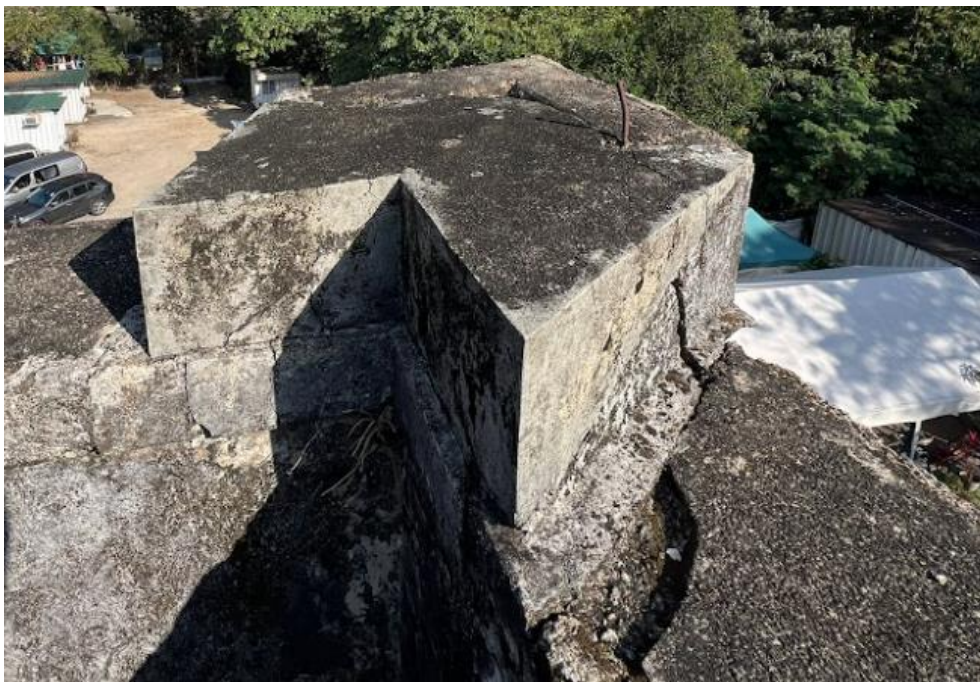
B4.3.6 – Roof crenellation features as observed from roof level, Main Building.

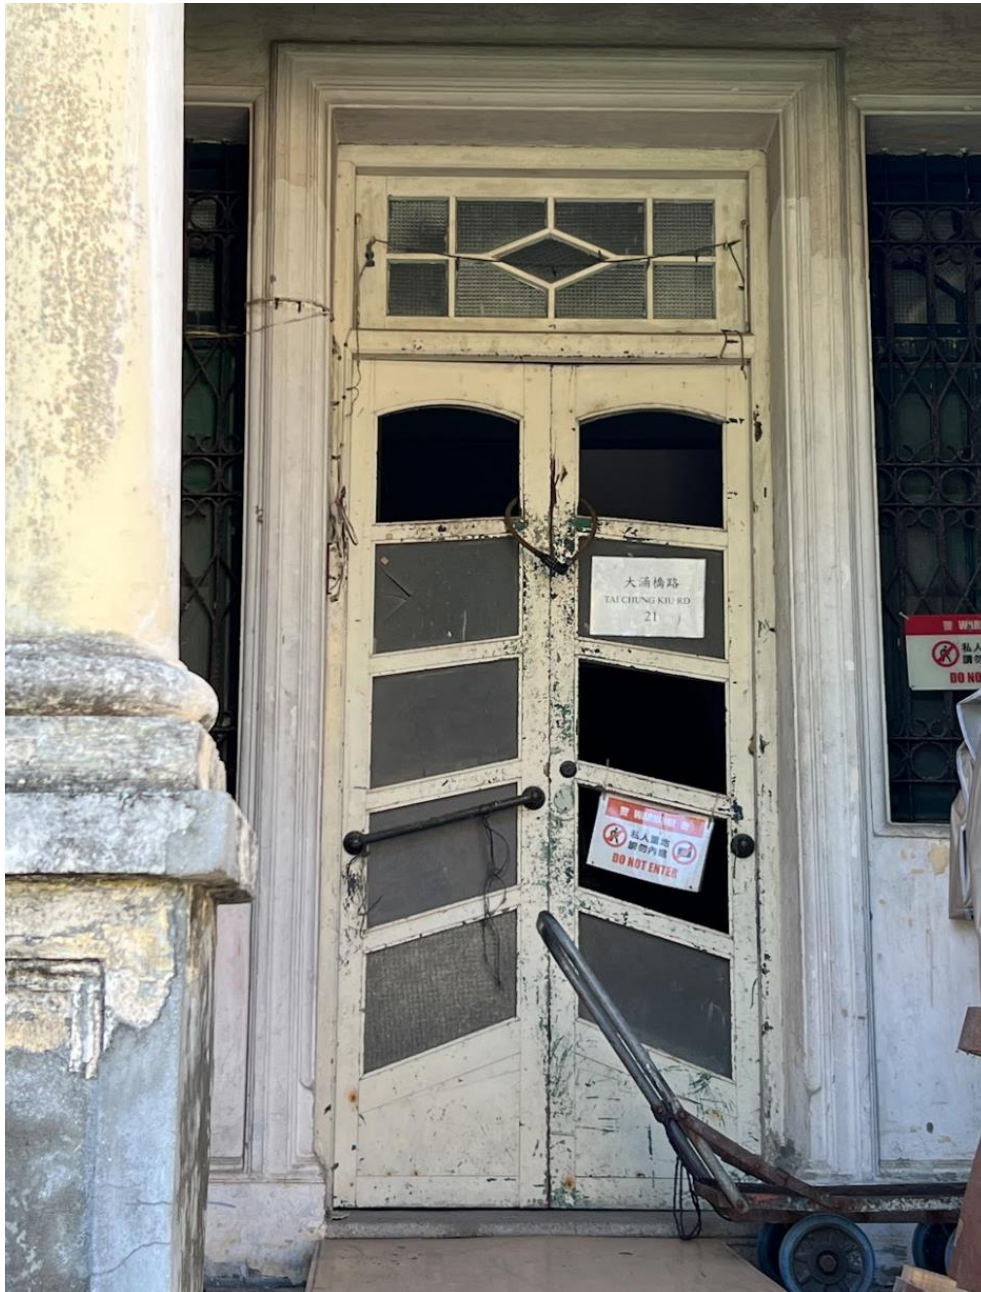
B4.3.7 – G/F main entrance door with fanlight at the top, Main Building.

The main entrance door and windows show careful design intention for aesthetics while fulfilling the functional needs. They are equipped with fan lights at the top for natural ventilation. Glass panels of main entrance door are translucent for privacy. Windows are secured by metal grilles for security. Some windows are still secured with metal grilles. Most of them are equipped with mosquito nets that were not originally but later added.

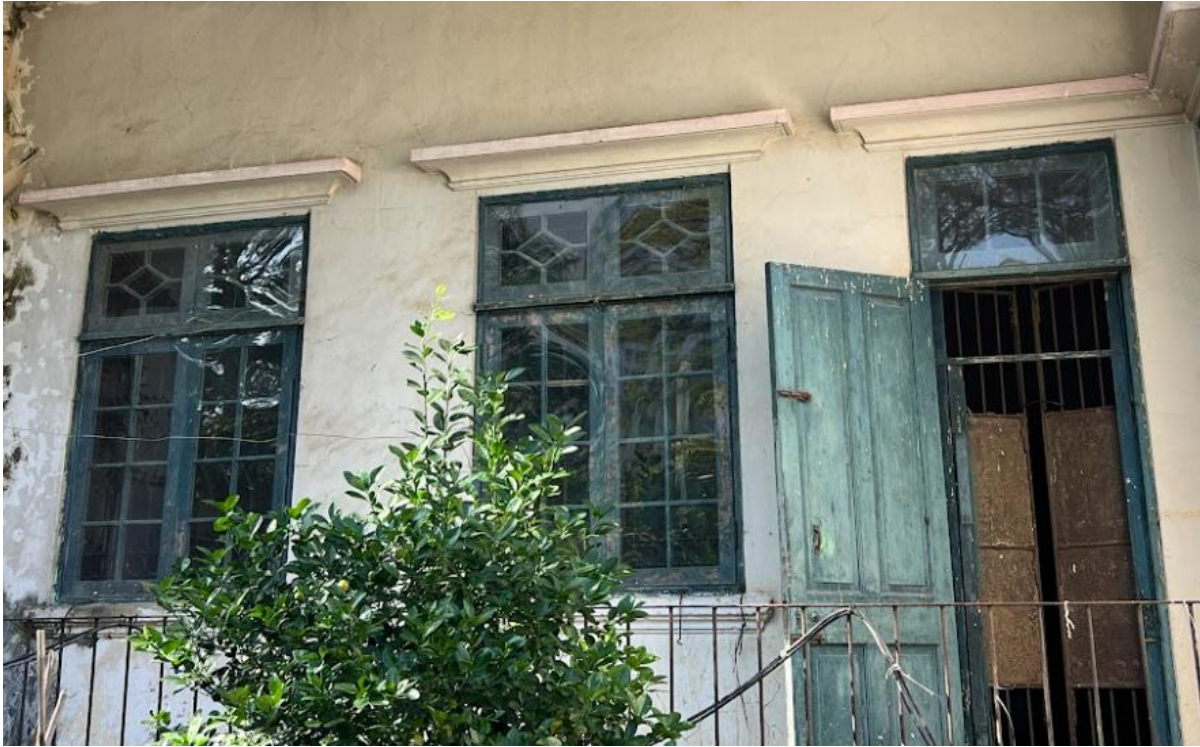
B4.3.8 – Side door providing access to the G/F balcony and windows on the east elevation, Main Building.

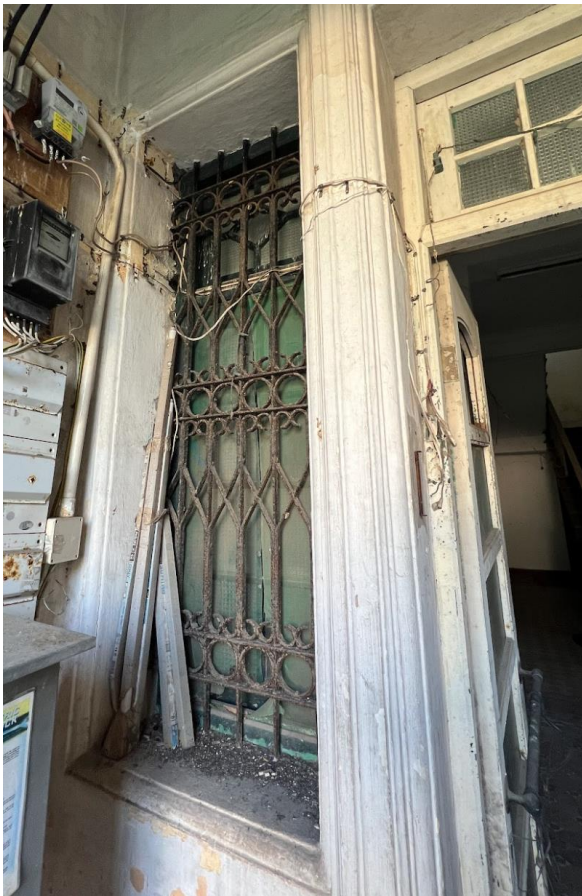
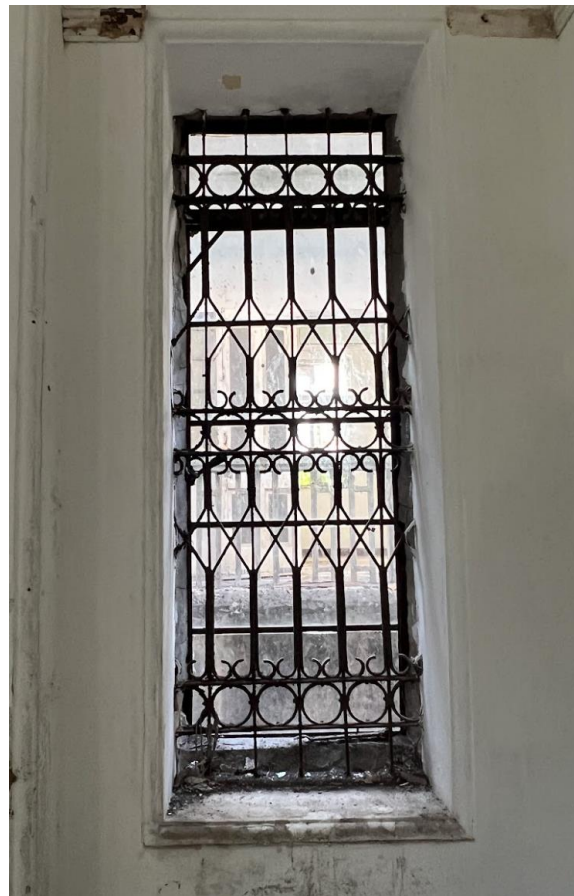
B4.3.9 & 10 – Metal grilles are installed at sidelights of the G/F main entrance, and other G/F windows, Main Building.

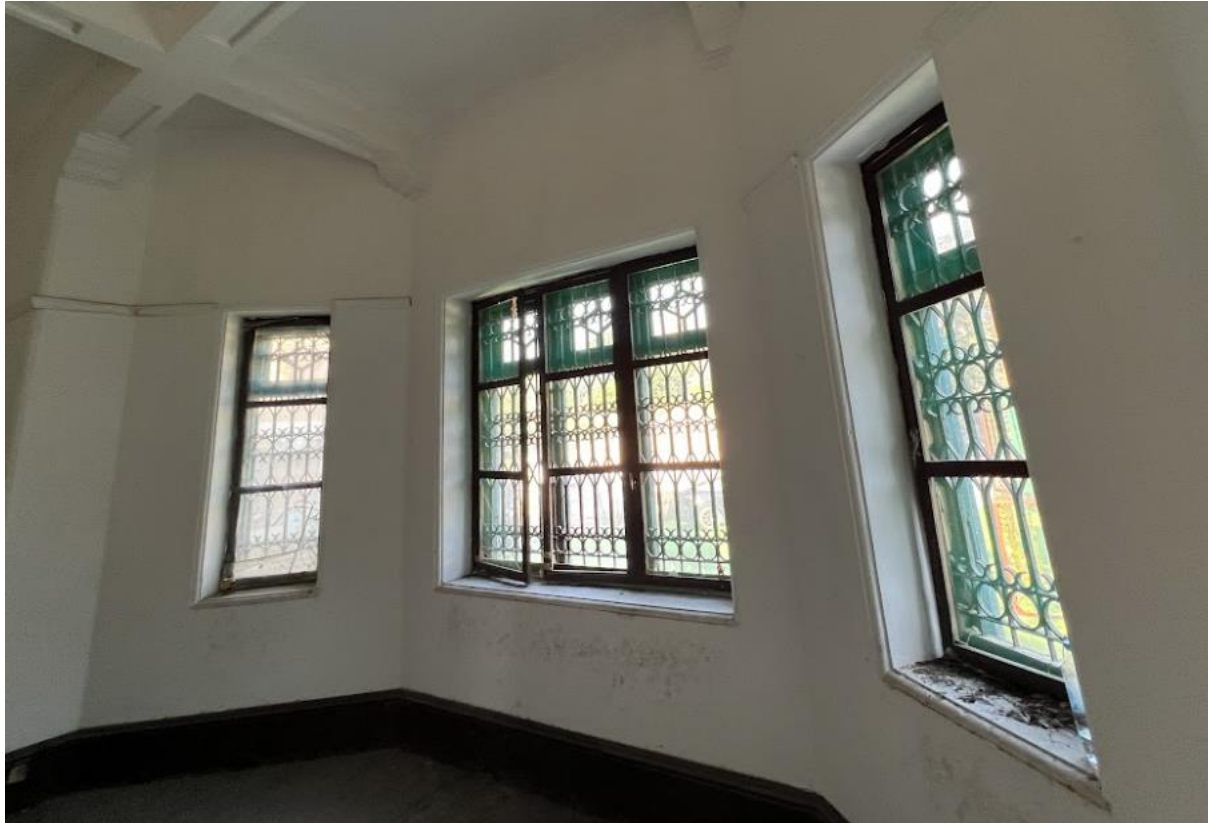
B4.3.11 – Windows at the G/F living room, Main Building.

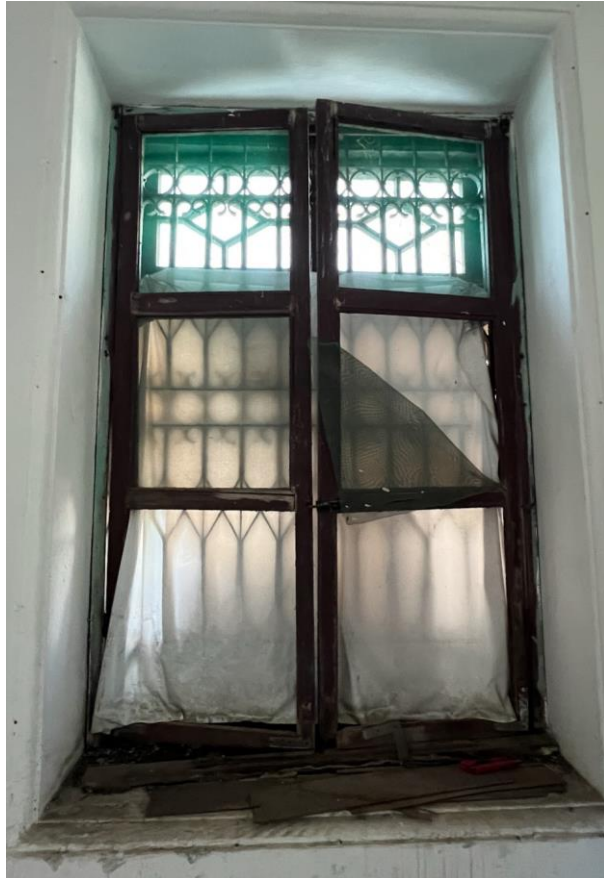
B4.3.12 – Mosquito nets open towards the interior, Main Building.
