Appendix A
Conservation Management Plan

Conservation Management Plan with Implementation Proposal for the Proposed Hotel Development with Adaptive Reuse of Ng Yuen at Shing Mun River, Sha Tin

2026 June

Prepared by Substance Lab Limited

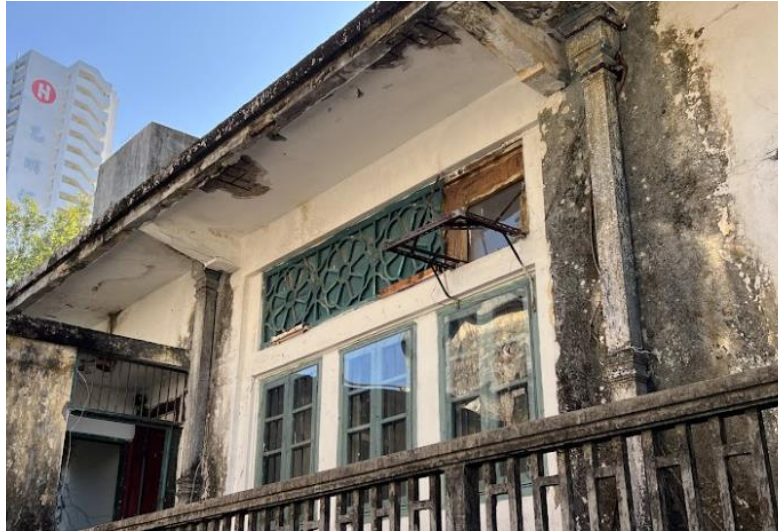
B4.3.13 – Fanlights with timber carving, Sub Building.

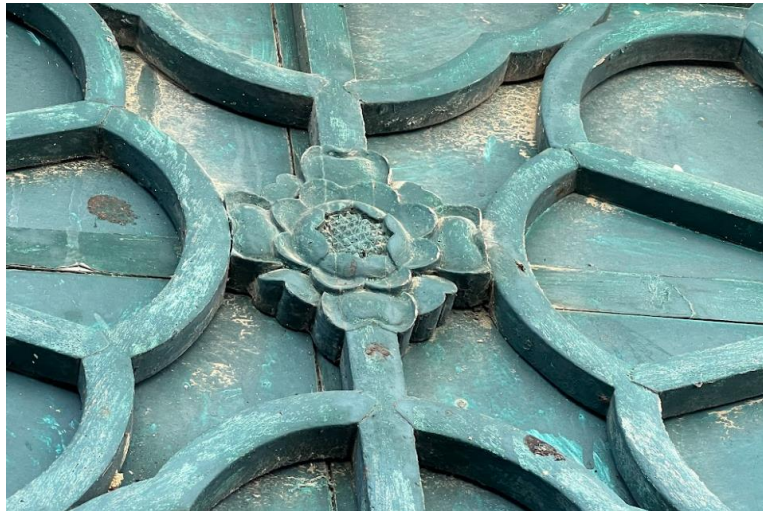
B4.3.14 – Blow-up of the carving at timber air grilles featuring the Chinese motif of peony representing the blessing for great fortune, Sub Building.

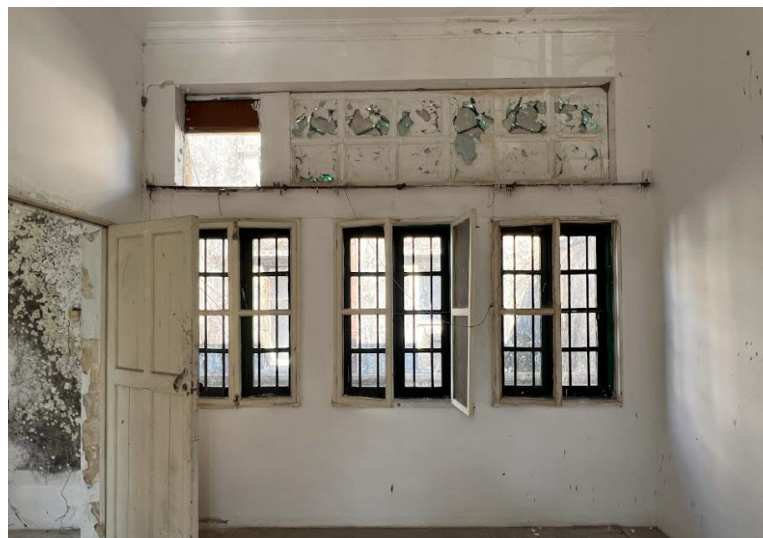
B4.3.15 – Interior view of the 2/F fanlight and windows with metal grilles and mosquito nets, Sub Building.

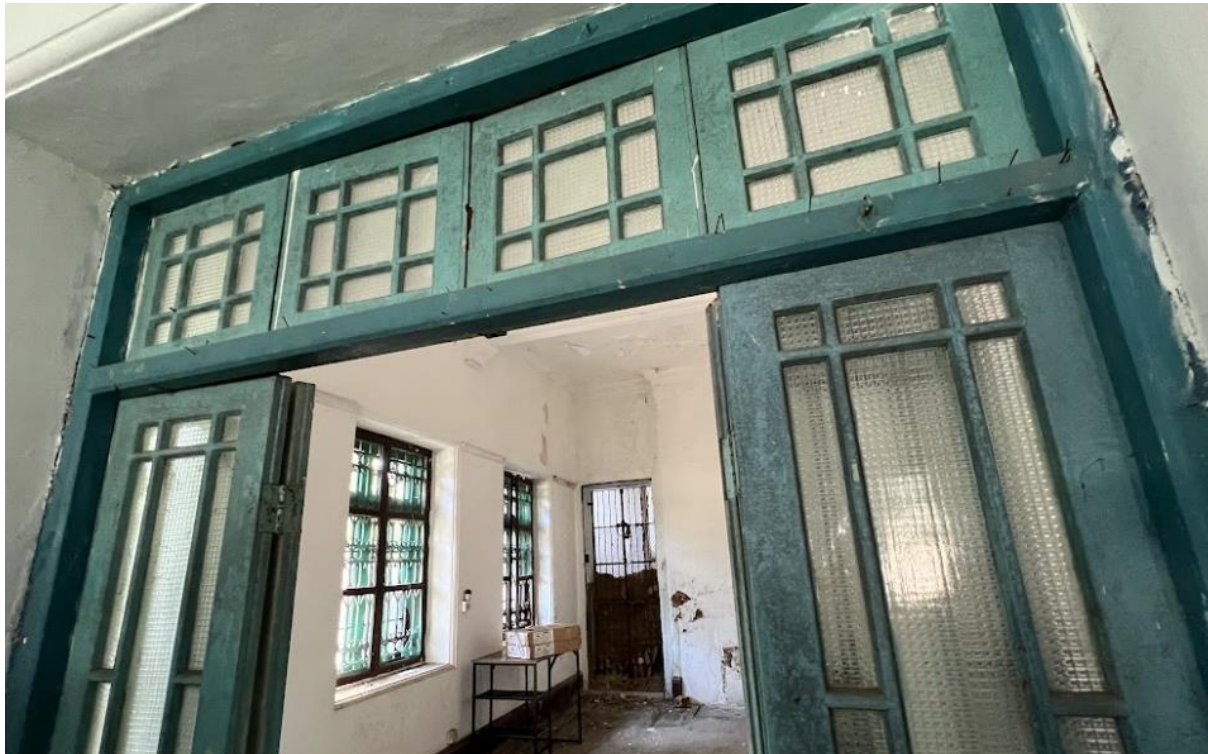
B4.3.16 – G/F partitioning doors, Main Building.

The G/F partitioning doors can allow the flexible use of the living room and the inner room. The granite flooring and ornate floor tiles of different forms, colours and patterns were used for circulation areas at different locations. For example, white hexagonal tiles are found at the main entrance and the staircase landing on the roof level, that are the locations at the interface of the indoor and outdoor spaces. The colourful tiles are found at the hallway on the G/F. Teak parquet flooring in long wood strips have finished most of the rooms as well as the concrete staircase at the Main Building. The floor of rooms at the Sub Building are finished by light-colored terrazzo with bright yellow or vermillion borders.

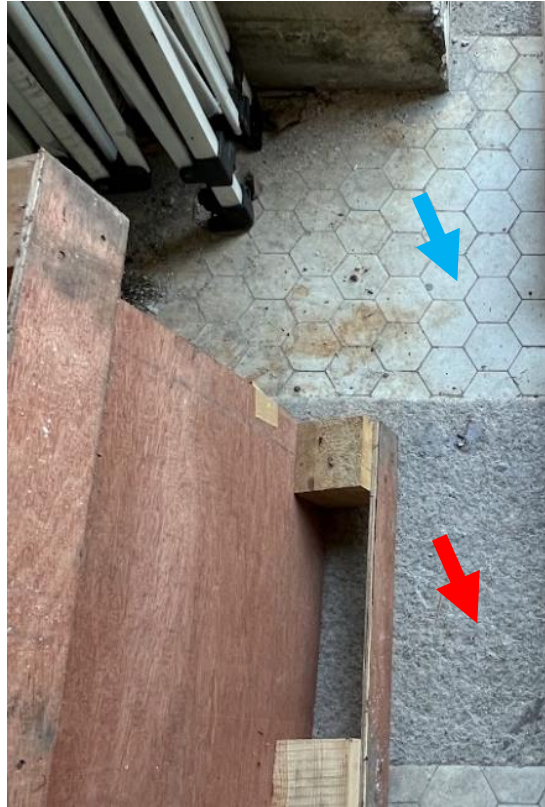
B4.3.17 – Granite (red arrow) and hexagonal tile flooring (blue arrow) at the main entrance porch of Main Building.

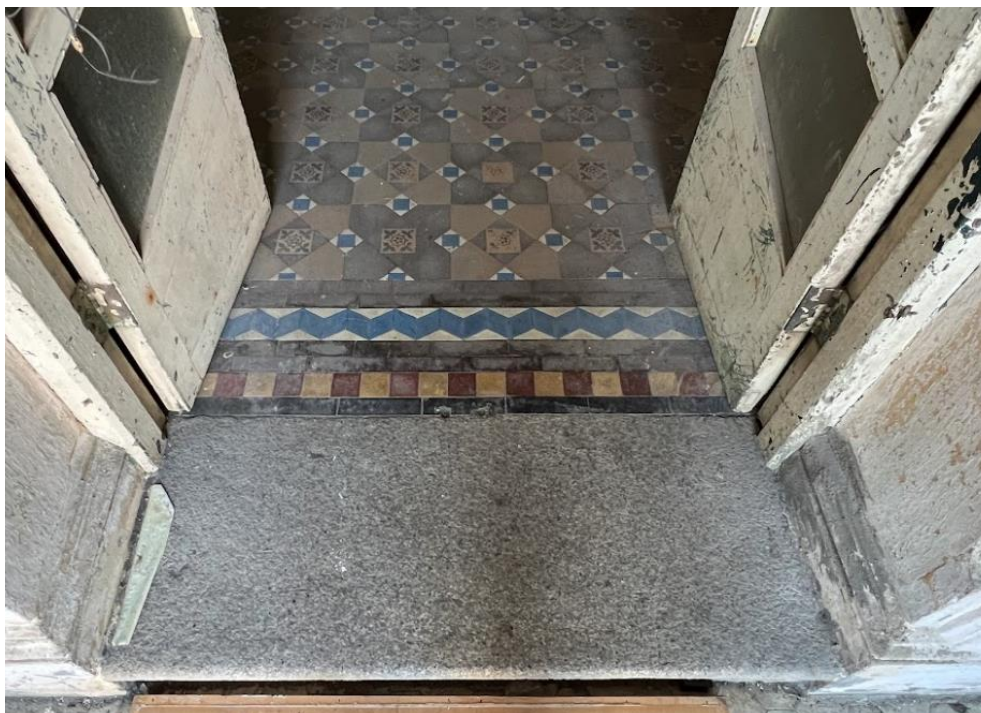
B4.3.18 – G/F entrance granite threshold ornate tile flooring, Main Building.

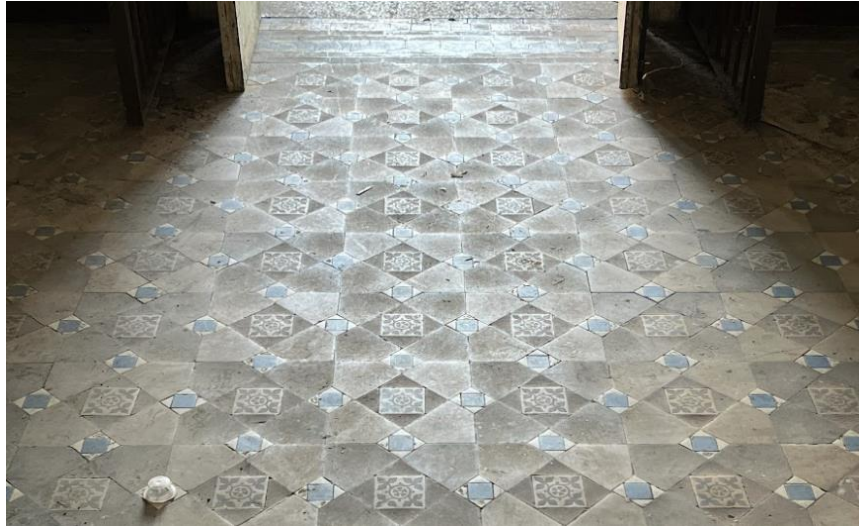
B4.3.19 – Ornate tile flooring at the entrance hallway, Main Building.

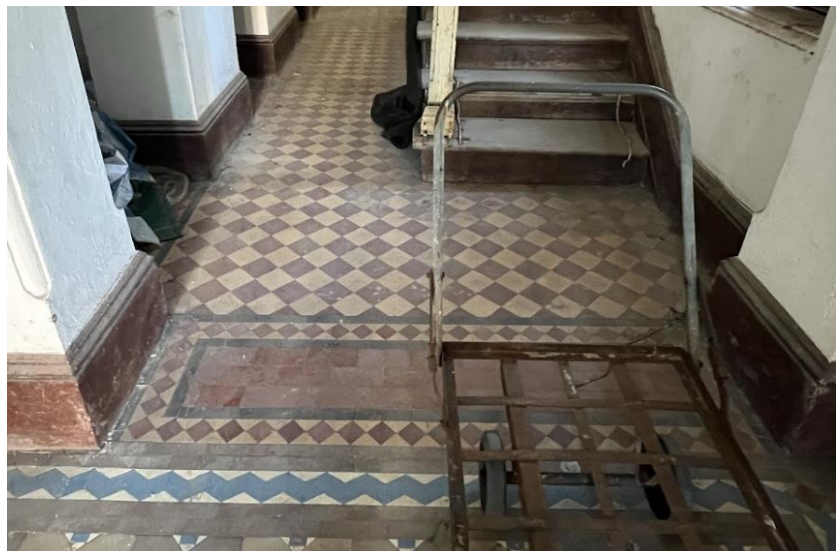
B4.3.20 – Ornate tile flooring at the hallway.

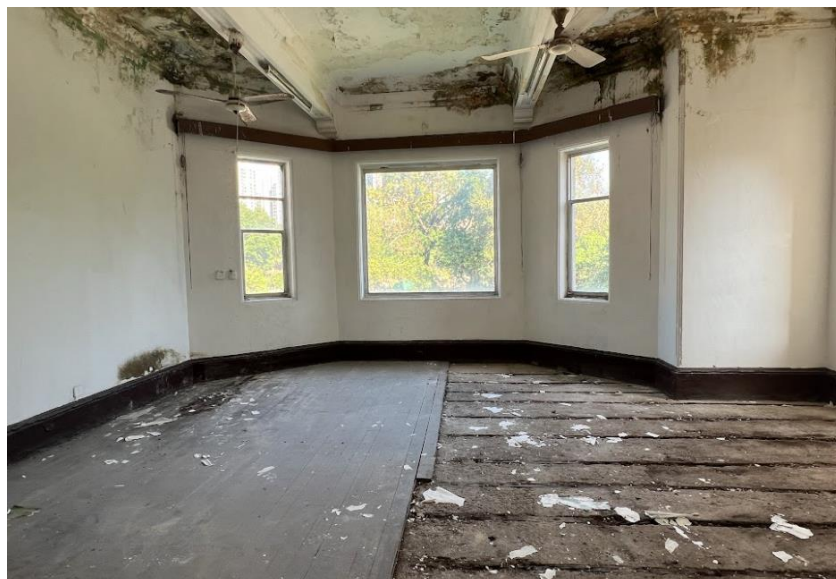
B4.3.21 – Teak flooring at 1/F dining room, Main Building.

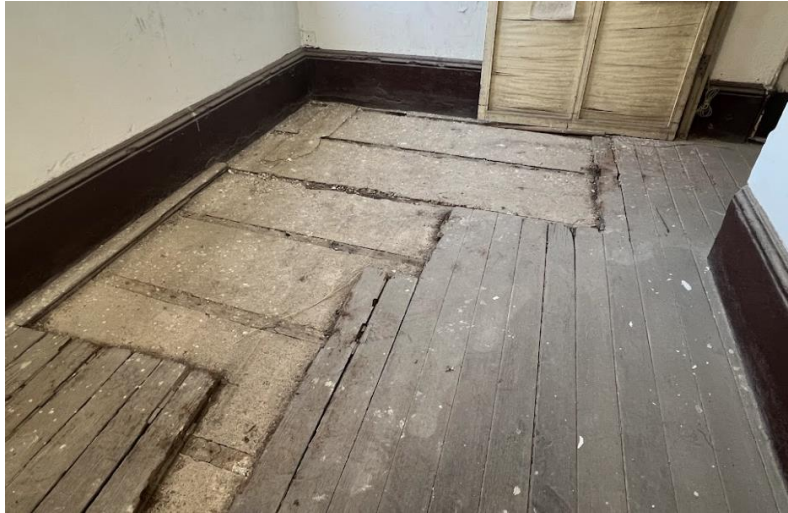
B4.3.22 – Teak flooring at a room on the 1/F, Main Building.

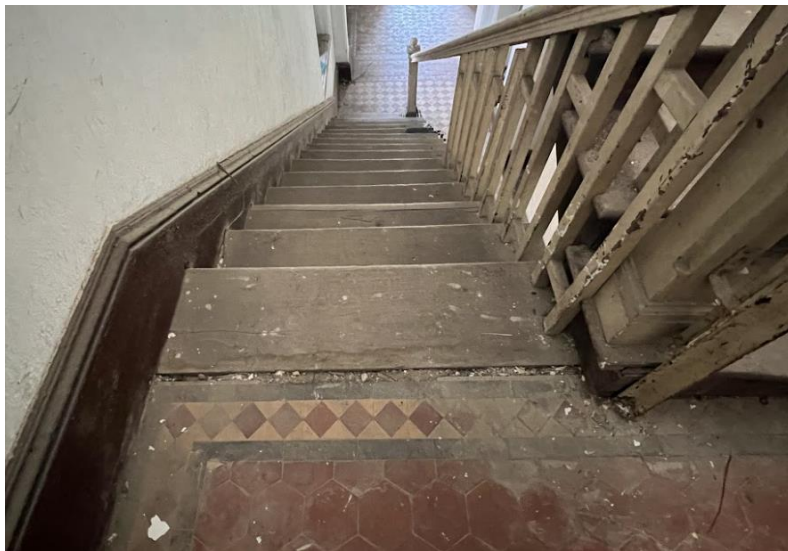
B4.3.23 – Teak flooring at the staircase at Main Building.

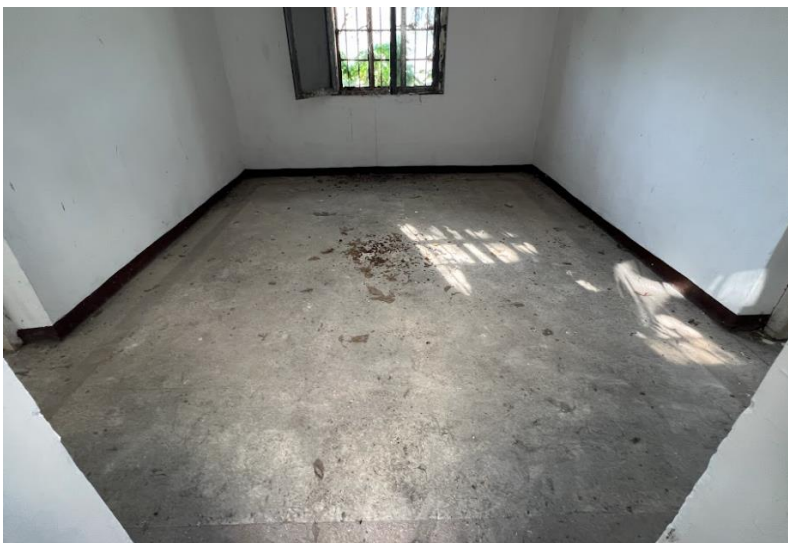
B4.3.24 – Terrazzo flooring with vermillion border, Sub Building.

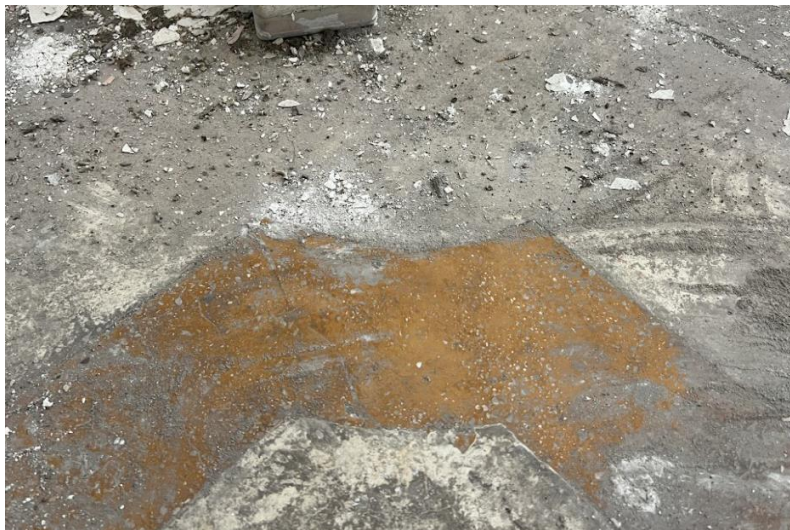
B4.3.25 – Terrazzo flooring with yellow border, Sub Building.

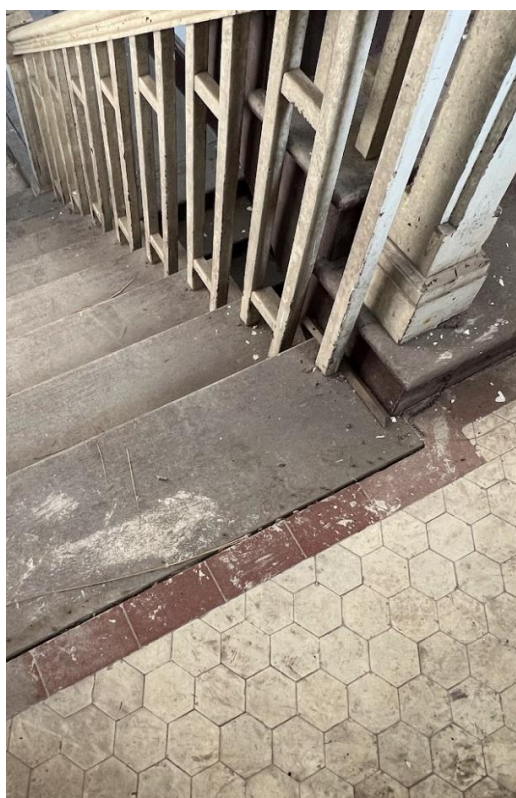
B4.3.26 – Hexagonal tiles at the landing on the roof of Main Building.

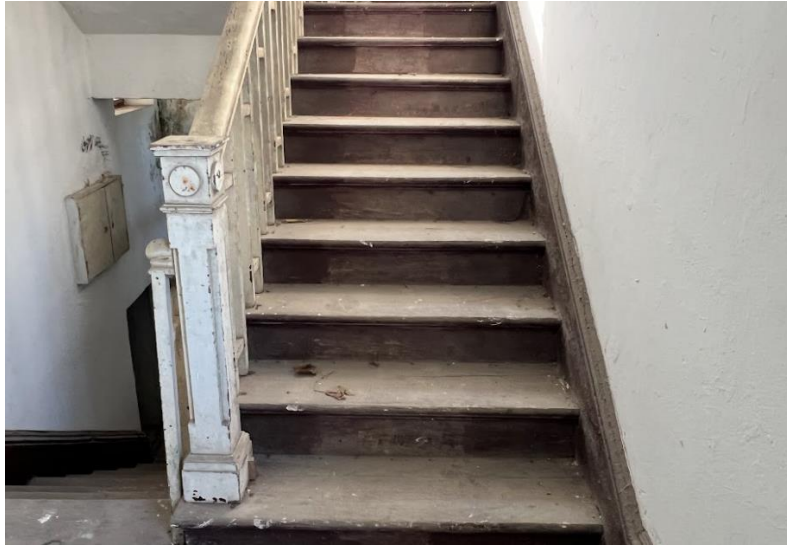
B4.3.27 – Teak flooring at the interior staircase at Main Building.

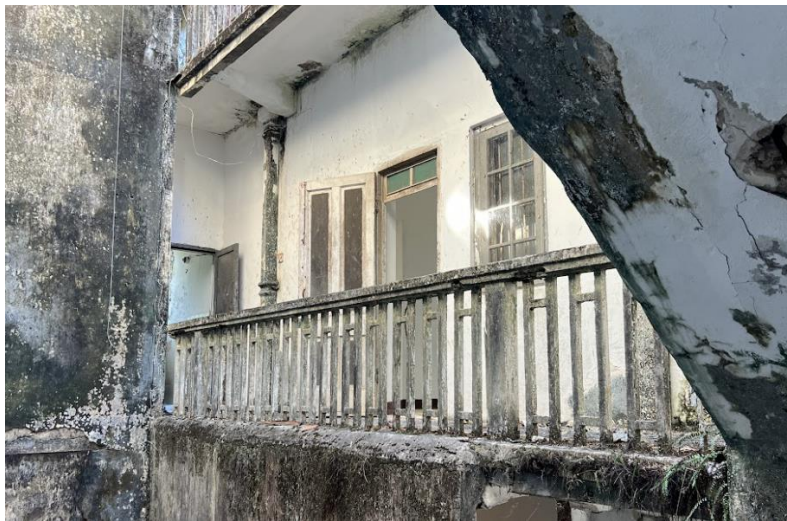
B4.3.28 – Concrete balustrades along the corridors at the Sub Building.

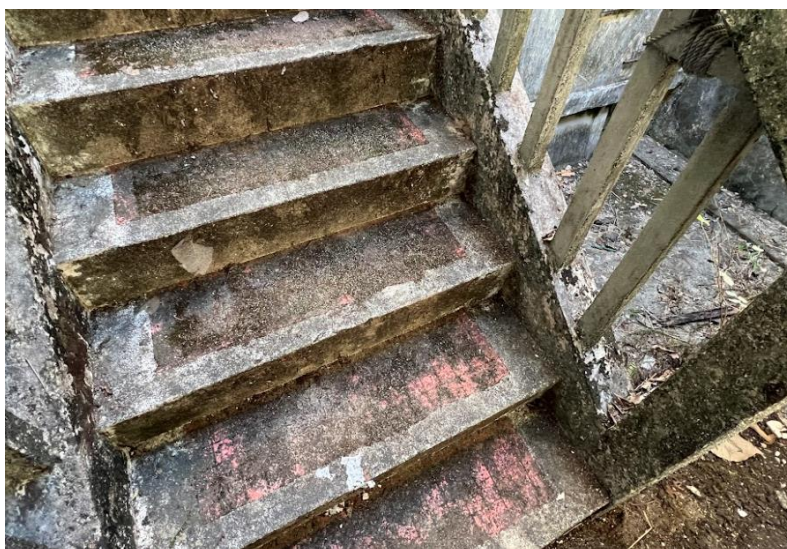
B4.3.29 – Granolithic finish of the external staircase at lightwell, the staircase serves Sub Building only.

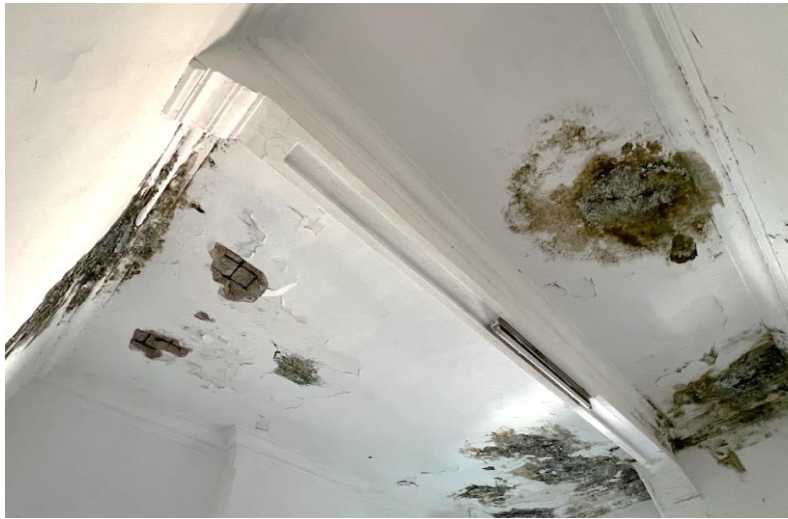
B4.3.30 – Ceiling corner crown moulding, Main Building

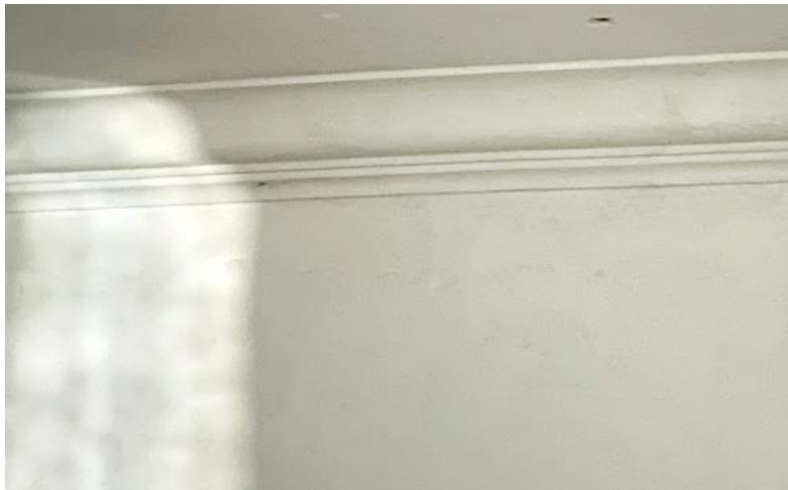
B4.3.31 – Ceiling corner crown moulding at Main Building.

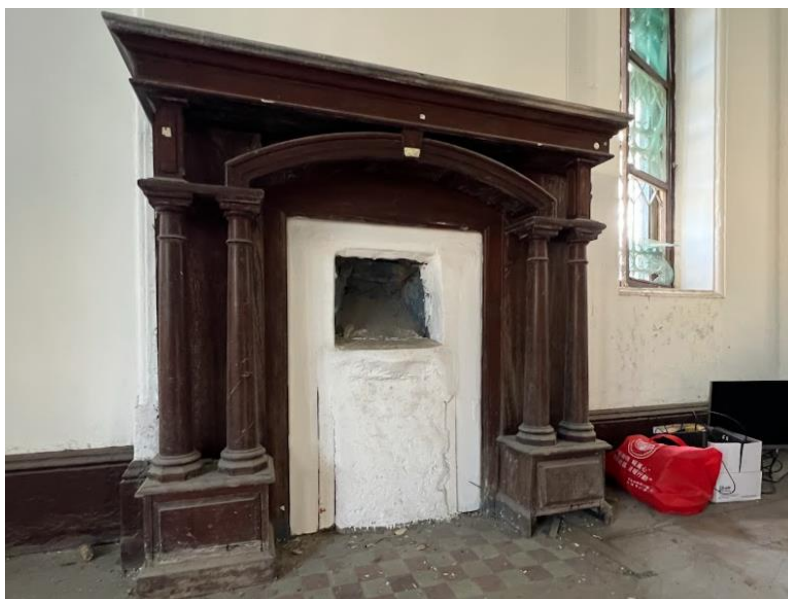
B4.3.32 – The fireplace with a surround resembling the main entrance arch porch is found on the G/F living room at Main Building of NY.

A number of fireplaces of different conditions are found or have their locations identified, all at the Main Building. No bedrooms at the Sub Building have been equipped with a fireplace.

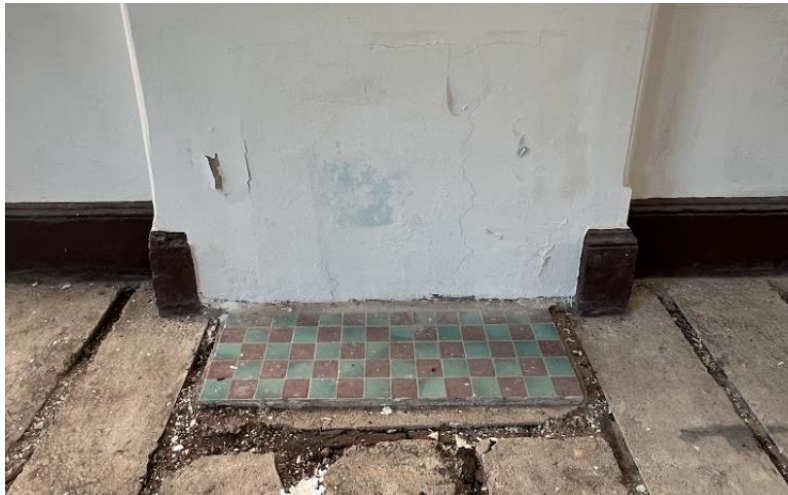
B4.3.33 – The fireplace at the 1/F dining room (east side) at Main Building of NY has been sealed and with the surround removed.

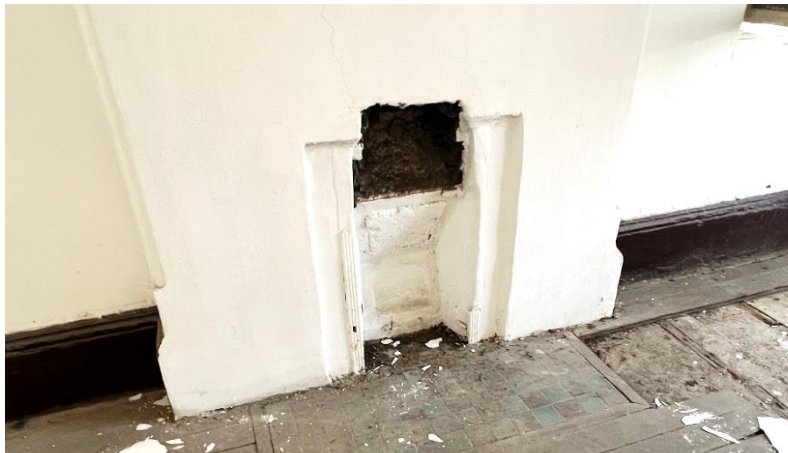
B4.3.34 –The fireplace on the 1/F west side at Main Building of NY.

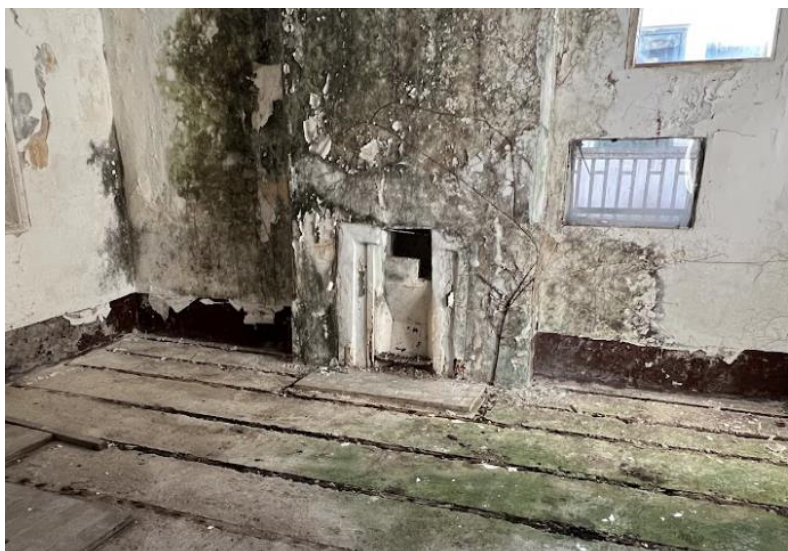
B4.3.35 –The fireplace on the 1/F south side at Main Building of NY.

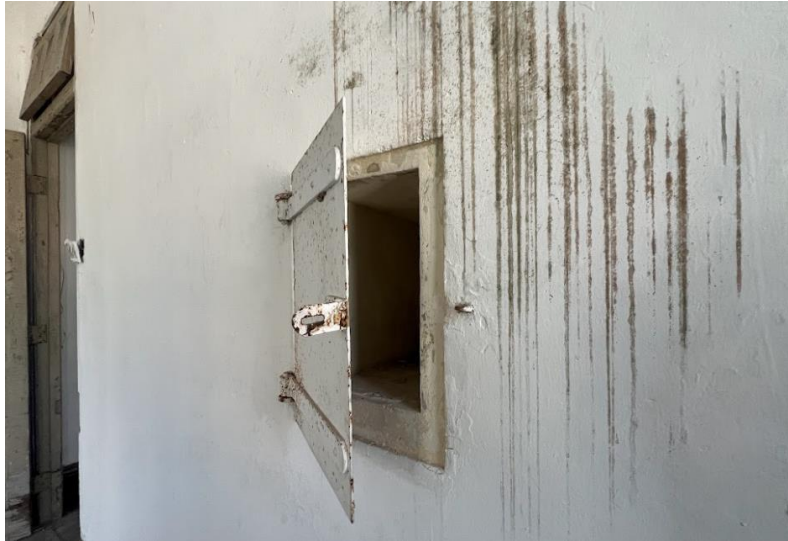
B4.3.36 – A storage space on the wall of the room on the west of the 1/F of Main Building.

There are also some hidden safe storage spaces on a wall and floor on the 1/F, signifying the need to keep valuables at spaces unknown to outsiders.

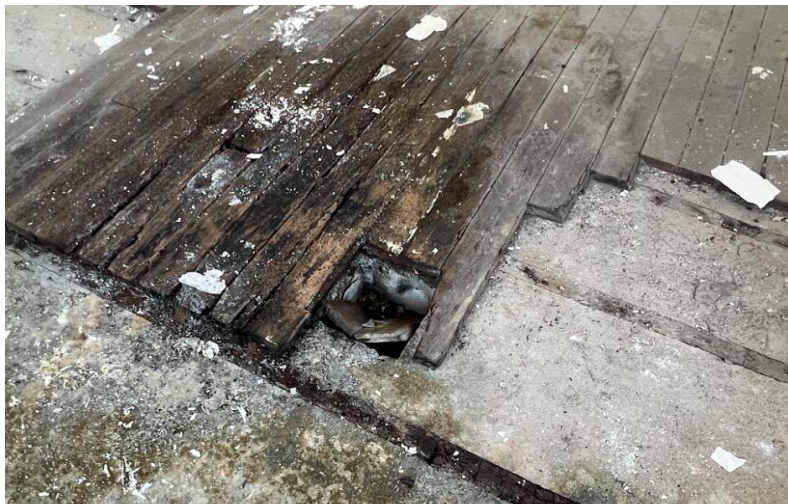
B4.3.37 – A storage space on the floor on the west of the 1/F of Main Building.

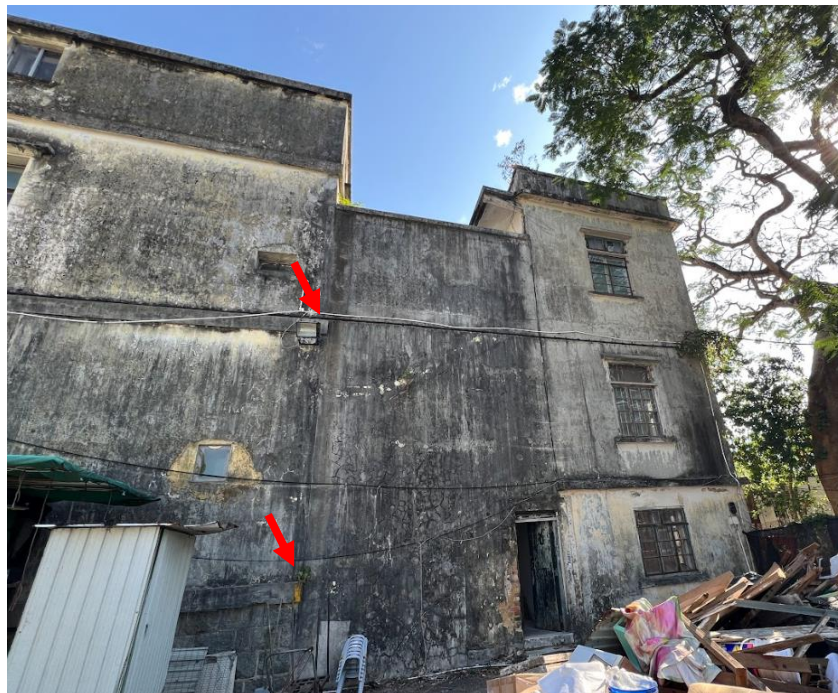
B5.1.1 – String courses of MB wrap around the four sides of MB and terminate abruptly on the side (west) elevation (red arrows) where the later added wall of lightwell is in contact of MB.

- (a) The G/F levels of the two buildings are different;
- (b) Awkward interfacing of the two buildings at the staircase landings of the staircases at Main Building and lightwell, and G/F rear fence of Main Building (Section B4.2);
- (c) String courses of MB appear to terminate abruptly on the side (west) elevation where the later added wall of lightwell is in contact of MB, in fact, they continue on MB south façade which faces the lightwell;
- (d) Difference in the reinforced concrete construction;
- (e) Difference in the details and design of windows, e.g. window frame, ironmongery and mouldings at wall openings on interior walls, etc; and
- (f) Crown mouldings in the interior, etc.

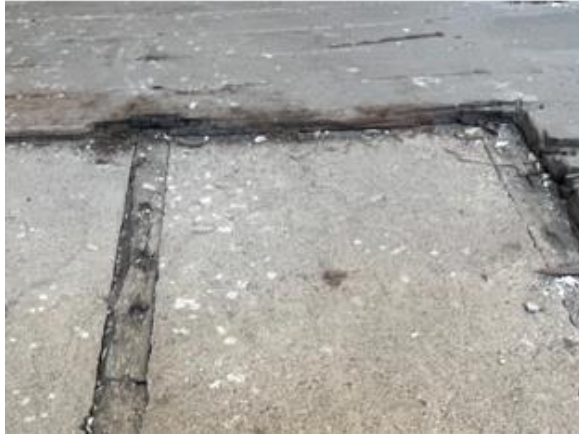
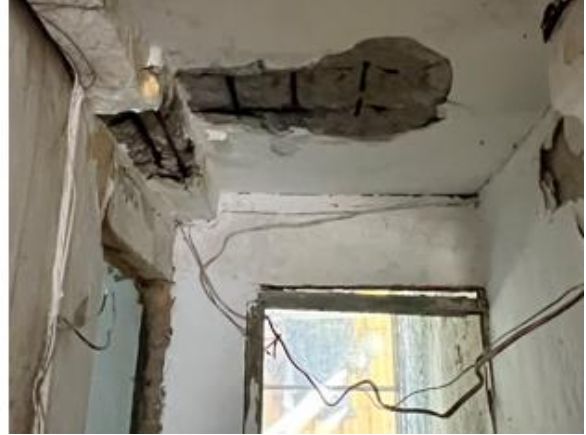
B5.1.2 – Comparison of the reinforced concrete construction of Main Building (left) and Sub Building (right).

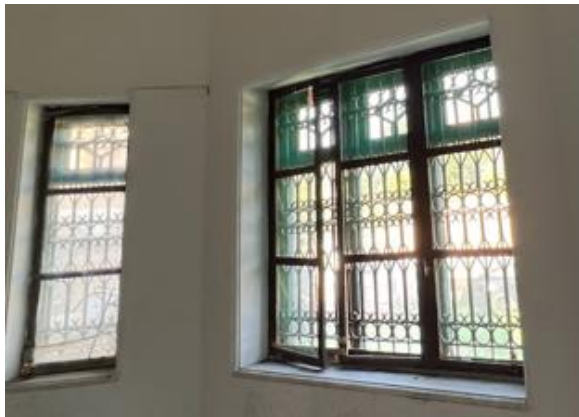
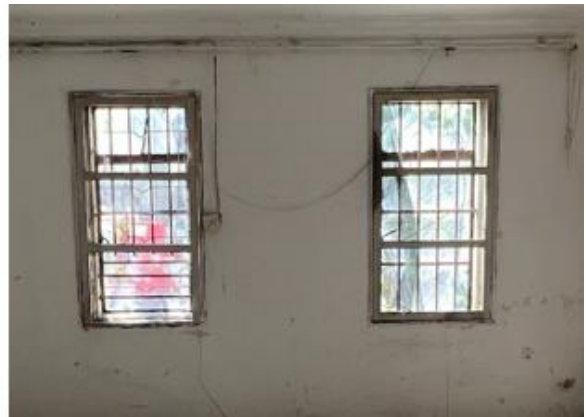
B5.1.3 – Comparison of windows of Main Building (left) and Sub Building (right).

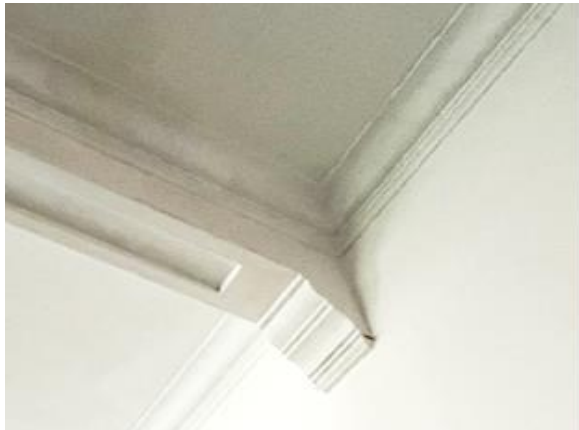
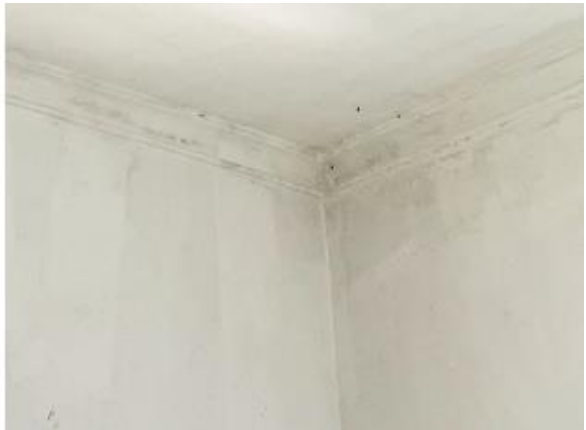
B5.1.4 – Comparison of ceiling crown mouldings of Main Building (left) and Sub Building (right).

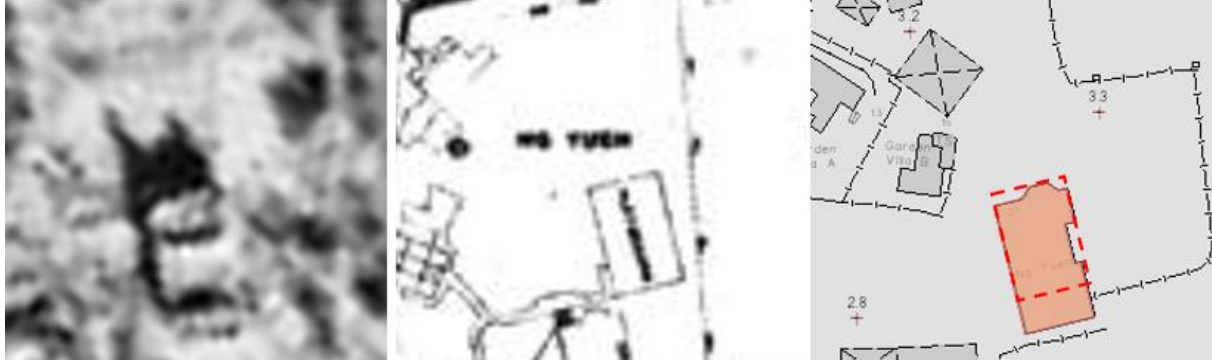
B5.1.5 – Comparison of 1963 aerial photo (left), 1967 Survey Map (middle), and existing GIS plan retrieved in 2026 of NY. The red dotted line represents the footprint of NY as shown on the 1967 Survey Map. (Source: Survey and Mapping Office, GIS)

Before digitization, updates of Survey Maps were labour-intensive and took more than a year. The 1967 Survey Map showing an earlier footprint of NY was not updated to reflect the addition of Sub Building which took place in or before 1963, as recorded in the 1963 aerial photo.

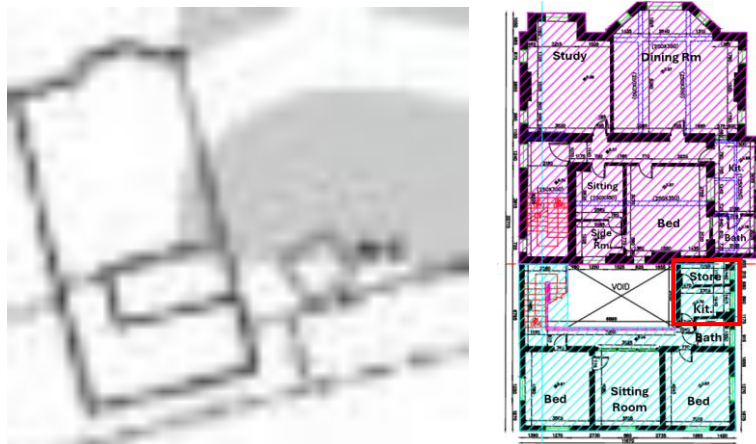
B5.2.1 – The kitchen and bathroom core at Sub Building (as marked in red) on the existing 2/F plan of Sub Building was not found in the Survey Map in 1975 (left). (Source: Survey and Mapping Office)

The addition of the kitchen and bathroom core at the east side of SB was not shown on the Survey Map in 1975, advising that it might have been added after 1975. Noting that the users of SB could have access MB via the landings of the staircases at lightwell and MB (before the adding of the wall which disconnect the two landings), one can deduce that SB users might have used the kitchen and bathroom of G/F, MB when there was no kitchen and bathroom core at SB.

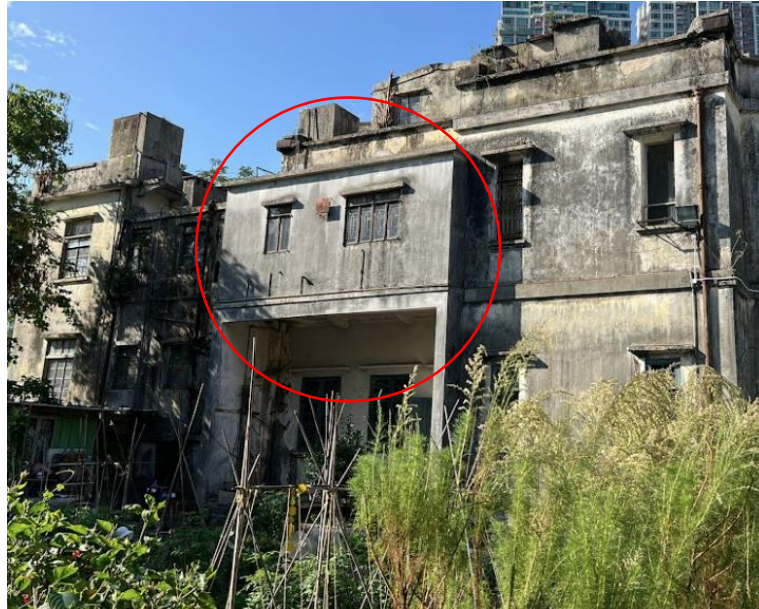
B5.3.1 – The 1/F kitchen and washroom of Main Building as viewed from the exterior.

and 1/F. The kitchen with white wall tiling and bathroom paved with pink wall and floor tiles and equipped with pink fixtures was added to serve the 1/F of Main Building. The addition is presented as a protruded addition to a cantilevered bay on the east façade. It is supported by structural walls at two ends that transfer the load to the ground. The window frames and ironmongery of the 1/F kitchen and bathroom are significantly different from that of the other areas of the MB, but similar to those of SB.

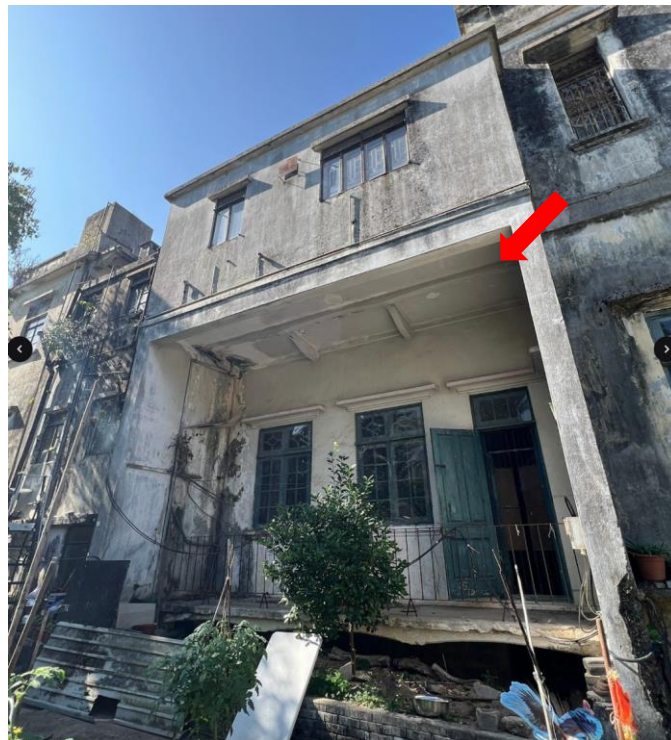
B5.3.2 – The 1/F kitchen and washroom of Main Building as viewed from below. The edge beam with curvilinear profile (indicated by the red arrow) might be the original footprint of the cantilevered bay on the 1/F, providing shelter to the sitting-out area on the G/F.

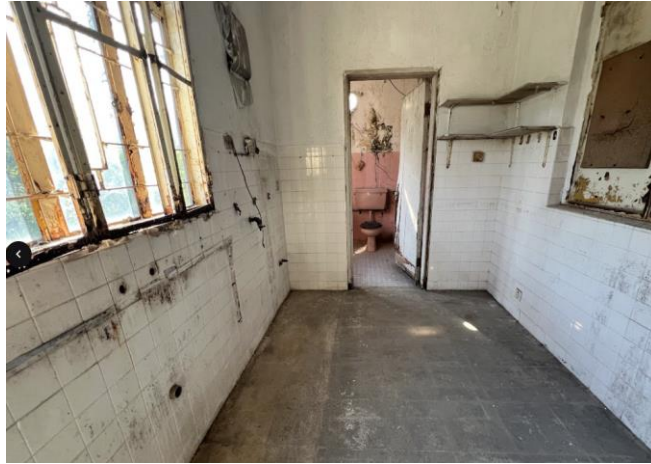
B5.3.3 – The 1/F kitchen with a bathroom at the end as viewed from the interior, Main Building.

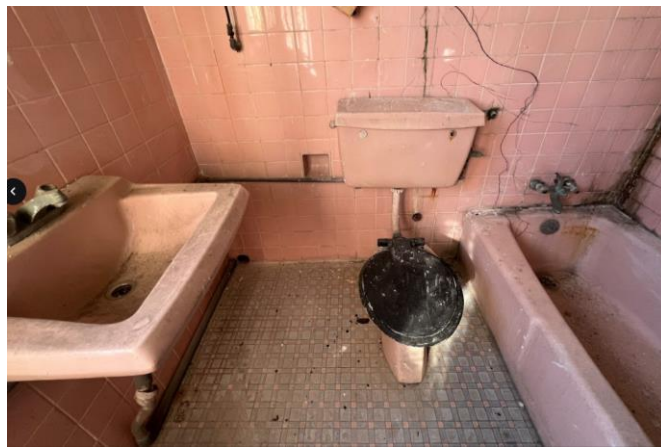
B5.3.4 – The 1/F bathroom as viewed from the interior, Main Building.

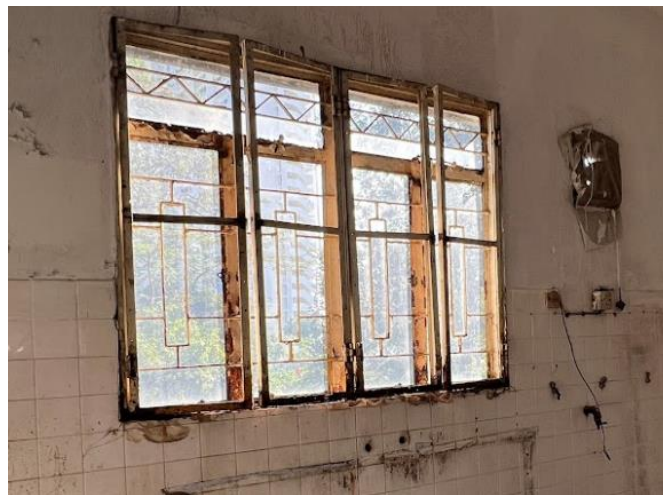
B5.3.5 – The window frames and ironmongery of the 1/F kitchen, Main Building.

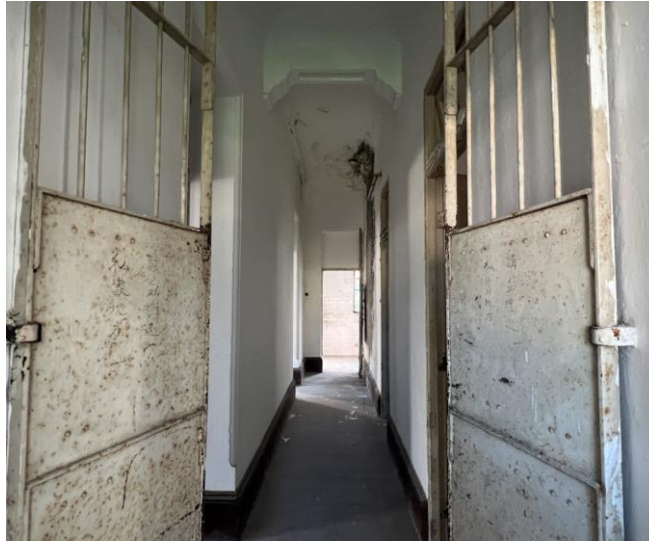
B5.3.4 – The metal gate at staircase landing on Main Building 1/F on which “Private Area. No Entry” are written on both leaves of the gate.

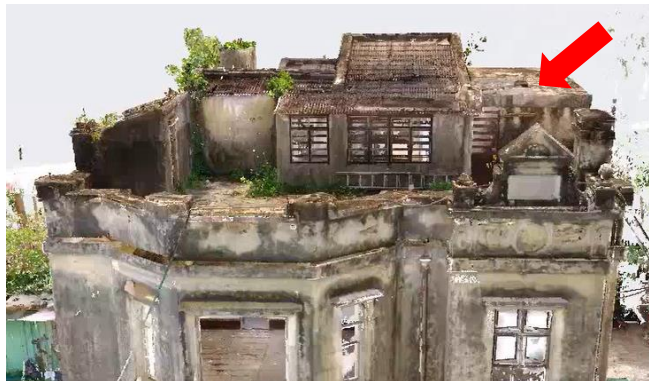
The additional structure on the roof with a roof made of corrugated panels was used as a kitchen, bathroom, and very likely a bedroom. White glazed tiles on wall and working table tops, and other toilet fixtures are noted.

B5.4.1 – The additional structure on the roof, Main Building in 2025. (Source: THE APPLICANT, 2025)

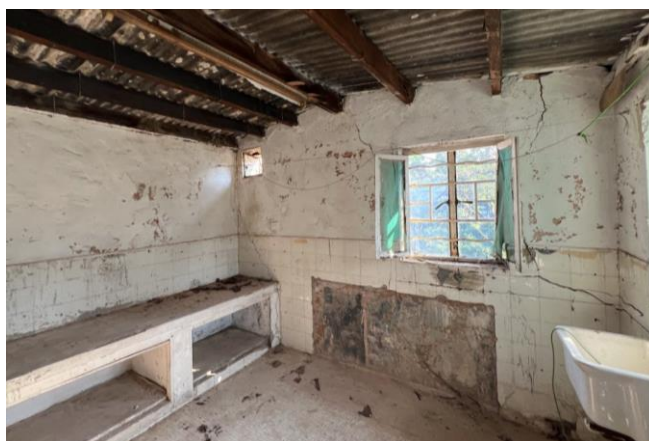
B5.4.2 – The later added kitchen on the roof, Main Building.

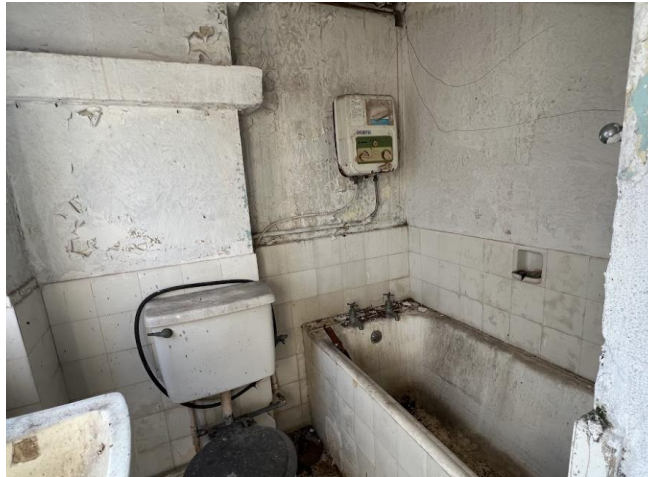
B5.4.4 – The later added bathroom on the roof, Main Building. The toilet is fixed to the roof chimney.

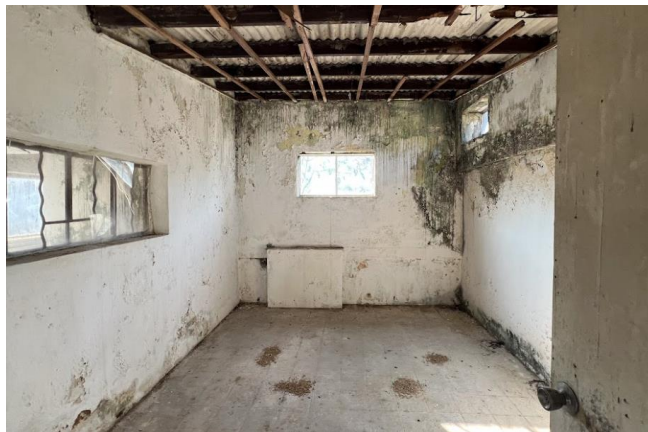
B5.4.4 – This space found on the roof of Main Building is believed to be a bedroom.

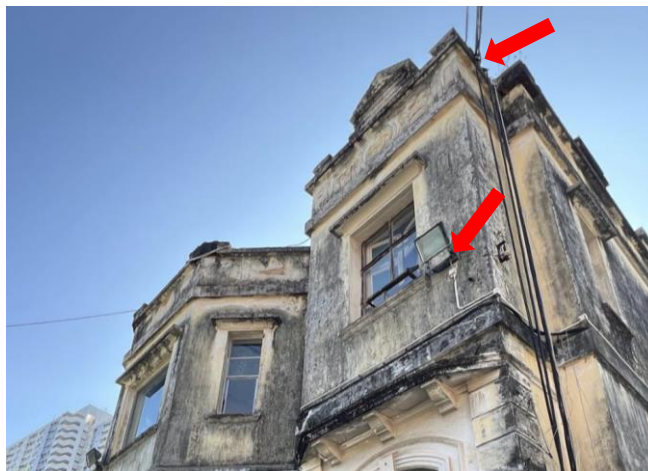
Flood lights on the main facades could be traced back to the earlier photos in 2000s. The black electrical cables should have been added in recent years as they were not shown in earlier photos.

B5.5.1 – Floodlights and electrical cables are found on the facades, Main Building.

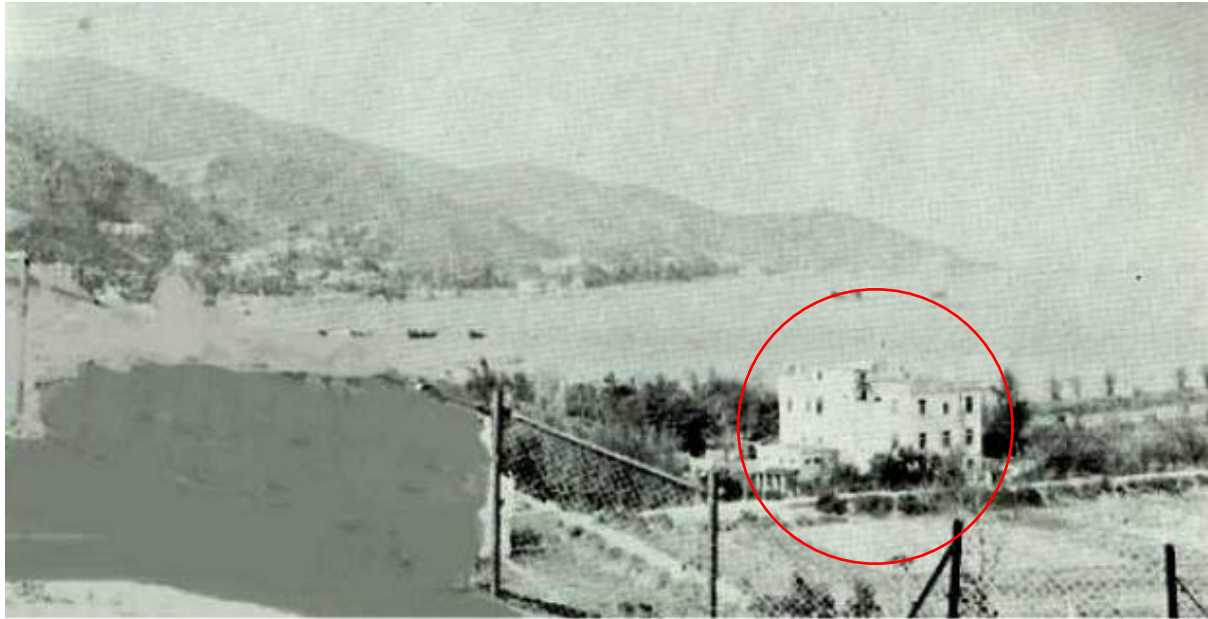
B7.3.1 Side (west) and back (south) elevations of Ng Yuen in 1965.
(Source: tkjho, <https://gwulo.com/media/52269>)

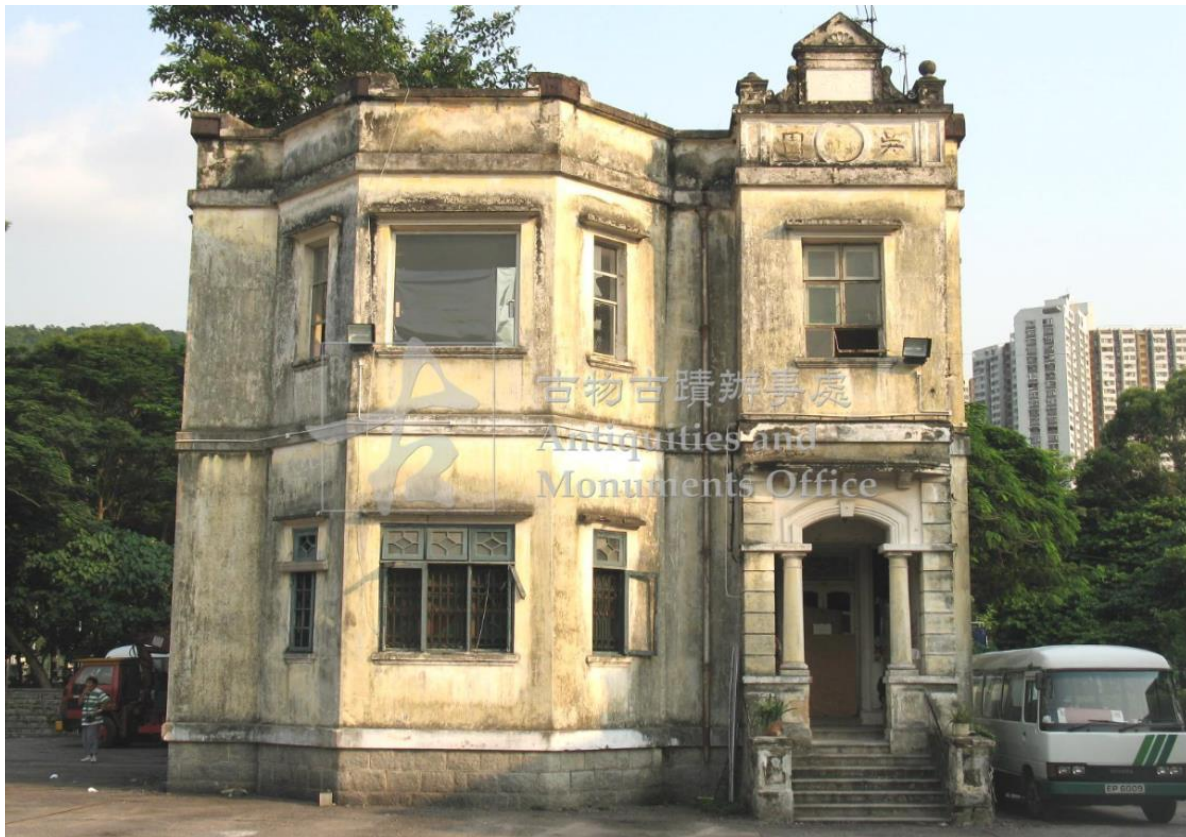
B7.3.7 Front elevation of Ng Yuen. (Source: AMO, c. 2000s)

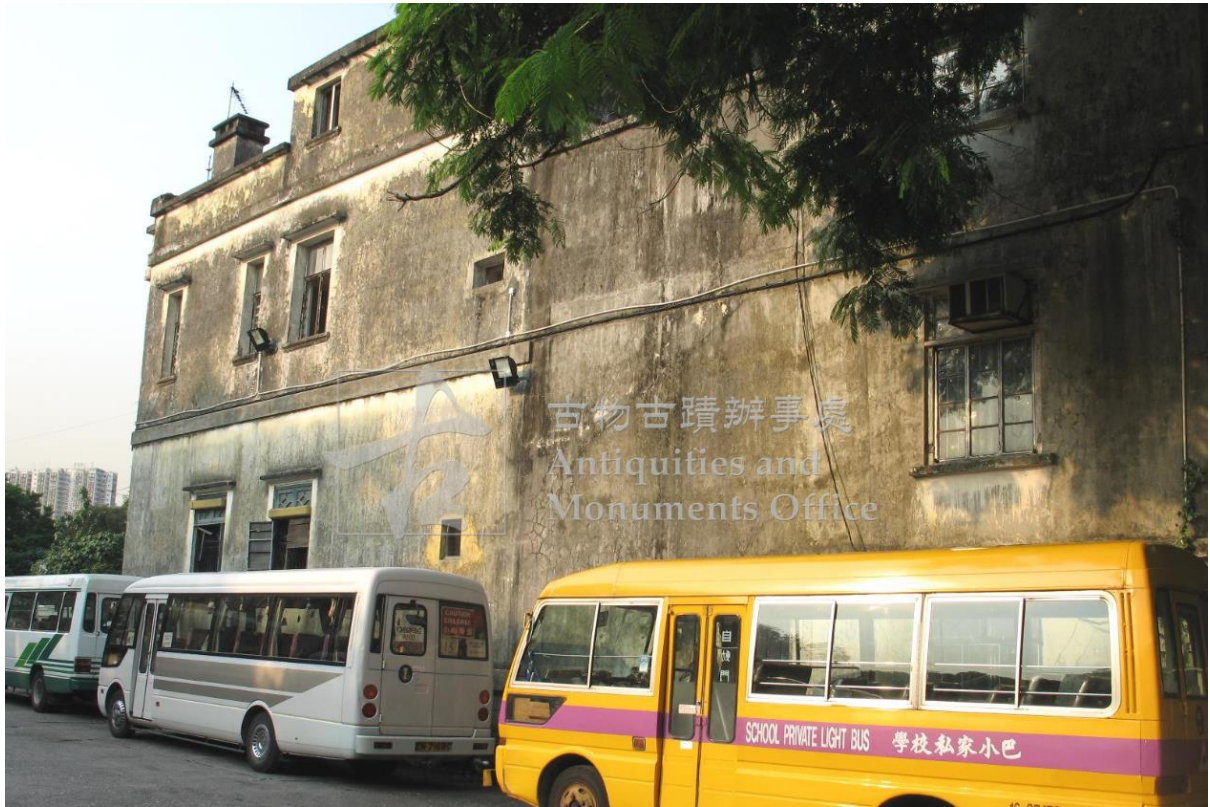
B7.3.8 Side (west) elevation of Ng Yuen. (Source: AMO, c. 2000s)
