Appendix A
Conservation Management Plan

Conservation Management Plan with Implementation Proposal for the Proposed Hotel Development with Adaptive Reuse of Ng Yuen at Shing Mun River, Sha Tin

2026 June

Prepared by Substance Lab Limited

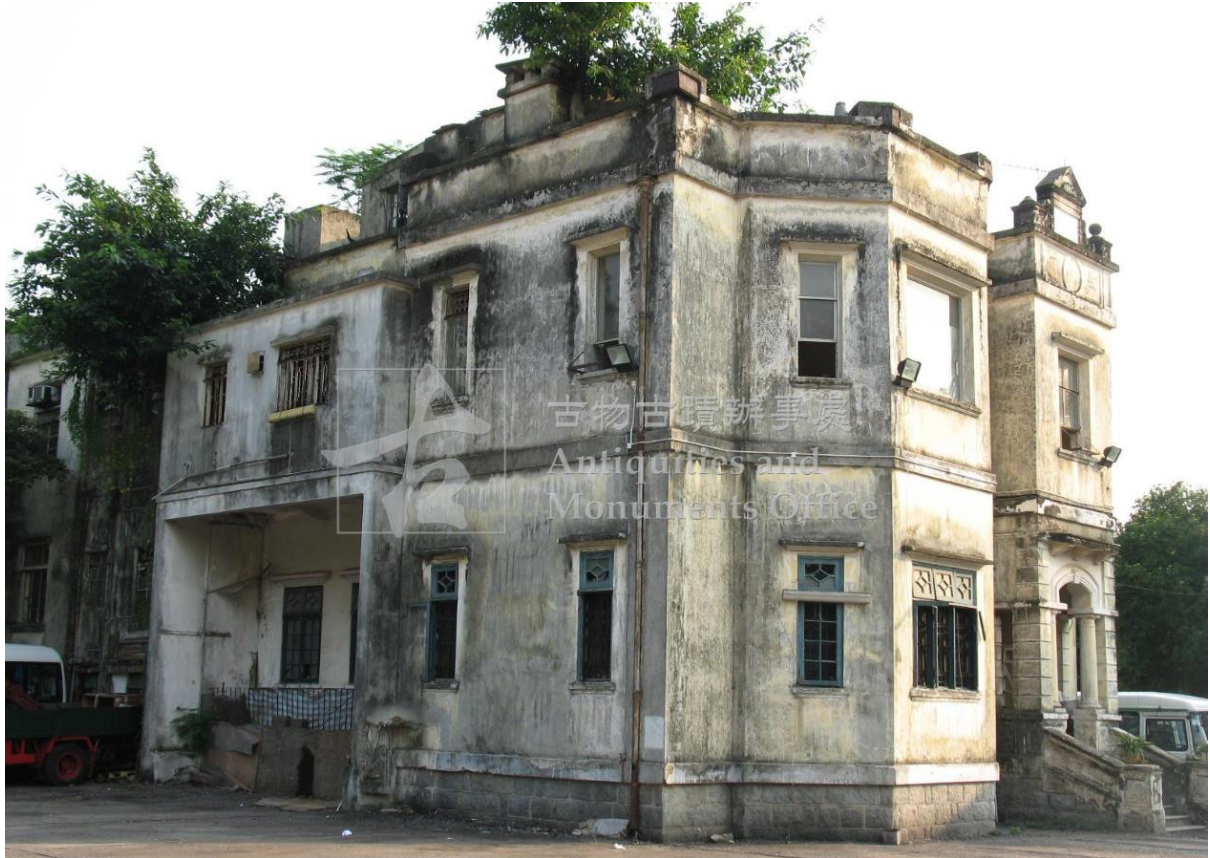
B7.3.9 Side (east) elevation of Ng Yuen. (Source: AMO, c. 2000s)

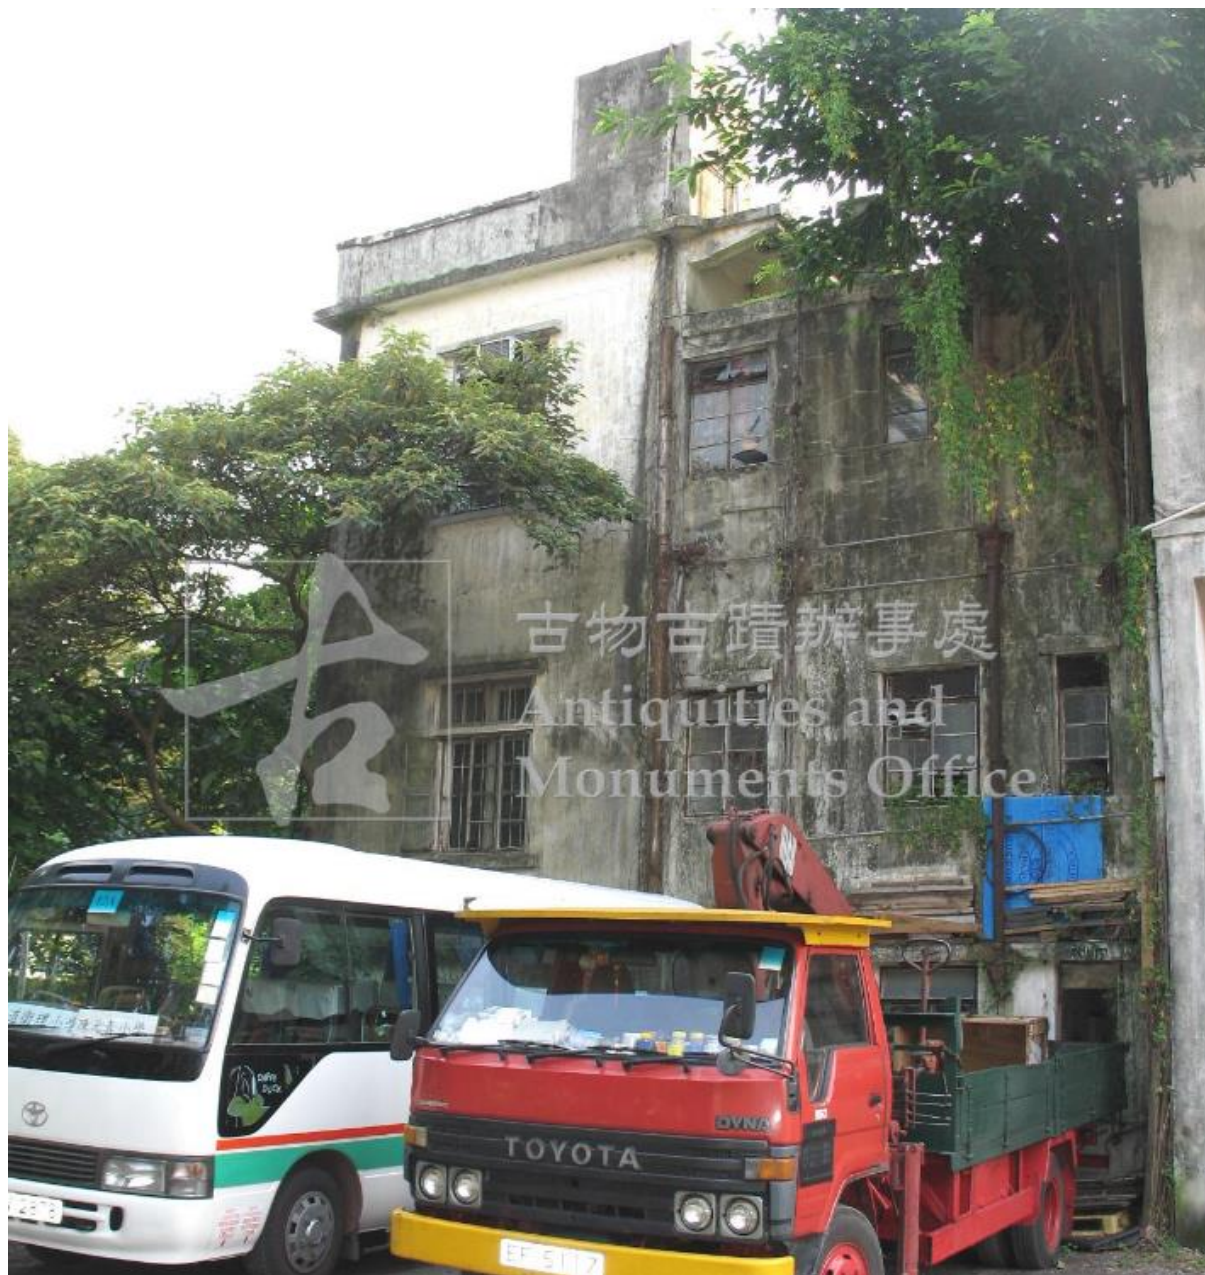
B7.3.10 Side (east) elevation of Ng Yuen. (Source: AMO, c. 2000s)

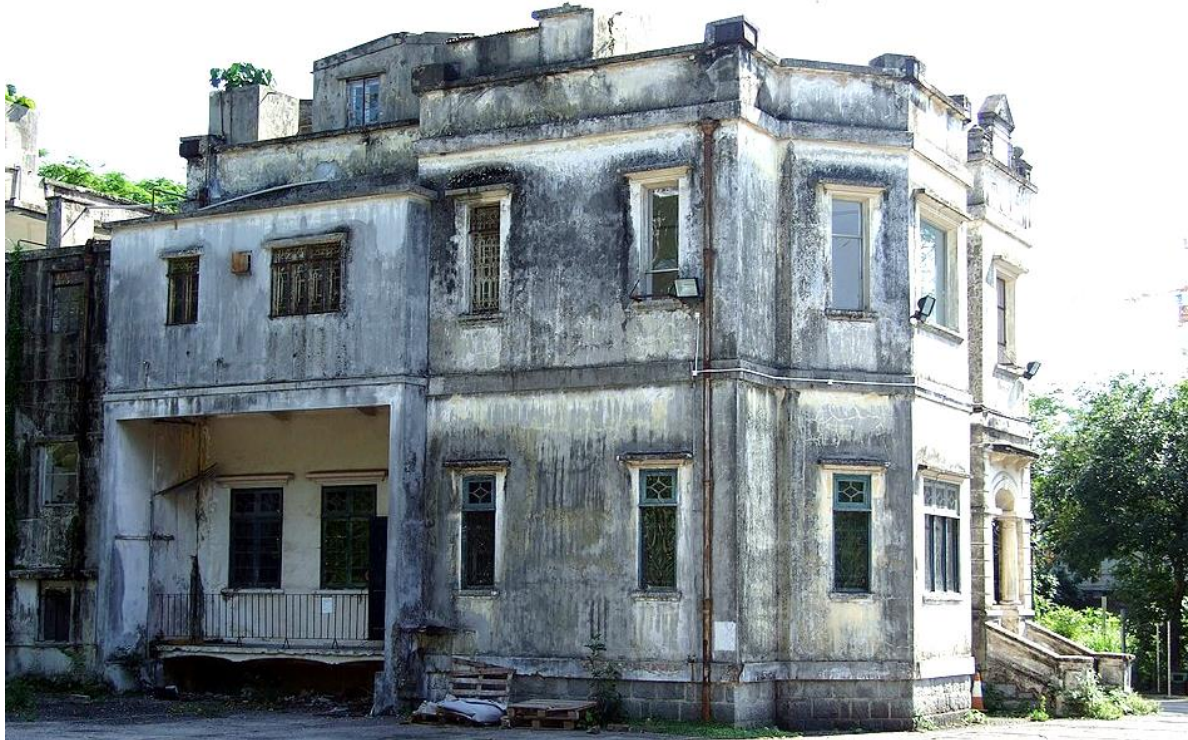
B7.3.6 Side (east) elevations in 2010.

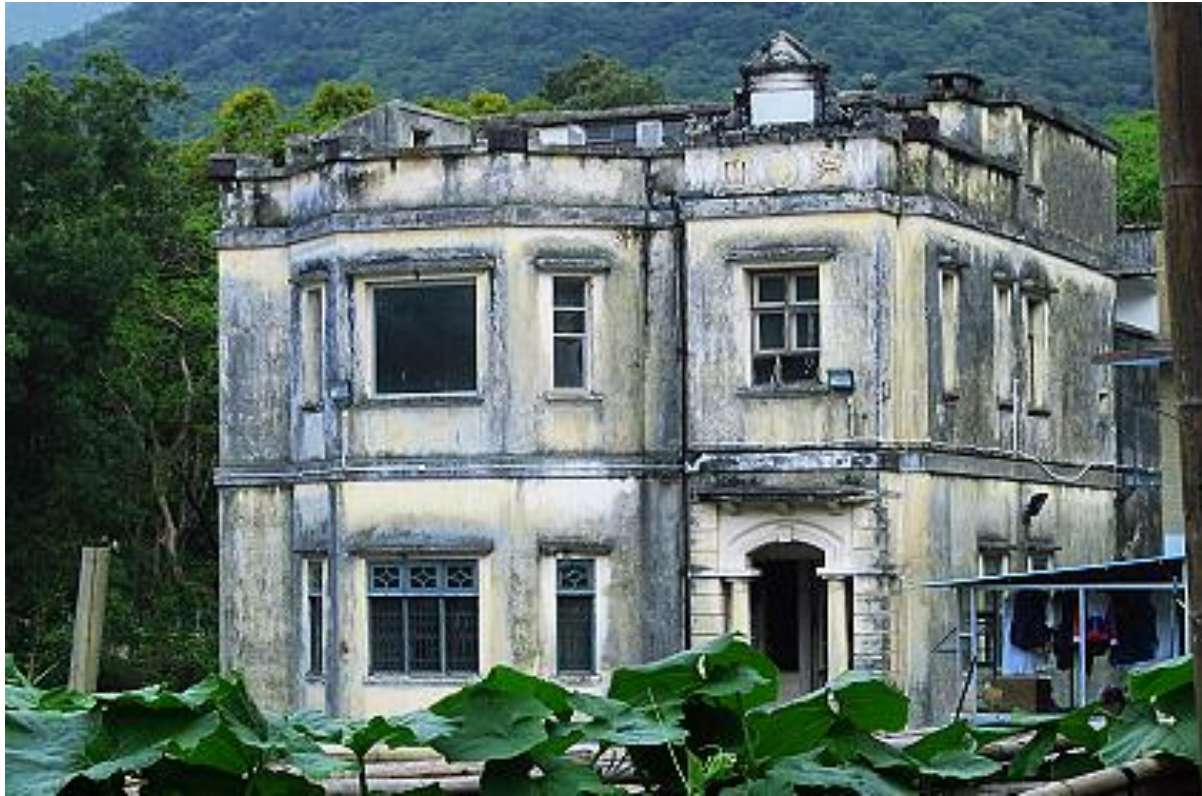
B7.3.11 Front (north) and side (west) elevations in 2012.
(Photo by Tere Wong. Source: <https://blog.terewong.com/archives/7434>)

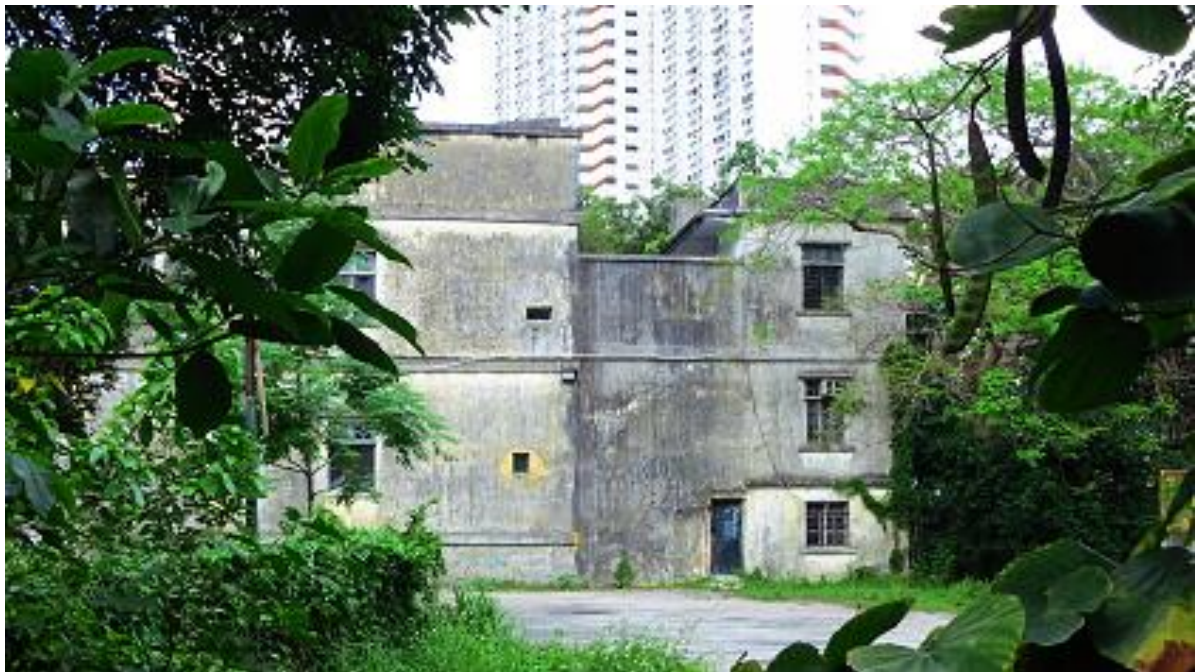
B7.3.12 Side (west) elevation in 2012.
(Photo by Tere Wong. Source: <https://blog.terewong.com/archives/7434>)

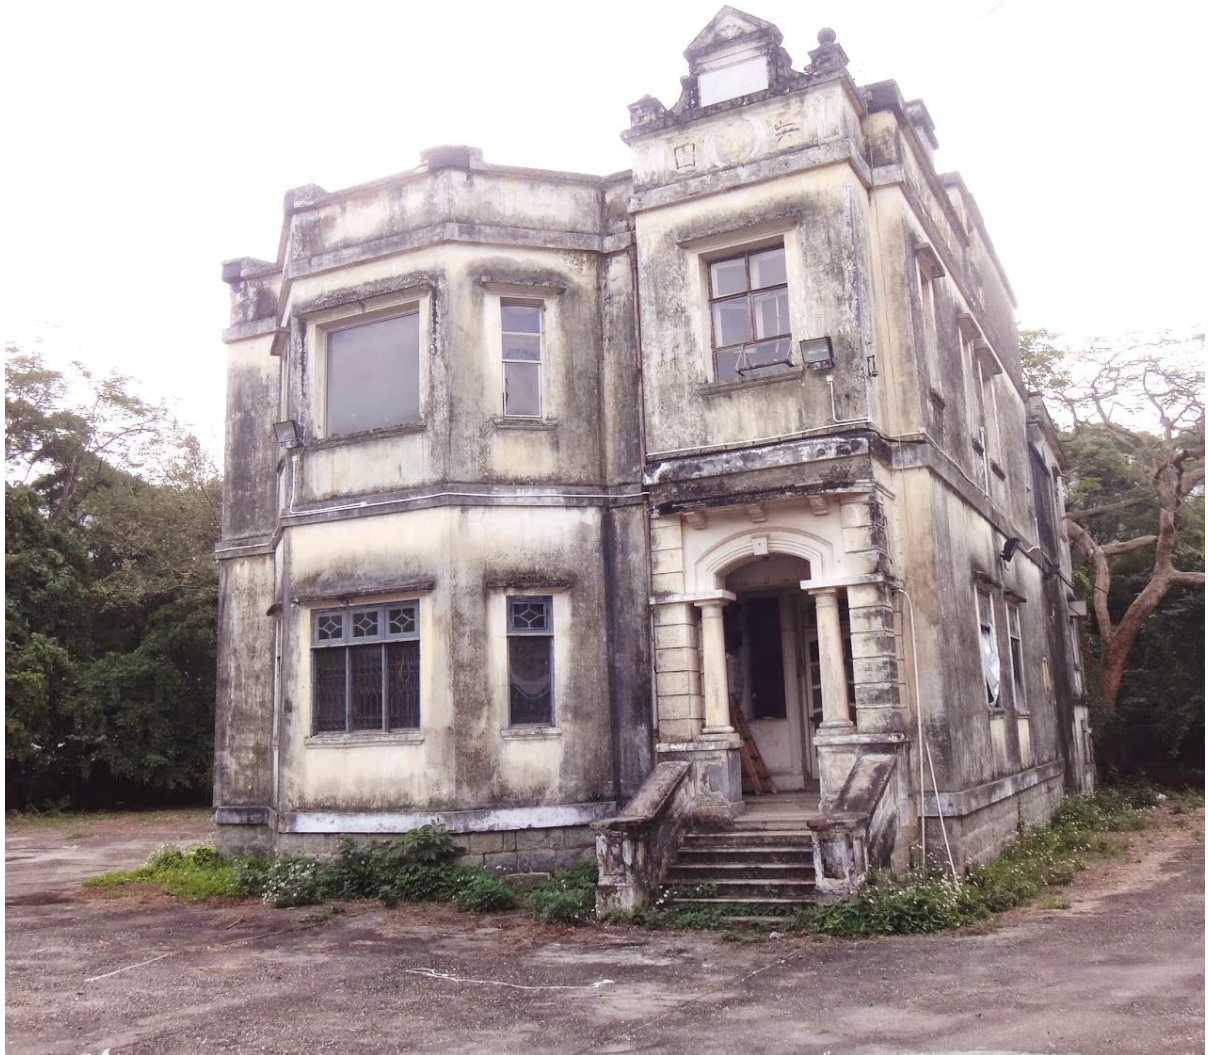
B7.3.13 Front elevation in 2015.

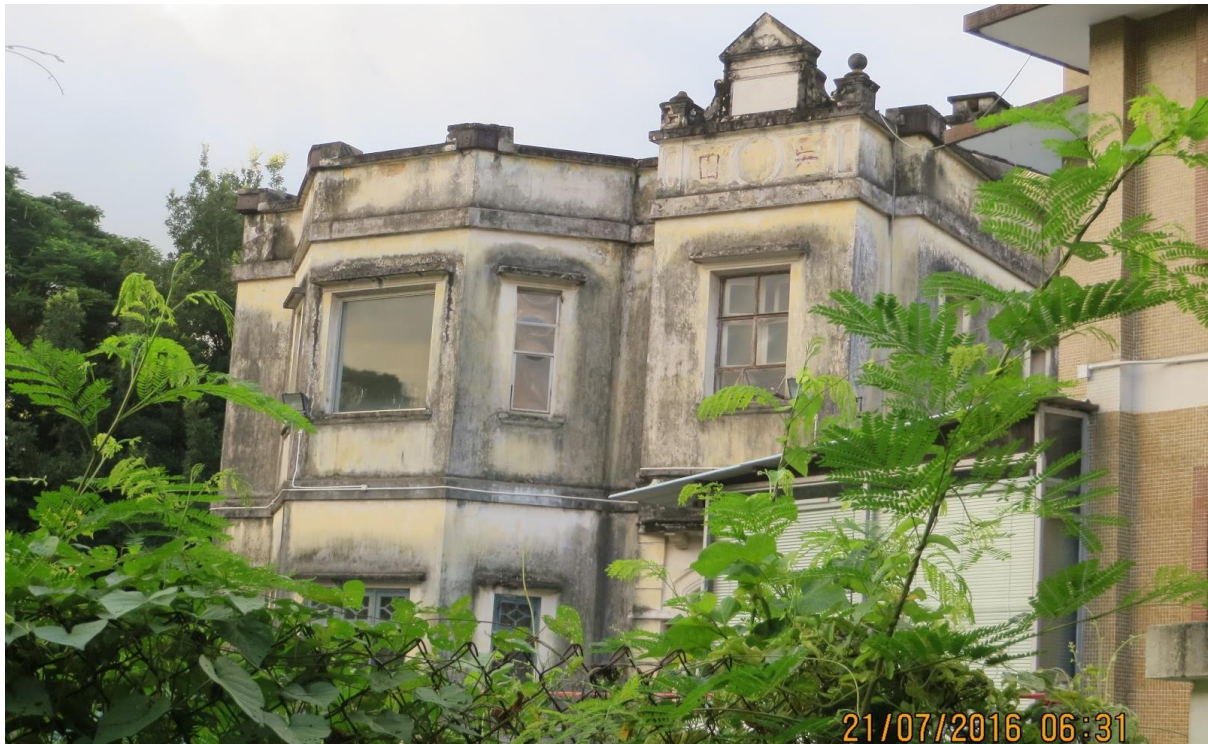
B7.3.14 Roof balustrade wall with pediment in 2016.

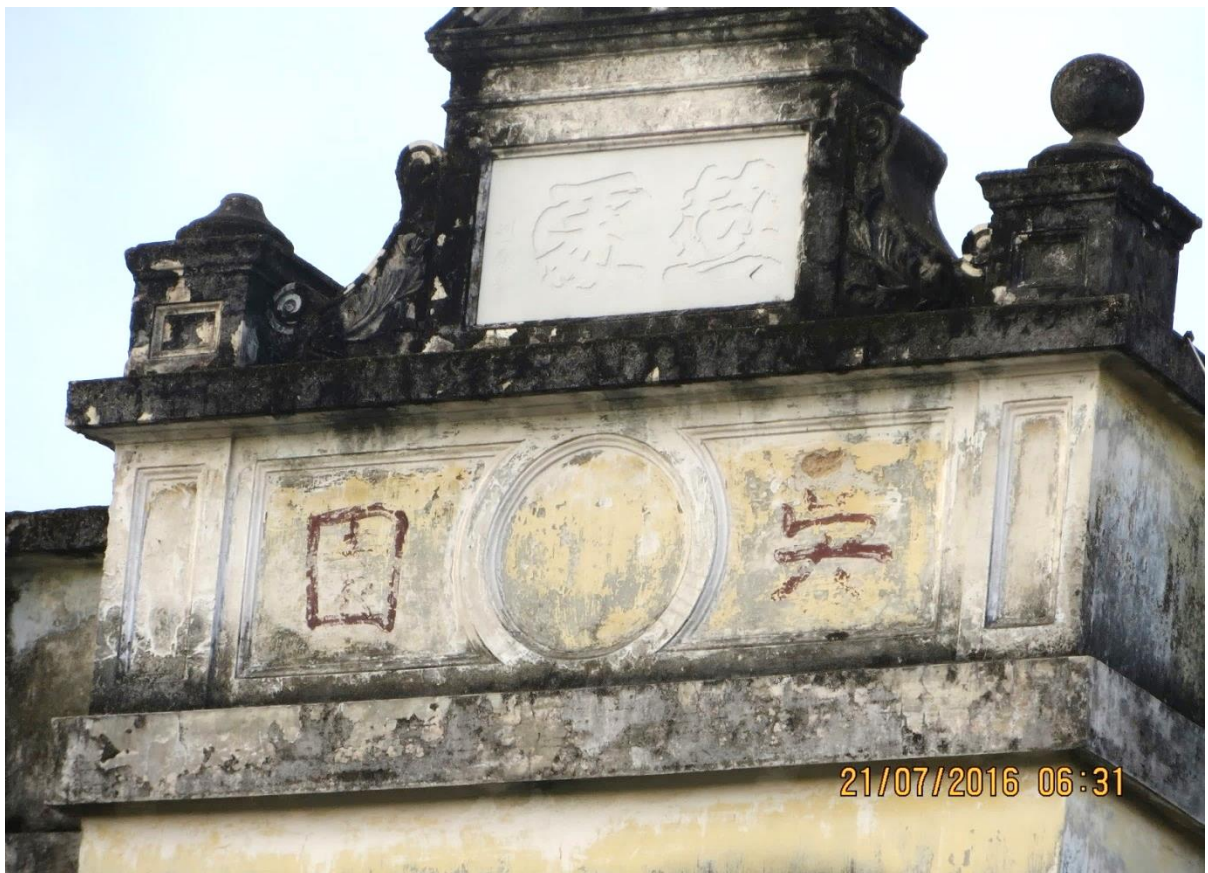
B7.3.15 Roof balustrade wall with pediment in 2016.

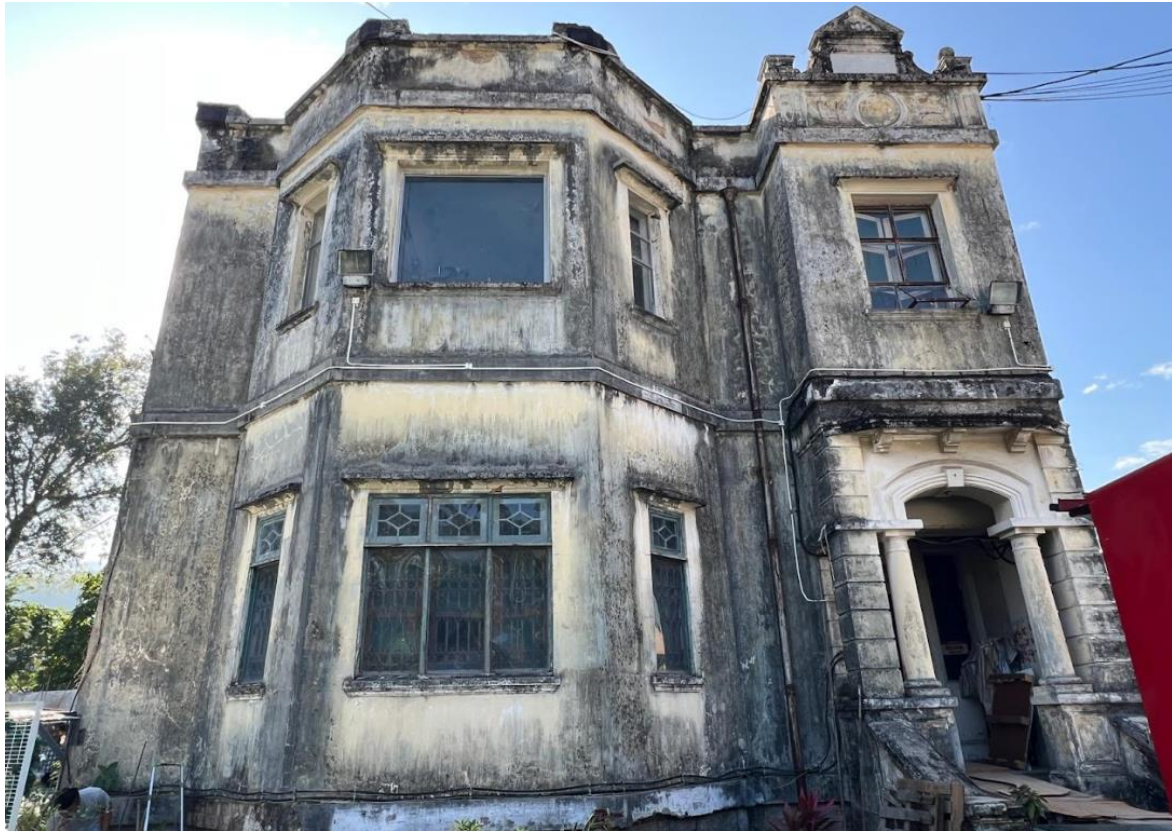
B7.3.16 Front elevation in 2025 Dec.

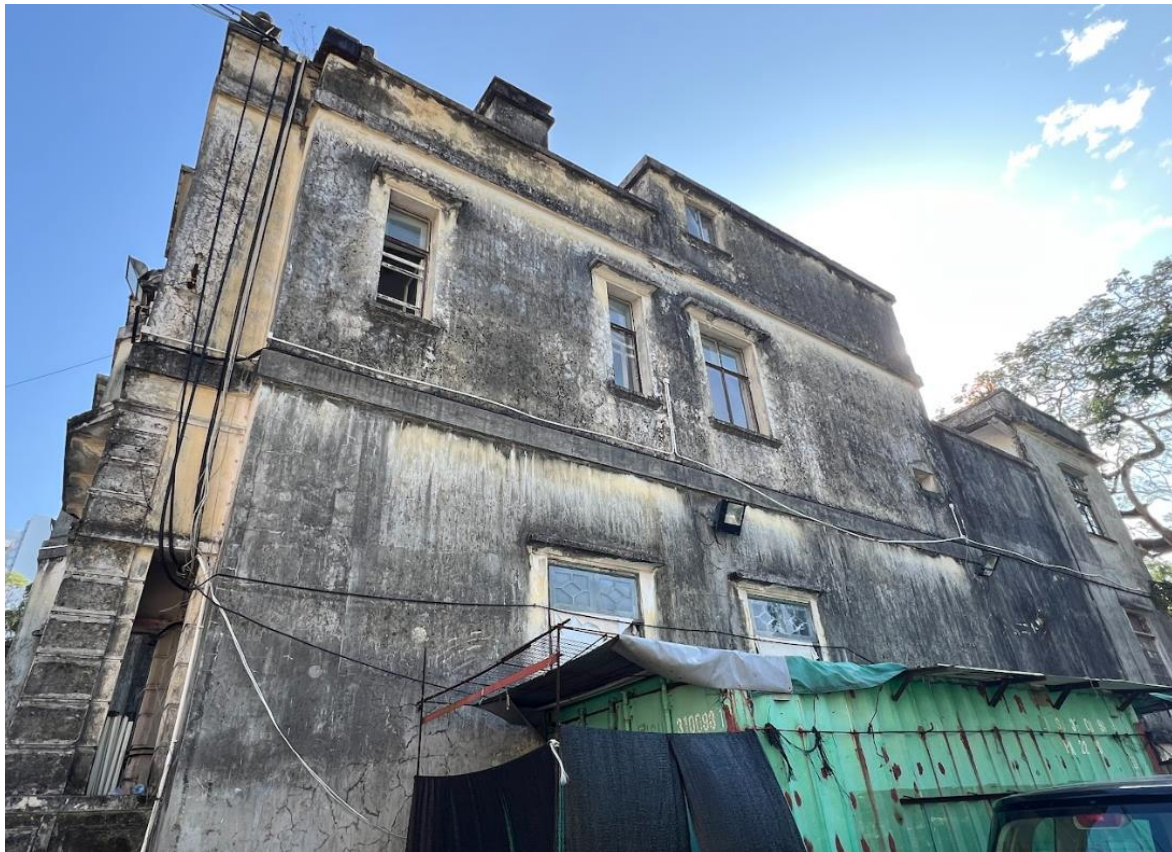
B7.3.17 Side (west) elevation in 2025 Dec.

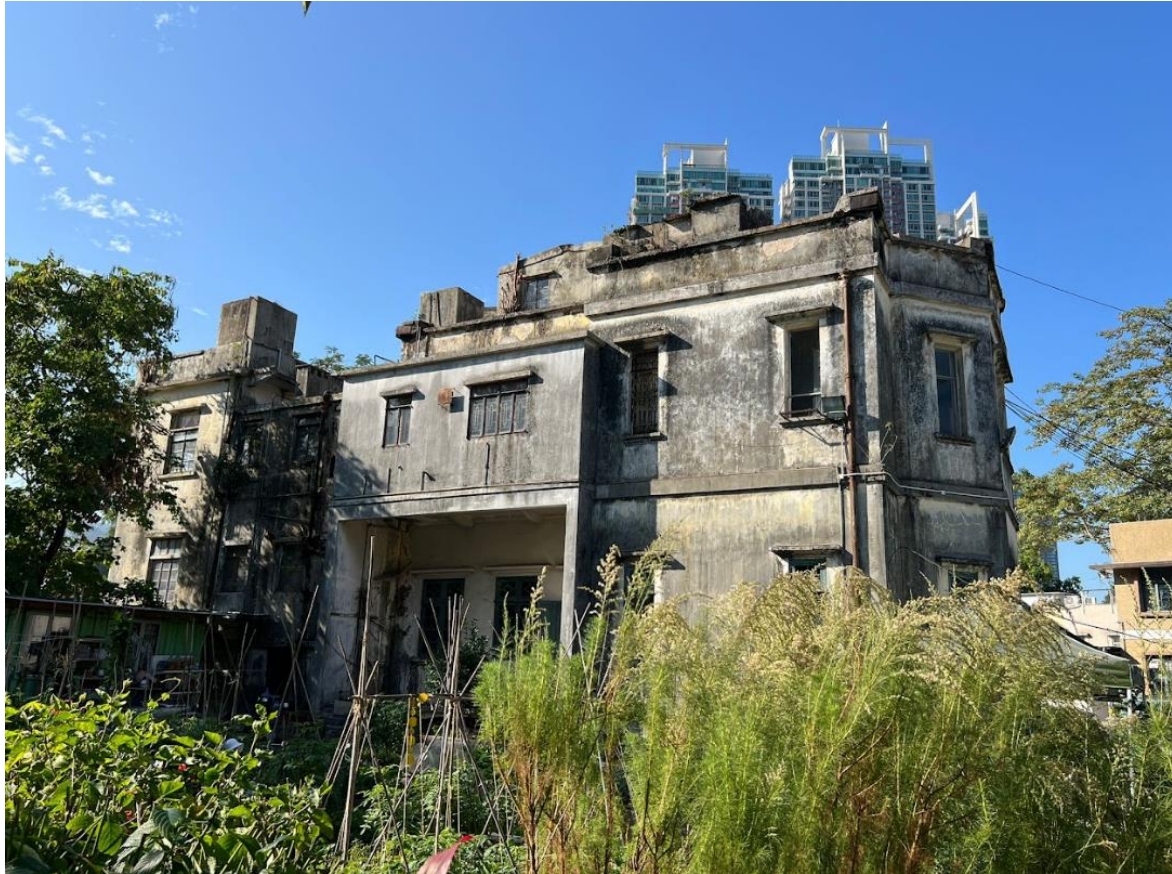
B7.3.18 Side (east) elevation in 2025 Dec.

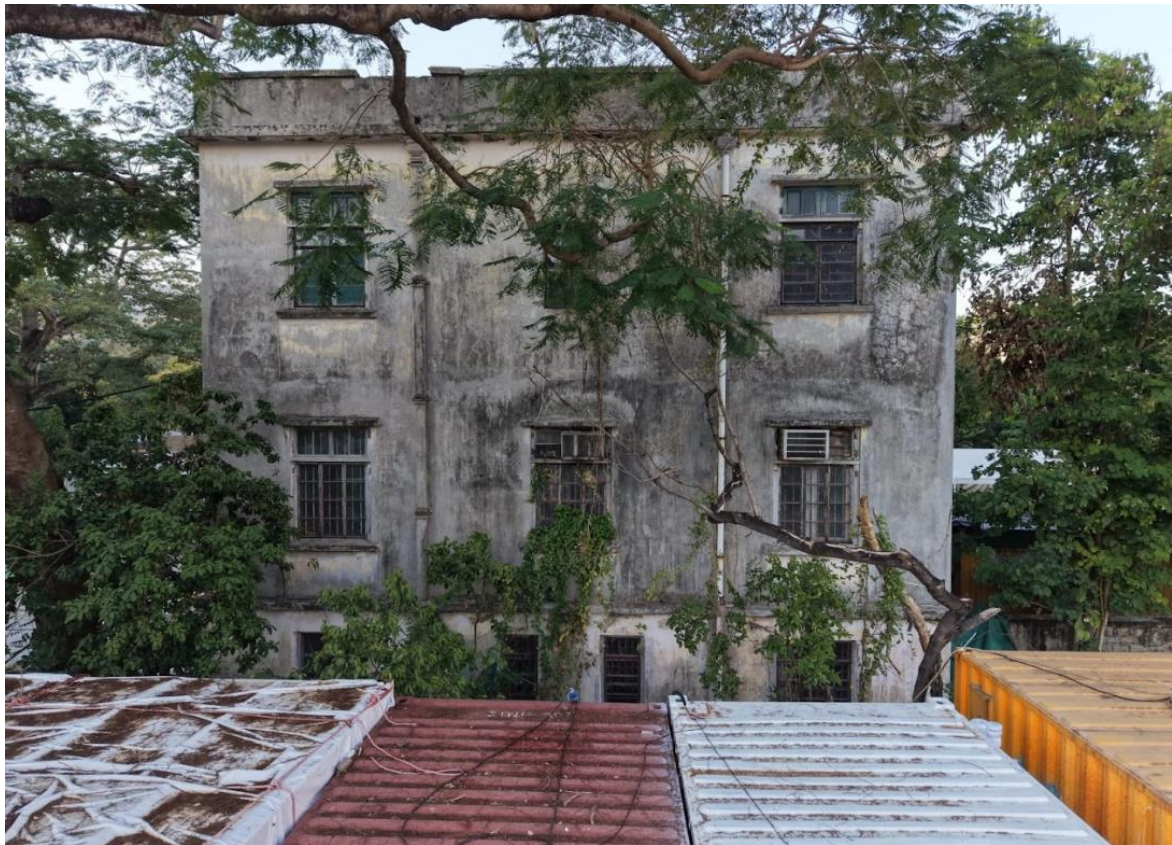
B7.3.19 Rear (south) elevation in 2025 Dec.

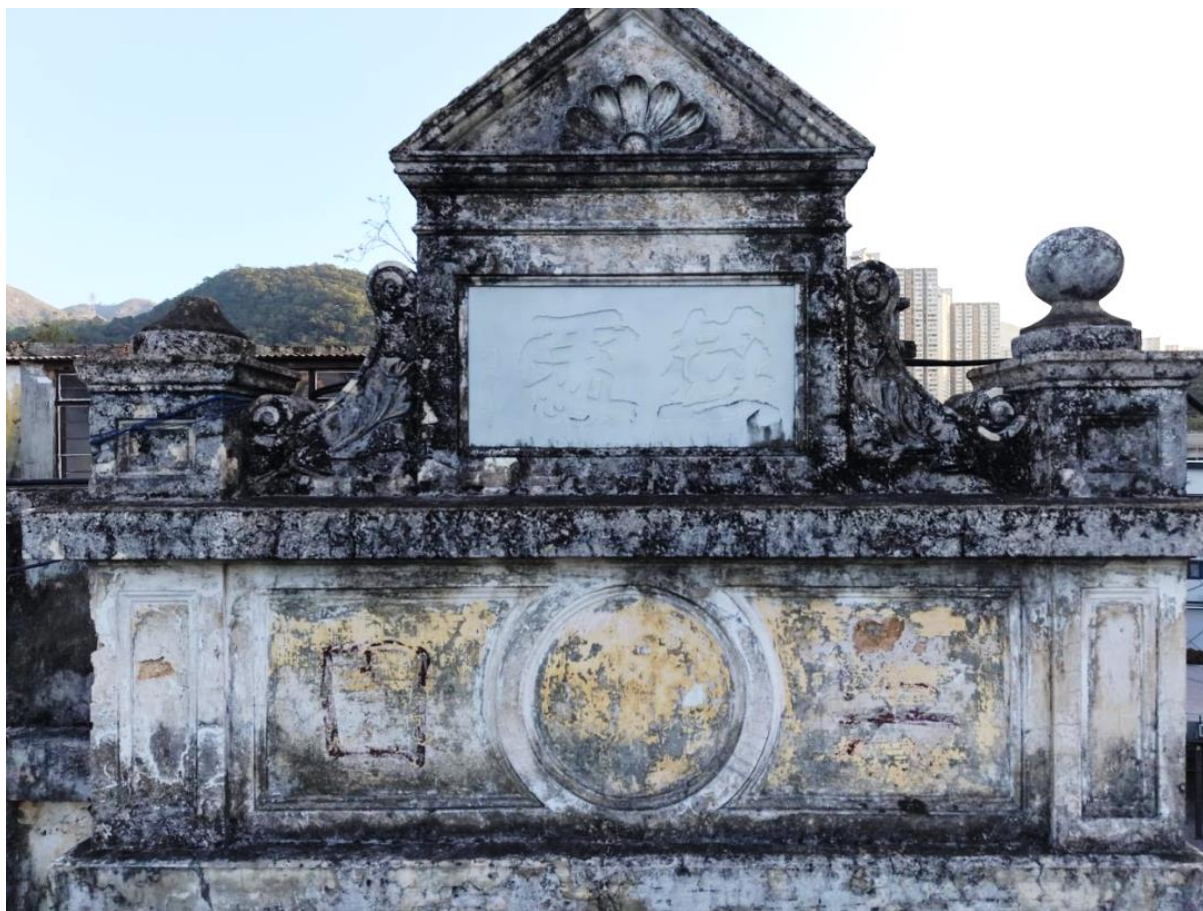
B7.3.20 Roof balustrade wall with pediment in 2025 Dec. (Source: Nam)

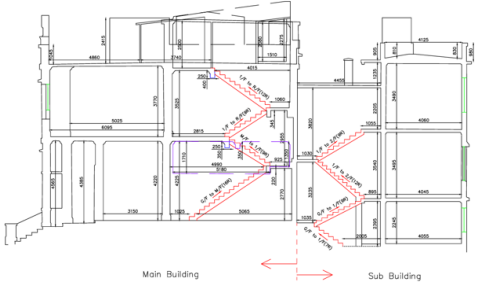
<p>1.3 Levels, Slabs & Walls</p> <p>a. Raised MB G/F b. MB floor slabs and high headroom c. SB floor slabs and low headroom d. MB external and partitioning walls e. SB external and partitioning walls</p> <ul style="list-style-type: none"> • a. is the raised G/F of MB which creates an ascending experience thus grandeur for the residence • For b. and c., the difference in levels and headroom advises the spatial hierarchy of the spaces where MB is of a much superior status than SB • d. of MB forms the interior spaces that have been nicely designed and arranged • e. of SB represents a practical solution for the forming of spaces to be leased out 	<p>Exceptional Exceptional Low High Low</p>

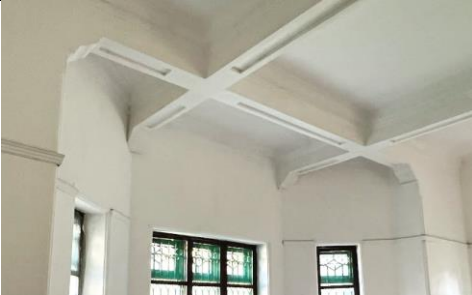
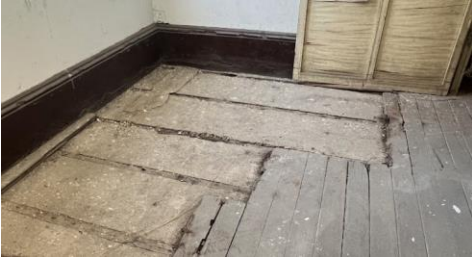
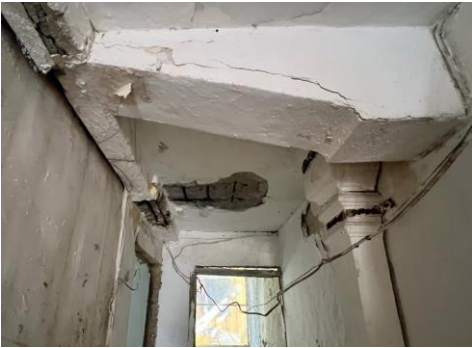
<p>1.4c</p>	<p>1.4 Structural Systems</p> <p>a. MB structural beams with relief slots and curvilinear corbel</p> <p>b. MB reinforced concrete slab with timber strips</p> <p>c. SB reinforced concrete post and beam system</p> <ul style="list-style-type: none"> a. & b. demonstrate the structural design of RC structure that was fairly new in HK back then. The articulation of the beams and profile of corbels enhance the aesthetics of the functional elements. The timber strips laid in the slabs facilitated the installation of timber parquet flooring c. Typical modern post and beam system 	<p>Exceptional</p> <p>Exceptional</p> <p>Low</p>

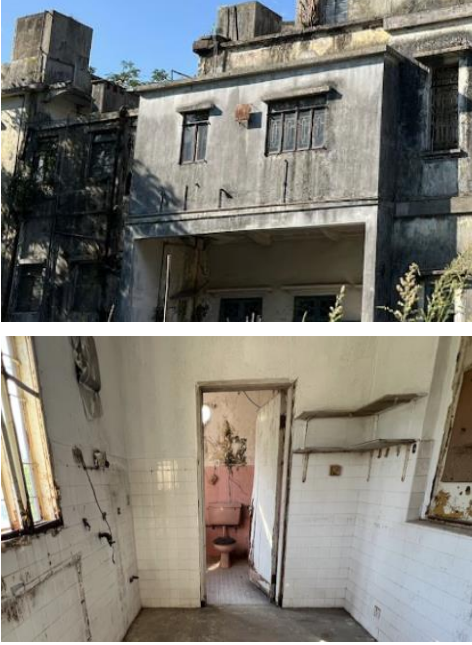
<p data-bbox="206 928 250 960">1.5</p>	<p data-bbox="707 274 1057 338">1.5 Main Building 1/F Kitchen & Washroom</p> <ul data-bbox="707 370 1034 481" style="list-style-type: none"> Expanded due to practical need at a later stage 	<p data-bbox="1133 370 1245 402">Intrusive</p>

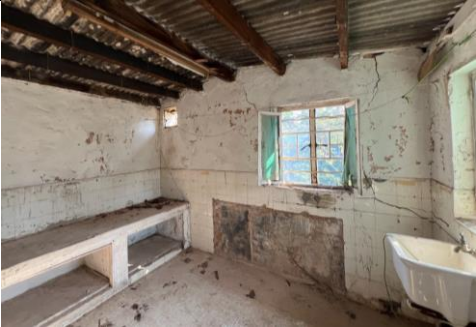
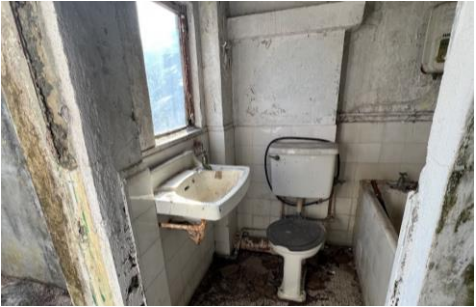
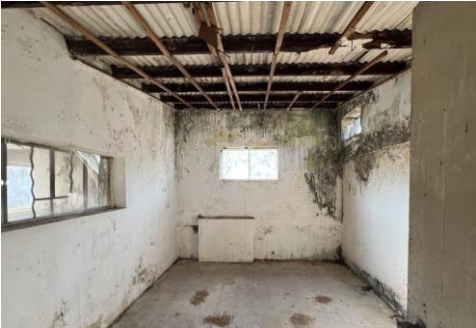
<p>1.6c</p> </div>	<p>1.6 Main Building roof unauthorized structure including walls with doors and windows, corrugated metal roof, fixtures, etc. at:</p> <ul style="list-style-type: none"> a. kitchen b. bathroom c. bedrooms <ul style="list-style-type: none"> • Added due to practical need for a bigger kitchen at a later stage 	<p>Intrusive</p>

The additional structure on the roof with a roof made of corrugated panels was used as a kitchen, bathroom, and very likely a bedroom. White glazed tiles on wall and working table tops, and other toilet fixtures are noted.

B5.4.4 – This space found on the roof of Main Building is believed to be a bedroom.

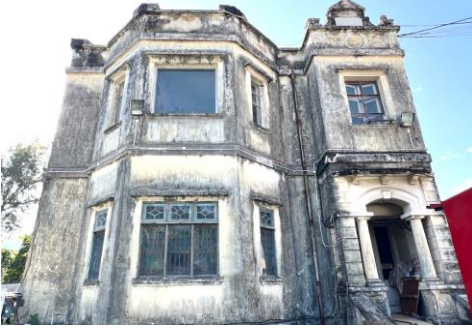
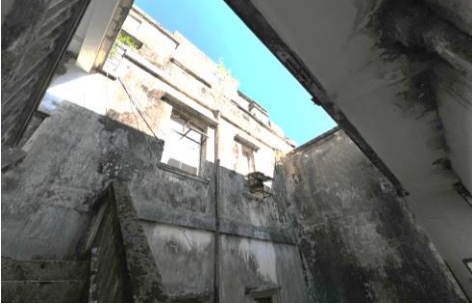
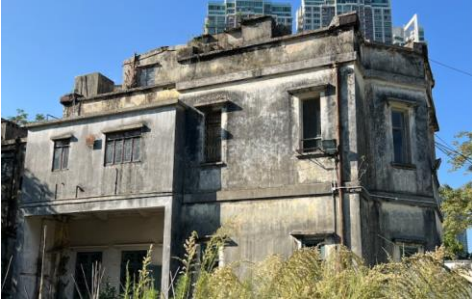
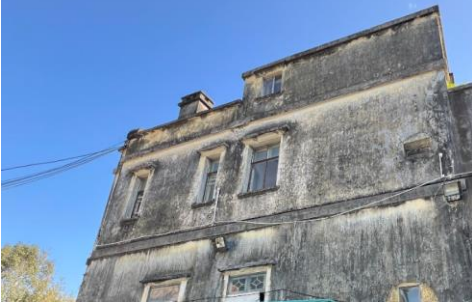
<p>1.7c</p>	<p>1.7 Main Building facades: a. North (main) façade b. South facade c. East façade d. West facade</p> <ul style="list-style-type: none"> a. showcases the flamboyant architectural languages with influence from western cultures Design of b. to d. corresponds to the functional layout of the floors, of which b. has been obstructed and intervened by the later added SB, and c. has been altered by 1/F later added kitchen and bathroom 	<p>Exceptional Medium Medium Medium</p>

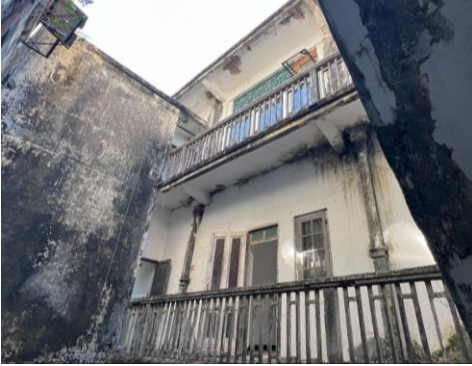
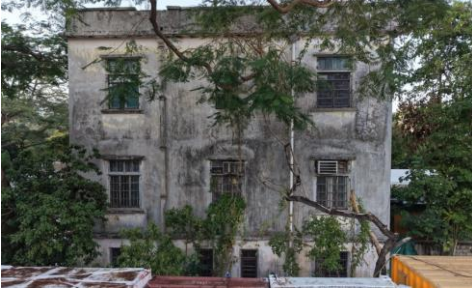
<p>1.8a</p>	<p>1.8 Sub Building and lightwell external facades:</p> <ul style="list-style-type: none"> a. North façade b. South facade c. East façade d. West facade <ul style="list-style-type: none"> • The facades represent a practical solution fulfilling functional needs of the later added SB, of which a. although relatively more articulated is not visible from the outside 	<p>Low Low Low Low</p>

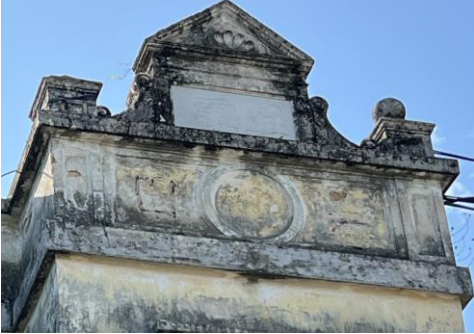
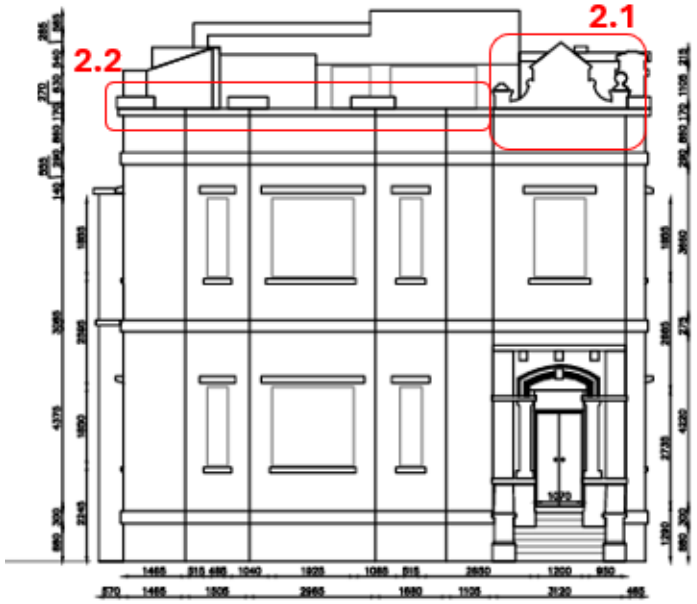
<p>2.1</p>	<p>2.1 Main Building Roof Ornate Balustrade Wall with Upstand Pediment inscribed with the Name and Nickname of NY</p> <ul style="list-style-type: none"> • Displays the Chinese root of the original owner • Demonstrates the western architectural influences • Represents the aesthetics popular in HK in the 1920s 	<p>Exceptional</p>

The entrance porch is topped at the roof level with the parapet wall enriched with an upstand pediment with scroll ornamentations featuring floral and leave motives on top. The Chinese name of the residence 「吳園」 has been inscribed on the roof parapet wall directly above the entrance porch. The inscribed Chinese characters 「燕處」 signifying the residence as the place of retirement or rest for the owner are found on the rectangular panel at the pediment. Note that the Chinese character 「處」 here is presented by way of replace the top portion of 「處」 by 「雨」 (such approach is also known as 「雲頭」¹⁰, “head of cloud”).

B4.3.4 – Ornate balustrade wall with upstand as observed from the roof level, Main Building.

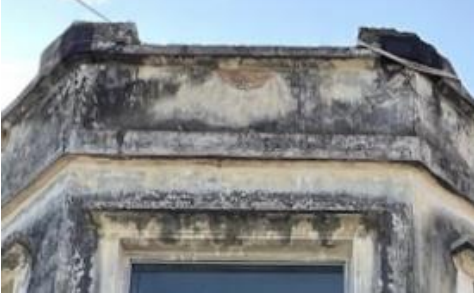
<p>2.2</p>	<p>2.2 Main Building Roof Balustrade with Crenellation</p> <ul style="list-style-type: none"> • Demonstrates the western architectural influences • Represents the aesthetics popular in HK in the 1920s 	<p>Exceptional</p>

B4.3.5 – Roof crenellation features as observed from street level, Main Building.

B4.3.6 – Roof crenellation features as observed from roof level, Main Building.

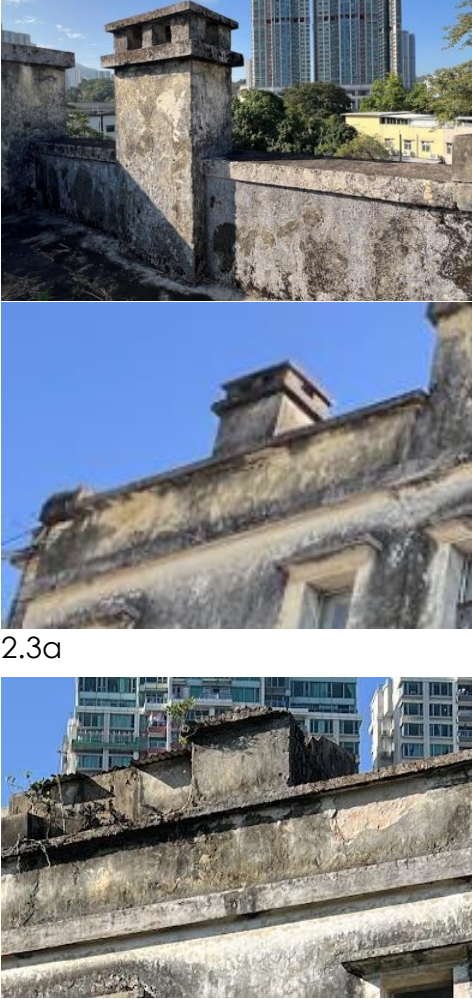
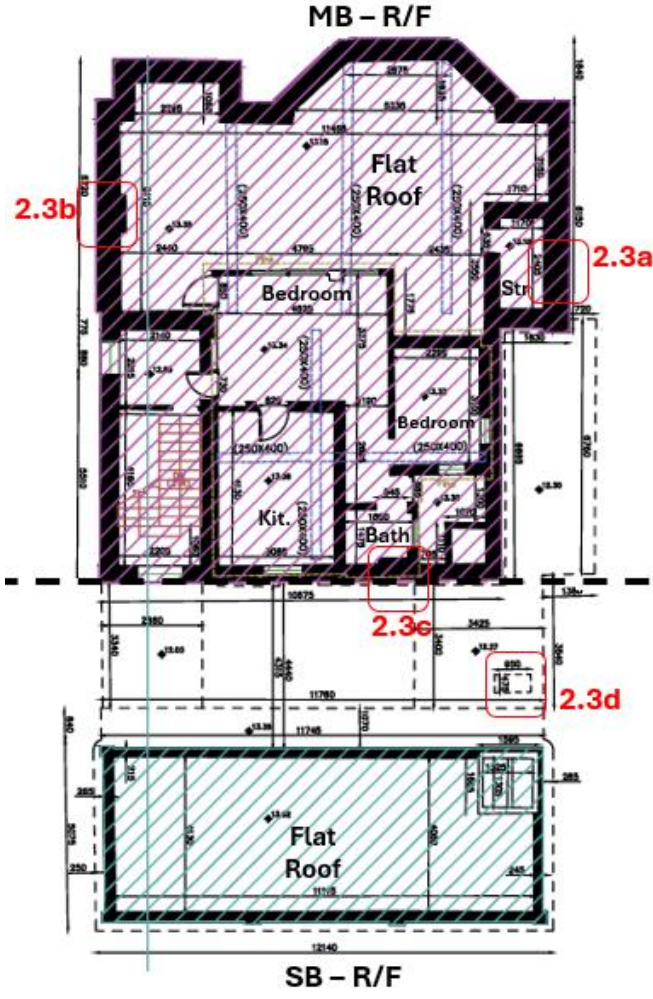
<p data-bbox="206 948 268 979">2.3a</p> <p data-bbox="206 1321 268 1353">2.3b</p>	<p data-bbox="707 312 927 344">2.3 Chimney at</p> <ul style="list-style-type: none"> <li data-bbox="757 360 1066 392">a. MB roof (west side) <li data-bbox="757 395 1066 427">b. MB roof (east site) <li data-bbox="757 430 1066 462">c. MB roof (south site) <li data-bbox="757 466 1066 497">d. SB roof (east site) <ul style="list-style-type: none"> <li data-bbox="707 545 1088 753">• a. b. & c. illustrate the western way of living of wealthy/ educated Chinese for having fireplaces at home back then <li data-bbox="707 759 1088 865">• d. functioned as the exhaust flue for kitchen added to SB in c. 1980s. 	<p data-bbox="1124 370 1191 507">High High High Low</p>

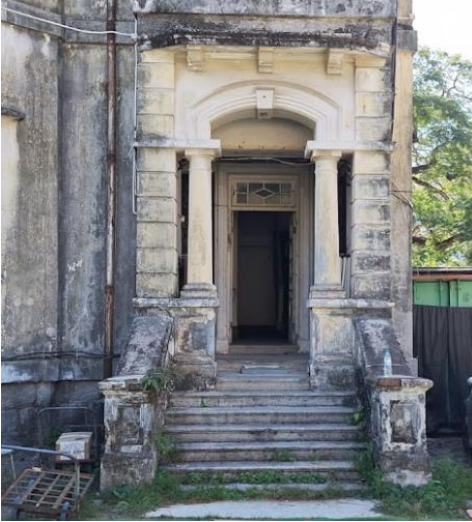
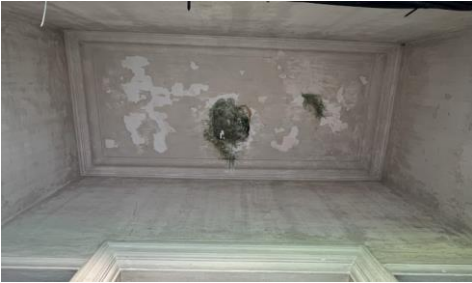
<p>2.4a to 2.4f</p>

<p>2.4g</p>	<p>2.4 MB Main Entrance Porch with</p> <ol style="list-style-type: none"> a. canopy with 3 corbels b. opening with segmented arch surround with headstone c. doric columns with base on plinths d. imitation masonry quoins e. granite steps with nosing f. balustrades with pillars g. ceiling crown moulding <ul style="list-style-type: none"> • Demonstrates the western architectural influences • Represents the aesthetics popular in HK in the 1920s • Displays the love in architecture and wealth of the original owner 	<p>Exceptional</p>

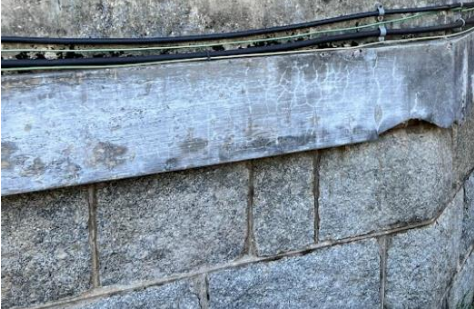
<p>2.5</p>	<p>2.5 Granite to the Base of MB</p> <ul style="list-style-type: none"> Enhances the sense of a solid base of MB Elevates the G/F of MB Acts as a structural element 	<p>High</p>

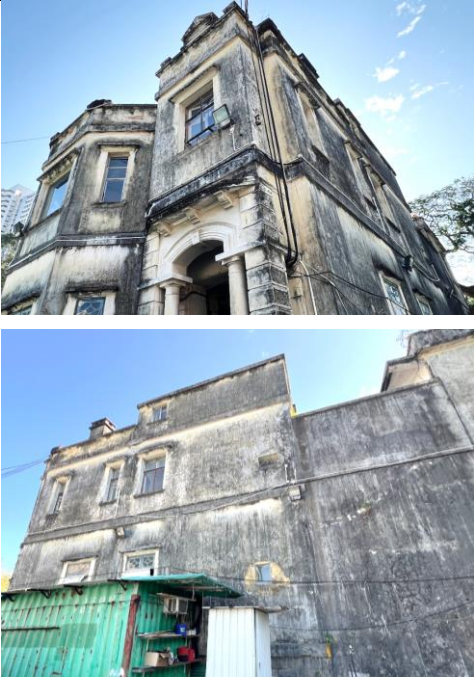
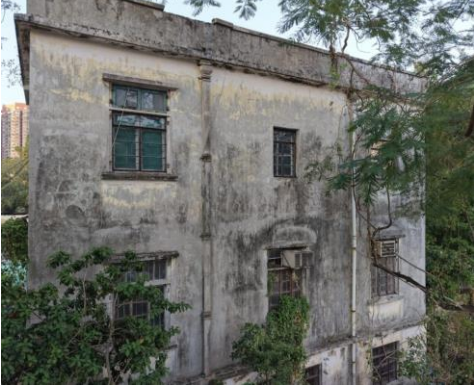
<p>2.6a</p>	<p>2.6 String Courses</p> <p>a. on four facades of MB</p> <p>b. on 1/F and Roof level of SB</p> <ul style="list-style-type: none"> a. delineate the levels and articulate all the facades of MB b. delineate the 1/F and roof level of SB 	<p>High</p> <p>Low</p>

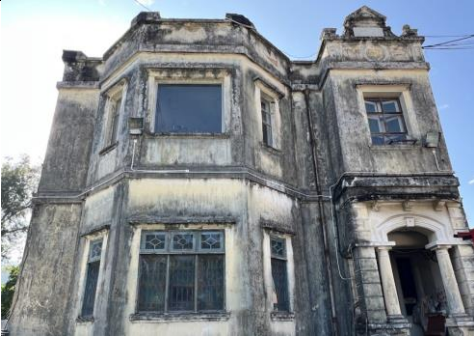
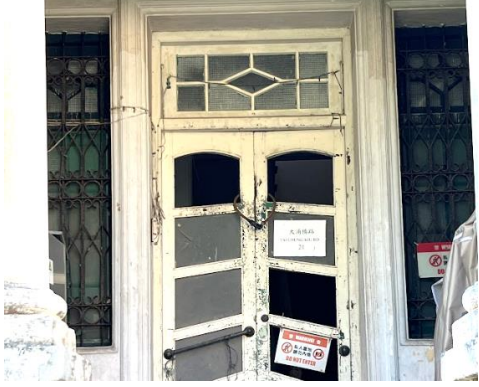
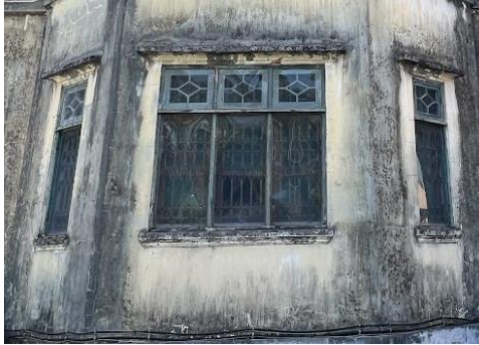
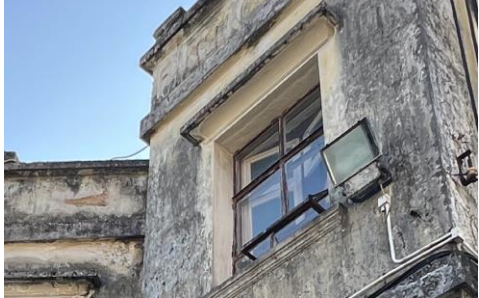
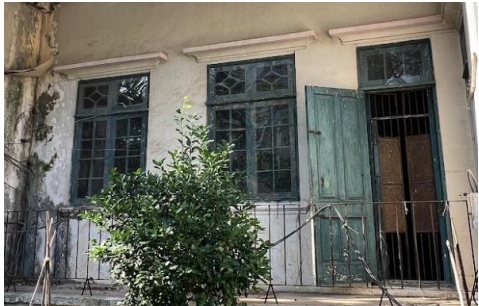
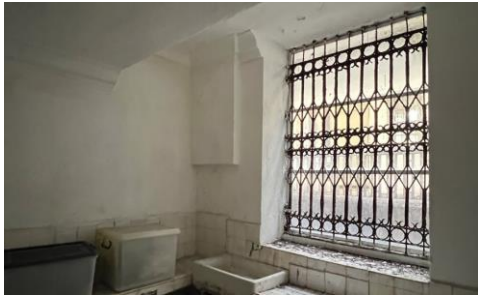
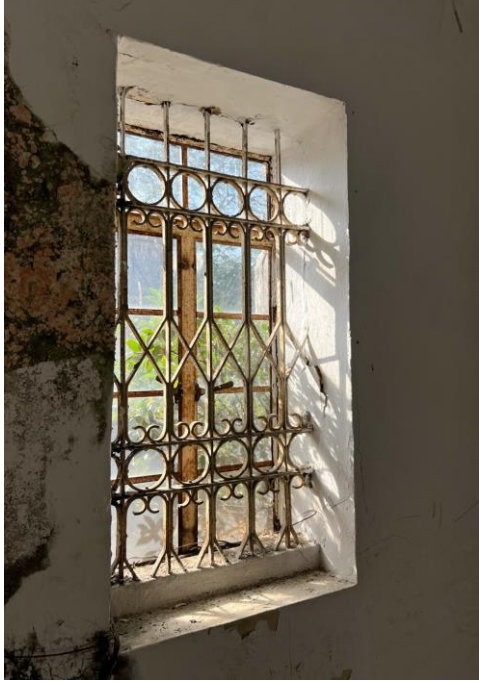
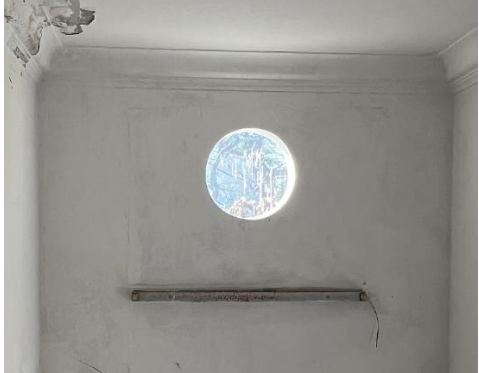
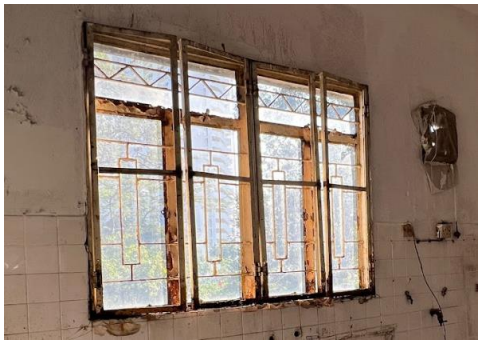
<p>2.7a</p>	<p>2.7 MB Fenestration:</p> <ul style="list-style-type: none"> a. window arrangement b. entrance sidelights c. fanlights to windows d. window mouldings and sills e. timber barriers f. metal barriers g. circular opening at high level of 2/F staircase 	<p>Exceptional Exceptional High High High High High Intrusive</p>

<p>2.7c</p>	<p>h. windows at 1/F kitchen and bathroom</p> <ul style="list-style-type: none"> • a. to c. tally the architectural design of Georgian terrace house that uses well-proportioned, varied, and extensive glazed areas to allow natural lighting to lit up the interior spaces. Rhombus motif has been consistently applied at all fanlights • d. prevents rainwater from entering the interior • e. and f. provide the security measures to the residence and decorate the openings • g. is the only circular opening at MB. Being at high level, it provides natural lighting to and highlight the interior staircase

<p>2.7f</p>	<ul style="list-style-type: none"> h. were later added when the space was expanded as a kitchen and bathroom. They do not tally with the design of the remaining windows in MB
