Appendix A
Conservation Management Plan

Conservation Management Plan with Implementation Proposal for the Proposed Hotel Development with Adaptive Reuse of Ng Yuen at Shing Mun River, Sha Tin

2026 June

Prepared by Substance Lab Limited

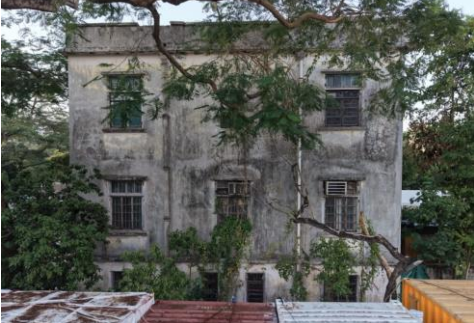
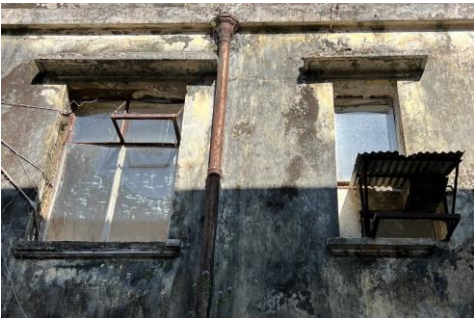
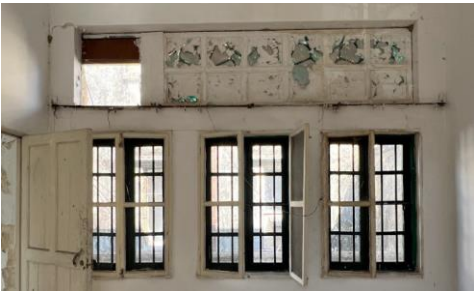
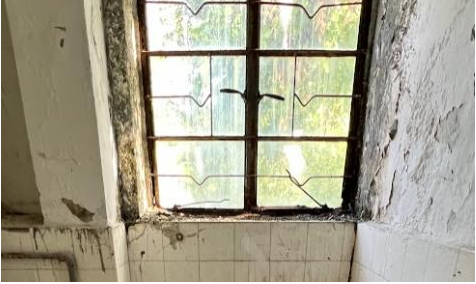
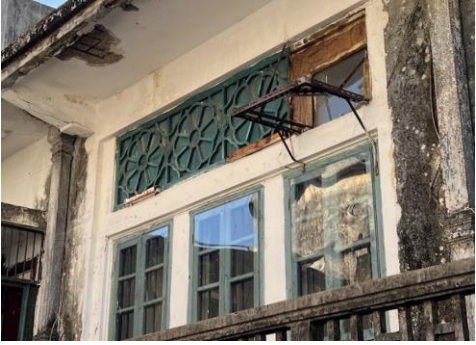
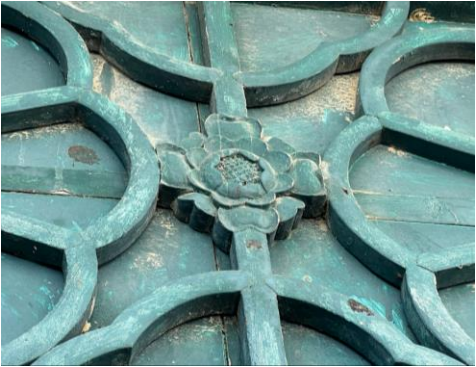
<p>2.8c</p> </div>	<p>2.8 SB Fenestration:</p> <ul style="list-style-type: none"> a. window arrangement b. window mouldings and sills c. windows at sitting rooms and bedrooms d. windows at washrooms e. 2/F sitting room timber grilles (not blocked) bearing carved peony, and floral motifs <ul style="list-style-type: none"> • a. to d. fulfill the functional needs of the interior spaces only • e. is of a unique design combining both traditional Chinese carving technique and modern geometric pattern. It was damaged for the installation of an A/C 	<p>Low Low Low Low High</p>	<div data-bbox="1429 343 1960 790">

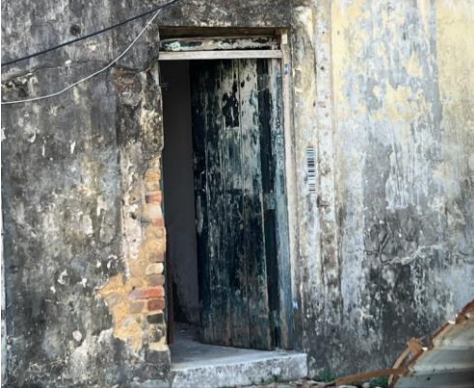
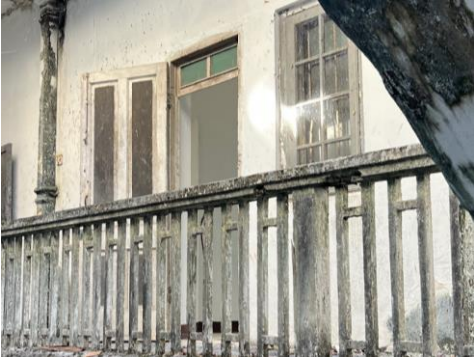
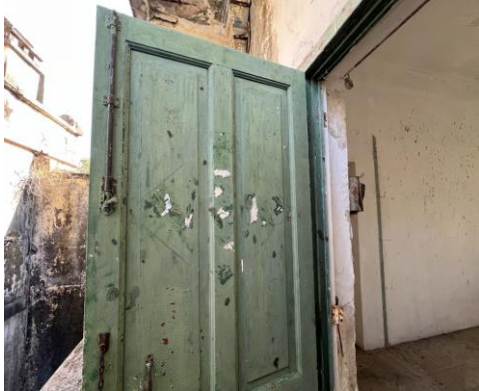
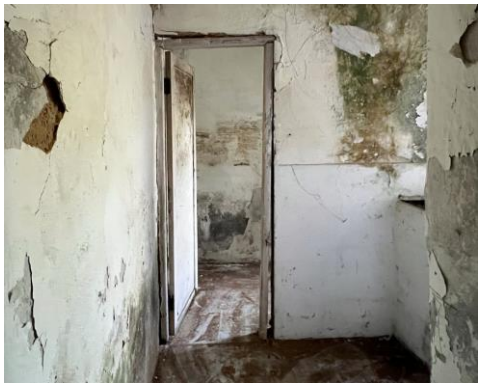
<p>2.10b</p>	<p>2.10 SB Doors at</p> <ul style="list-style-type: none"> a. west wall providing access to lightwell b. sitting room c. bedrooms d. kitchens, bathrooms, stores at east end <ul style="list-style-type: none"> • a. to d. were introduced at a later stage and bear no aesthetic values 	<p>Low</p>

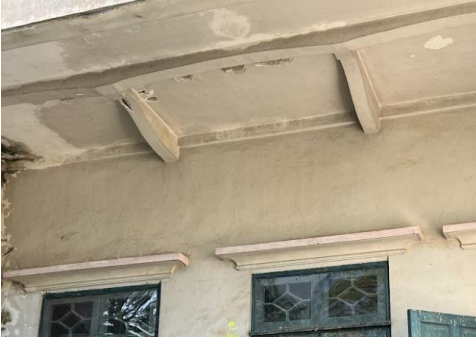
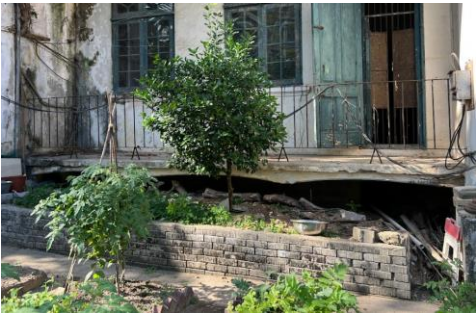
<p>2.11b</p>	<p>2.11 Main Building G/F Balcony with</p> <ul style="list-style-type: none"> a. curvilinear cantilevered beams b. curvilinear edge beams on G/F and 1/F c. metal balustrade <ul style="list-style-type: none"> • The beams' curvilinear profile contributes to the eclecticism architectural style adopted in NY 	<p>Exceptional</p> <p>Exceptional</p> <p>Low</p>

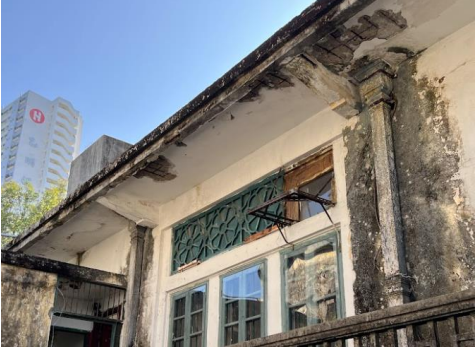
<p>2.12</p>	<p>2.12 SB Canopy with Cantilevered Beams</p> <ul style="list-style-type: none"> • Functional design without aesthetic value 	<p>Low</p>

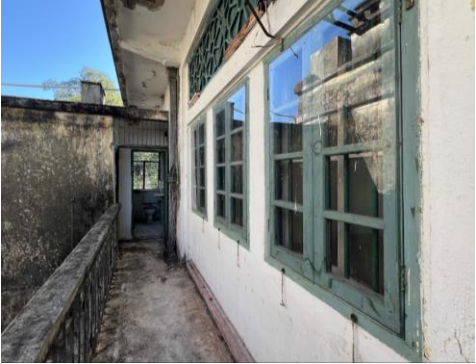
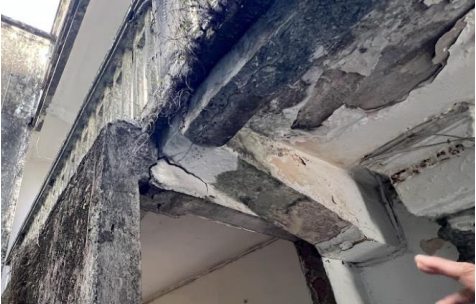
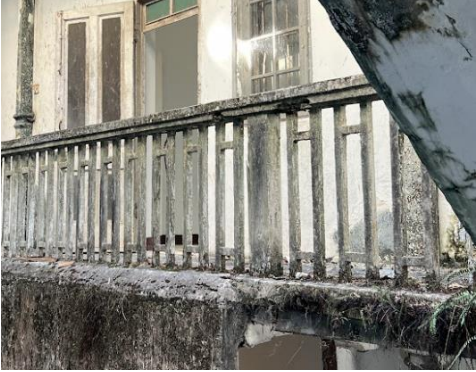
<p>2.13 SB Cantilevered Balcony with a. Cantilevered beams b. H-shaped balustrades</p> <ul style="list-style-type: none"> • a. Functional design without aesthetic value • b. Its design echoes to the balustrades at staircase, MB 	<p>Low Medium</p>

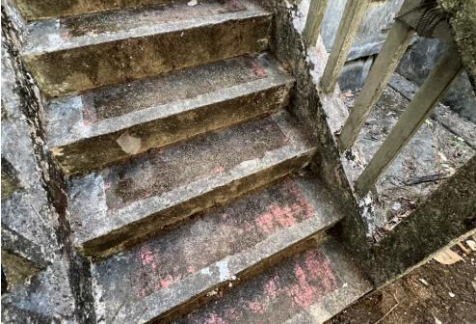
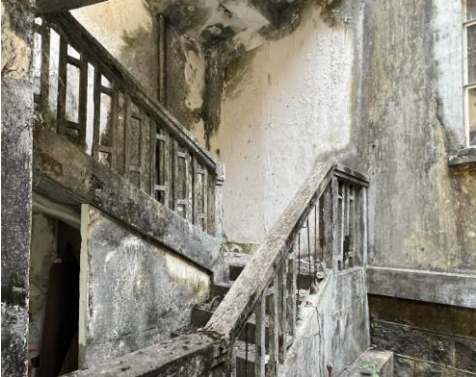
<p>2.14 SB Staircase</p> <p>a. Steps with granolithic finish in vermillion colour</p> <p>b. Balustrades with H-shaped barriers</p> <ul style="list-style-type: none"> • a. Functional design without aesthetic value • b. Its design echoes to the balustrades at MB staircase 	<p>Low</p> <p>Medium</p>

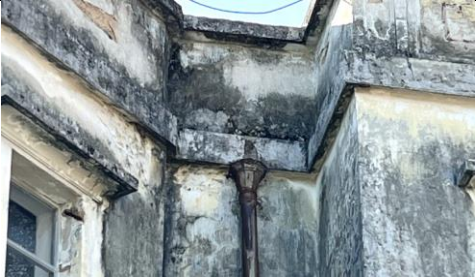
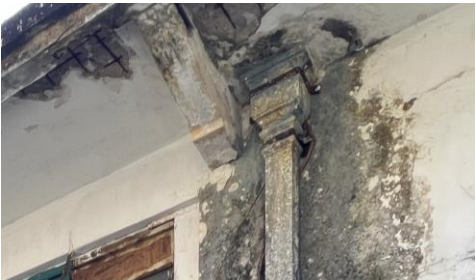
<p>2.15b</p>	<p>2.15 Metal Rain Hopper & Downpipes at a. MB b. SB</p> <ul style="list-style-type: none"> a. Original fixtures b. Later added fixtures 	<p>High Low</p>

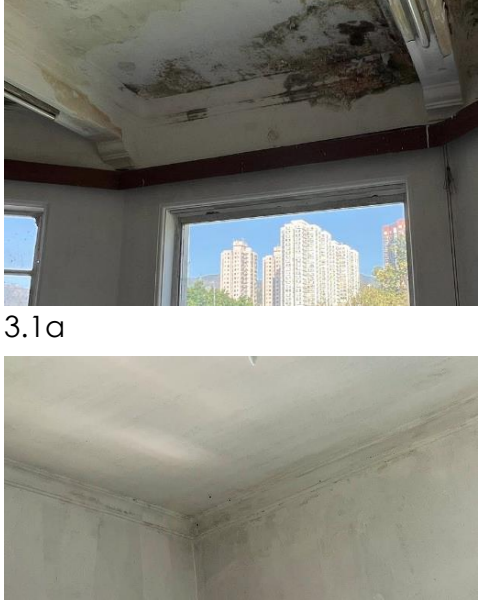
<p>3.1a</p> <p>3.1b</p>	<p>3.1 Ceiling Corner Mouldings at a. Main Building b. Sub Building</p> <ul style="list-style-type: none"> a. The MB mouldings are very detailed in its design and carefully executed. It is matched by the mouldings surrounding MB window openings b. The SB mouldings are simple in design, introduced at the time when SB was added to NY 	<p>High Low</p>

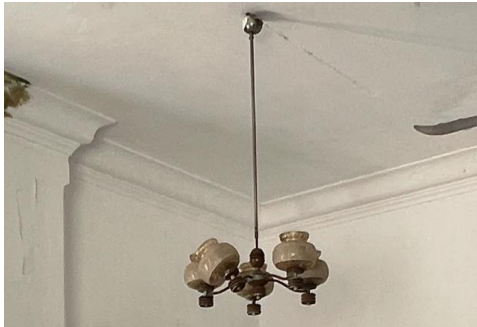
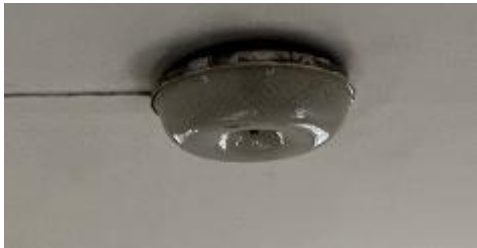
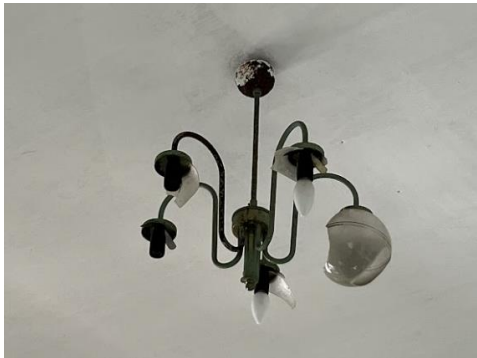
</div> <p data-bbox="203 1316 271 1348">3.2c</p>	<p data-bbox="707 274 1106 448">3.2 Lighting Fixtures at a. Dining Room of MB b. G/F Sitting Room of SB c. 2/F Bedroom of SB</p> <ul data-bbox="707 470 1106 783" style="list-style-type: none"> • a. Demonstrates the life style and taste of the Ng family • b. and c. fulfill the functional needs for illumination, and were introduced at the time when SB was added to NY 	<p data-bbox="1133 311 1254 343">Medium</p> <p data-bbox="1133 351 1191 383">Low</p> <p data-bbox="1133 422 1191 454">Low</p>	<div data-bbox="1473 274 1928 1193">

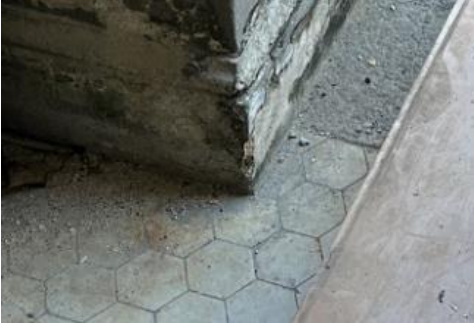
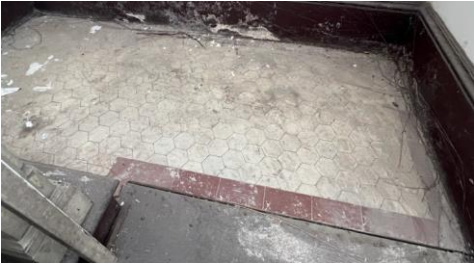
<p>3.3b & 3.3h</p>	<p>3.3 Floor tiles and skirting at Main Building –</p> <ul style="list-style-type: none"> a. G/F granite paving b. G/F and roof white hexagonal tiles (with vermilion border on roof only) c. G/F hallway ornate encaustic tiles in varied patterns d. Vermillion hexagonal tiles on staircase landing with ornate border e. G/F kitchen & washroom cement tiles in red and dark yellow 	<p>Exceptional</p> <p>Exceptional</p> <p>Exceptional</p> <p>Exceptional</p> <p>High</p>

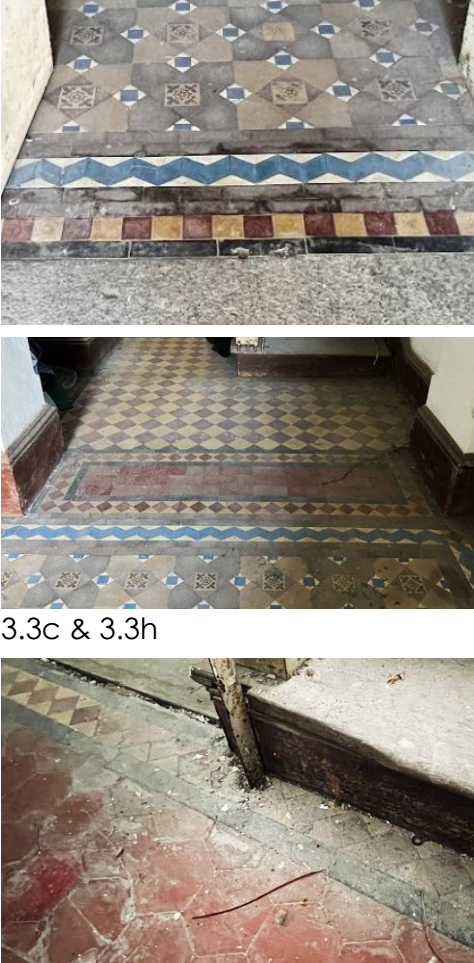
<p>3.3c & 3.3h</p> <p>3.3d</p>	<p>f. 1/F bathroom mosaic tiles</p> <p>g. 1/F kitchen cement tiles</p> <p>h. Dark brown timber skirtings throughout MB</p> <ul style="list-style-type: none"> a. to e. present a diversified selection of floor tile forms, sizes, colours, composition, etc. for the circulation and back-of-house areas. They do not only decorate the different spaces, but also illustrate the spatial hierarchy of NY f. & g. were introduced when the corresponding spaces were added to MB h. form an integral part to the design of the ornate floor tiles and timber parquet flooring 	<p>Intrusive</p> <p>Intrusive</p> <p>High</p>

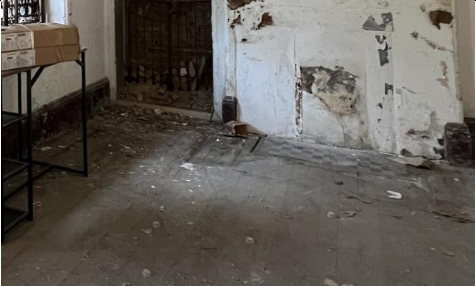
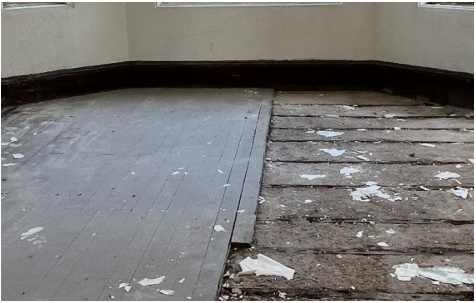
<p>3.4b</p>	<p>a. G/F living and sitting rooms b. 1/F dining rooms, study, sitting room, wardrobe, and bedroom</p> <ul style="list-style-type: none"> a. and b. are found in all the non-circulation and back-of-house spaces of NY, and reflect the luxurious flair of the house whose design was influenced by Georgian terrace house

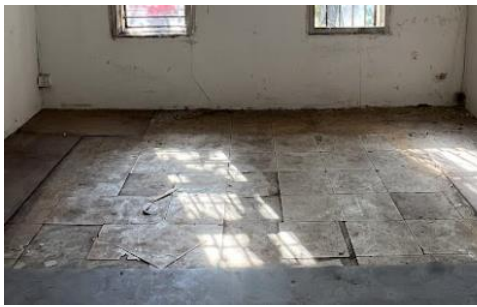
<p>3.6</p>	<p>3.6 Vinyl tiled flooring on G/F, SB</p> <ul style="list-style-type: none"> Applied on terrazzo floor finish in recent decades 	<p>Intrusive</p>

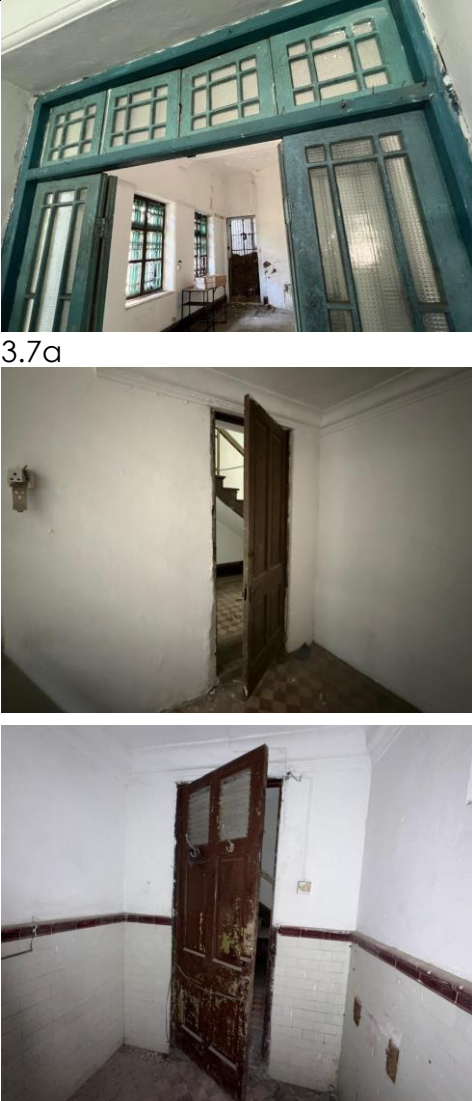
<p>3.7a</p>	<p>3.7 MB Doors in the Interior</p> <p>a. G/F partitioning door between Living and Sitting Rooms</p> <p>b. G/F kitchen and bathroom</p> <p>c. Door and metal gate between 1/F staircase landing and corridor</p> <p>d. Doors to 1/F study, sitting room</p> <p>e. 1/F Doors between dining room and kitchen, and bedroom and wardrobe</p> <p>f. Metal gate at sitting room, G/F</p> <ul style="list-style-type: none"> a. The door allows the merge of the living and sitting rooms and is equipped with translucent glass panels enhancing privacy b. They are original doors c. The later added door and metal gate with the writing "private area, no 	<p>Exceptional</p> <p>Medium</p> <p>Low</p> <p>Medium</p> <p>Low</p> <p>Medium</p>

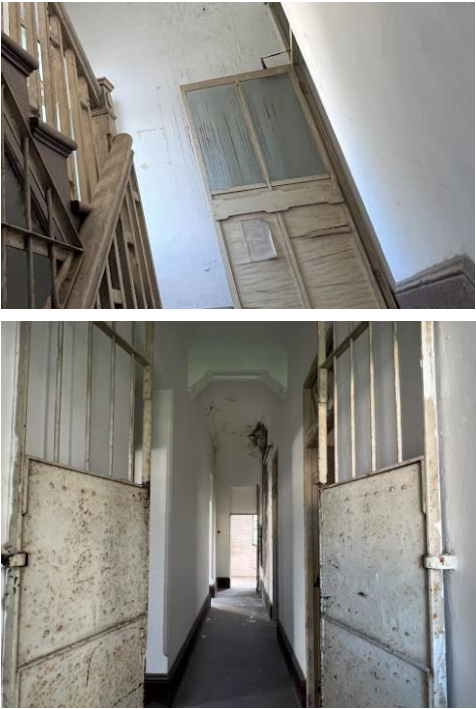
<p>entry" signify the fact that MB 1/F was used separately from the G/F and roof for a certain period in the past</p> <ul style="list-style-type: none"> d. The provision of fanlight facilitates natural ventilation e. Door to the later expanded 1/F kitchen f. It demarcates the wall opening which is believed to be the original rear entrance of NY

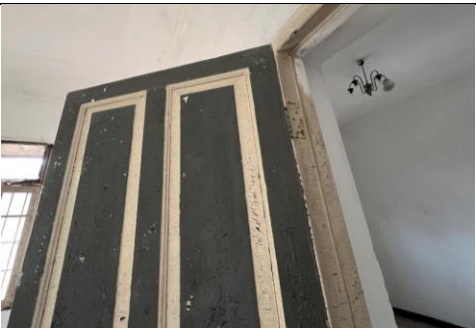
<p>3.8 SB Doors in the connecting rooms on all floors</p> <ul style="list-style-type: none"> • Later added doors 	<p>Low</p>

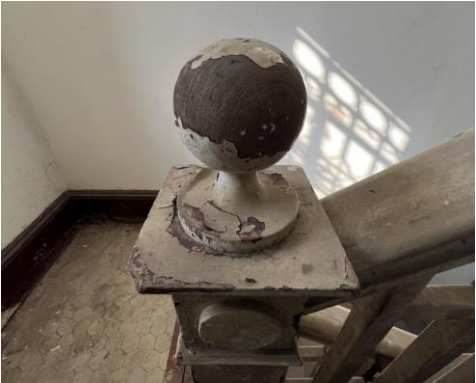
<p>3.9</p>	<p>3.9 RC Staircases at Main Building with:</p> <ul style="list-style-type: none"> a. Timber balustrade b. Timber flooring c. Timber balustrades with newel posts with ball finials <ul style="list-style-type: none"> • They signify the grandeur of NY 	<p>Exceptional</p>

In terms of statutory compliance, some of the areas of NY do not comply with the Buildings Ordinance. For instance, the balustrades to the staircases at both Main and Sub Buildings do not fulfil the prescribed height requirement to prevent the danger of falling. With the redevelopment project, these inadequacies found in NY shall be investigated in further technical detail and be tackled through professional designs. The quality of NY, in terms of fulfilling modern standards in building safety, shall be improved.

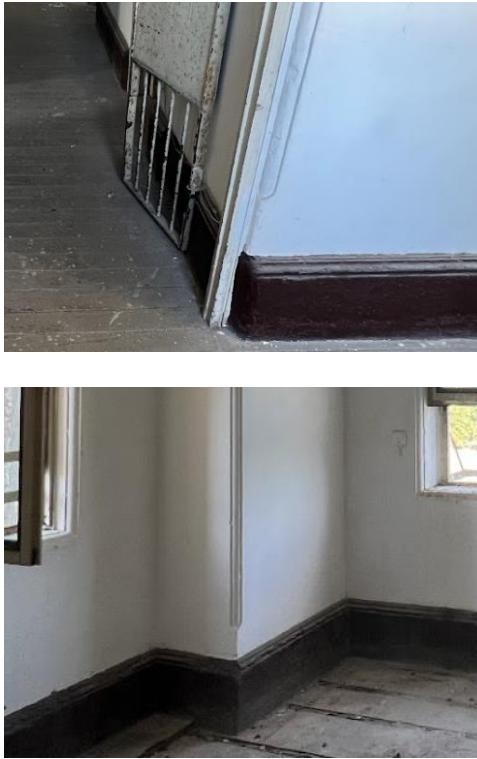
<p>3.10 Main Building mouldings at</p> <ul style="list-style-type: none"> a. G/F and 1/F wall corners, e.g. hallway, study, etc. b. window and door openings 	<p>Exceptional</p>

<p>3.10a</p>	<p>c. smoke chambers of fireplaces</p> <ul style="list-style-type: none"> • They imply that great efforts were put into the architectural details of NY. Besides, such design can minimize damages caused to sharp wall corners

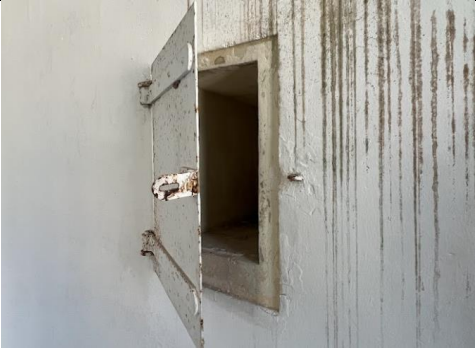
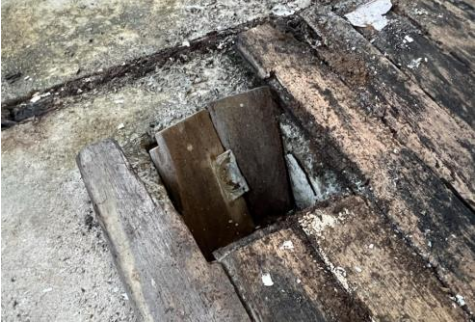
<p>3.12b</p>	<p>3.12 Lockers at Study, MB 1/F</p> <p>a. On wall b. On floor</p> <ul style="list-style-type: none"> Both lockers advise the concern on the need to store valuables of the original owner 	<p>Exceptional</p>

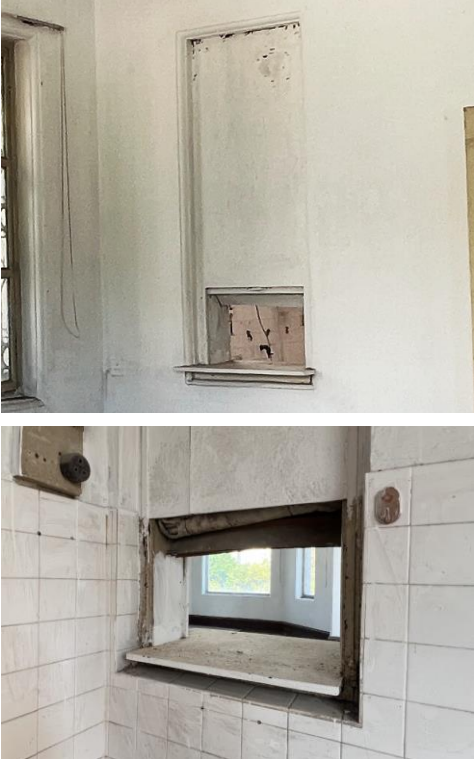
<p>3.13</p>	<p>certain period in the past</p>

<p>MB - 1/F</p>
	<p>3.13 Wall Opening between MB 1/F Dining Room and Kitchen</p> <ul style="list-style-type: none"> The opening was a later added provision when MB was used by different families/tenants for a 	<p>Low</p>

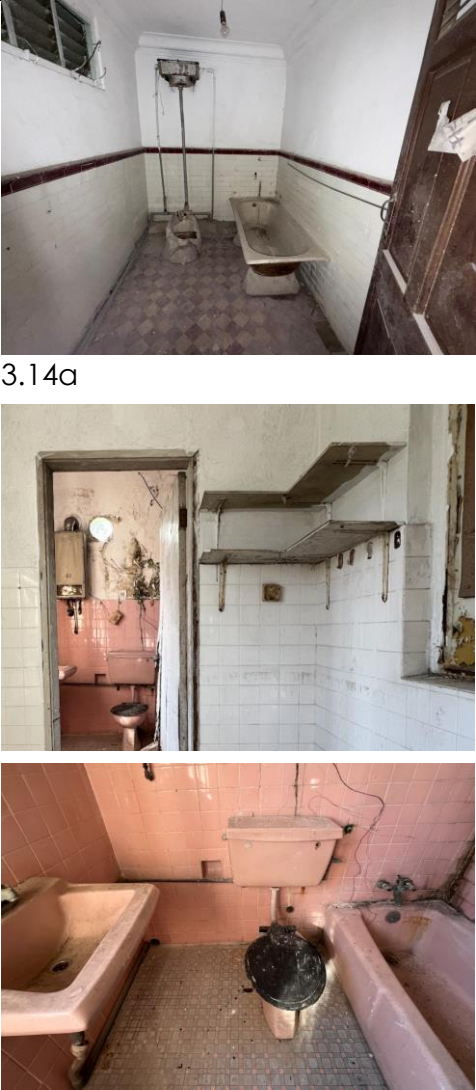
<p>3.14 MB Fixtures, Fitments, Wall & Floor Tiling at Kitchen and Bathroom on:</p> <ul style="list-style-type: none"> a. G/F b. 1/F c. Roof <ul style="list-style-type: none"> • a. was original 	<p>Medium Intrusive Intrusive</p>

<p>3.14a</p> <p>3.14b</p>	<ul style="list-style-type: none"> b. and c. were all later added and do not tally with the original design

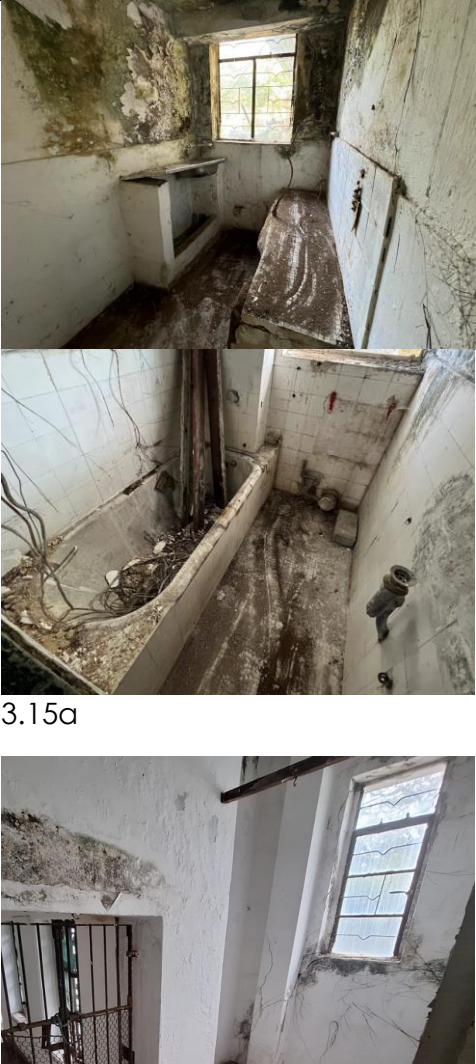
<p>3.15 SB Storeroom/Toilet, Kitchen and Bathroom, and their Fixtures, Fitments, Wall & Floor Tiling on: a. G/F b. 1/F c. 2/F</p>	<p>Intrusive</p>

<p>3.15a</p>	<ul style="list-style-type: none"> These are later added spaces and fixtures at NY

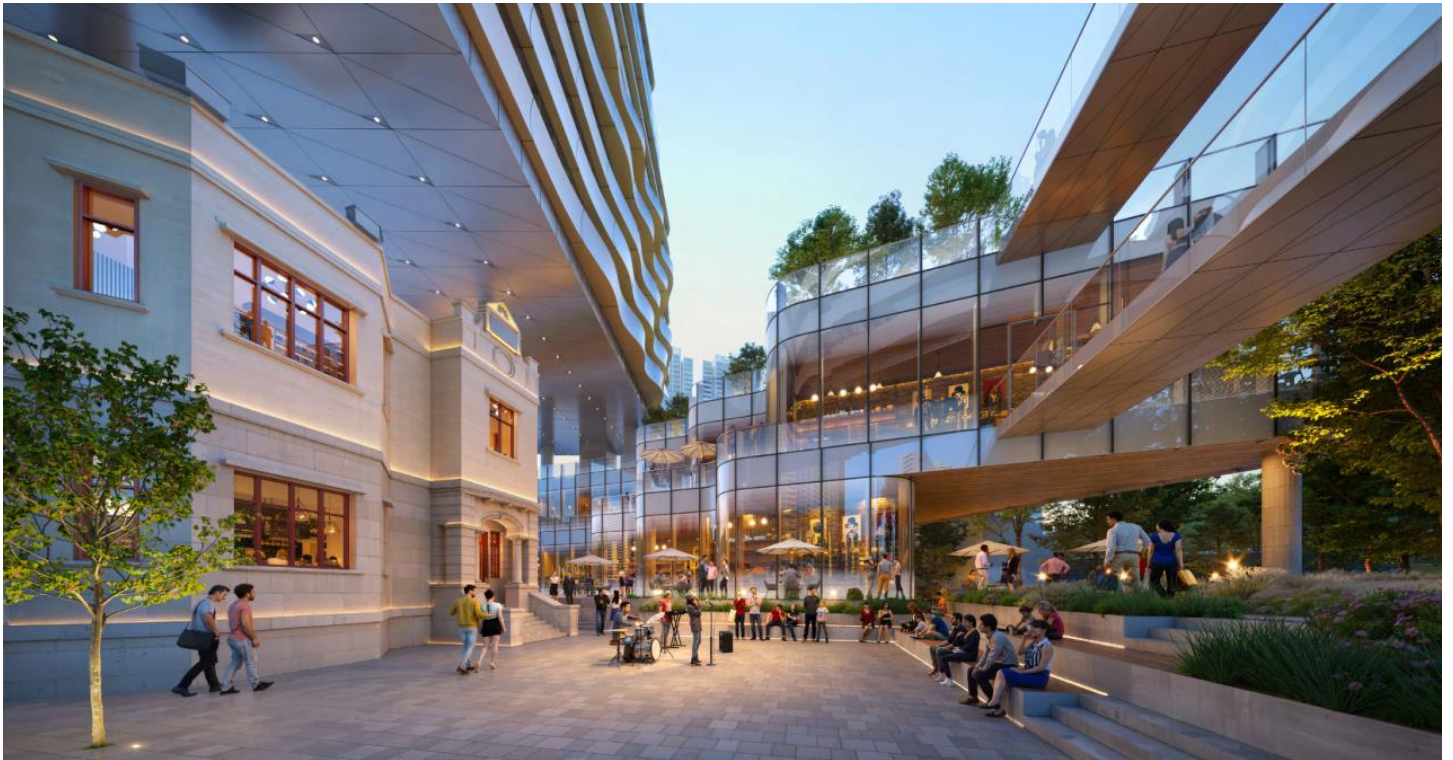
E 1.2.3 – Artist's impression of the proposed development. Ng Yuen is on the left of the image.
(Source: THE APPLICANT)

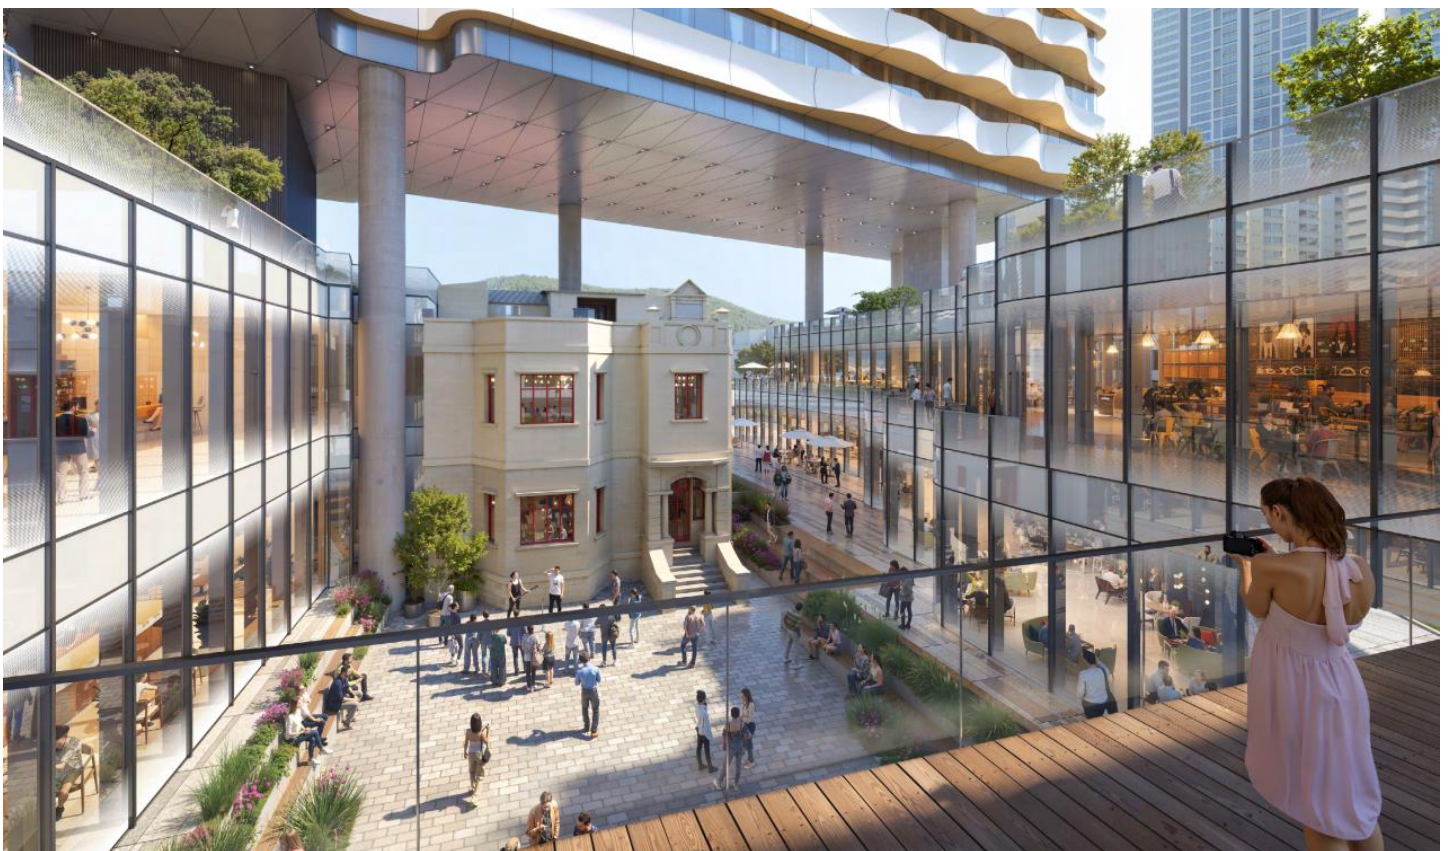
E 1.2.4 – Artist's impression (viewed from proposed footbridge) of the proposed development.
(Source: THE APPLICANT)

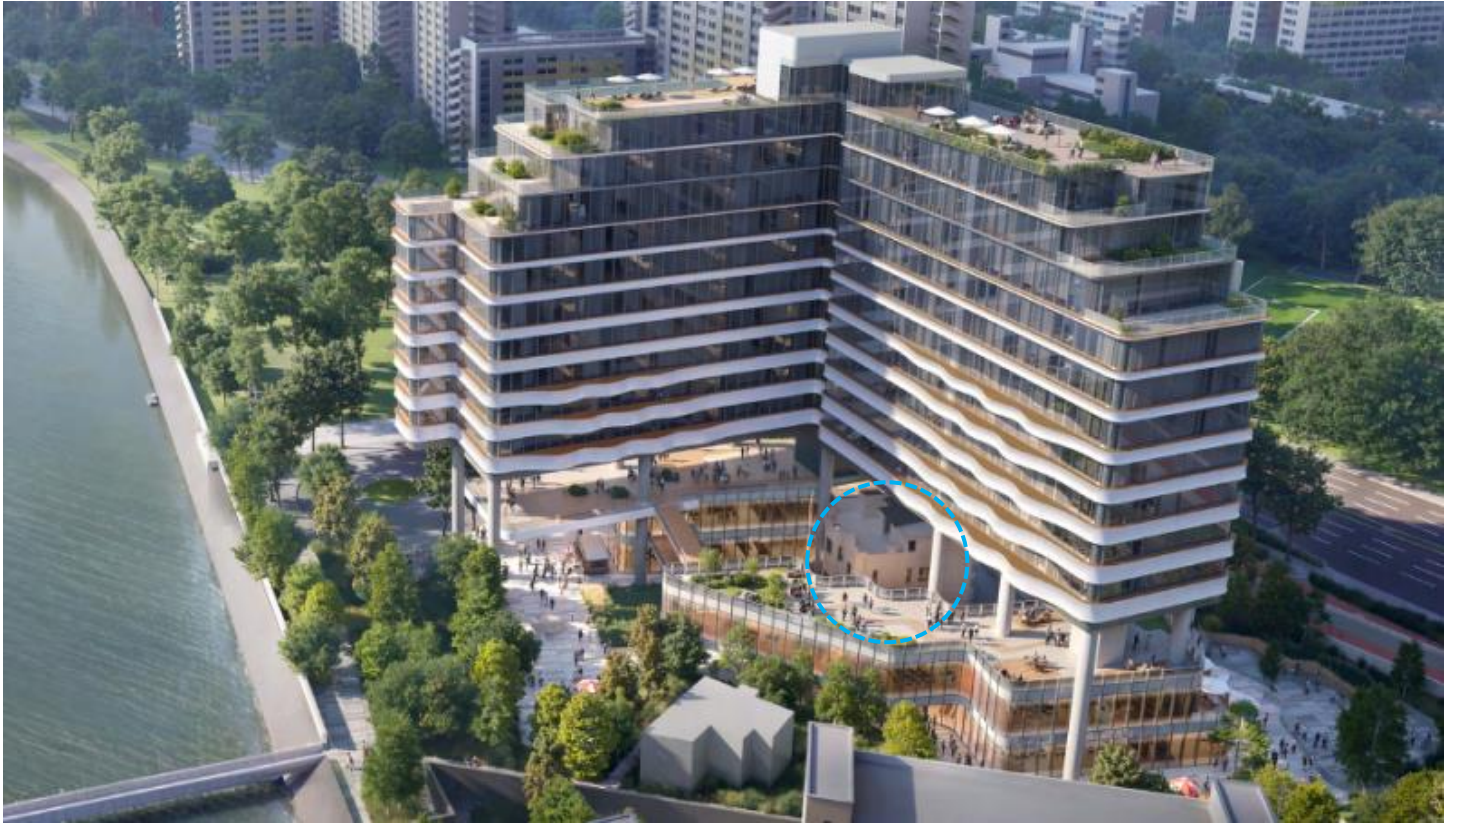
E 1.2.5 – Artist's impression (aerial view as viewed from northwest) of the proposed development. Ng Yuen is circled in blue. (Source: THE APPLICANT)

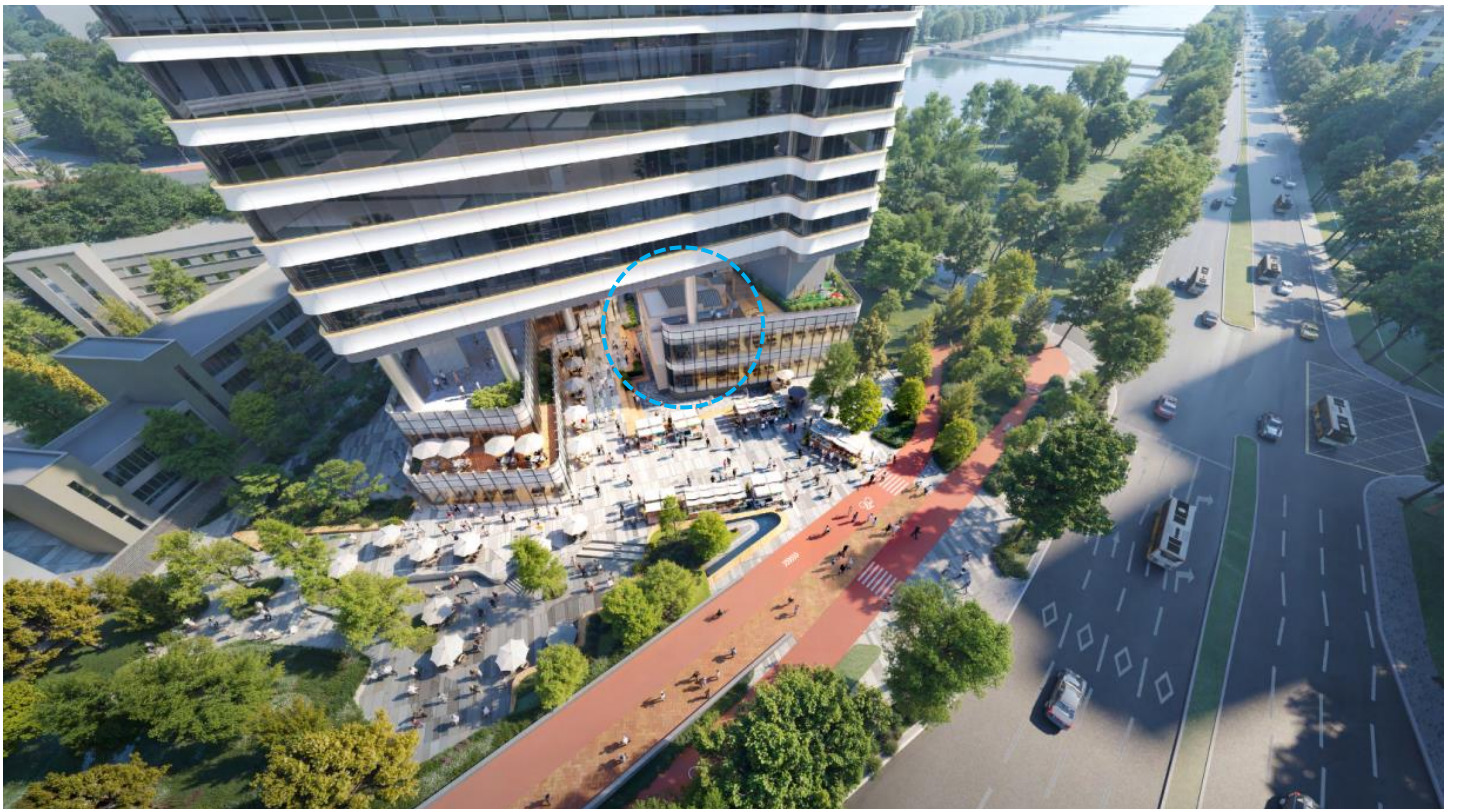
E 1.2.6 – Artist's impression (aerial view above Tai Chung Kiu Road) of the proposed development. Ng Yuen is circled in blue. (Source: THE APPLICANT)

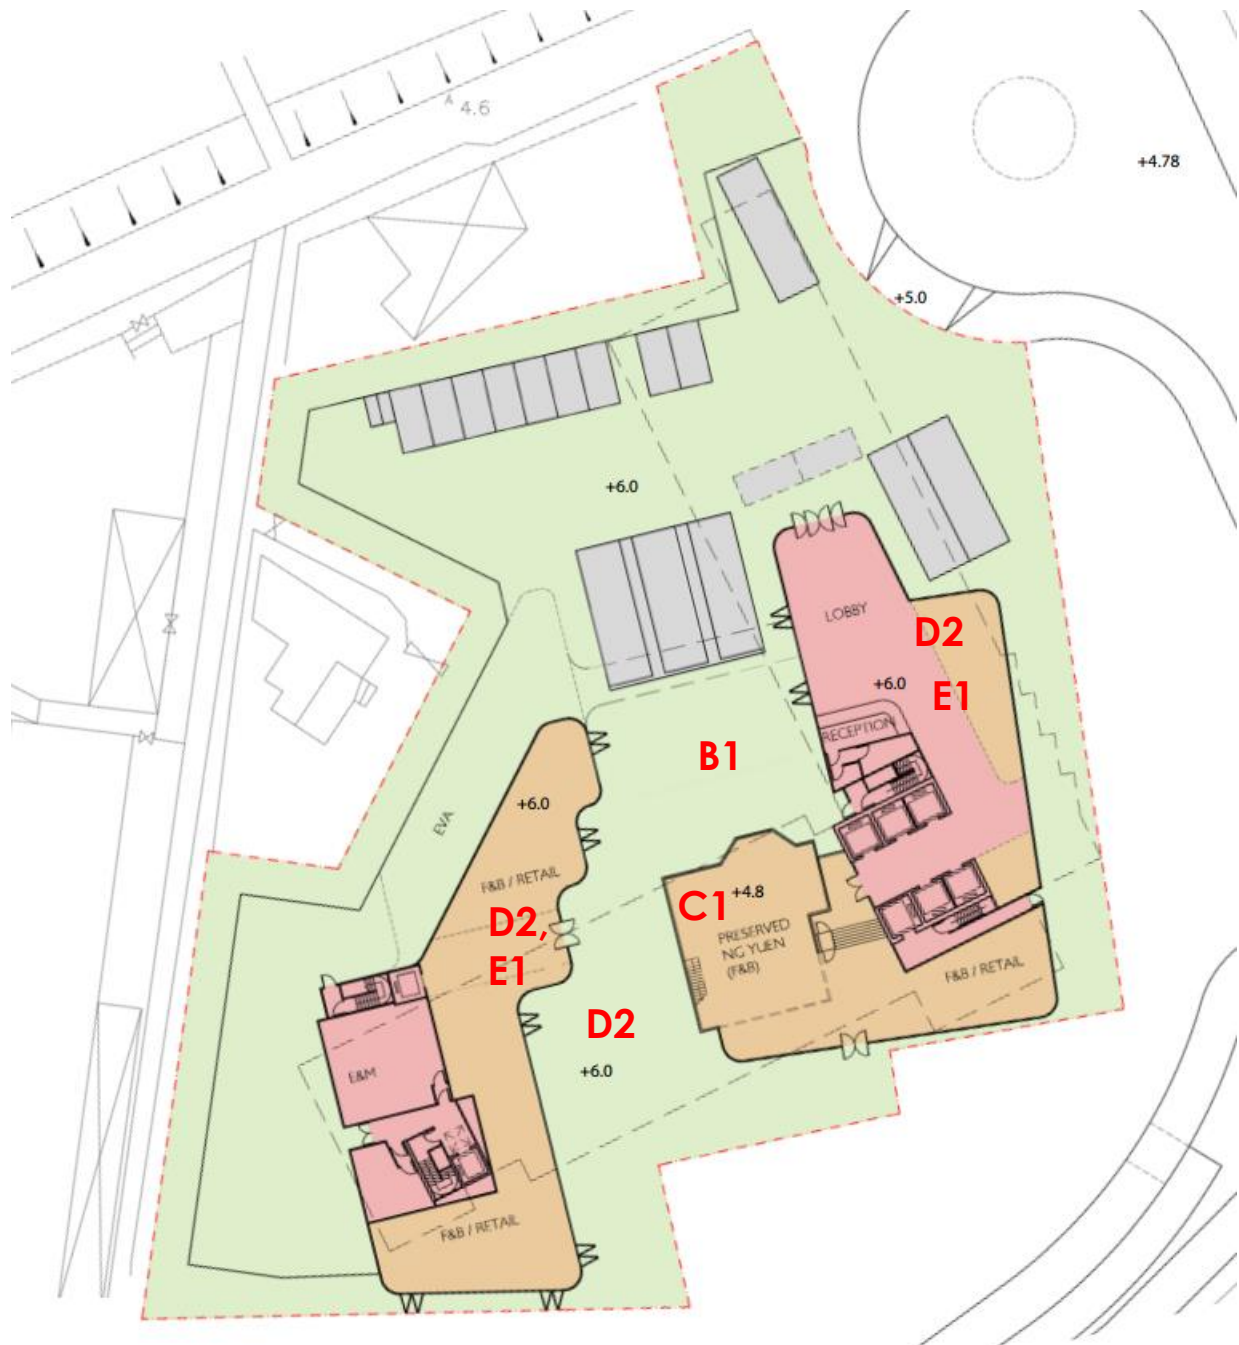
F2.3.1 G/F plan showing the assessment items B1, C1, D2 and E1. (Source: THE APPLICANT)

B. Façade Preservation, Restoration and Improvement Work						
B1	Façades (including the roof) of NY	<ul style="list-style-type: none"> ▪ To conserve and restore the façade (including the roof) 	<ul style="list-style-type: none"> ▪ The façades of NY 	Exceptional	<p><i>Recommendation</i></p> <ul style="list-style-type: none"> ▪ Although most of the features on the NY façades are currently intact, some of them have been broken, missing and diminished due to wear and tear or renovations 	Beneficial impact

C. Interior Alteration and Addition Work						
C1	Interior of NY	<ul style="list-style-type: none"> ▪ To restore the interior architectural features in its earliest known state ▪ To provide renovated and modified spaces to suit the new uses of NY 	<ul style="list-style-type: none"> ▪ Interior decorative features, e.g. fireplaces, ceiling mouldings, floor finishes ▪ Partitioning walls ▪ Sanitary fitment 	<p>Exceptional/ High</p> <p>High</p> <p>Low</p>	<p><i>Recommendations</i></p> <ul style="list-style-type: none"> ▪ The original room layout at MB has been largely preserved, most of the interior decorative features are fairly intact but in dilapidated conditions. Some fireplaces have gone missing. Floor finishes, e.g. granite, tiles at MB have been largely preserved, while timber finishes at the Main Building have gone missing or in dilapidated condition. They provide solid evidence on the original design and functions of the rooms of NY for restoration ▪ Concrete staircases finished with timber and equipped with balustrades not fulfilling current fire codes <p><i>Mitigation Measures</i></p> <ul style="list-style-type: none"> ▪ Document the existing interior design appropriately before the commencement of any works and utilize these data for restoration works ▪ Preserve CDEs with exceptional or high level of heritage significance, e.g. fire places, ornate tiled flooring, timber staircases, ceiling moulding, etc. These CDEs should be appropriately propped and protected prior to the commencement of and during the works 	Acceptable impact with mitigation measures

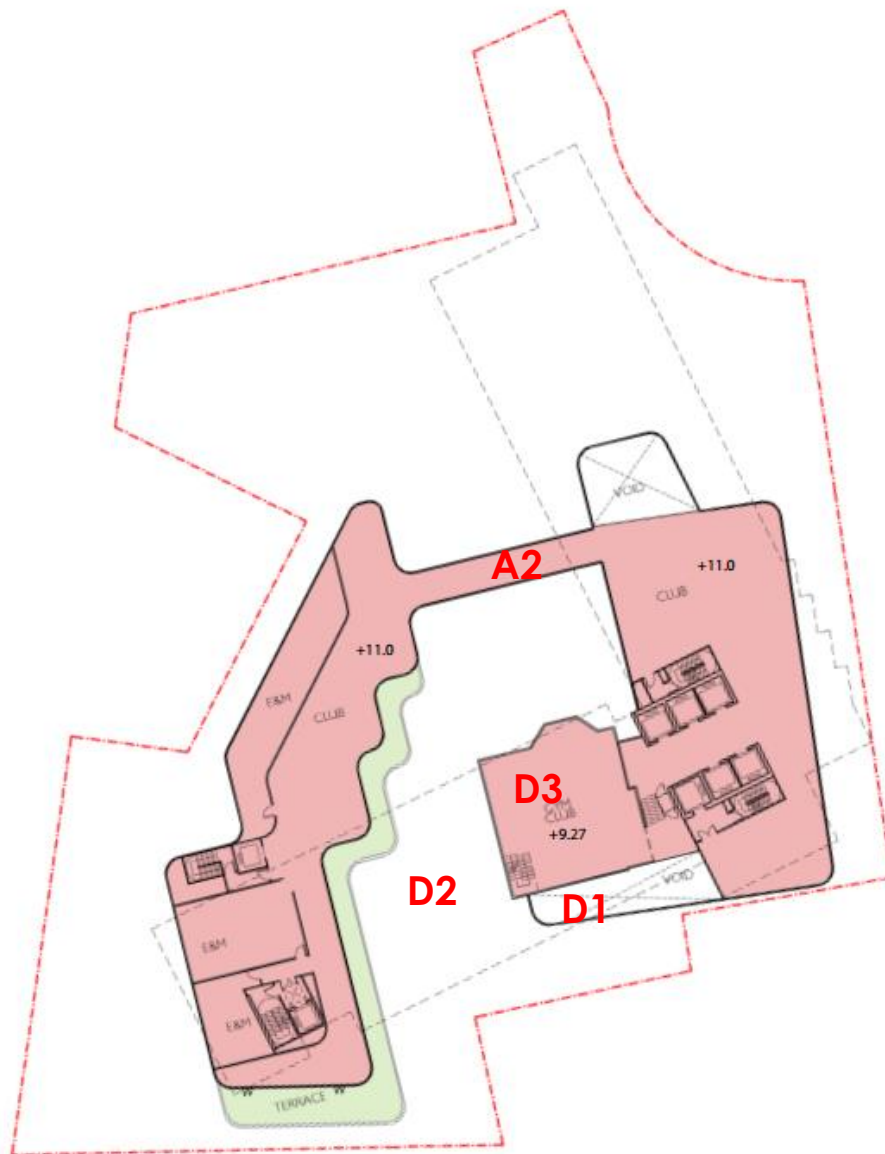
F2.3.1 1/F plan of the proposed new building and NY showing the assessment items A2, D1, D2 and D3. (Source: THE APPLICANT)

A2	Visual impact induced by the proposed new building	<ul style="list-style-type: none"> To have a modern building to serve as a hotel with up-to-date facilities 	<ul style="list-style-type: none"> Integrity of the site of NY 	The CDEs of NY are of various levels of significance	<p><i>Recommendations</i></p> <ul style="list-style-type: none"> NY has been idle for several decades and should receive new compatible uses so it can continue to serve its users. It is currently fenced off and the public cannot appreciate its cultural heritage significance There are successful precedent cases overseas where new taller buildings can be compatible with historic residences in 	Acceptable impact with mitigation measures

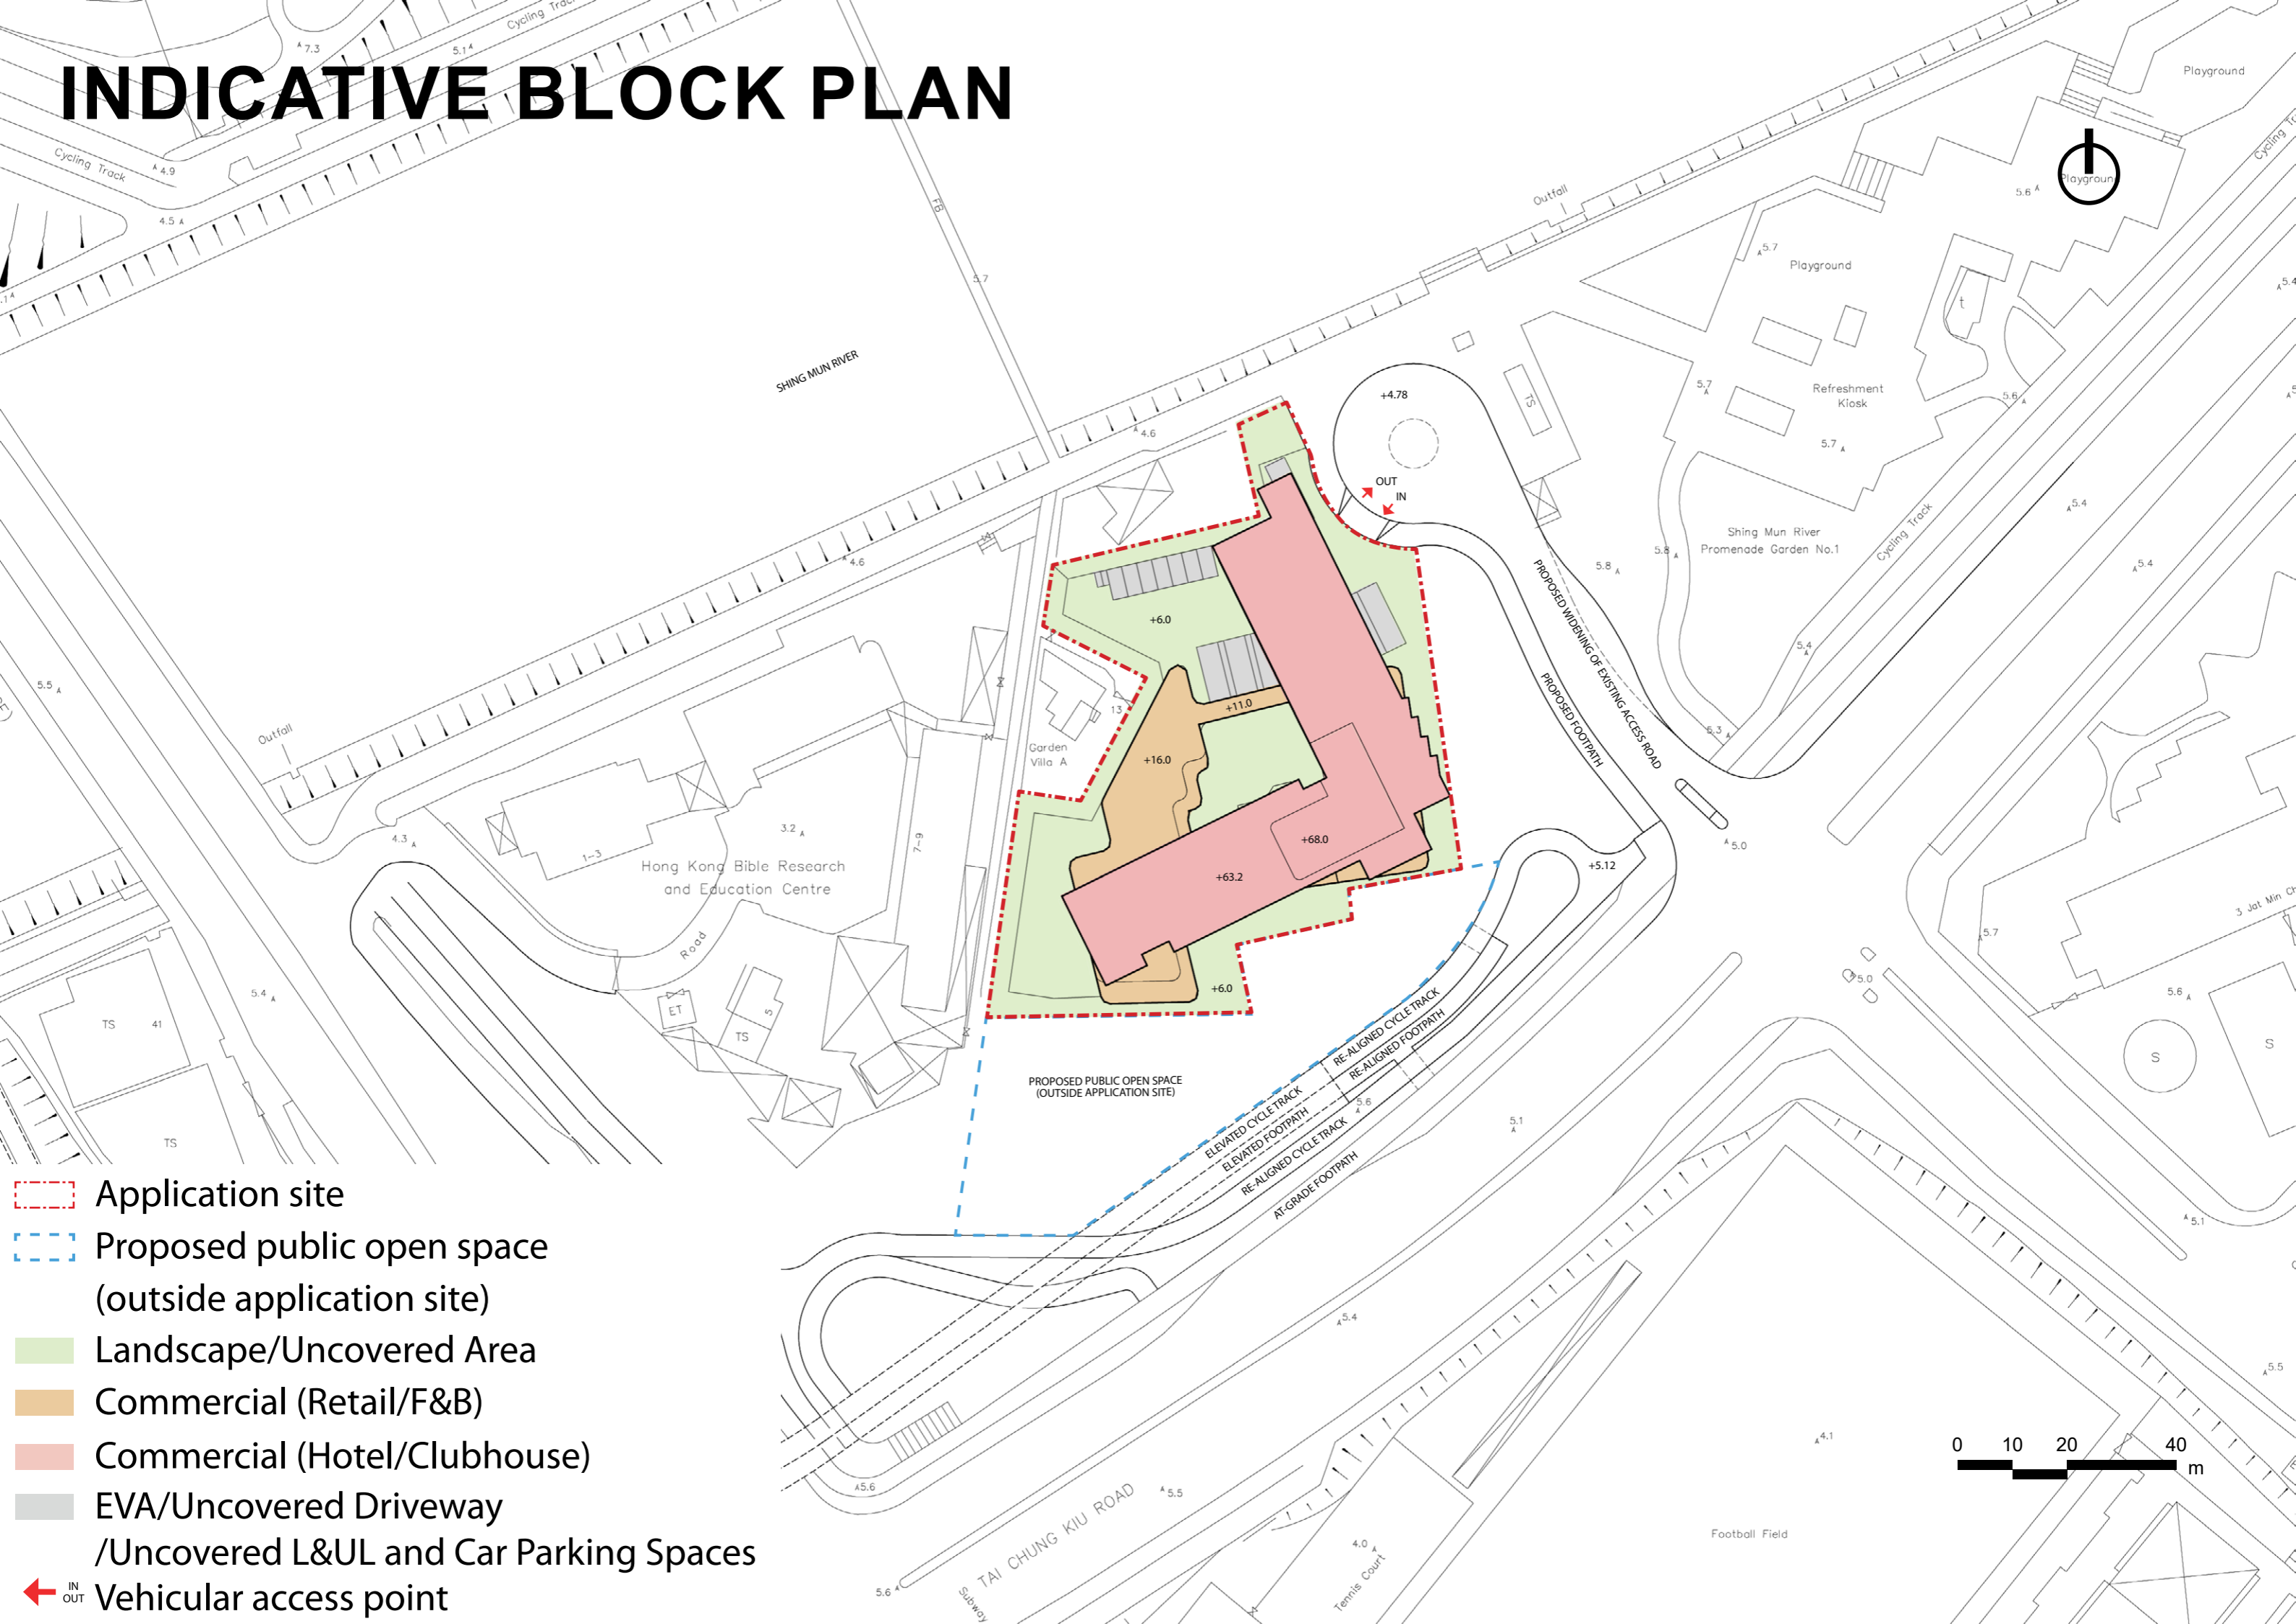
INDICATIVE BLOCK PLAN

- Application site
- Proposed public open space (outside application site)
- Landscape/Uncovered Area
- Commercial (Retail/F&B)
- Commercial (Hotel/Clubhouse)
- EVA/Uncovered Driveway /Uncovered L&UL and Car Parking Spaces
- IN
OUT Vehicular access point
