Appendix A
Conservation Management Plan

Conservation Management Plan with Implementation Proposal for the Proposed Hotel Development with Adaptive Reuse of Ng Yuen at Shing Mun River, Sha Tin

2026 June

Prepared by Substance Lab Limited

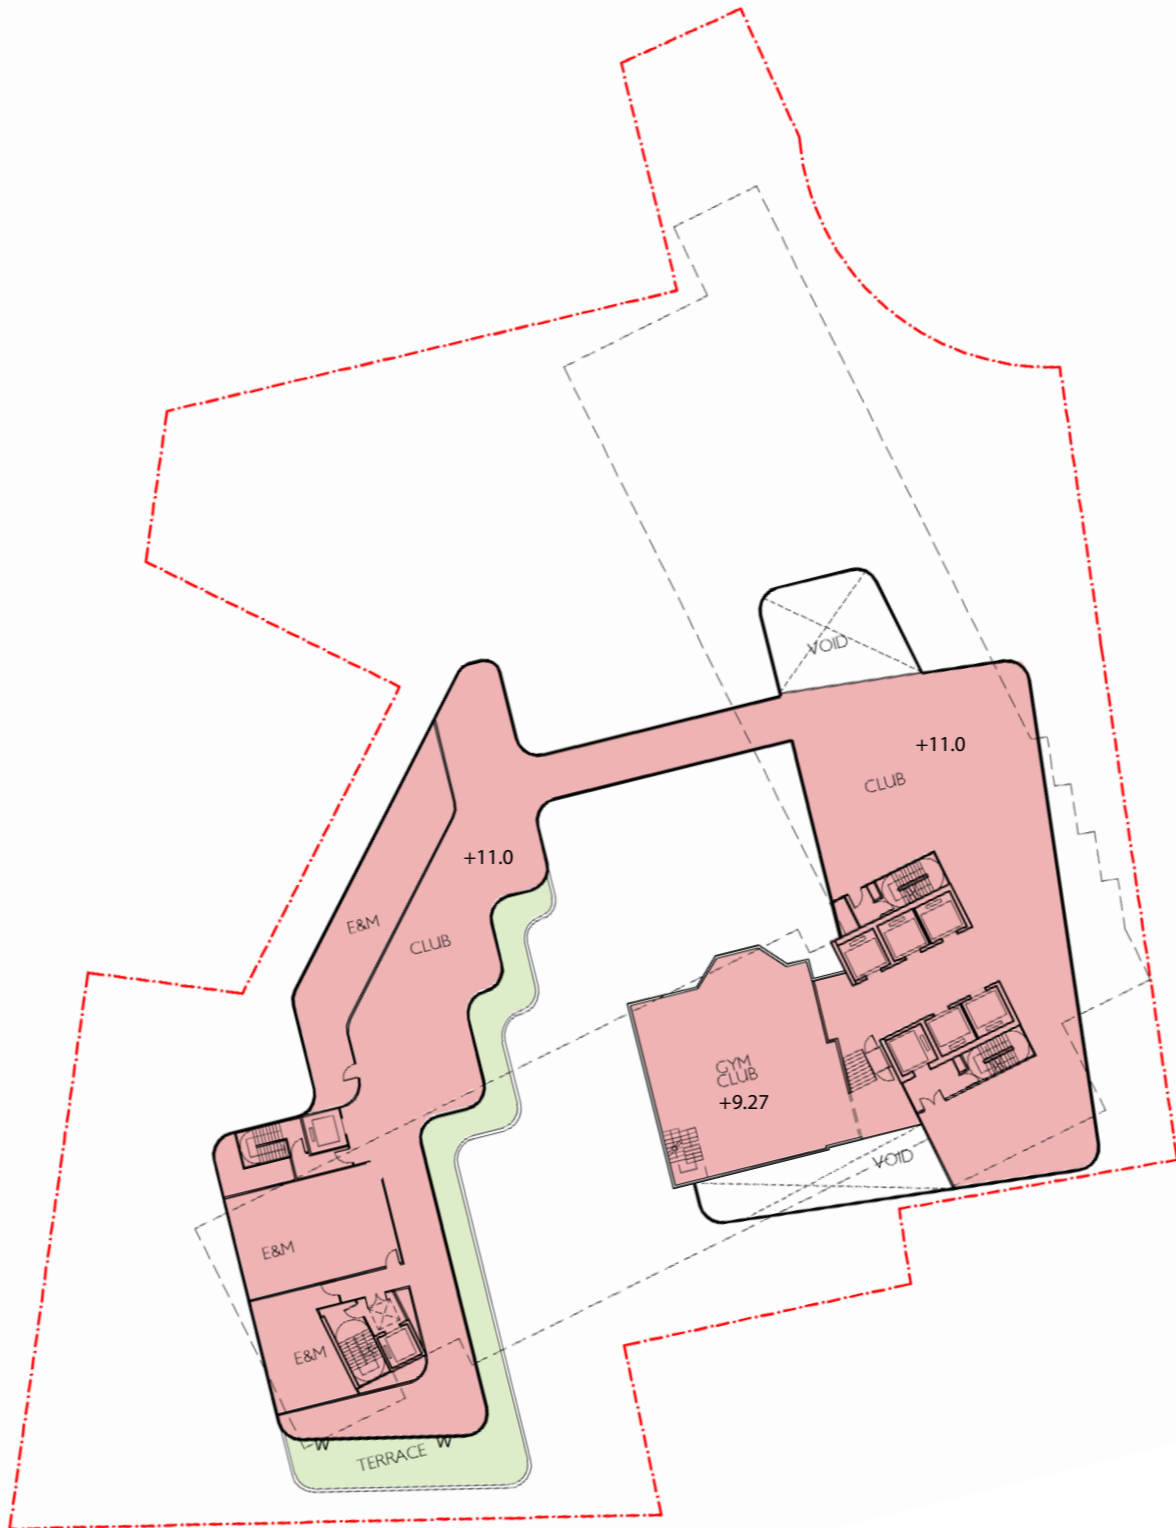
FIRST FLOOR PLAN

- Application site
- Landscape/Uncovered Area
- Commercial (Hotel/Clubhouse)

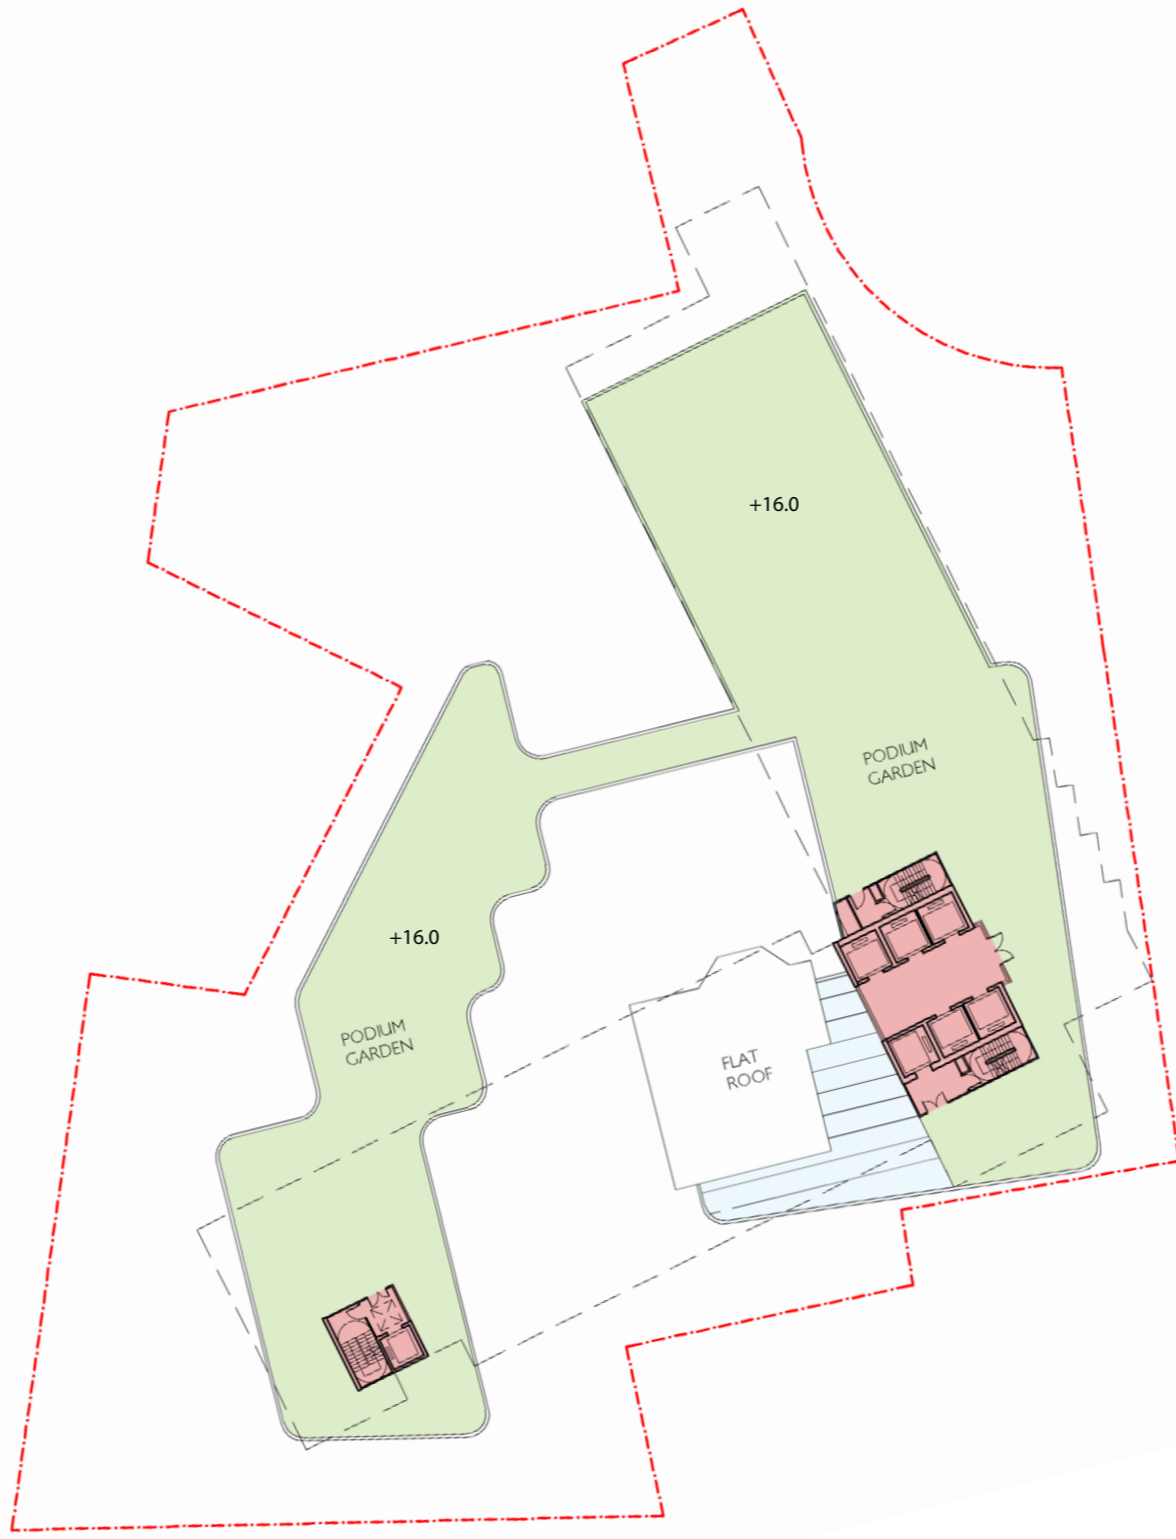
SECOND FLOOR PLAN

- Application site
- Skylight
- Landscape/Uncovered Area
- Commercial (Hotel/Clubhouse)

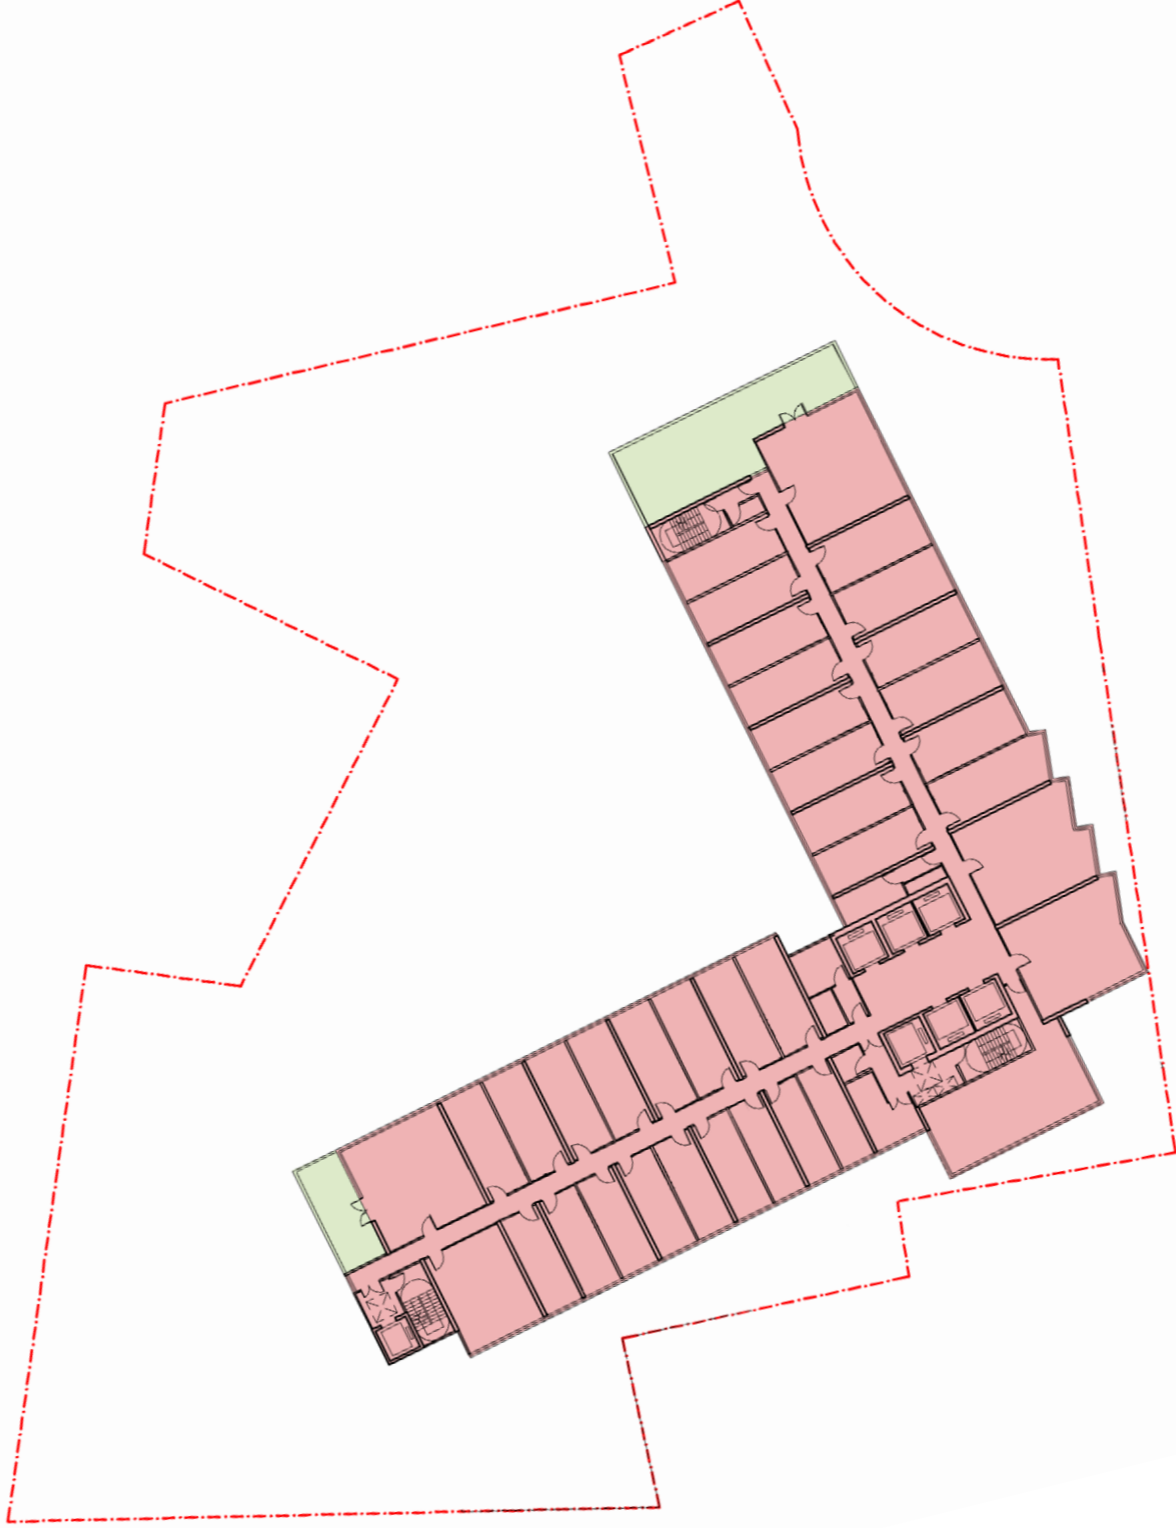
TWELFTH FLOOR PLAN

- Application site
- Landscape/Uncovered Area
- Commercial (Hotel/Clubhouse)

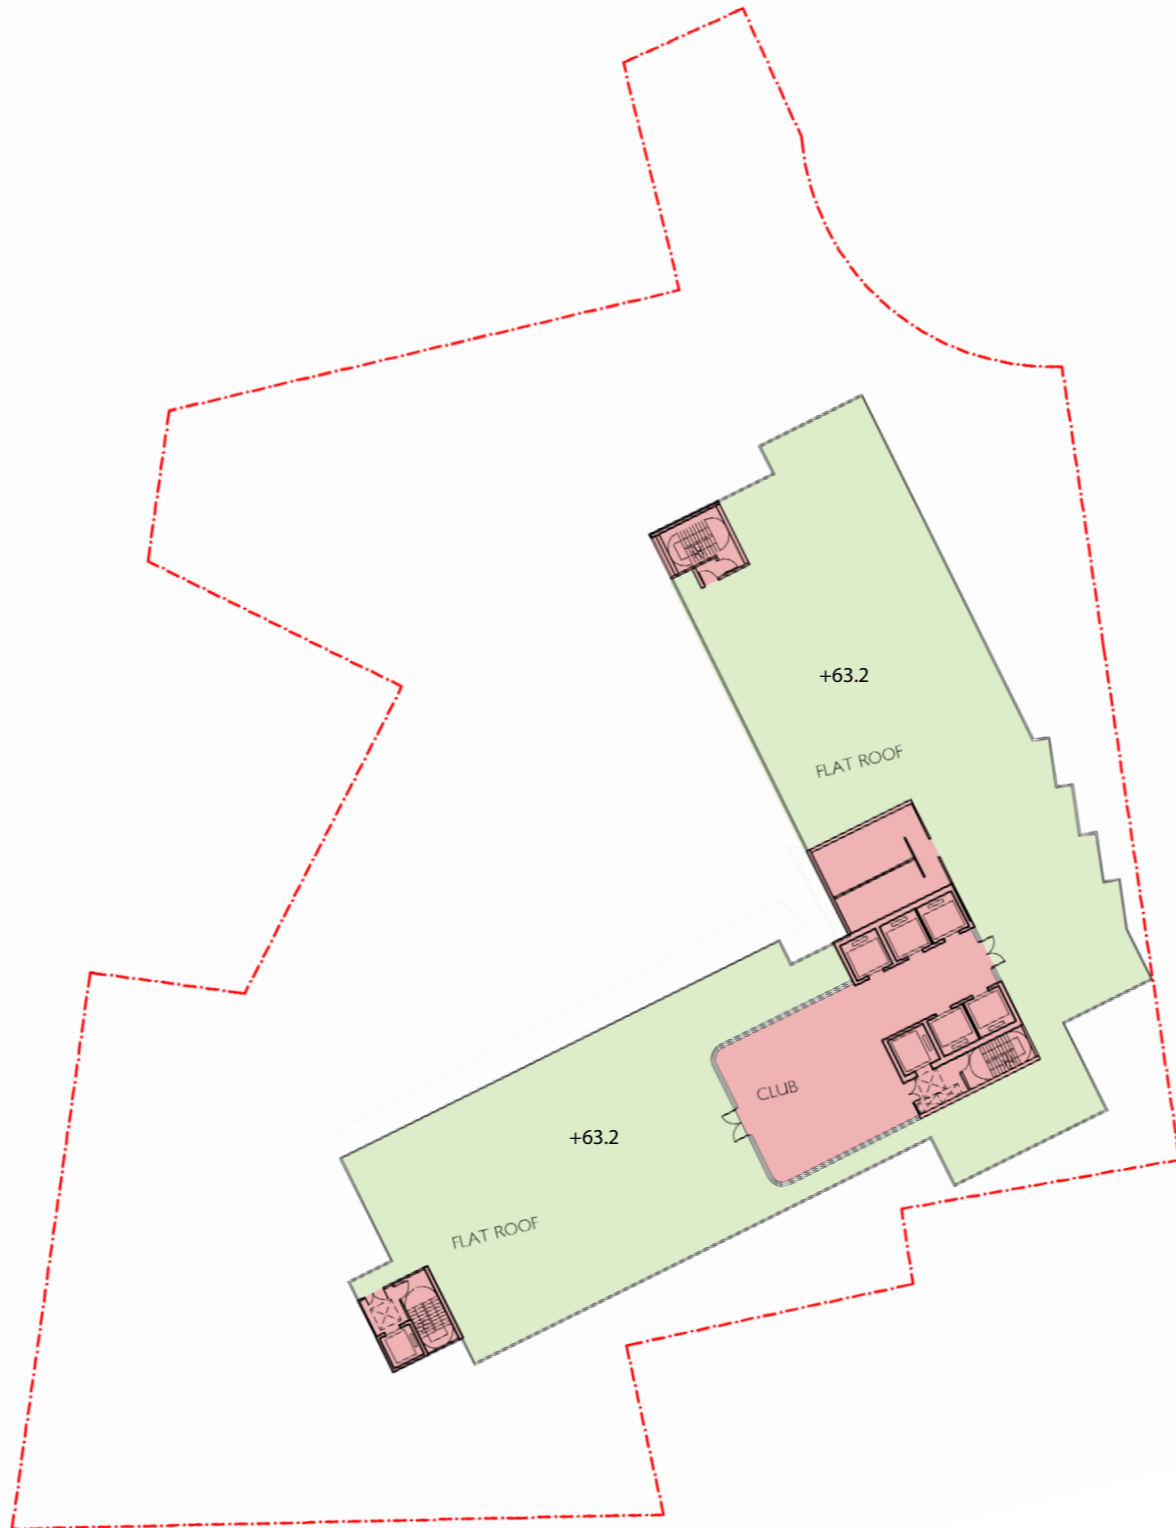
THIRTEEN FLOOR PLAN

- Application site
- Landscape/Uncovered Area
- Commercial (Hotel/Clubhouse)

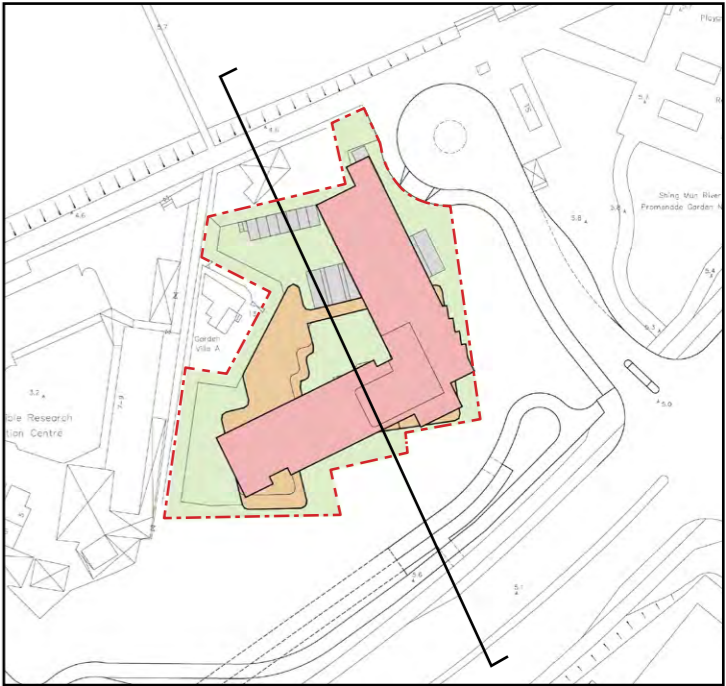
SECTION

- Application site
- Landscape/Uncovered Area
- Commercial (Retail/F&B)
- Commercial (Hotel/Clubhouse)

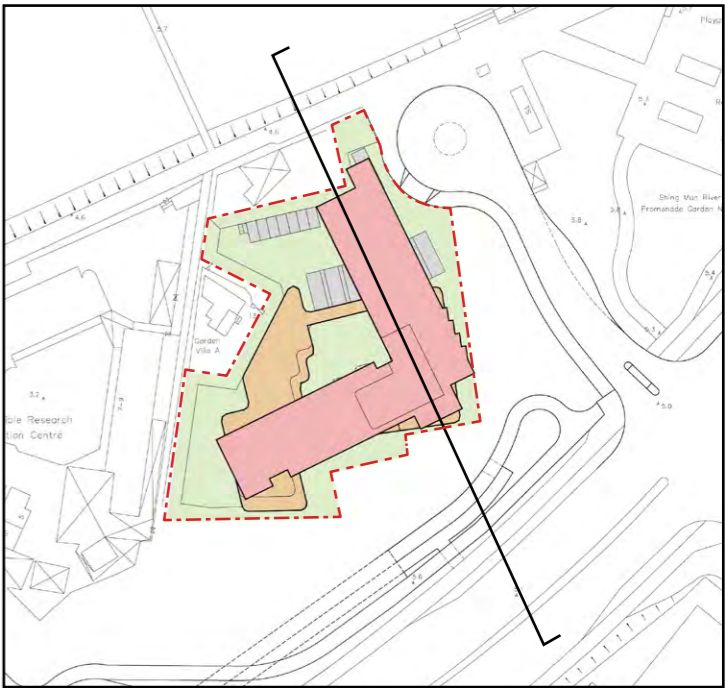
SECTION

- Application site
- Landscape/Uncovered Area
- Commercial (Retail/F&B)
- Commercial (Hotel/Clubhouse)
