Application for Amendment of Plan Under Section 12A of the Town Planning Ordinance (Cap. 131) to Rezone the Application Site from “Green Belt” and Area shown as ‘Road’ to “Residential (Group C)5” for Proposed Residential Development at Various Lots in D.D. 210 and Adjoining Government Land, Pak Wai, Sai Kung (Planning Application No. Y/SK-HC/8)

Submission of Further Information – Responses to Departmental Comments

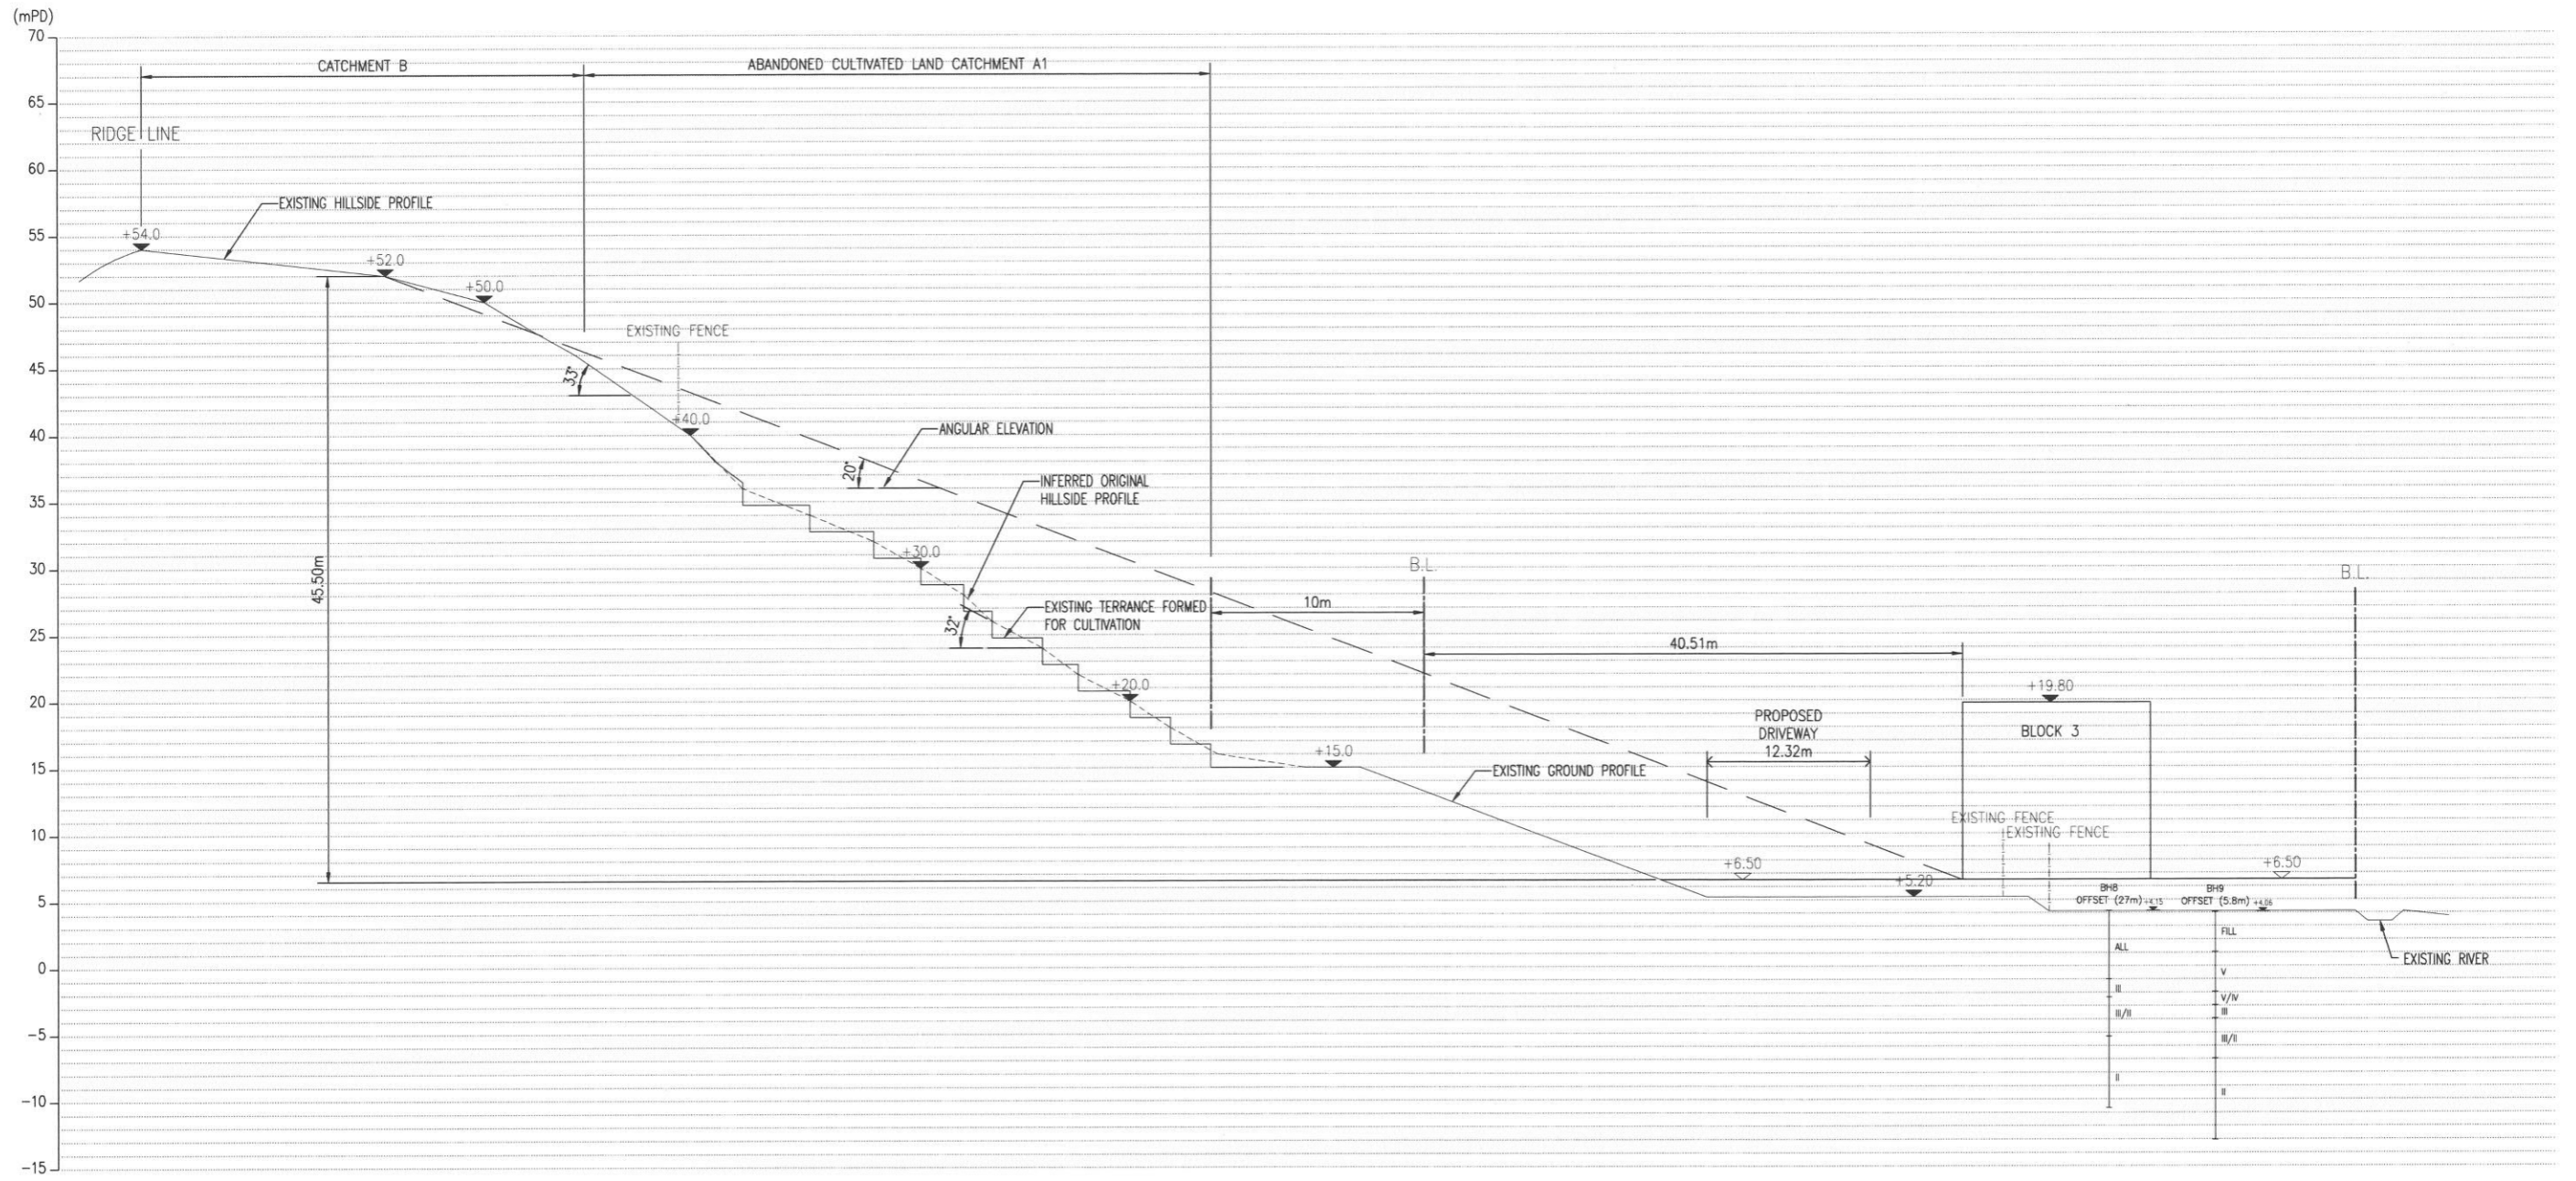
FIGURE 6

SECTION B-B
1 : 500

Based on available topographic maps No. 7SE-25A and 7SE-25C of Hong Kong from the Survey & Mapping Office (SMO) of the Lands Department, the hillside catchment westbound of proposed Redevelopment understudy are described below, and presented as Figure 4, with relevant cross-sections of the catchment presented as Figure 5 to 7.

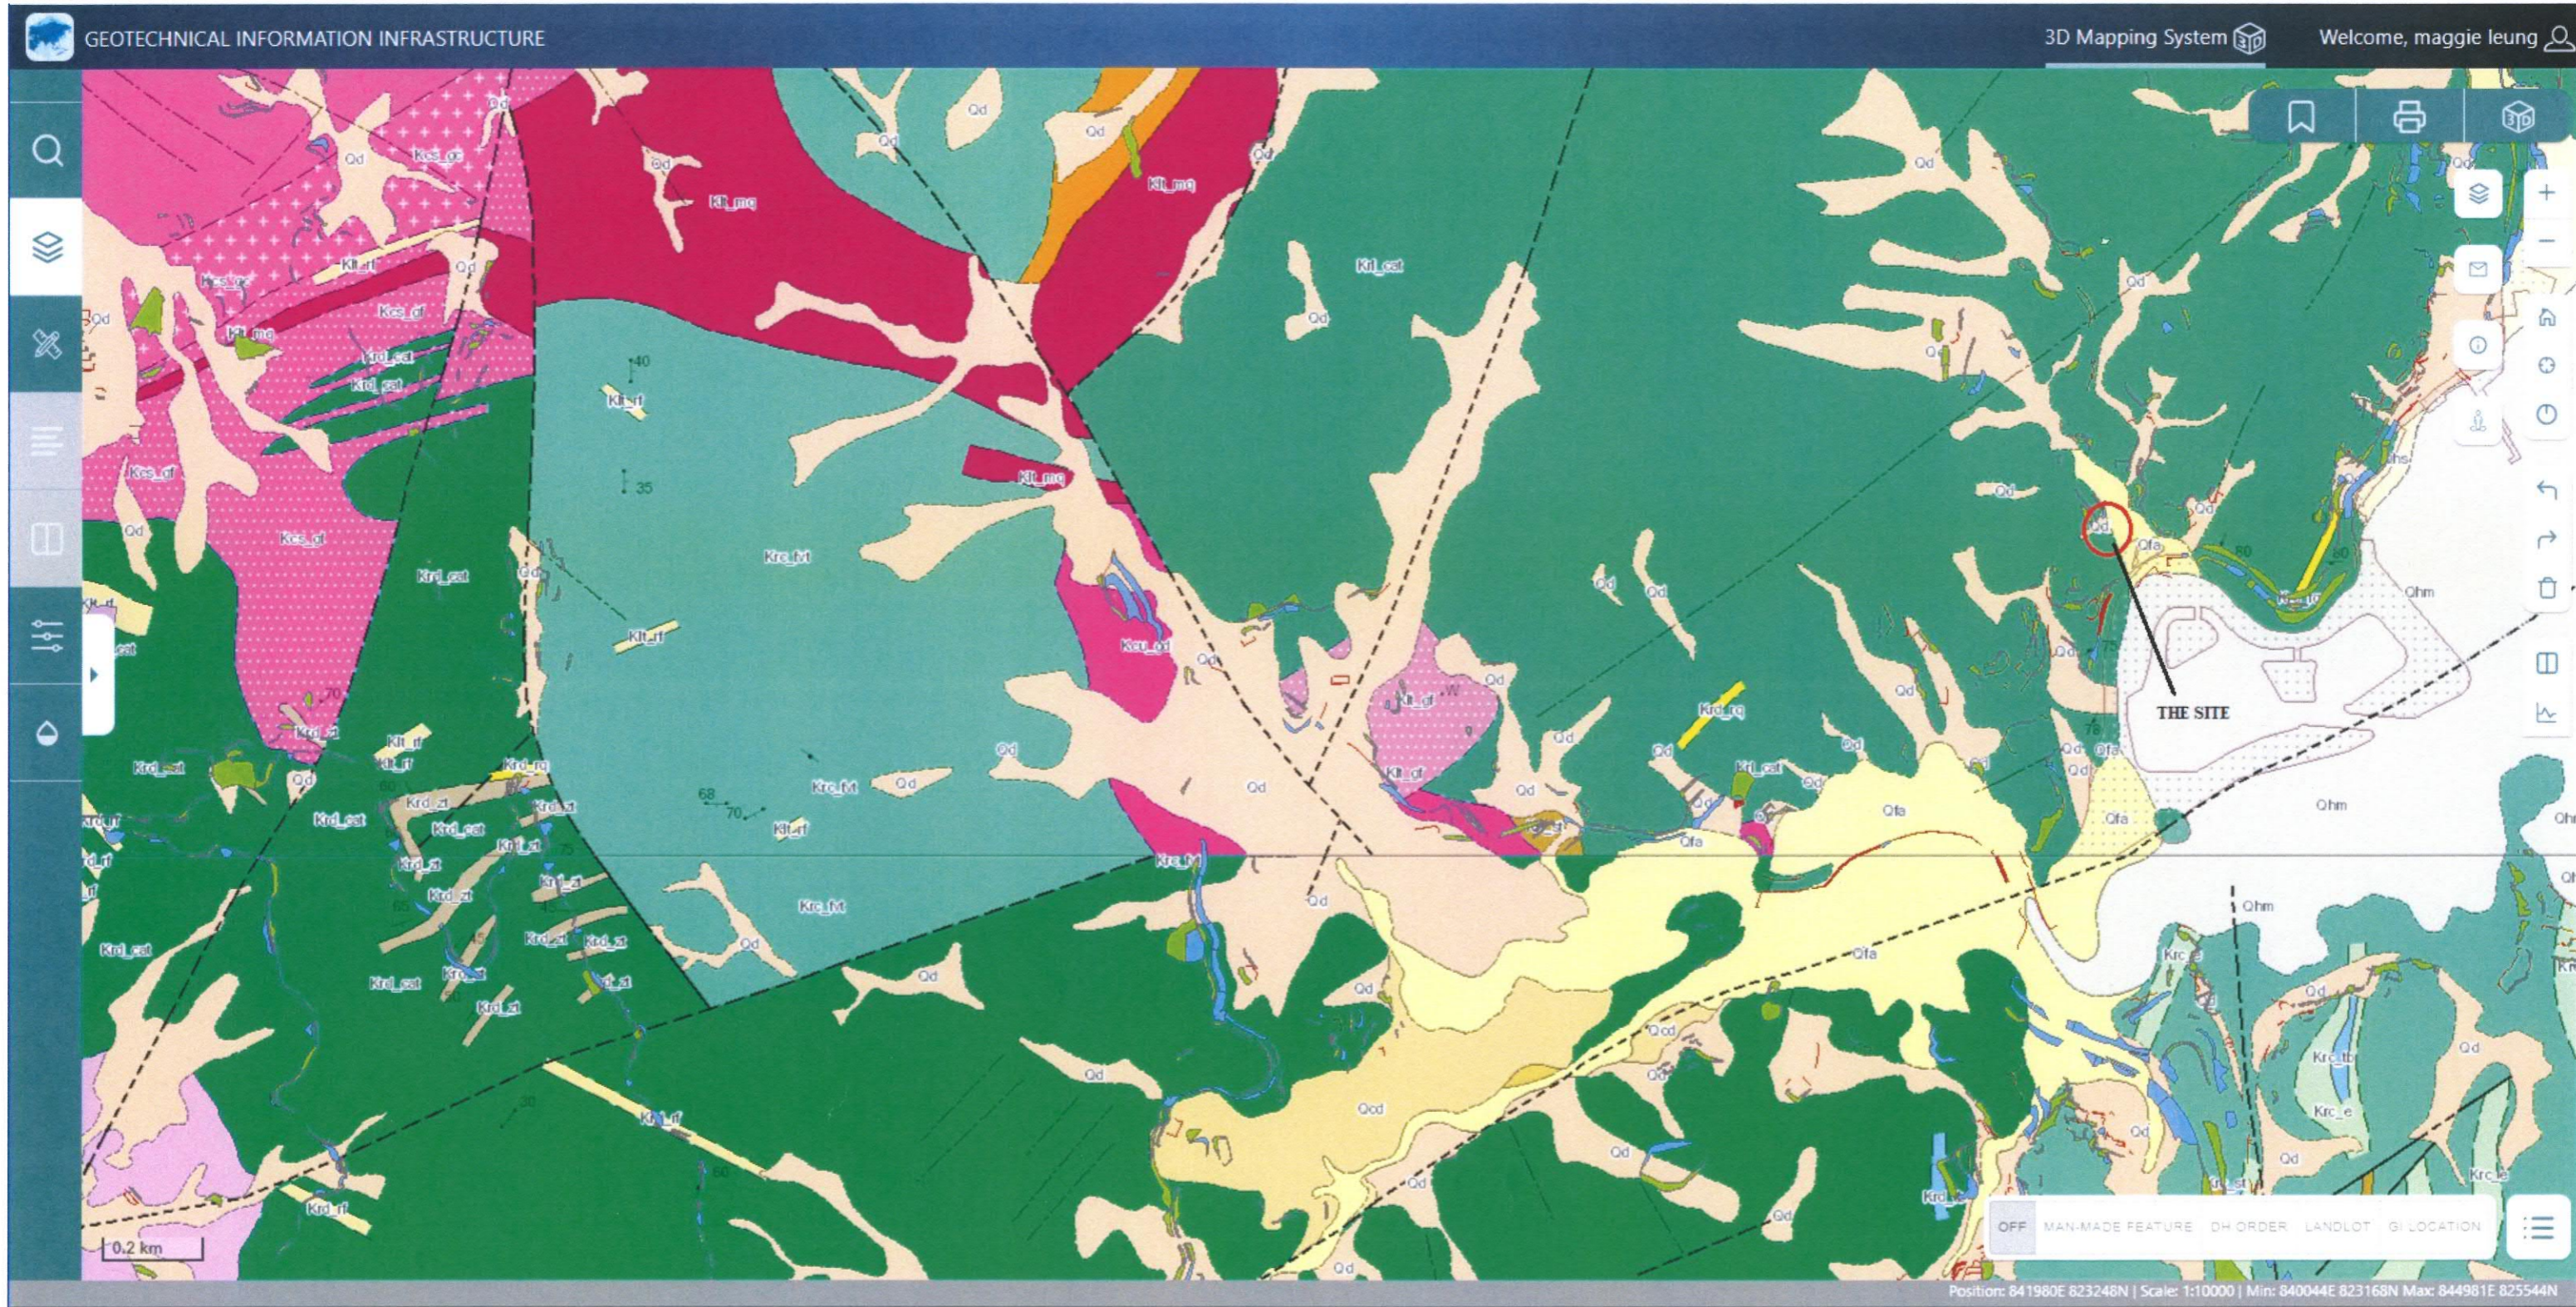
GEOLOGICAL MAP (2nd ED. AFTER 2008)

Sheet 7 SOLID AND SUPERFICIAL GEOLOGY
