Appendix I of RNTPC
Paper No. A/YL-ST/618B

APPLICATION FOR PERMISSION
UNDER SECTION 16 OF
THE TOWN PLANNING ORDINANCE
(CAP.131)

Project
GEO-TECHNICAL PLANNING REVIEW REPORT FOR THE
PROPOSED PUBLIC UTILITY INSTALLATION AND
ASSOCIATED FILLING AND EXCAVATION OF LAND (OHL
POLE & STAY ERECTION) AT GOVERNMENT LAND IN
D.D. 96, SAN TIN, YUEN LONG

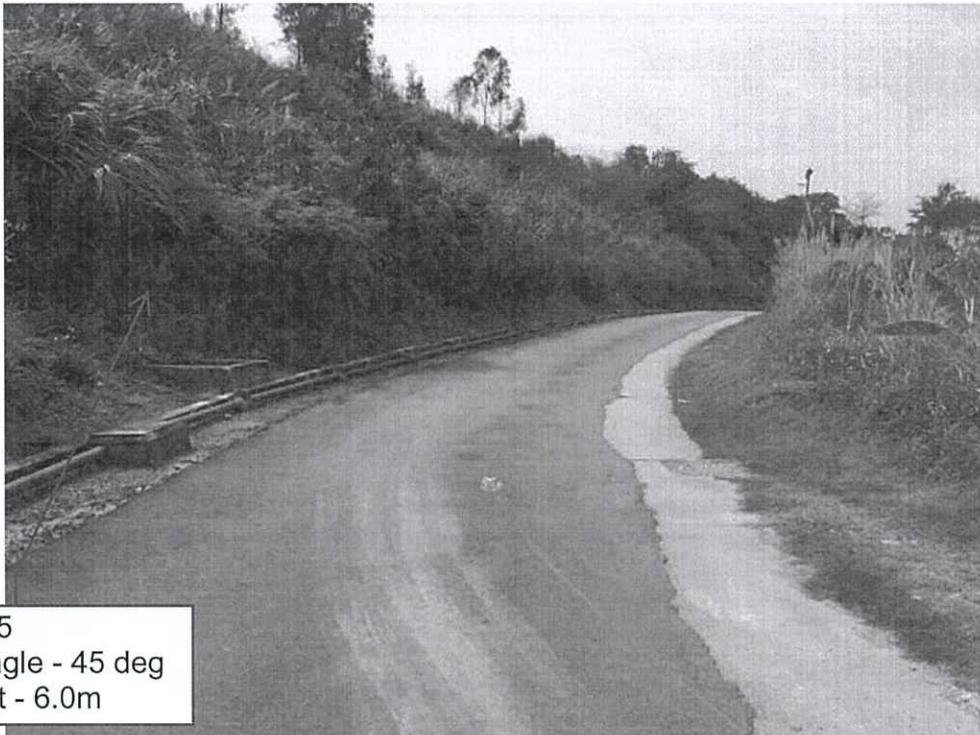
2SE-B/C305
Average Angle - 45 deg
Max. Height - 6.0m

These 2 registered man-made slopes are cut slopes with 6m in height at 45° slope angle. In view of failure of the man-made slopes would affect the OHL poles at the slope toe, stability analysis is proposed to be carried out.

Photo 2: General View of 2SE-B/C305

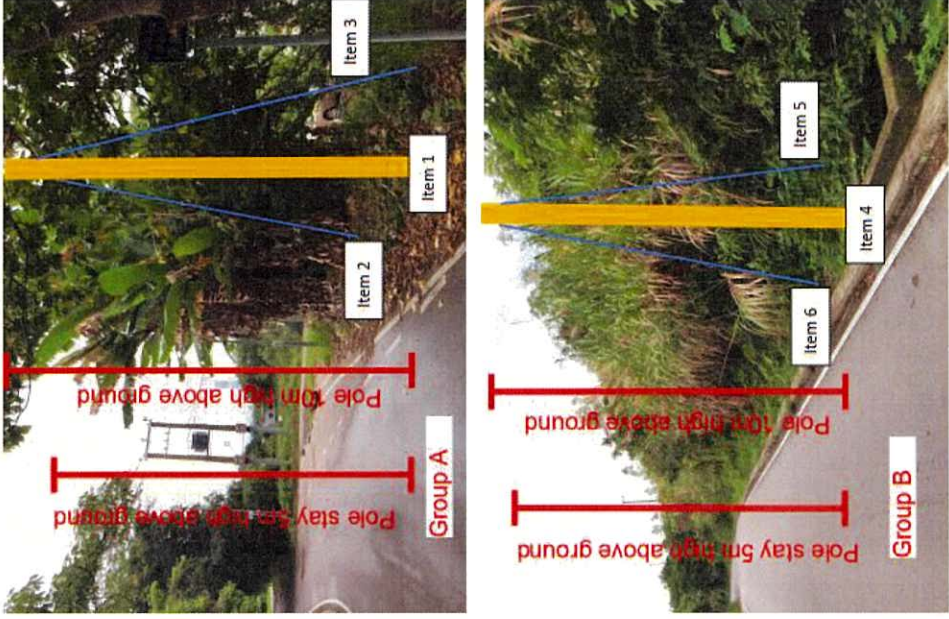
<p>The image contains two photographs of utility poles. The left photograph, labeled 'Group A', shows a yellow pole with three blue cross-arms. The top arm is labeled 'Item 1', the middle 'Item 2', and the bottom 'Item 3'. Red dimension lines indicate heights: 'Pole stay 5m high above ground' from the base to the middle arm, and 'Pole 10m high above ground' from the base to the top arm. The right photograph, labeled 'Group B', shows a yellow pole with three blue cross-arms. The top arm is labeled 'Item 4', the middle 'Item 5', and the bottom 'Item 6'. Red dimension lines indicate heights: 'Pole stay 5m high above ground' from the base to the middle arm, and 'Pole 10m high above ground' from the base to the top arm.</p>
--	----------------------------------------------------------------------------------------------------------------------------------------------------------------------------------------------------------------------------------------------------------------------------------------------------------------------------------------------------------------------------------------------------------------------------------------------------------------------------------------------------------------------------------------------------------------------------------------------------------------------------------------------------------------------------------------------------------------------------------------------------------------------------------------------------------------------------------------------

Ref. No.	Comments/Inputs/Concerns	Remark/Responses
1.	Clarifications of the dimensions, in particular, the height of the proposed pole and pole stay (including the above ground portion) with illustration on drawings (attached) and photos	1. The height of the proposed pole is 10m and pole stay is 5m above ground as shown on drawings (Drg. No. 01 – A and 01 G A) and photos in Appendix D in the revised GPRR
2.	clarification on which group of the pole and stays are being referred to in P1 and P2 on p.7 of the GPRR as there are 5 such groups in the application. Please provide illustration for each of the 5 groups for clarify sake	2. The pole and stays in P1 and P2 on P.7 are group A and group B. Location refer to Figure 2 in the GPRR.
