**APPLICATION FOR PERMISSION
UNDER SECTION 16 OF
THE TOWN PLANNING ORDINANCE
(CAP. 131)**

Appendix 1 - Application site

Geotechnical Planning Review Report for Installation of Proposed Public Utility Installation and Associated Filling and Excavation of Land (OHL Pole & Stay Erection)

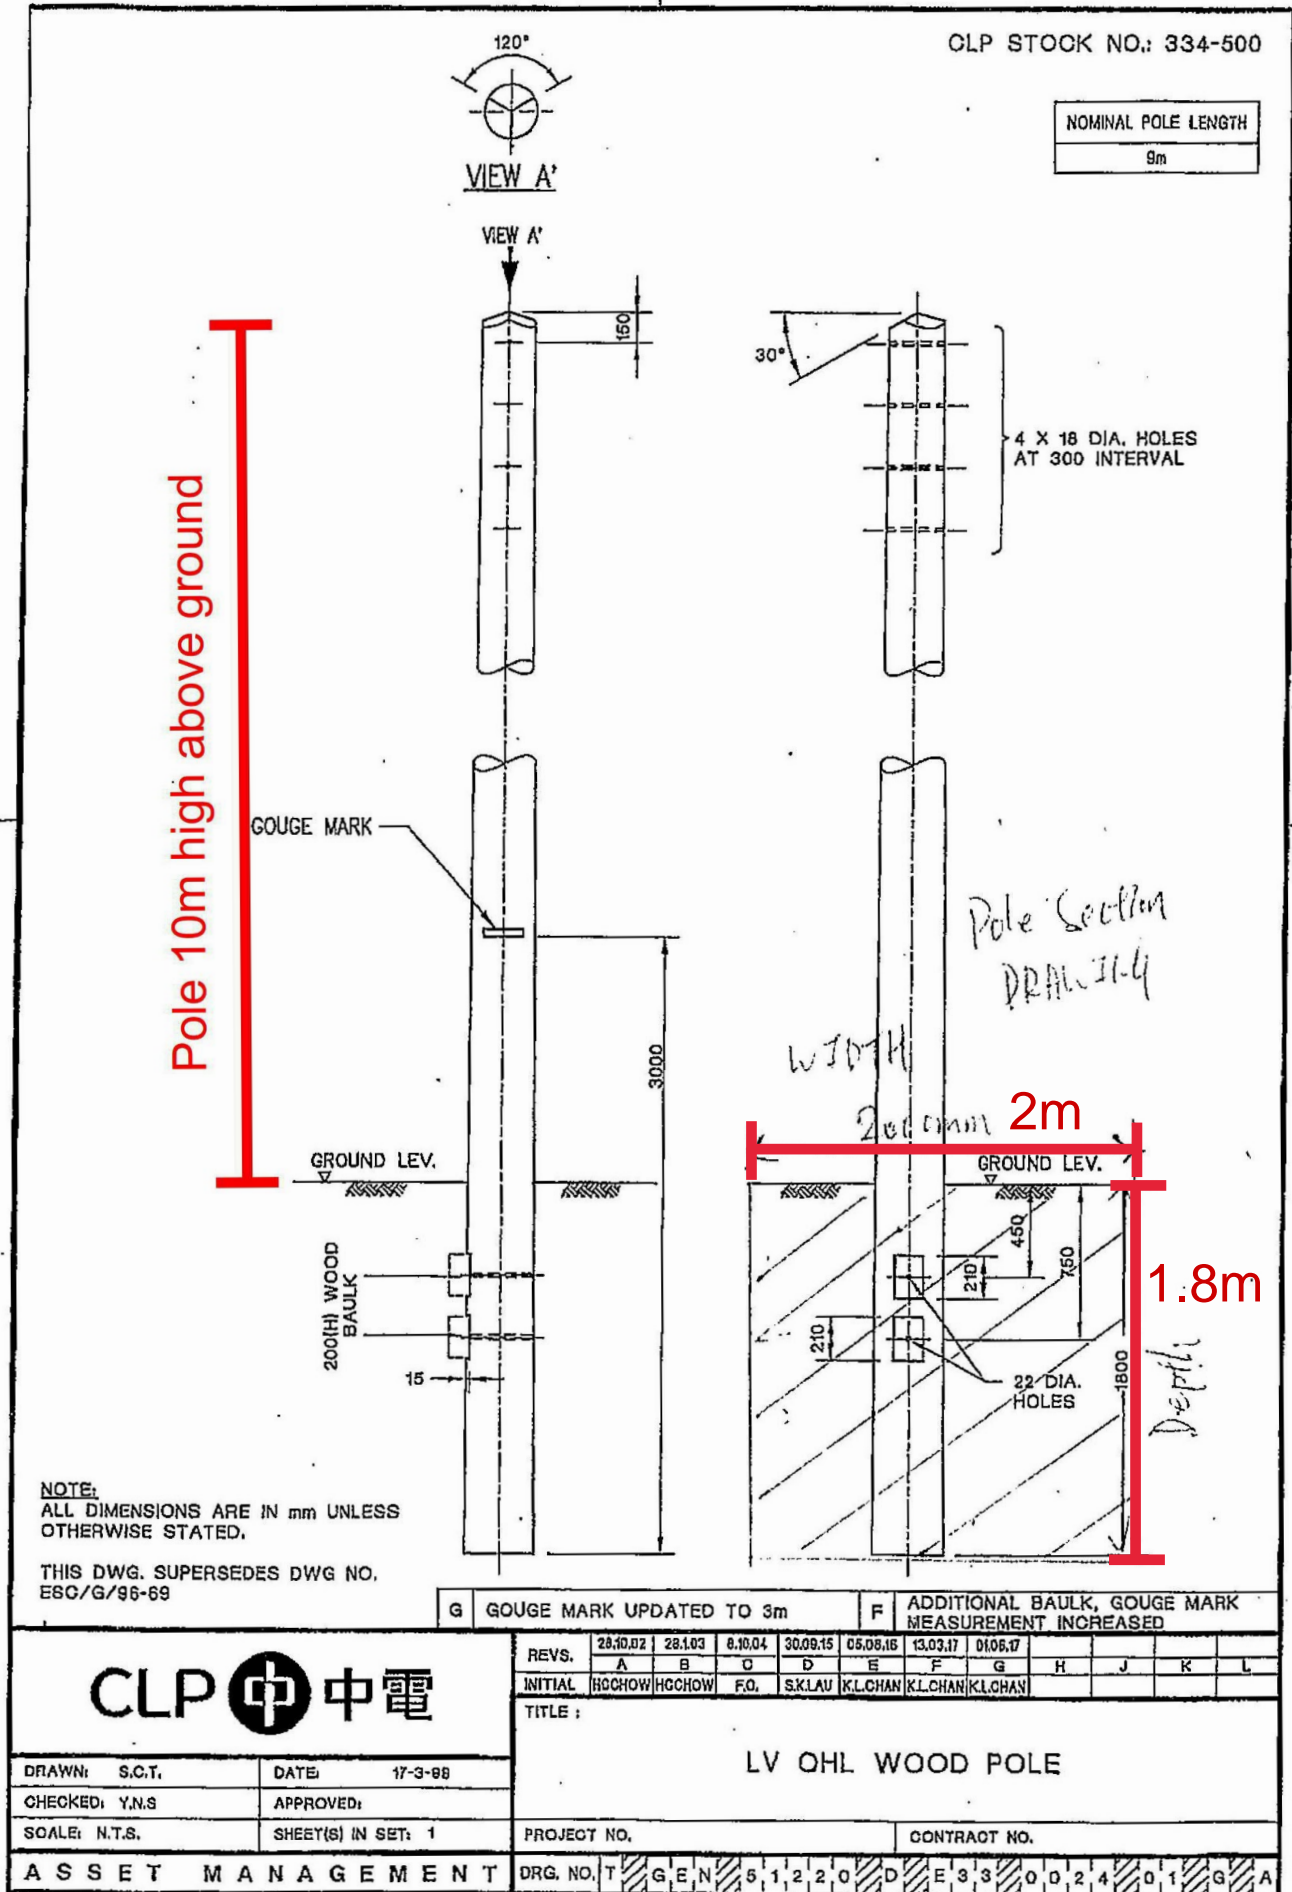
Excavation for pole stay:
1.5m(Length)x1.5m(Width)x1.5m(Depth)

Excavation for pole:
2m(Length)x2m(Width)x1.8m(Depth)

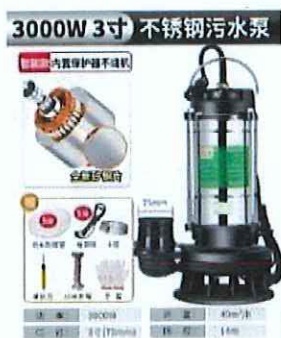
圖 1

- 1，為保安圍封上述地段及安裝視頻監控。（用電單相約 1 千至 2 千 w
 - 2，排洪及防洪水氾濫（安裝三相泵 7500w2 部圖 1，單相泵 3000w2 部圖 2。）供電時，請提供多 20 至 30%的供電設置，以防特大洪水時應急用。
- 需電約需三相電 32000w。

- 注：1 安裝抽水泵處每個泵都需掘地，每個深 4 百至 6 百 mm，直徑 6 百至 7 百 mm。內加一個直徑約 550mm 深 500mm 竹或鐵網做的格什麼網。安置電水泵組合房間 3.8mx2.5m 壹間高不起 3.6 米（室內 4 個泵各有一套洪水自動控制系統共 4 套，各自獨立運作，每一套控制 1 個排洪水泵。保護水泵運作良好。）
- 2 排洪渠在上述地址 1 百米內有 3 個井口，可供上述排洪泵的排洪管連接用，排洪排水可解決。

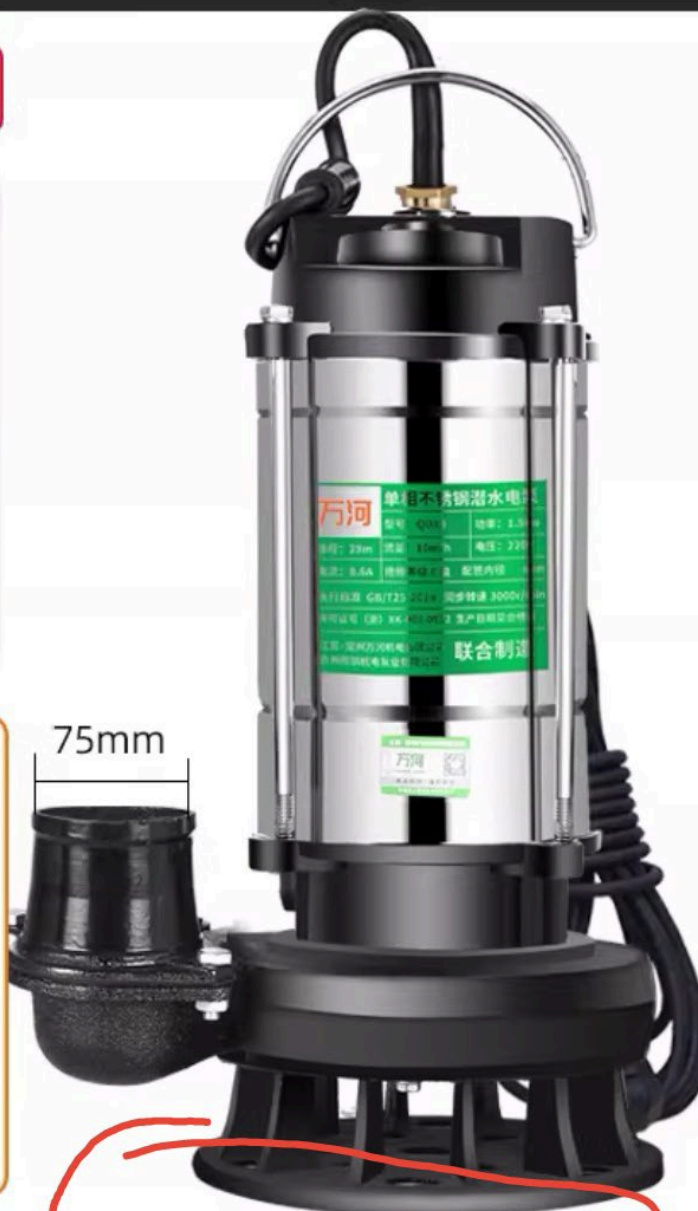
3000W 3寸 不锈钢污水泵

功率: 3000W

流量: 40m³/h

扬程: 14m

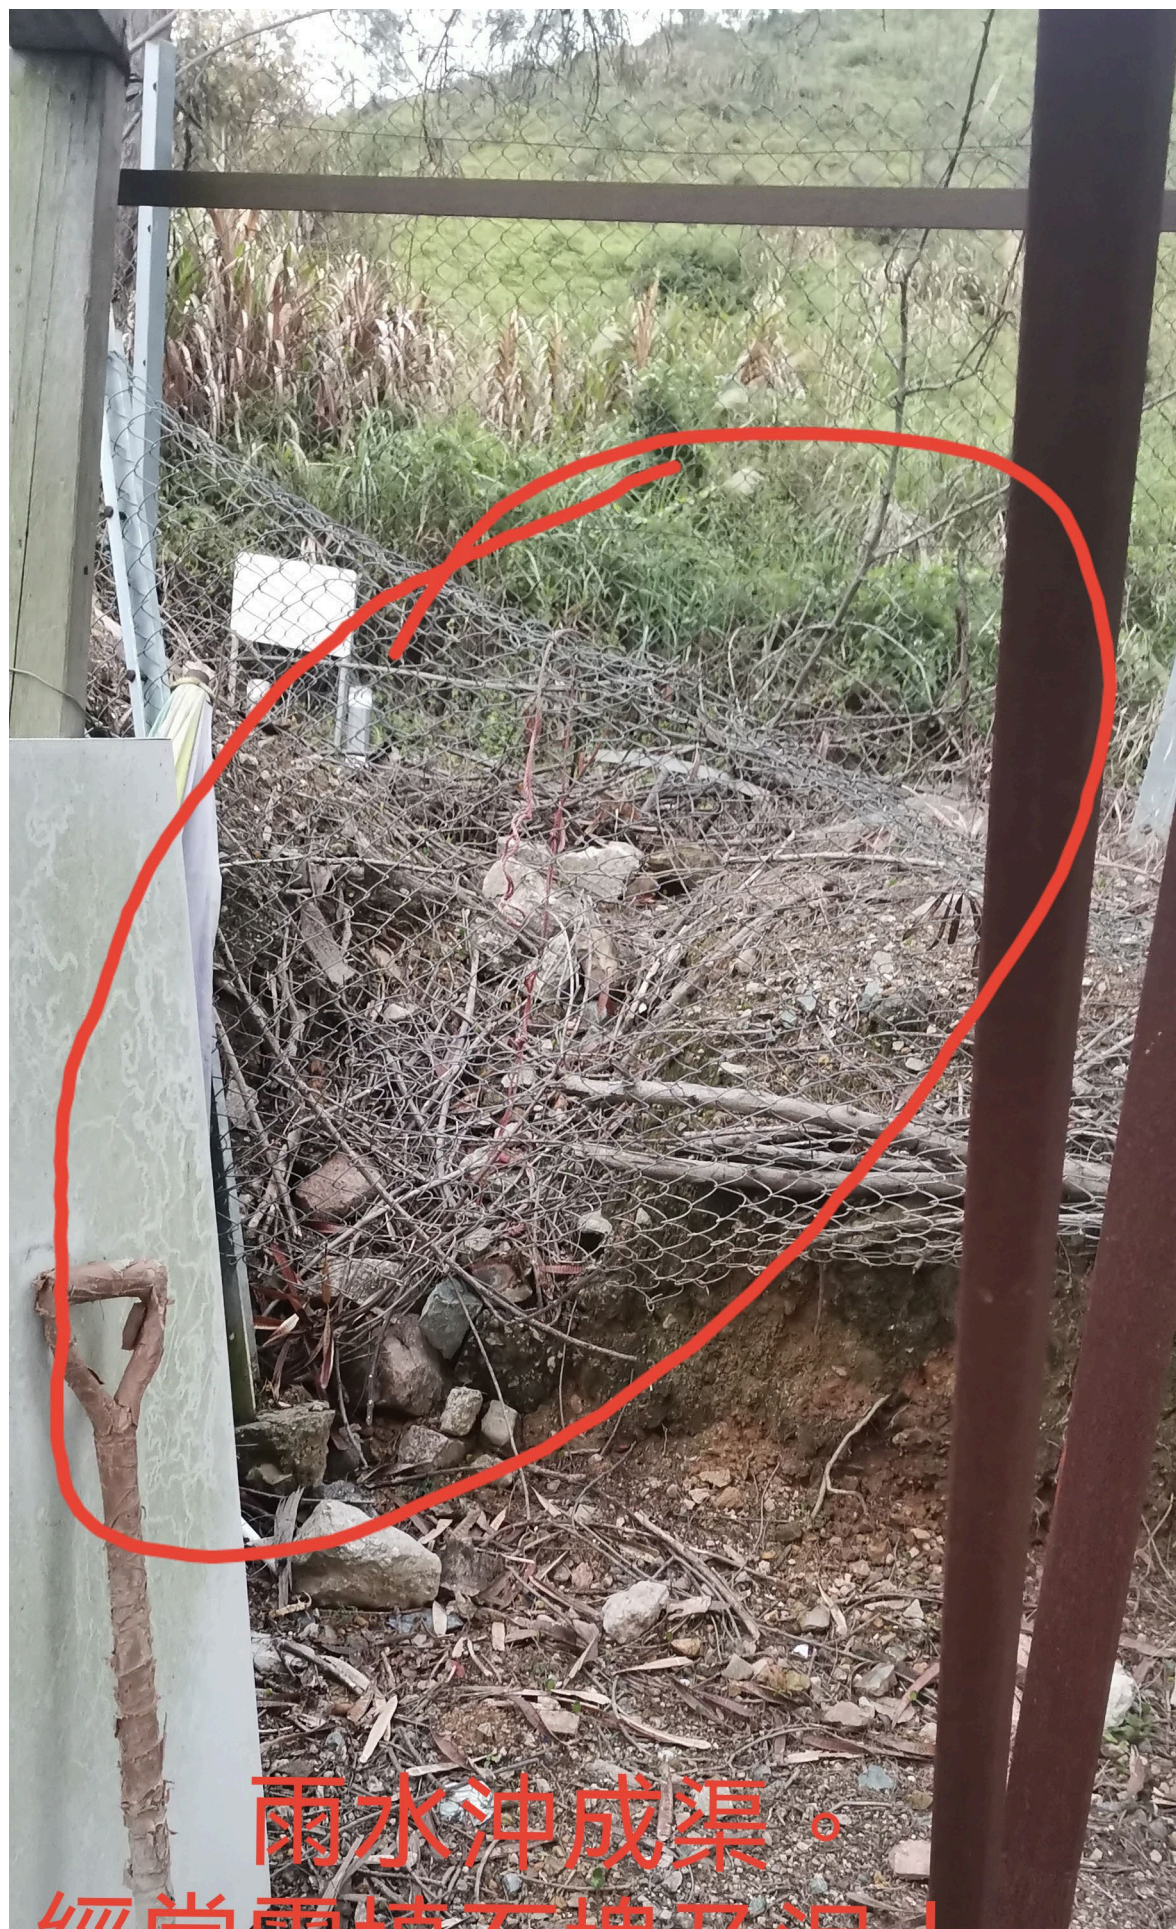
雨水沖成渠。

經尚雨積石塊及泥

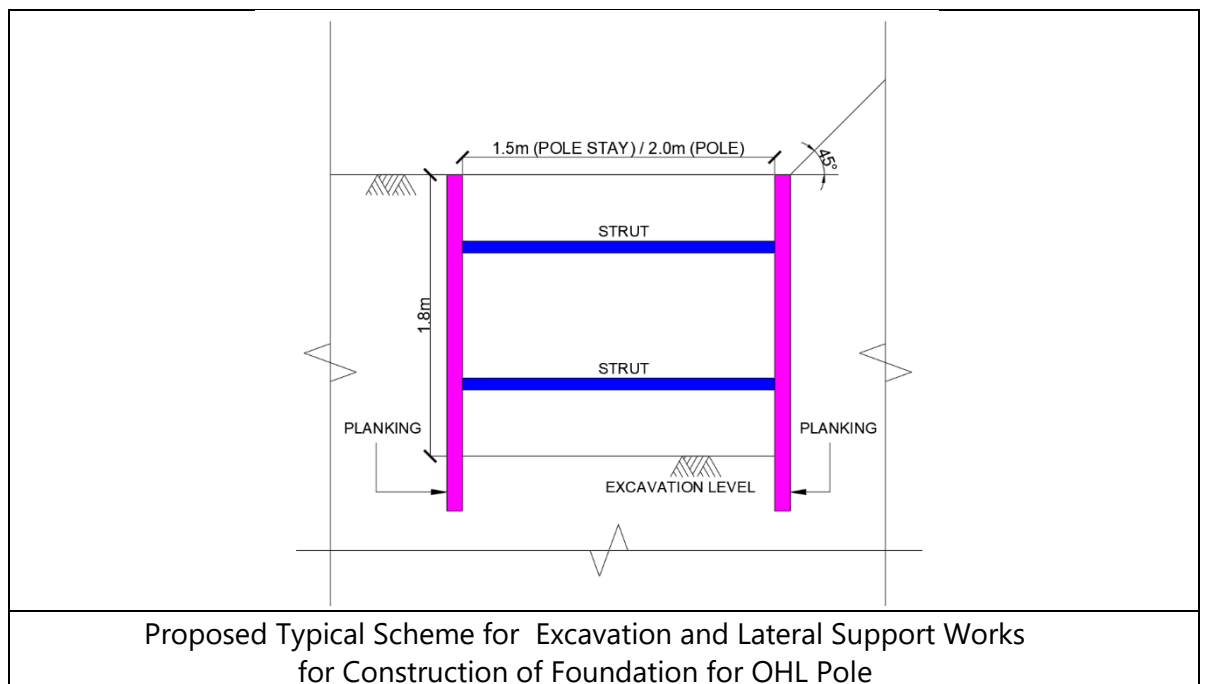
The foundation of the proposed OHL poles and pole stays will be constructed by pit excavation method. The pit will be 1.5m to 2m wide and 1.8m deep approximately. It is proposed that the pit will be supported by planking and struts as shown in the figure below.

In the design of excavation and lateral support works, attention should be paid to the excavation and strutting sequence and to the standard workmanship in order to limit loss of ground due to the inward movement of the temporary planking. Earth load, water load and surcharge should be taken into consideration. It was recorded that the water level of the site is approximately 1.2m below the existing ground, sufficient water pumps shall be provided to ensure that the pits are not submerged during the construction of foundation.

Since the pit excavation works involves excavation of depth 1.8m only, excavation effects on the adjacent slopes and change of ground profile should be minimal.

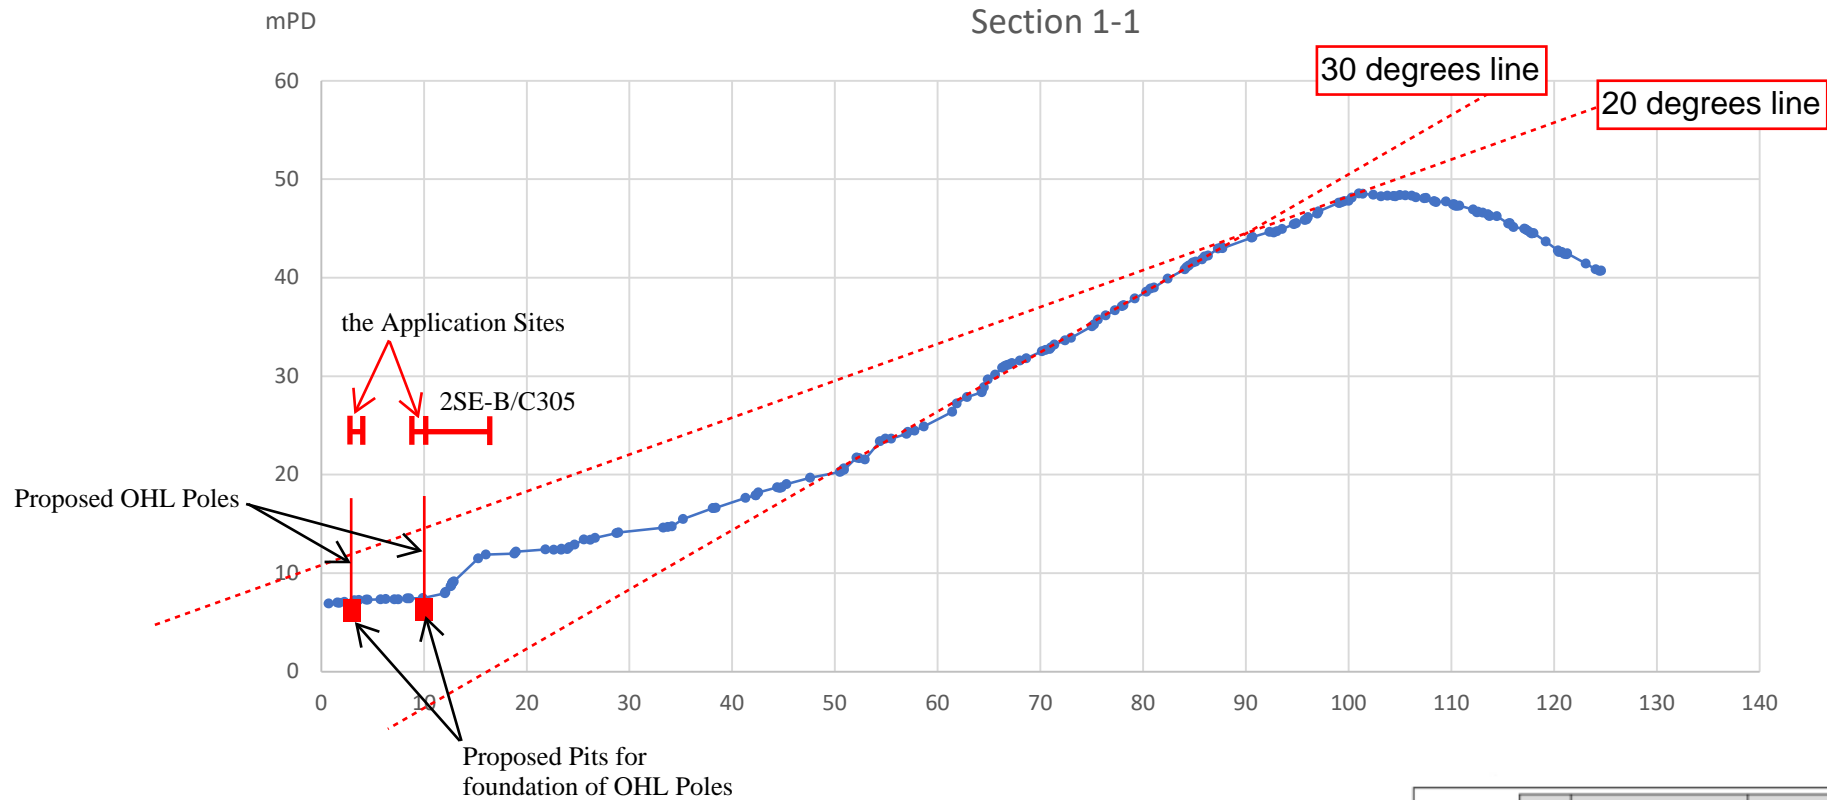
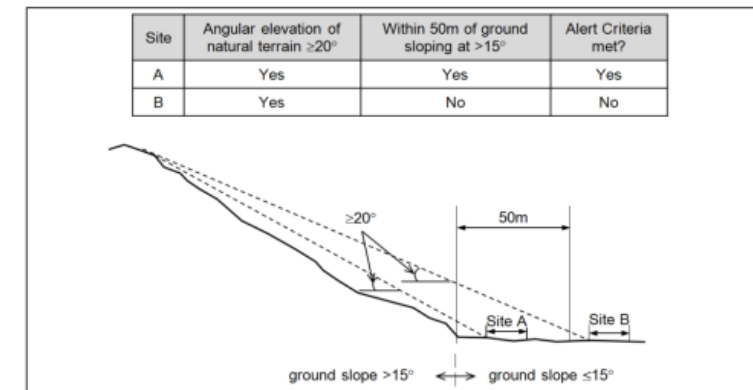
Figure 2.5 Application of Alert Criteria

Comparing Figure 2.5 and Section 1, the site for proposed OHL Pole meets alert criteria of natural terrain hazard.

Comparing Figure 2.5 and Section 1, the site for proposed OHL Pole meets alert criteria of natural terrain hazard.

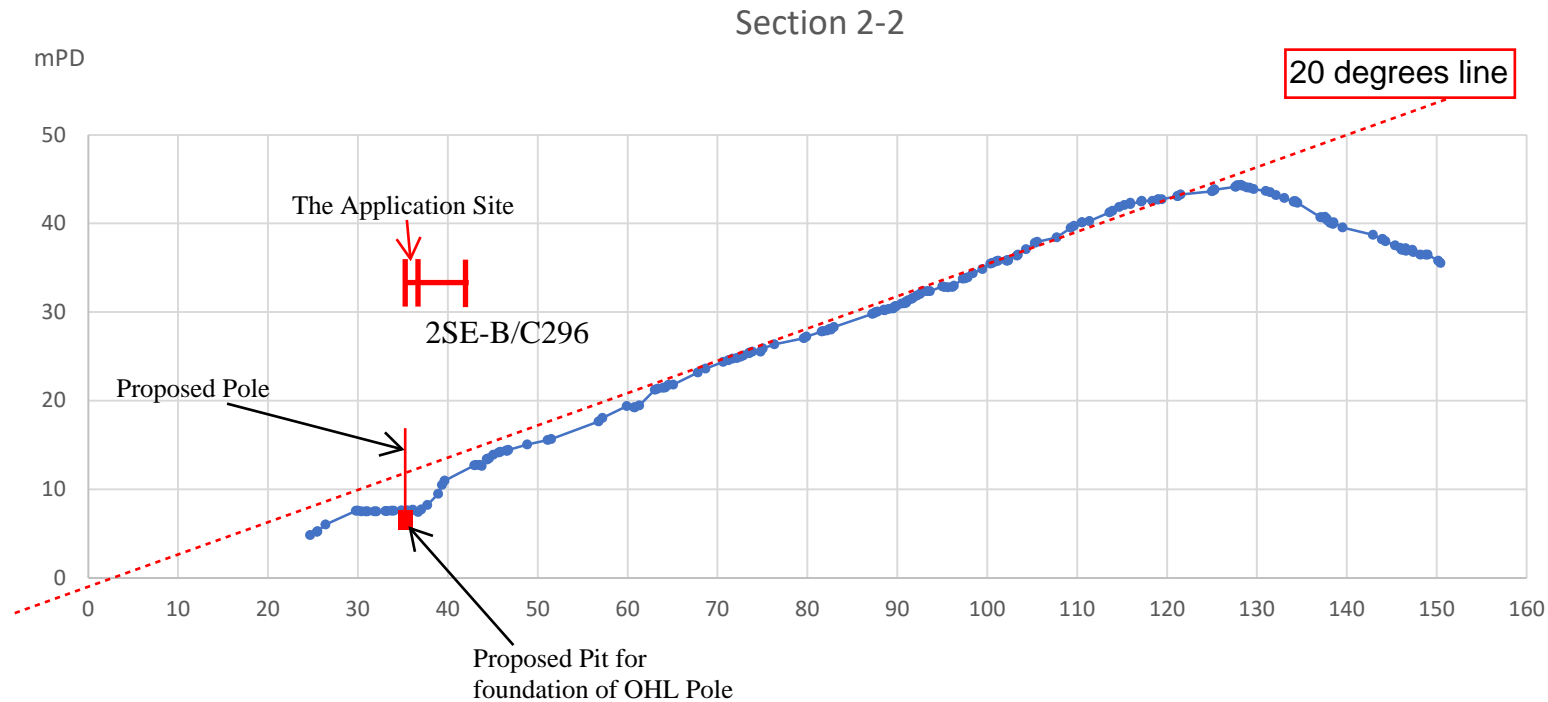
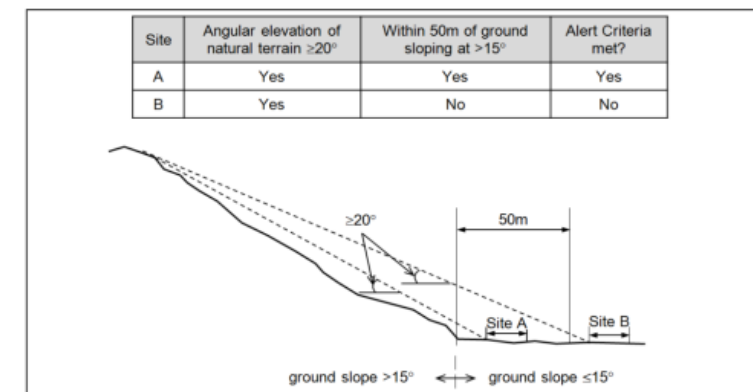
Figure 2.5 Application of Alert Criteria

Comparing Figure 2.5 and Section 2, the site for proposed OHL Pole meets alert criteria of natural terrain hazard.

Comparing Figure 2.5 and Section 2, the site for proposed OHL Pole meets alert criteria of natural terrain hazard.

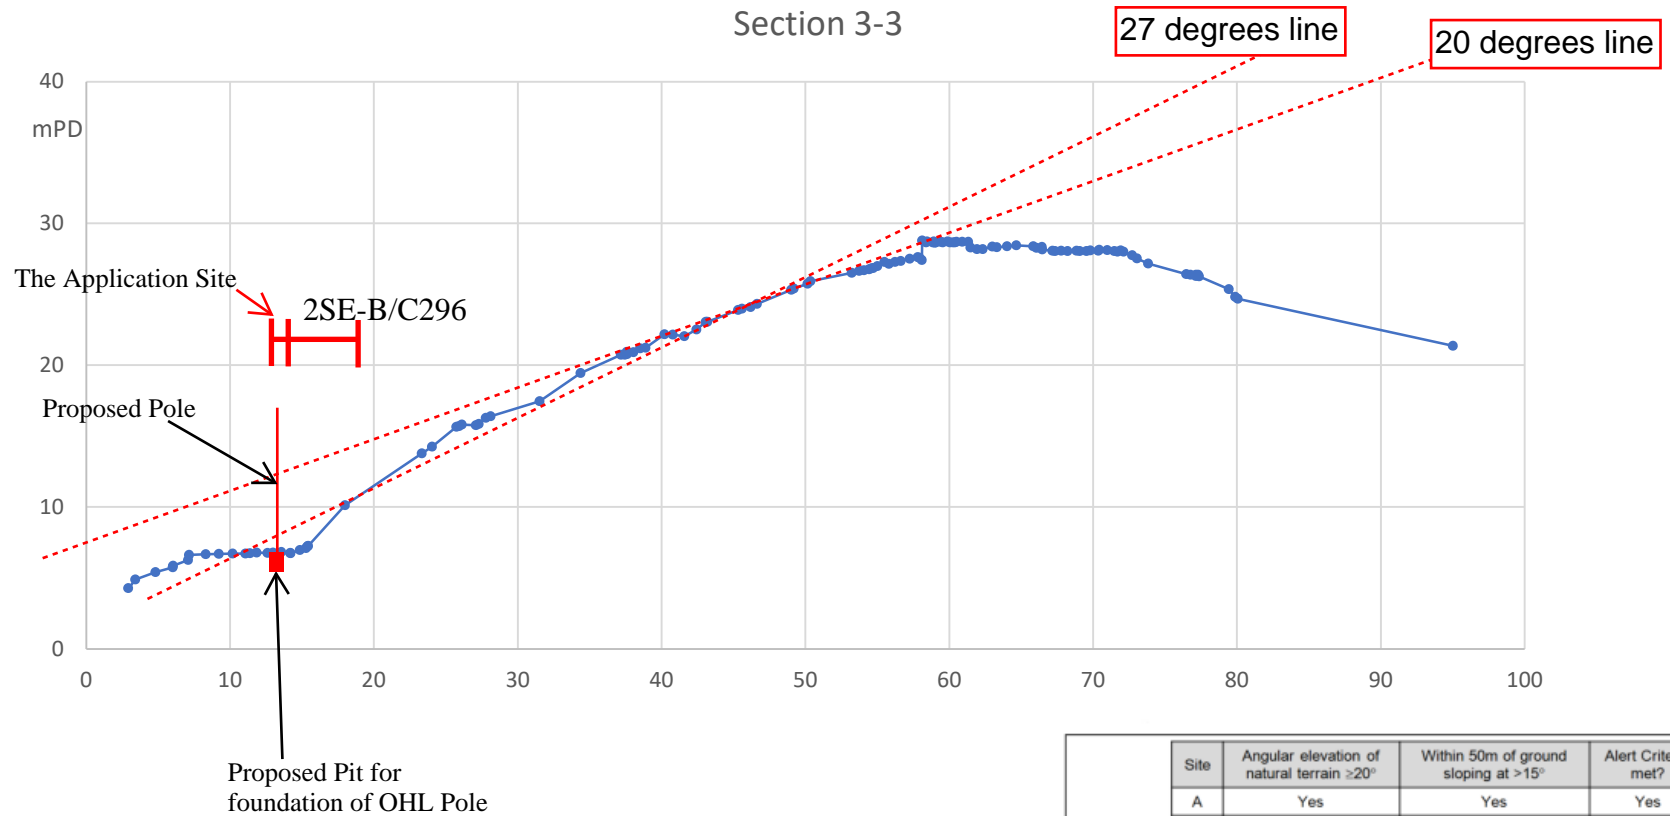
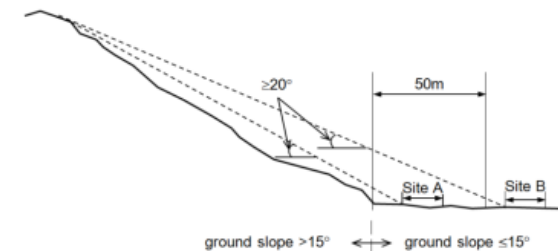
Figure 2.5 Application of Alert Criteria

Comparing Figure 2.5 and Section 3, the site for proposed OHL Pole meets alert criteria of natural terrain hazard.

Site	Angular elevation of natural terrain $\geq 20^\circ$	Within 50m of ground sloping at $>15^\circ$	Alert Criteria met?
A	Yes	Yes	Yes
B	Yes	No	No

Comparing Figure 2.5 and Section 3, the site for proposed OHL Pole meets alert criteria of natural terrain hazard.

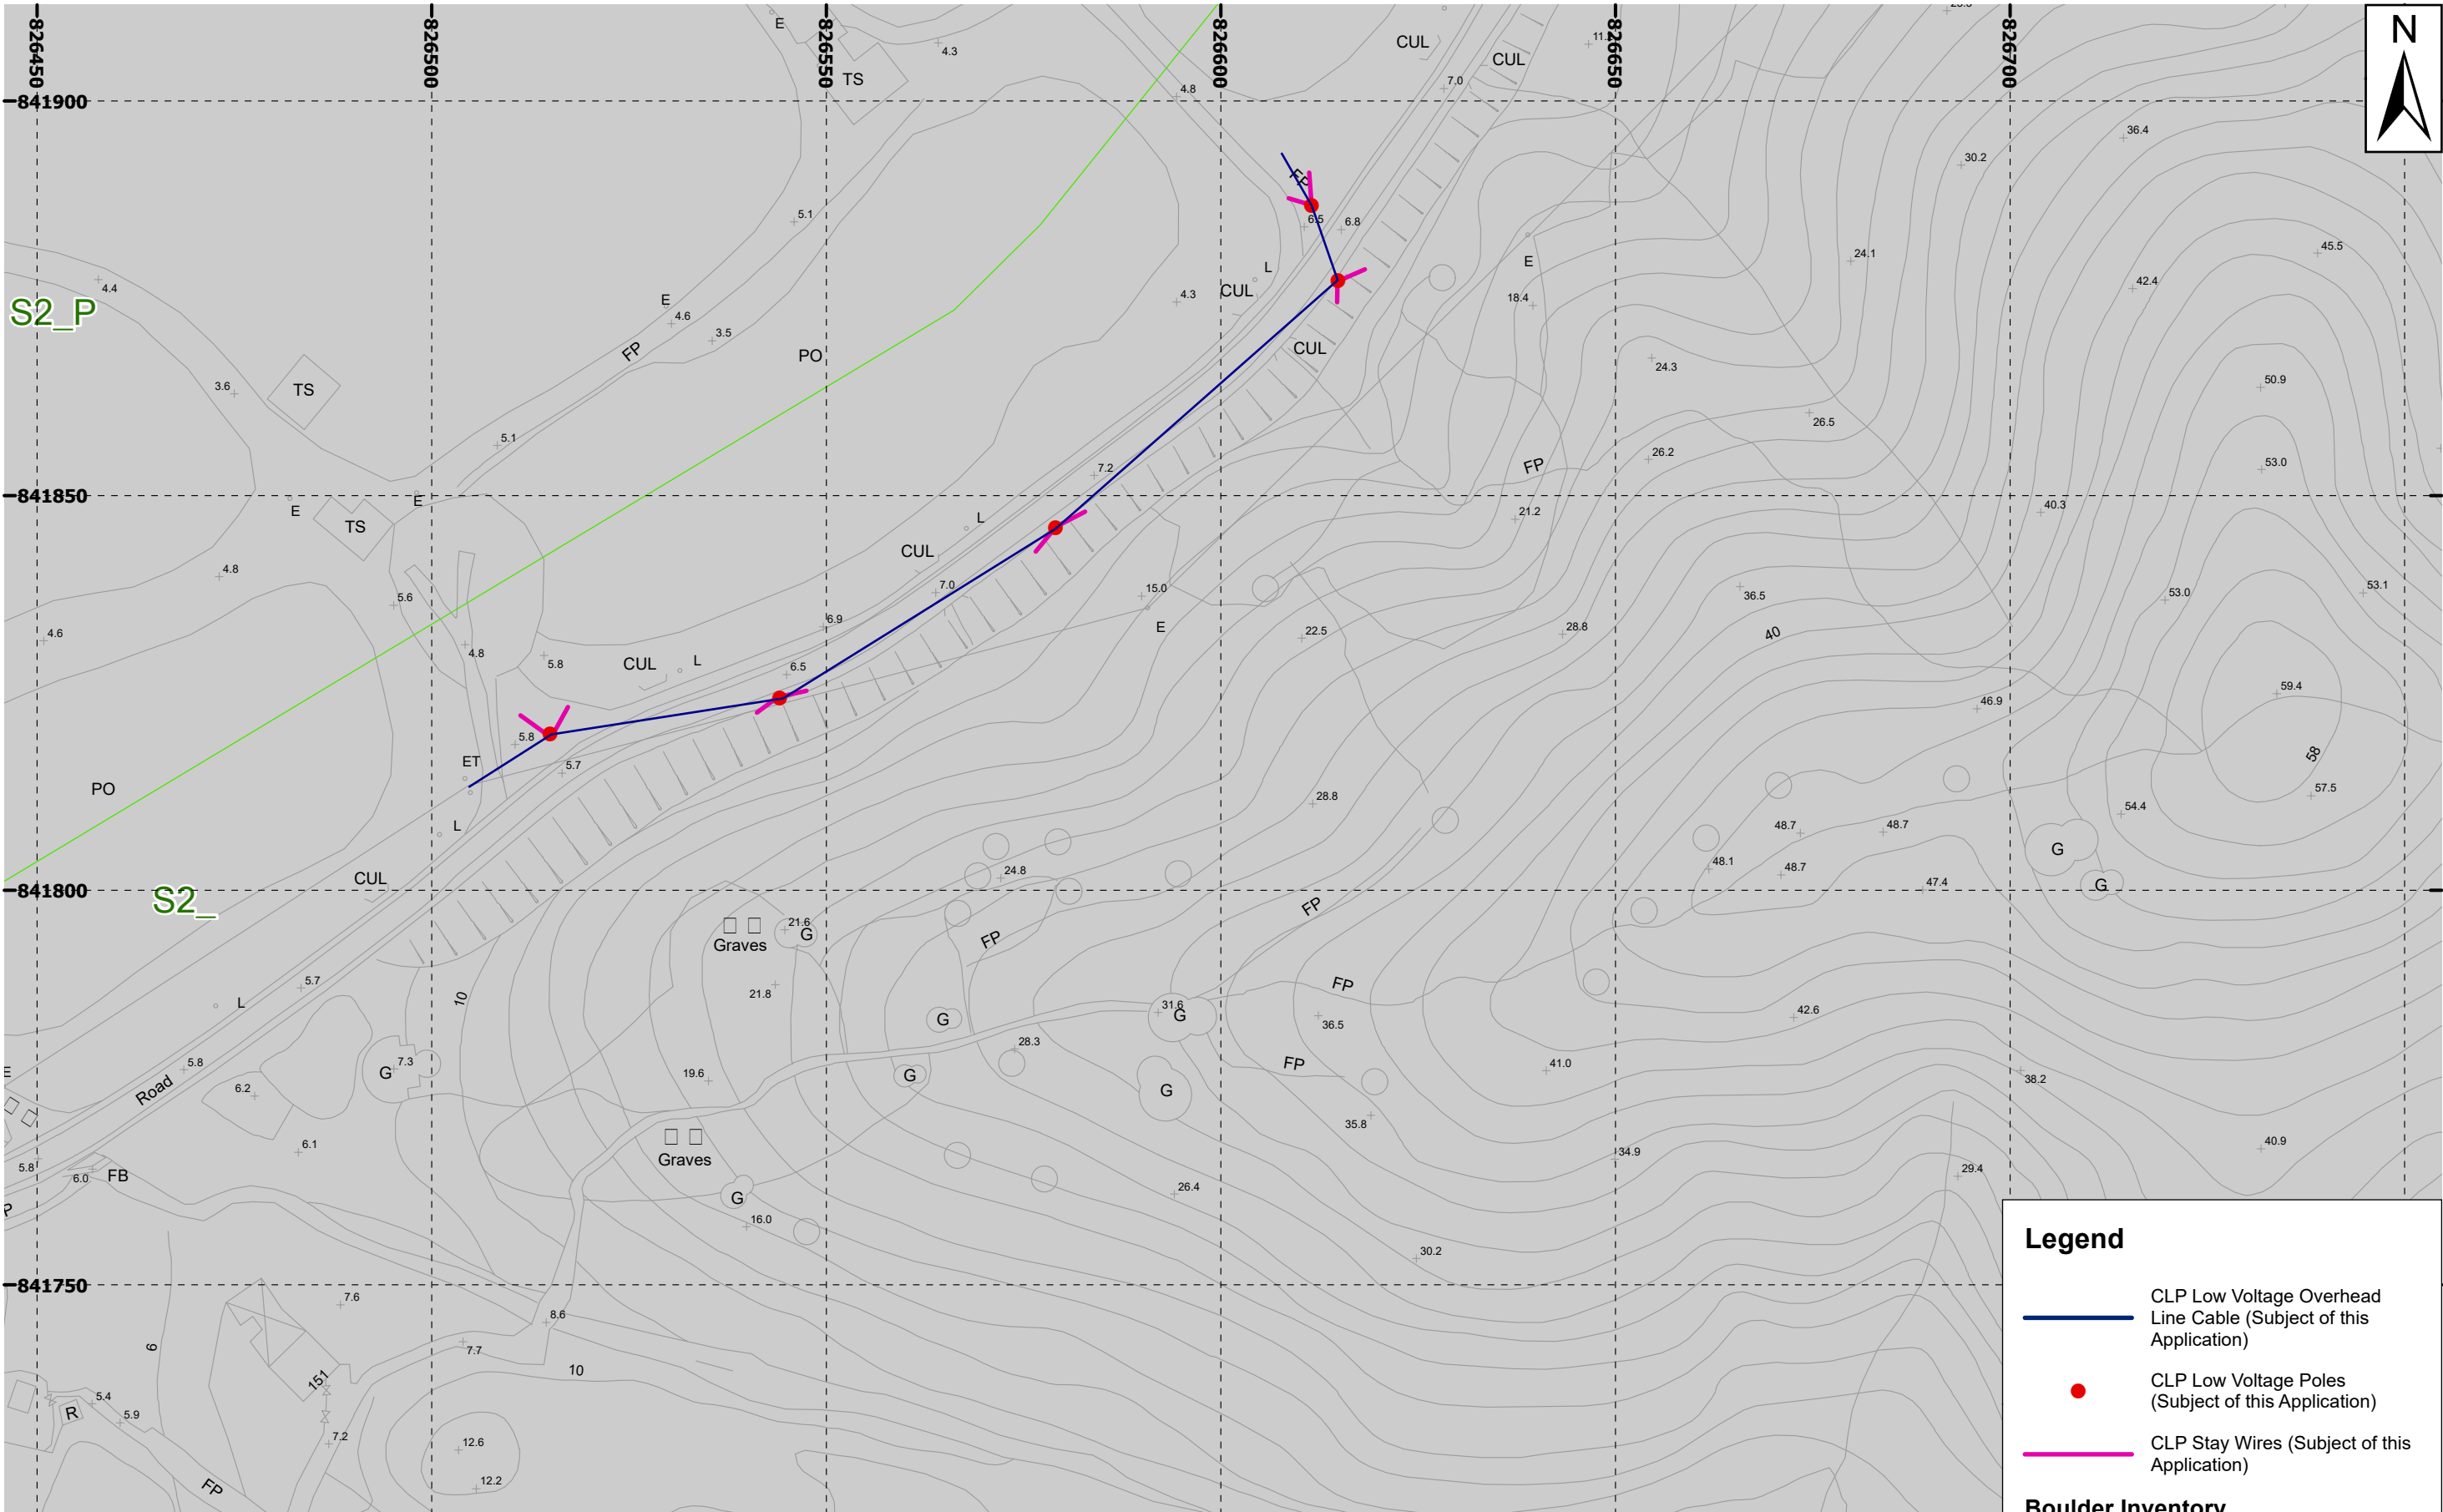
Conclusion
No record of boulder within the natural terrain area about the application site.

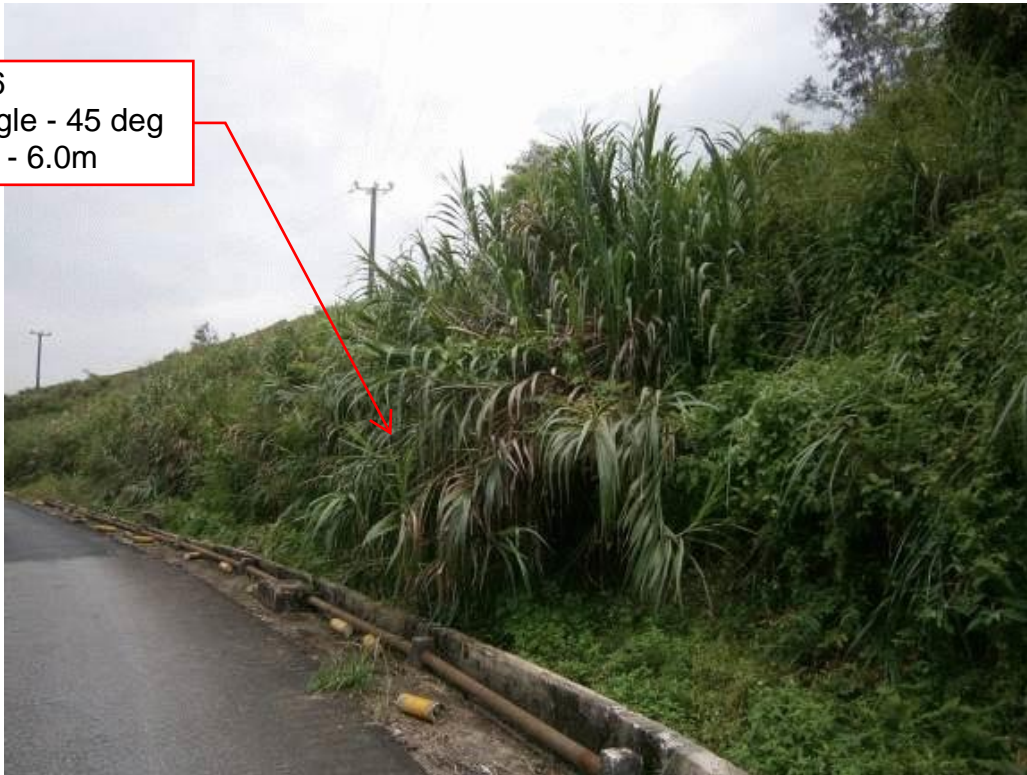
2SE-B/C296
Average Angle - 45 deg
Max. Height - 6.0m

These 2 registered man-made slopes are cut slopes with 6m in height at 45° slope angle. In view of failure of the man-made slopes would affect the OHL poles at the slope toe, stability analysis is proposed to be carried out.

Photo 1: General View of 2SE-B/C296

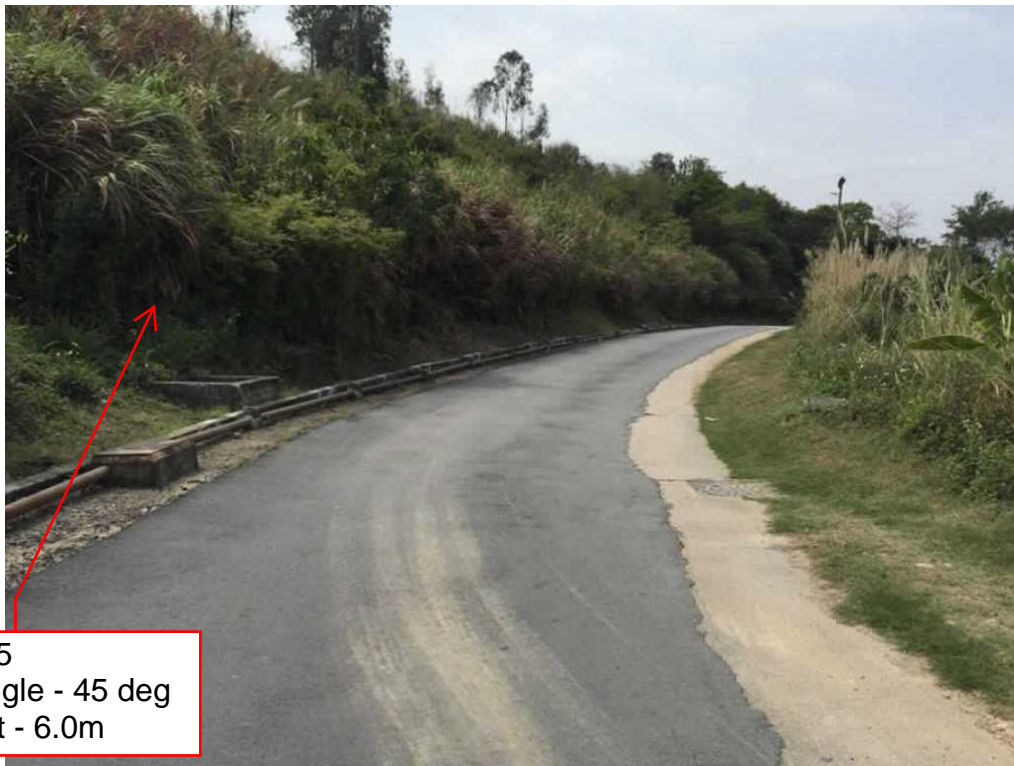
2SE-B/C305
Average Angle - 45 deg
Max. Height - 6.0m

Photo 2: General View of 2SE-B/C305

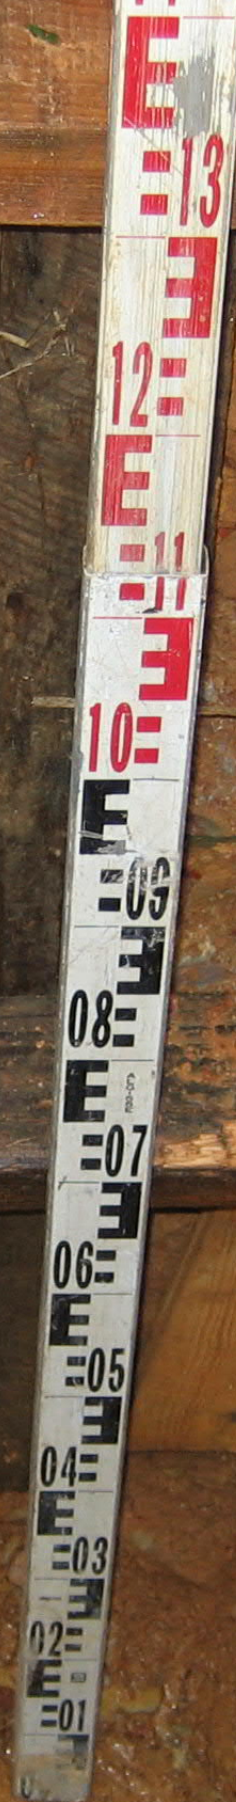
CONSTRUCTION OF A SECONDARY
SITE: BOUNDARY FENCE - PHASE 1
WO NO: ASD010414 DATE: 13-4-2005
T.P. NO: TP40
FACE: B (LOWER)

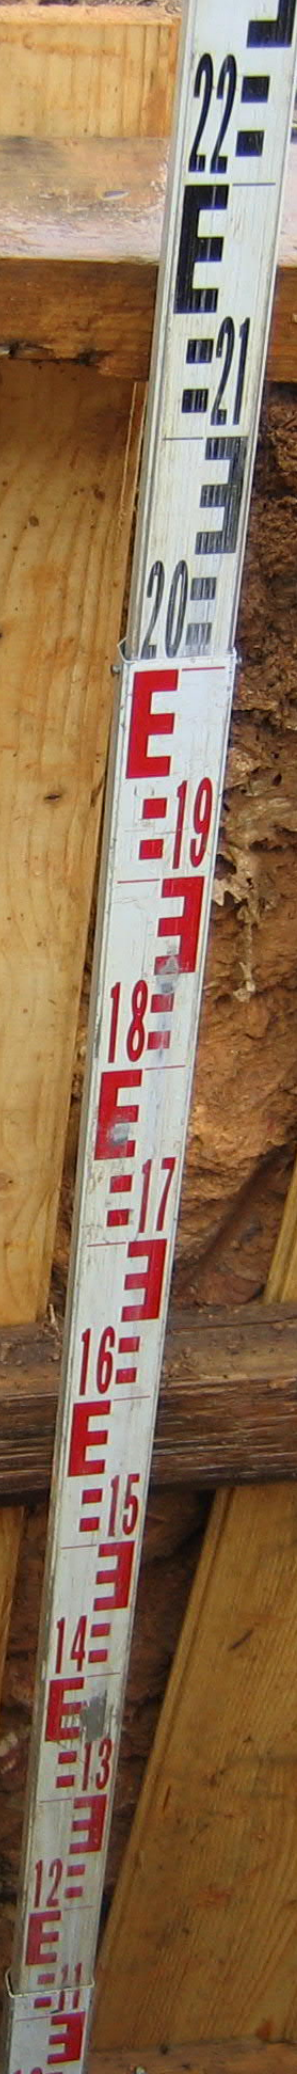
CONSTRUCTION OF A SECONDARY
SITE: BOUNDARY FENCE - PHASE 1
WO NO: ASD010414 DATE: 13-4-2005
T.P. NO: TP40
FACE: C (UPPER)

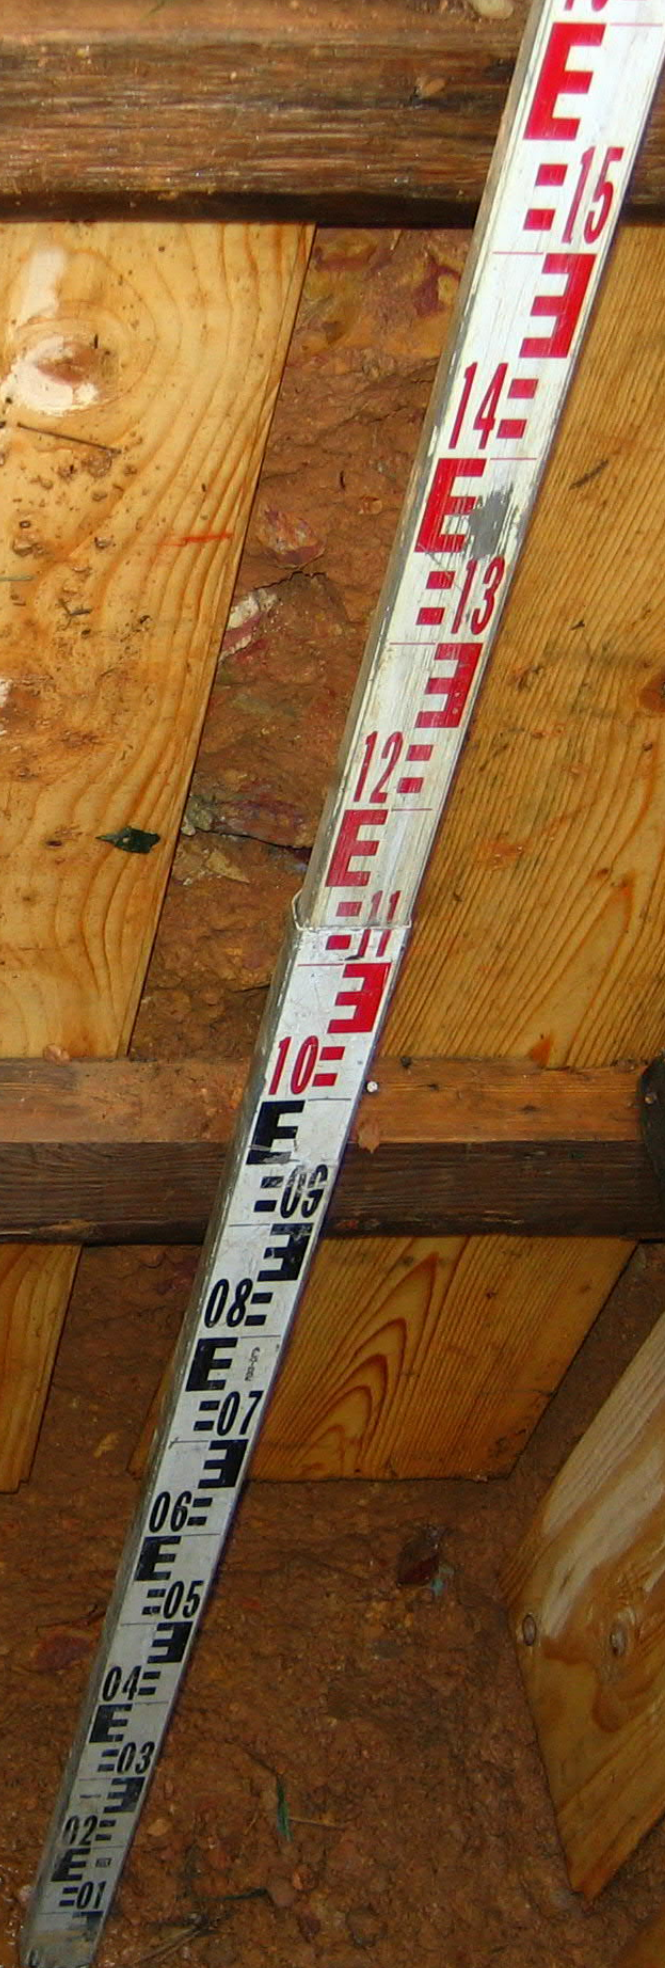
CONSTRUCTION OF A SECONDARY
SITE: BOUNDARY FENCE - PHASE 1
WO NO: ASD010414 DATE: 13-4-2005
T.P. NO: TP40
FACE: C (LOWER)

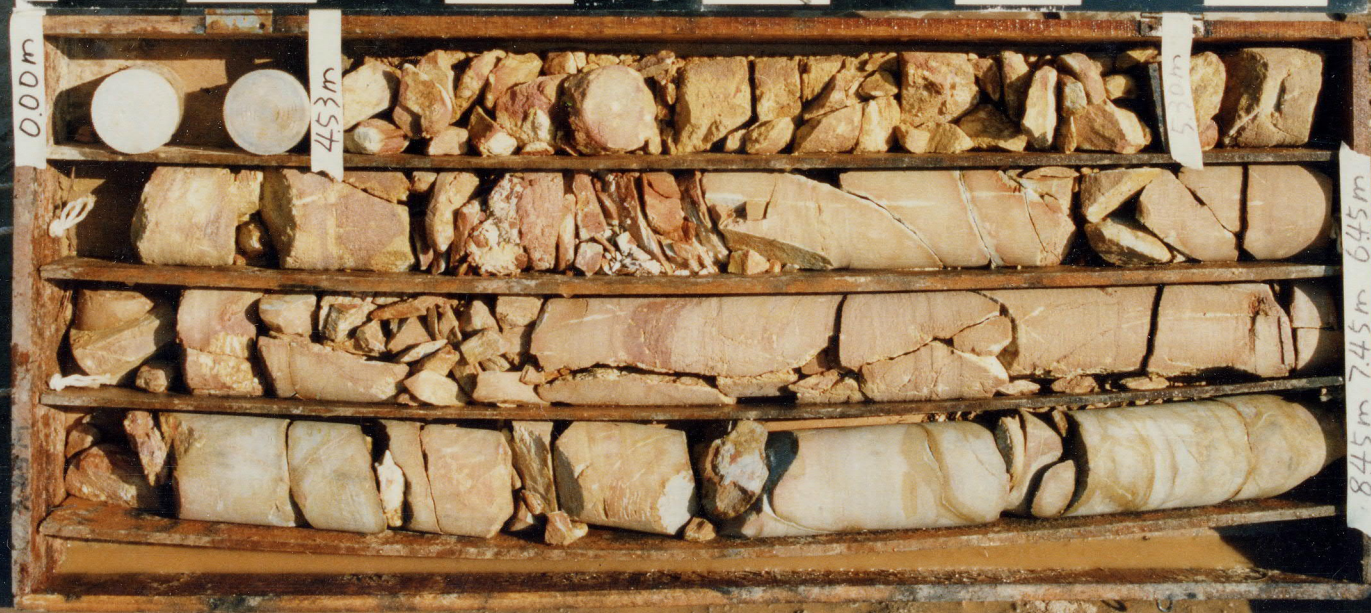
CLIENT	GEOTECHNICAL CONTROL OFFICE		
CONTRACT NO.	GC/85/09		
CONTRACTOR	LAM GEOTECHNICS LTD		
JOB NAME	LOK MA CHAU	W.O.NO.	PW7/2/16.75
HOLE NO.	BH-5	BOX'S NO.	1 OF 7
DEPTH	METRE FROM 0.00m TO 8.45m

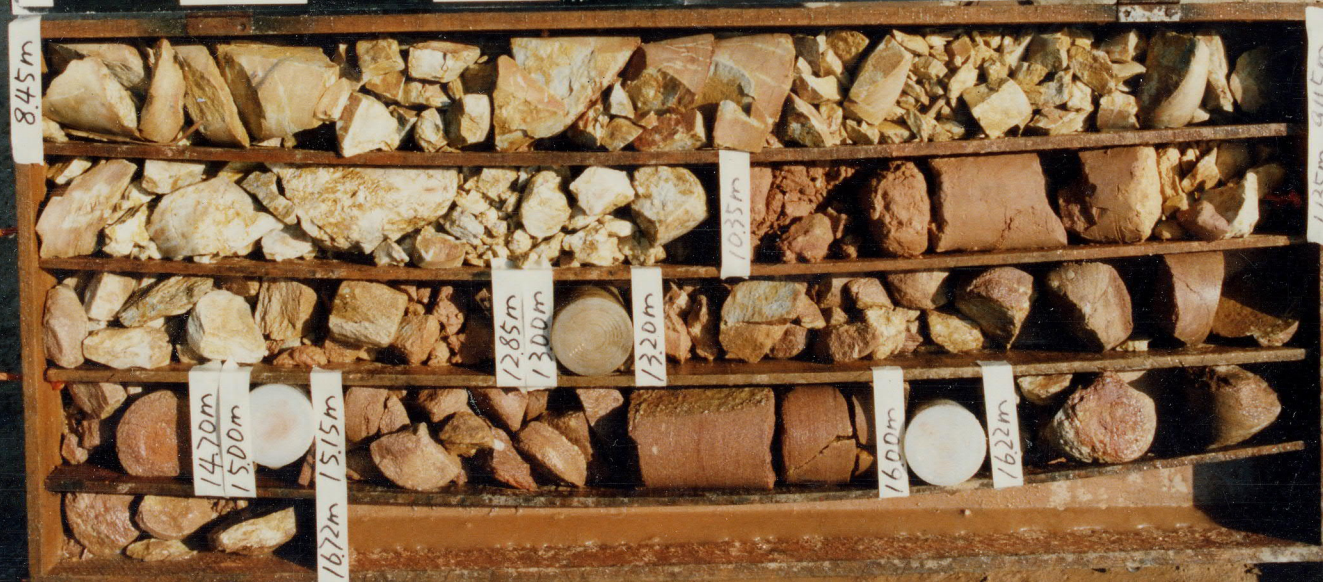
CLIENT | GEOTECHNICAL CONTROL OFFICE
CONTRACT NO. | GC/85/09
CONTRACTOR | LAM GEOTECHNICS LTD
JOB NAME | LOK MA CHAU | W.O.NO. | PW7/2/16.75
HOLE NO. | BH-5 | BOX'S NO. | 2 OF 7
DEPTH | METRE FROM 8.45m TO 16.72m

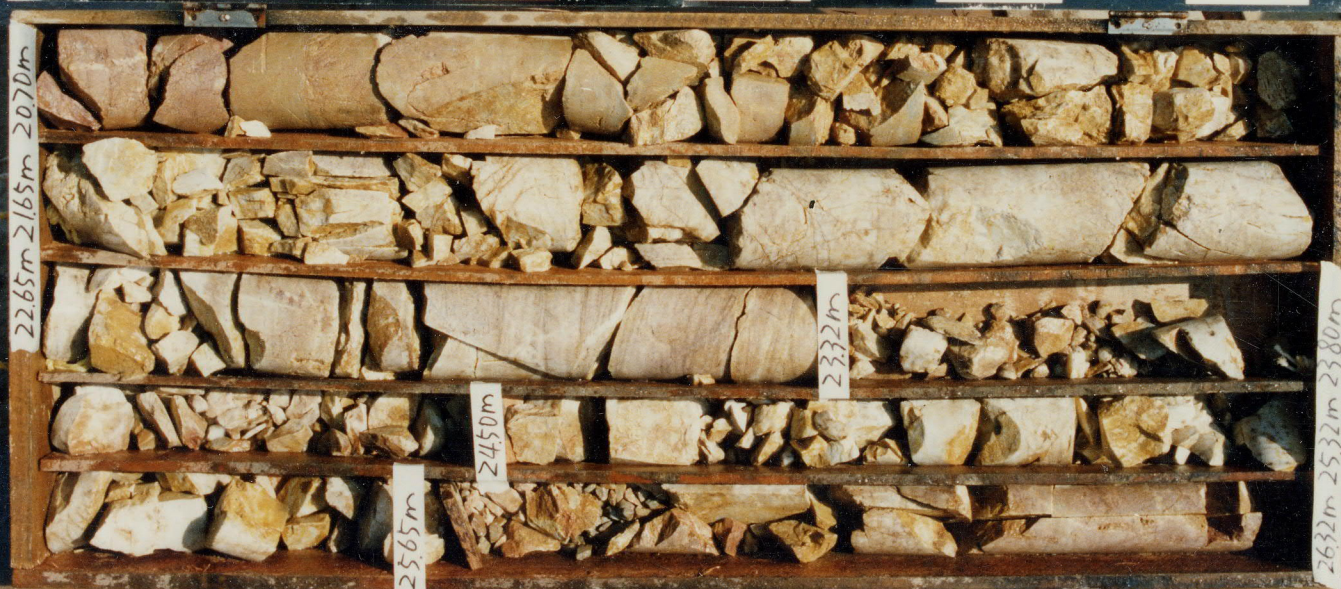
CLIENT	GEOTECHNICAL CONTROL OFFICE		
CONTRACT NO.	GC/85/09		
CONTRACTOR	LAM GEOTECHNICS LTD		
JOB NAME	LOK MA CHAU	W.O.NO.	PW7/2/16.75
HOLE NO.	BH-5	BOX'S NO.	4 OF 7
DEPTH	METRE FROM 20.70m TO 26.32m

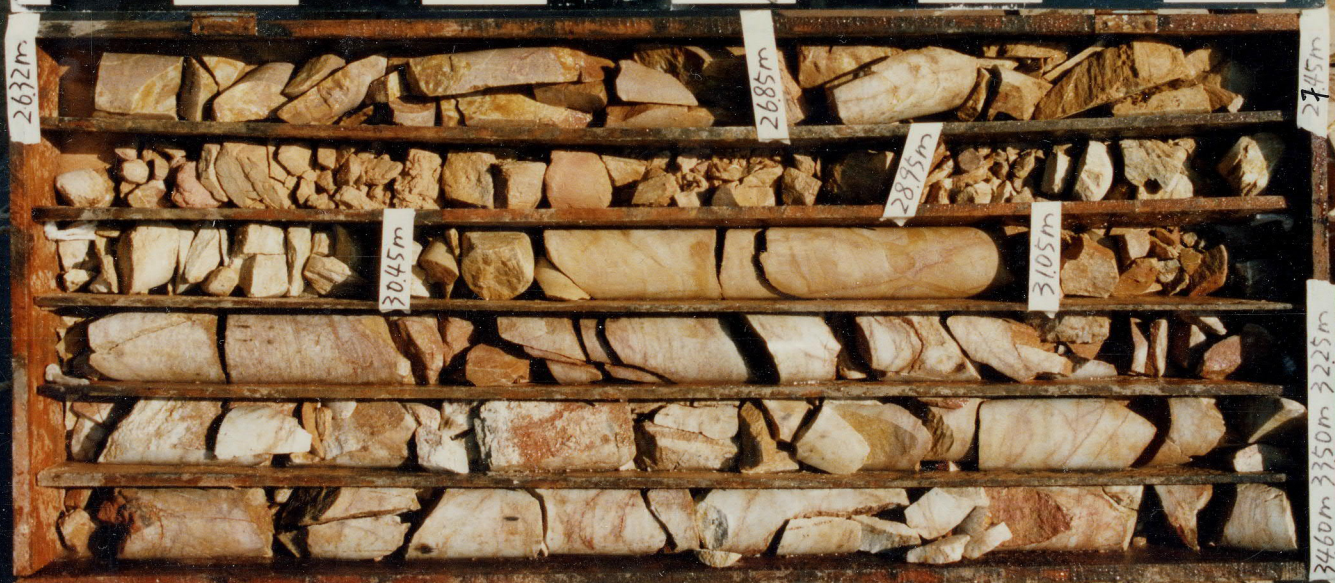
CLIENT	GEOTECHNICAL CONTROL OFFICE		
CONTRACT NO.	GC/85/09		
CONTRACTOR	LAM GEOTECHNICS LTD		
JOB NAME	LOK MA CHAU	W.O.NO.	PW7/2/16.75
HOLE NO.	BH-5	BOX'S NO.	5 OF 7
DEPTH	METRE FROM 26.32m TO 34.60m.
