**APPLICATION FOR PERMISSION
UNDER SECTION 16 OF
THE TOWN PLANNING ORDINANCE
(CAP. 131)**

Appendix 1 - Application site

Geotechnical Planning Review Report for Installation of Proposed Public Utility Installation and Associated Filling and Excavation of Land (OHL Pole & Stay Erection)

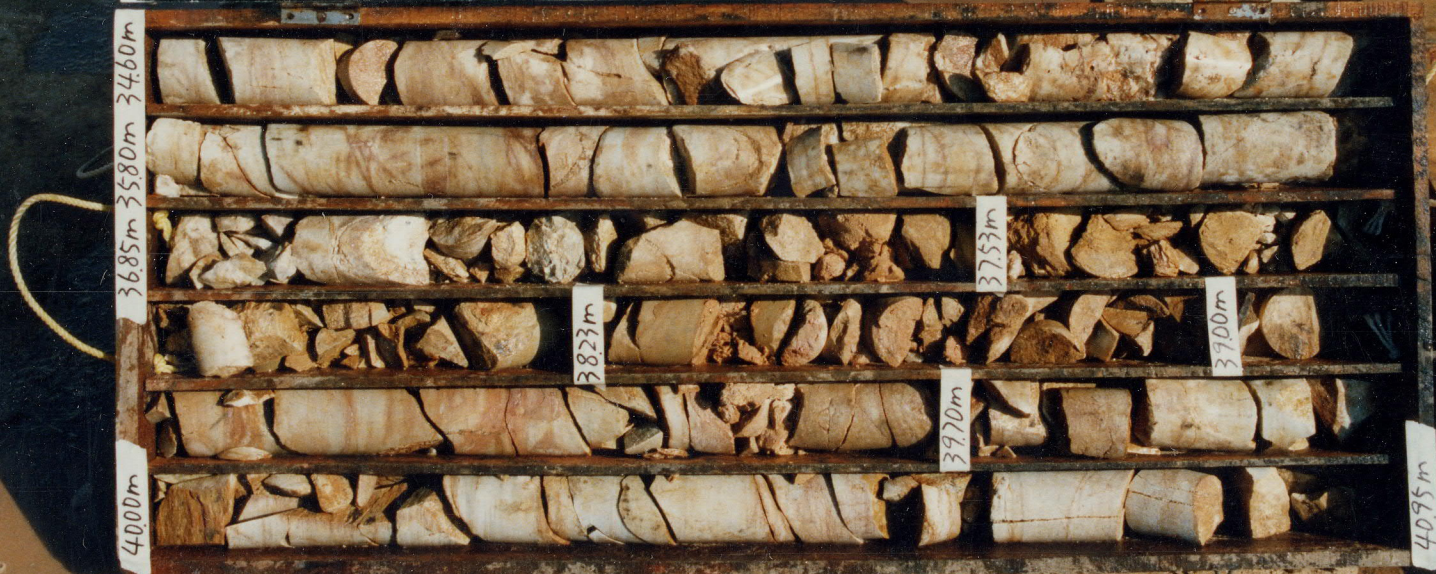
CLIENT	GEOTECHNICAL CONTROL OFFICE		
CONTRACT NO.	GC/85/09		
CONTRACTOR	LAM GEOTECHNICS LTD		
JOB NAME	LOK MA CHAU	W.O.NO.	PW7/2/16.75
HOLE NO.	BH-5	BOX'S NO.	6 OF 7
DEPTH	METRE FROM 34.60m TO 40.95m

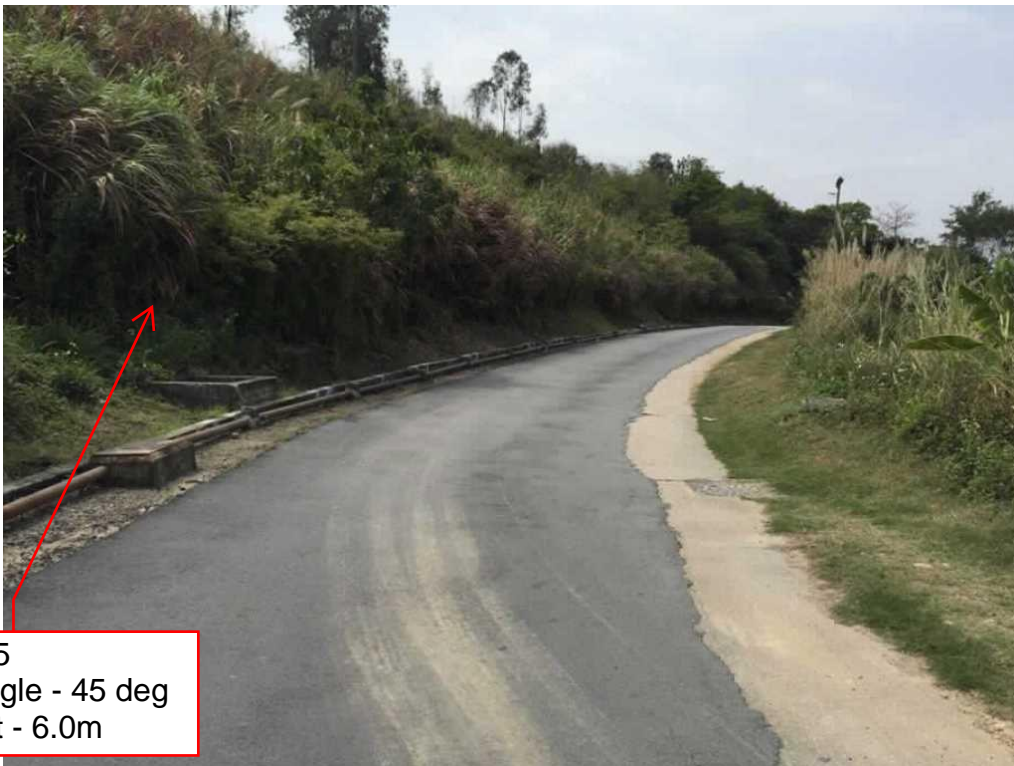
2SE-B/C305
Average Angle - 45 deg
Max. Height - 6.0m

Photo 2: General View of 2SE-B/C305

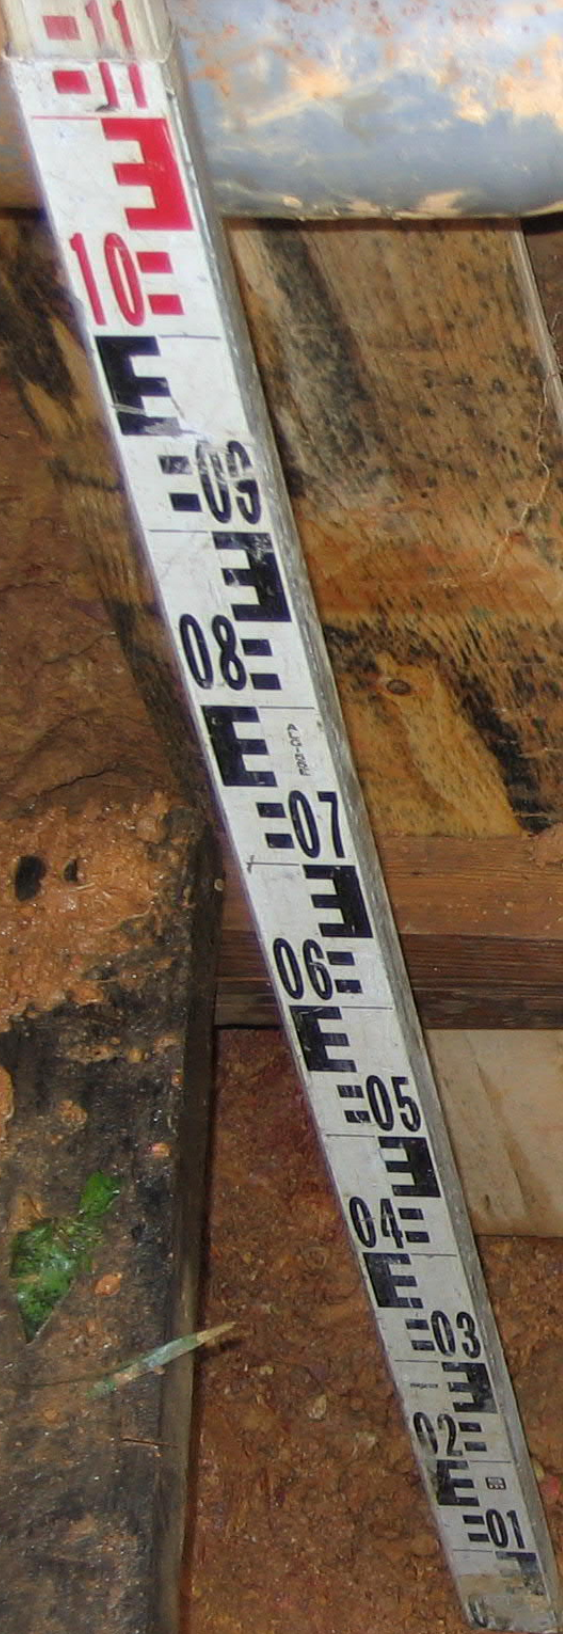
CONSTRUCTION OF A SECONDARY
SITE: BOUNDARY FENCE - PHASE 1
WO NO: ASD010414 DATE: 13-4-2005
T.P. NO: TP40
FACE: A (UPPER)

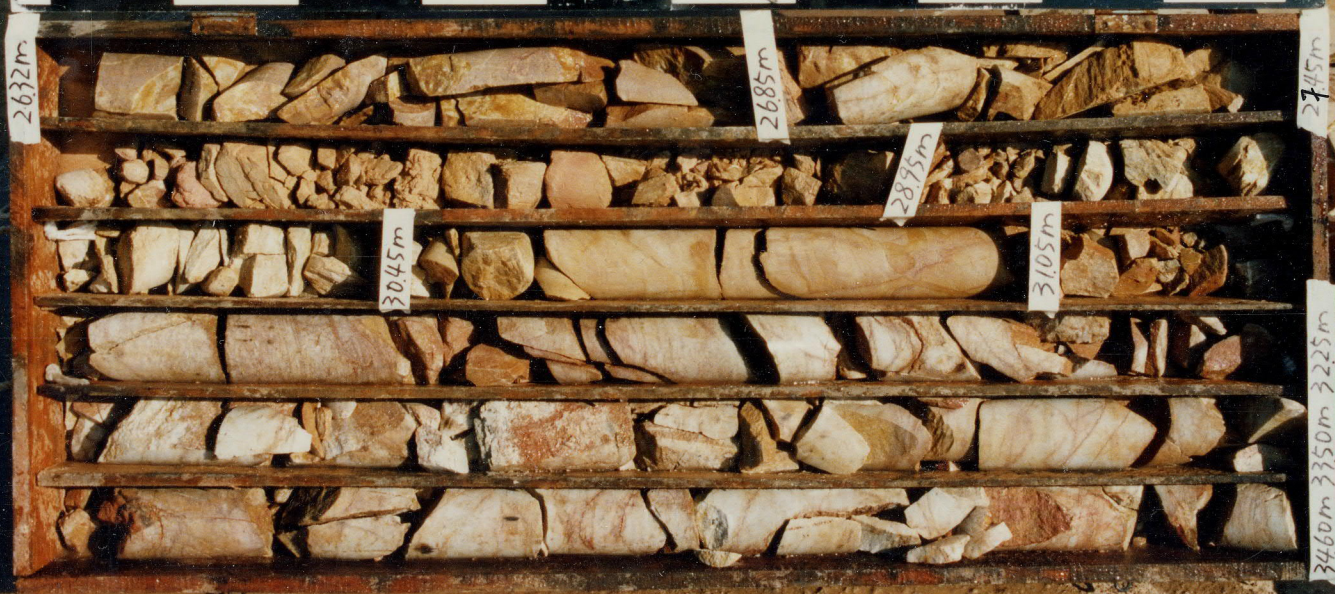
CLIENT	GEOTECHNICAL CONTROL OFFICE		
CONTRACT NO.	GC/85/09		
CONTRACTOR	LAM GEOTECHNICS LTD		
JOB NAME	LOK MA CHAU	W.O.NO.	PW7/2/16.75
HOLE NO.	BH-5	BOX'S NO.	5 OF 7
DEPTH	METRE FROM 26.32m TO 34.60m.

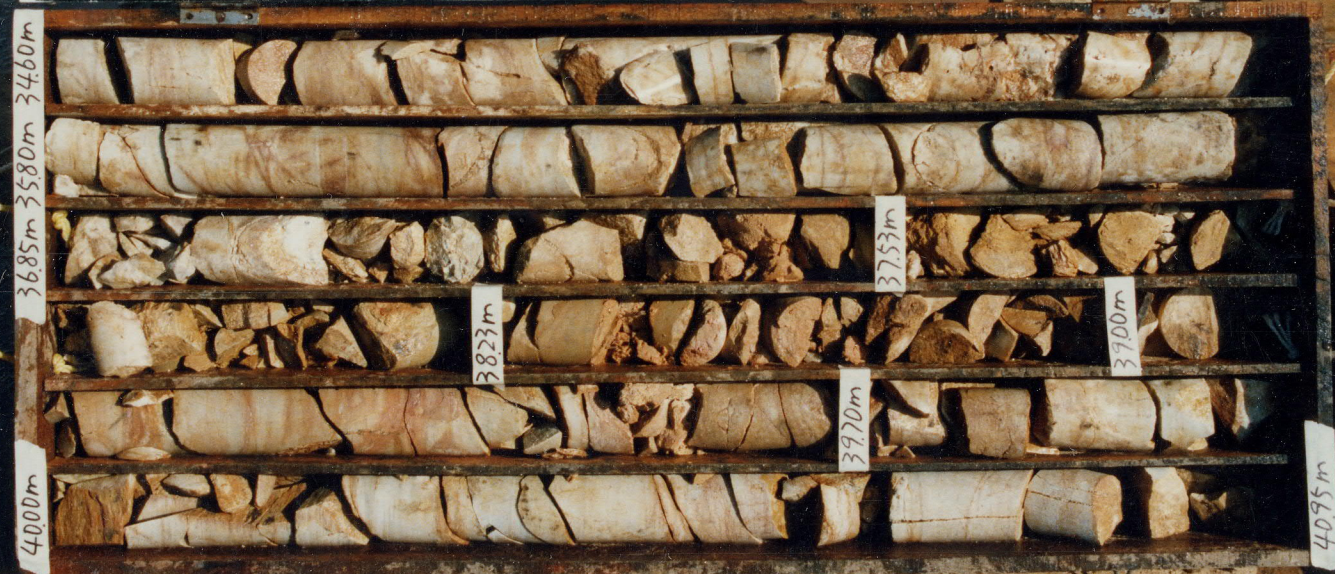
CLIENT	GEOTECHNICAL CONTROL OFFICE		
CONTRACT NO.	GC/85/09		
CONTRACTOR	LAM GEOTECHNICS LTD		
JOB NAME	LOK MA CHAU	W.O.NO.	PW7/2/16.75
HOLE NO.	BH-5	BOX'S NO.	6 OF 7
DEPTH	METRE FROM 34.60m TO 40.95m

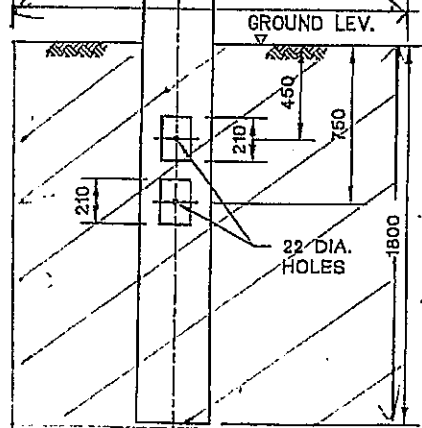
Pole Section
DRAWING

WIDTH

200mm

GROUND LEV.

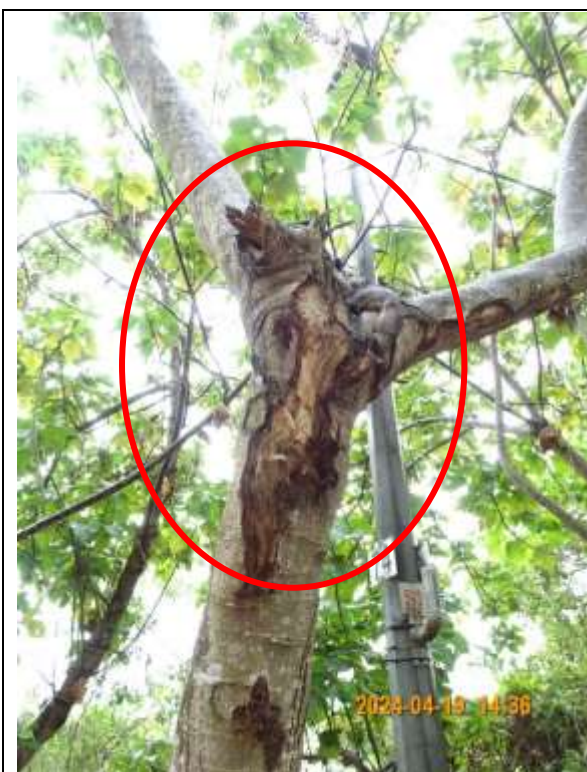
T008 – Wound wood

T007	T007	<i>Macaranga tanarius</i>	血桐	5	137	3	Fair	Fair	Fair	Fair	low	NA	NIL	retain	NA	
T008	T008	<i>Macaranga tanarius</i>	血桐	5	198	4	Fair	Fair	Fair	Fair	low	NA	NIL	retain	NA	Wound wood
T009	T009	<i>Macaranga tanarius</i>	血桐	4.5	205	5	Fair	Fair	Fair	Fair	low	NA	NIL	retain	NA	
T010	T010	<i>Macaranga tanarius</i>	血桐	4.5	228	4	Fair	Fair	Fair	Fair	low	NA	NIL	retain	NA	
T011	T011	<i>Leucaena leucocephala</i>	銀合歡	9	346	6	Fair	Fair	Fair	Fair	low	NA	NIL	retain	NA	Broken branch
T012	T012	<i>Leucaena leucocephala</i>	銀合歡	8	96	3	Fair	Fair	Fair	Fair	low	NA	NIL	retain	NA	
T013	T013	<i>Melia azedarach</i>	苦楝	9	223	5	Fair	Fair	Fair	Fair	low	NA	NIL	retain	NA	
T014	T014	<i>Ficus hispida</i>	對葉榕	4	179	4	Fair	Fair	Fair	Fair	low	NA	NIL	retain	NA	
T015	T015	<i>Leucaena leucocephala</i>	銀合歡	5	106	2	Poor	Fair	Poor	Fair	low	NA	NIL	retain	NA	Serious dieback
T016	T016	<i>Schefflera heptaphylla</i>	鵝掌柴(鴨腳木)	3	118	4	Fair	Fair	Fair	Fair	low	NA	NIL	retain	NA

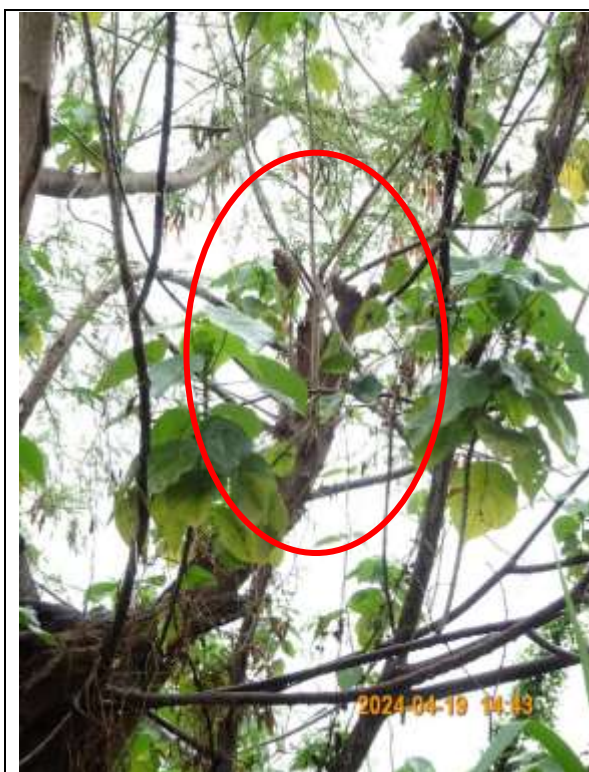
T011 – Broken branch

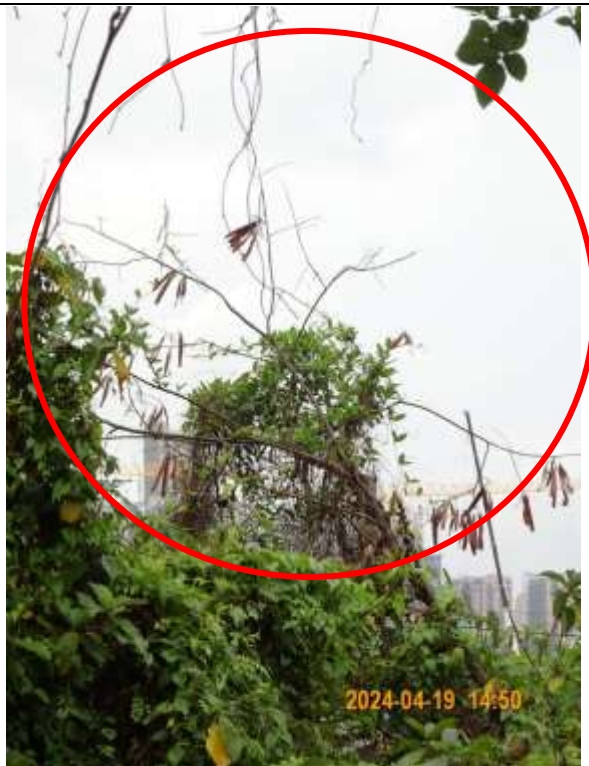
T015 – Serious dieback

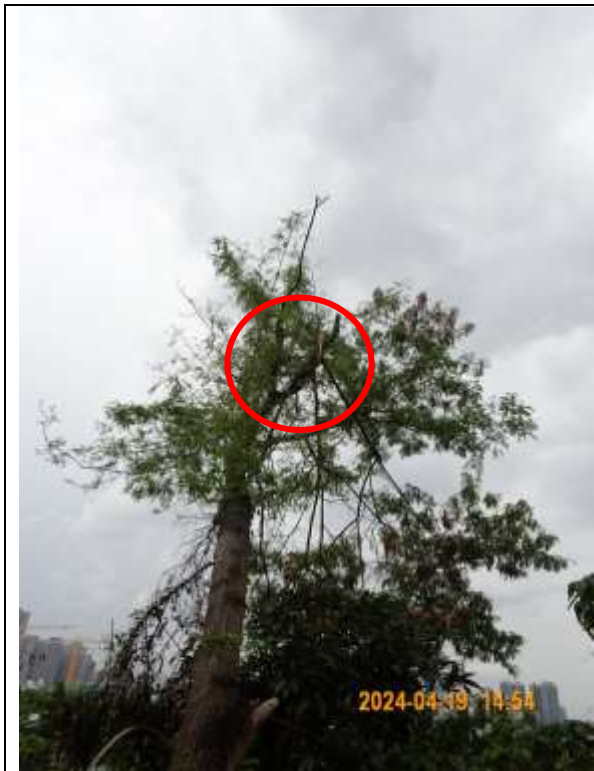
T017 – Broken branch

T017	T017	<i>Leucaena leucocephala</i>	銀合歡	9	256	5	Poor	Fair	Fair	Poor	low	NA	NIL	retain	NA	Broken branch
T018	T018	<i>Leucaena leucocephala</i>	銀合歡	8	220	4	Fair	Fair	Fair	Fair	low	NA	NIL	retain	NA	
T019	T019	<i>Macaranga tanarius</i>	血桐	4	260	6	Fair	Fair	Fair	Fair	low	NA	NIL	retain	NA	Heavily climbing plants
T020	T020	<i>Leucaena leucocephala</i>	銀合歡	6	273	4	Fair	Fair	Fair	Fair	low	NA	NIL	retain	NA	
T021	T021	<i>Dead tree</i>	/	3.5	187	3	Fair	Fair	Poor	Fair	low	NA	NIL	retain	NA	Dead tree
T022	T022	<i>Leucaena leucocephala</i>	銀合歡	6	158	4	Fair	Fair	Fair	Fair	low	NA	NIL	retain	NA	Heavily climbing plants
T023	T023	<i>Ficus hispida</i>	對葉榕	3.5	324	4	Fair	Fair	Fair	Fair	low	NA	NIL	retain	NA	
T024	T024	<i>Ficus variegata</i>	青果榕	3	166	2	Fair	Fair	Fair	Fair	low	NA	NIL	retain	NA	
T025	T025	<i>Sapium sebiferum</i>	烏桕	3.5	152	2.5	Fair	Fair	Fair	Fair	low	NA	NIL	retain	NA	Heavily climbing plants
T026	T026	<i>Macaranga tanarius</i>	血桐	5	245	7	Fair	Fair	Fair	Fair	low	NA	NIL	retain	NA	Broken branch

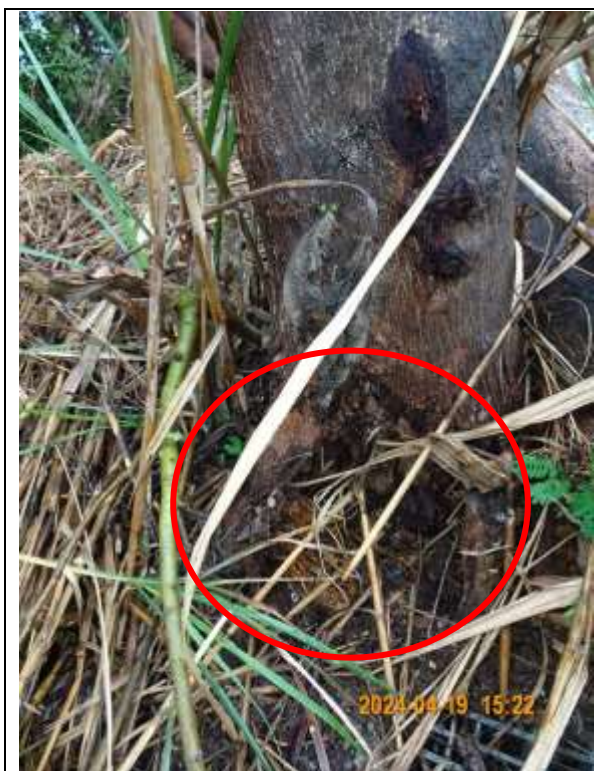
T017 – Decay basal trunk

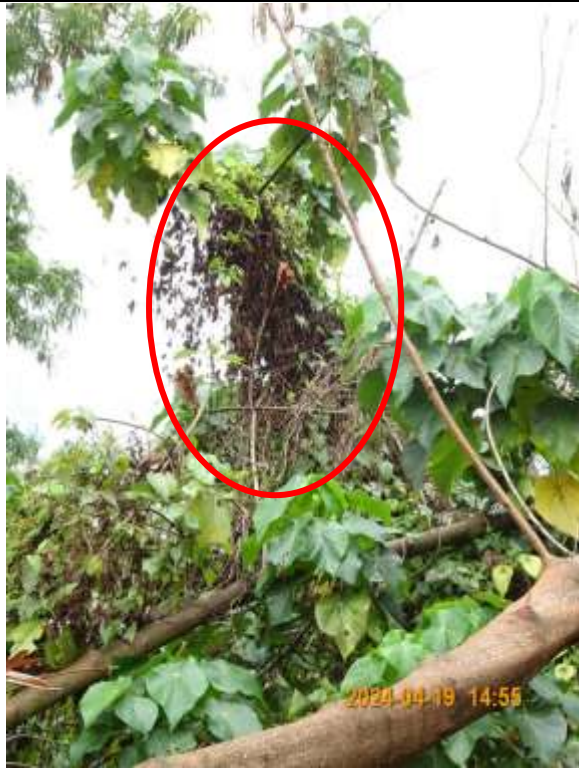
T019 – Overview

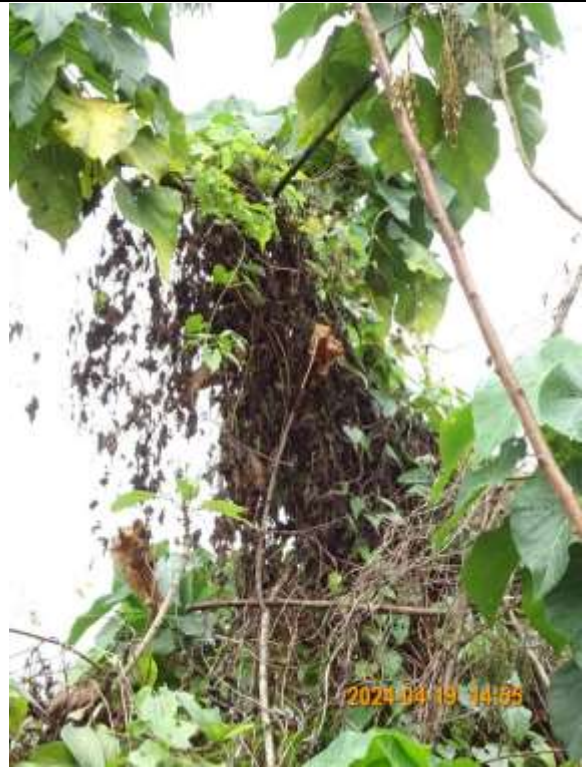
T019 – Heavily climbing plants

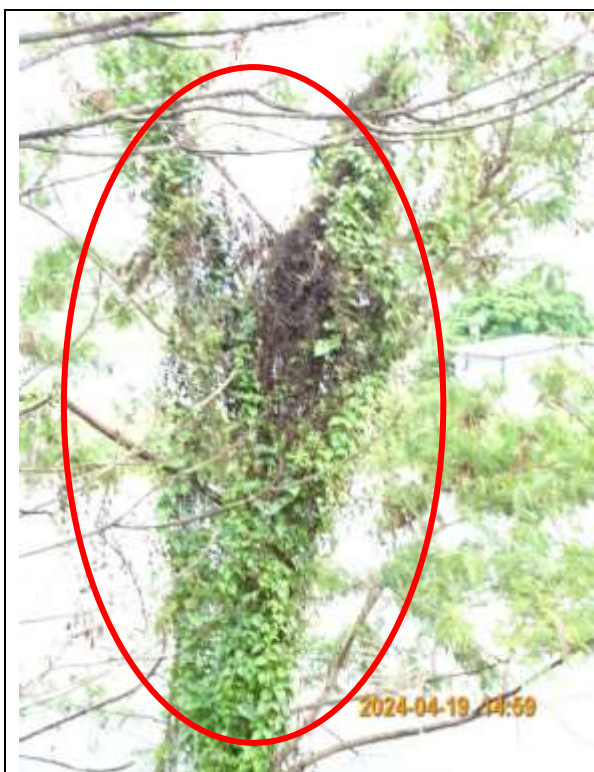
T022 – Overview

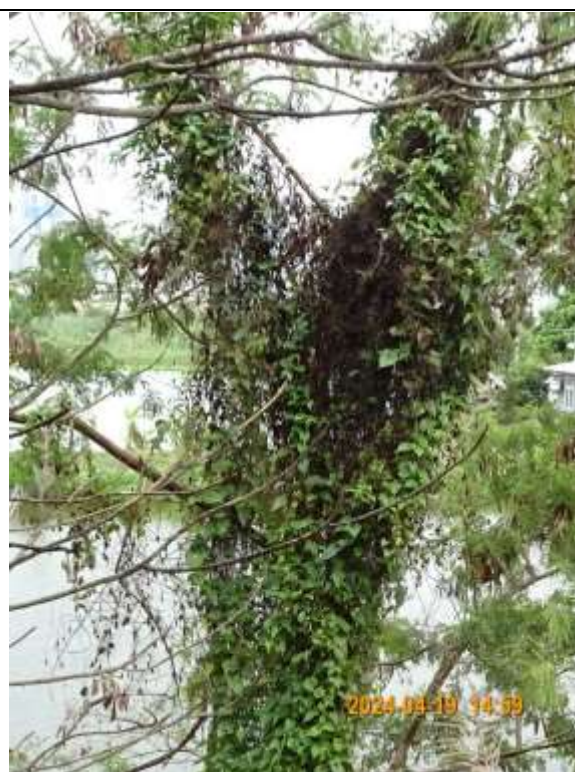
T022 – Heavily climbing plants

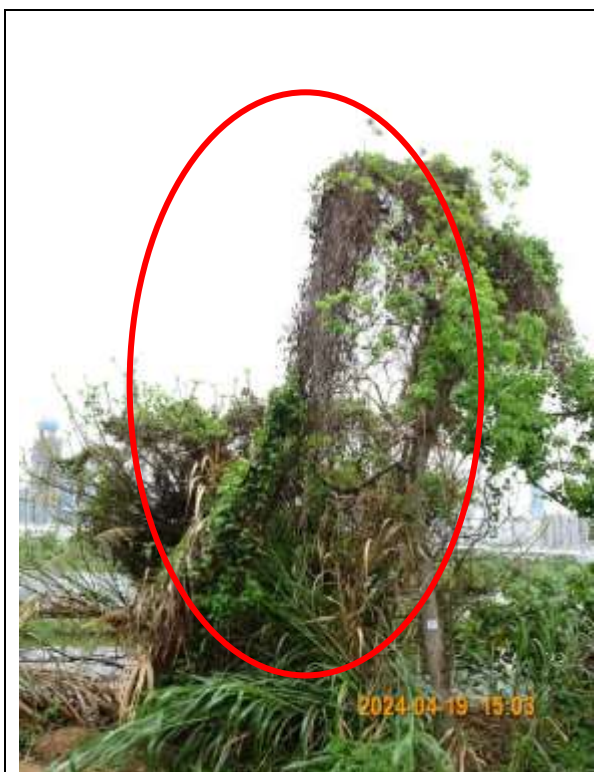
T025 – Overview

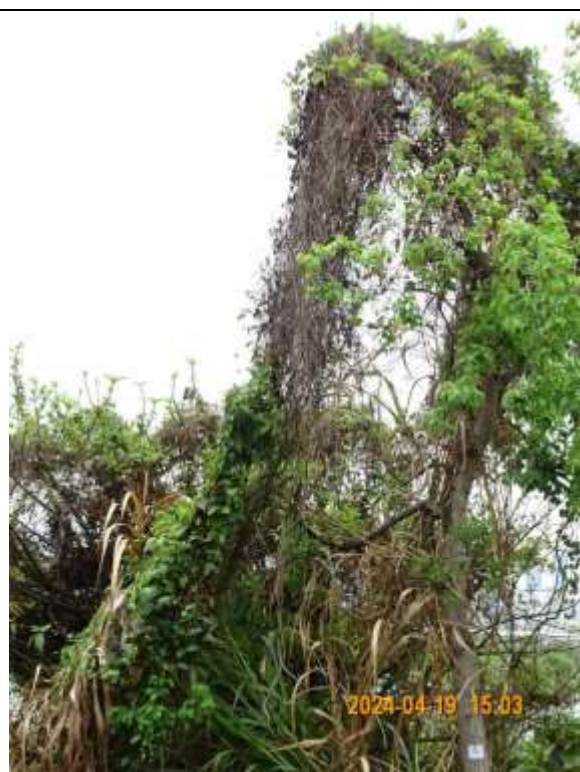
T025 – Heavily climbing plants

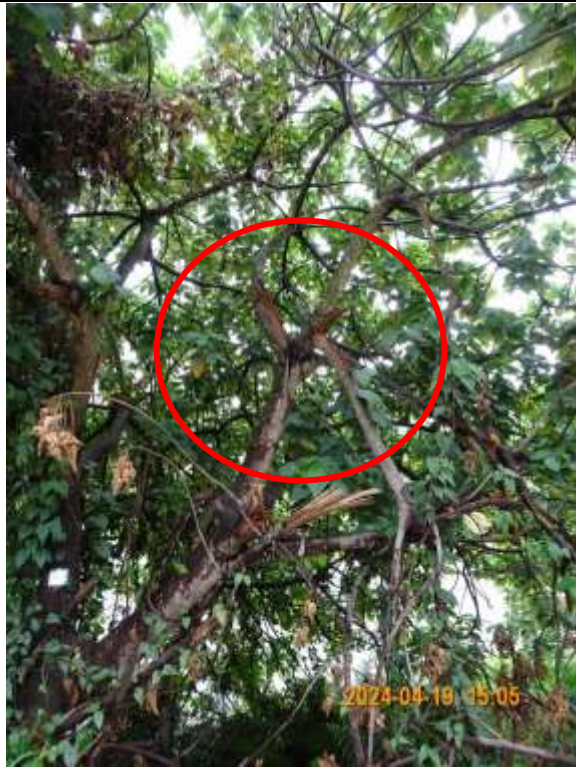
T026 – Overview

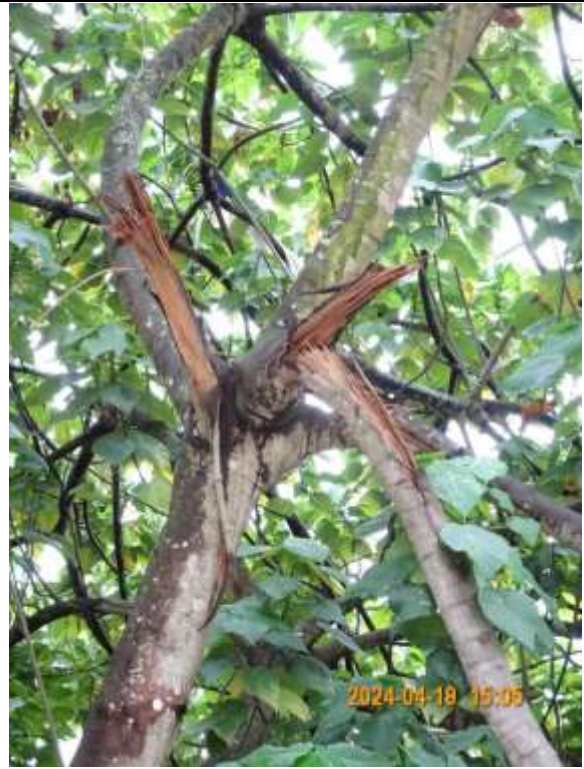
T026 – Broken branch

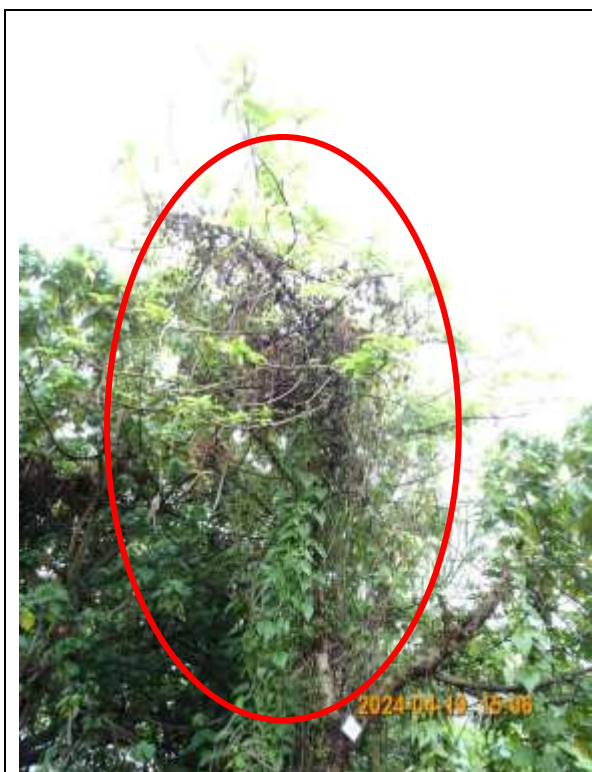
T027 – Overview

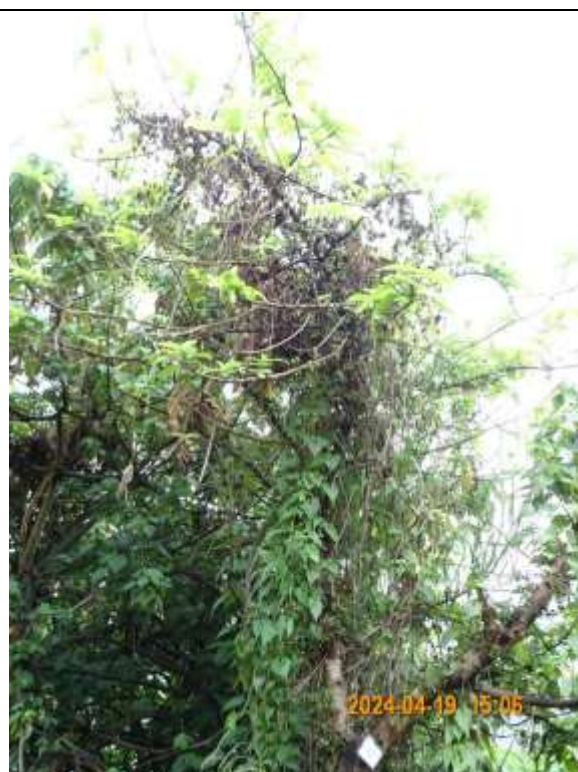
T027 – Heavily climbing plants

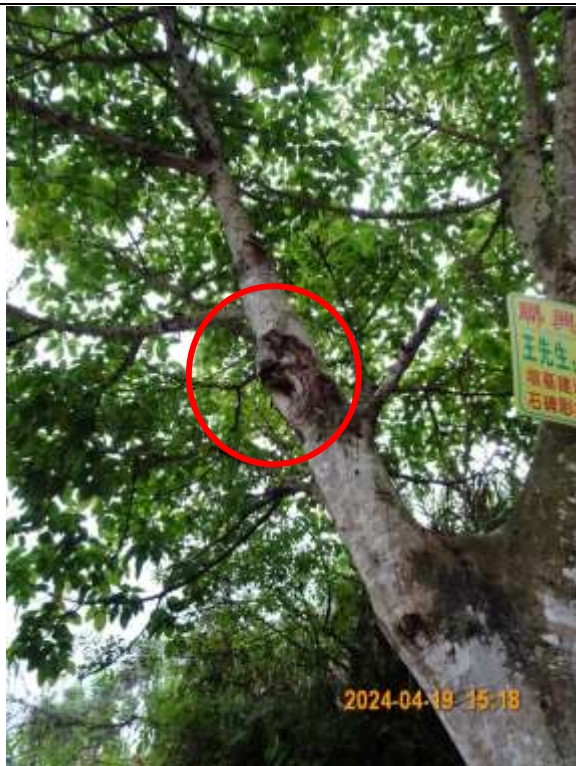
T035 – Wound wood

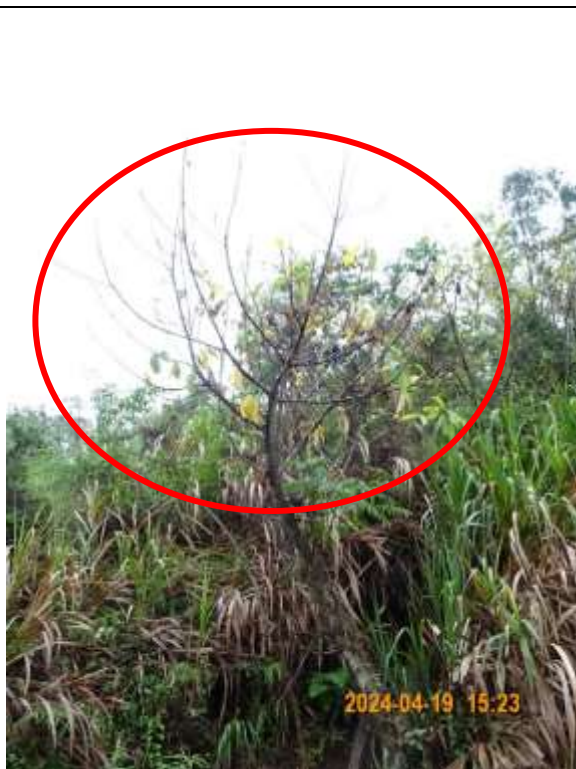
T040 – Serious dieback
