Section 12A Rezoning Application From "V" To "G/IC (3)" for Pre-Cut Off Columbariums at Buddhist Cheung Ha Temple, Lot Nos. 1087 and 1130 in D.D.6, and adjoining Government Land, Tai Po, New Territories

GEOTECHNICAL PLANNING REVIEW REPORT

JANUARY 2025

Project No.: J1926/B

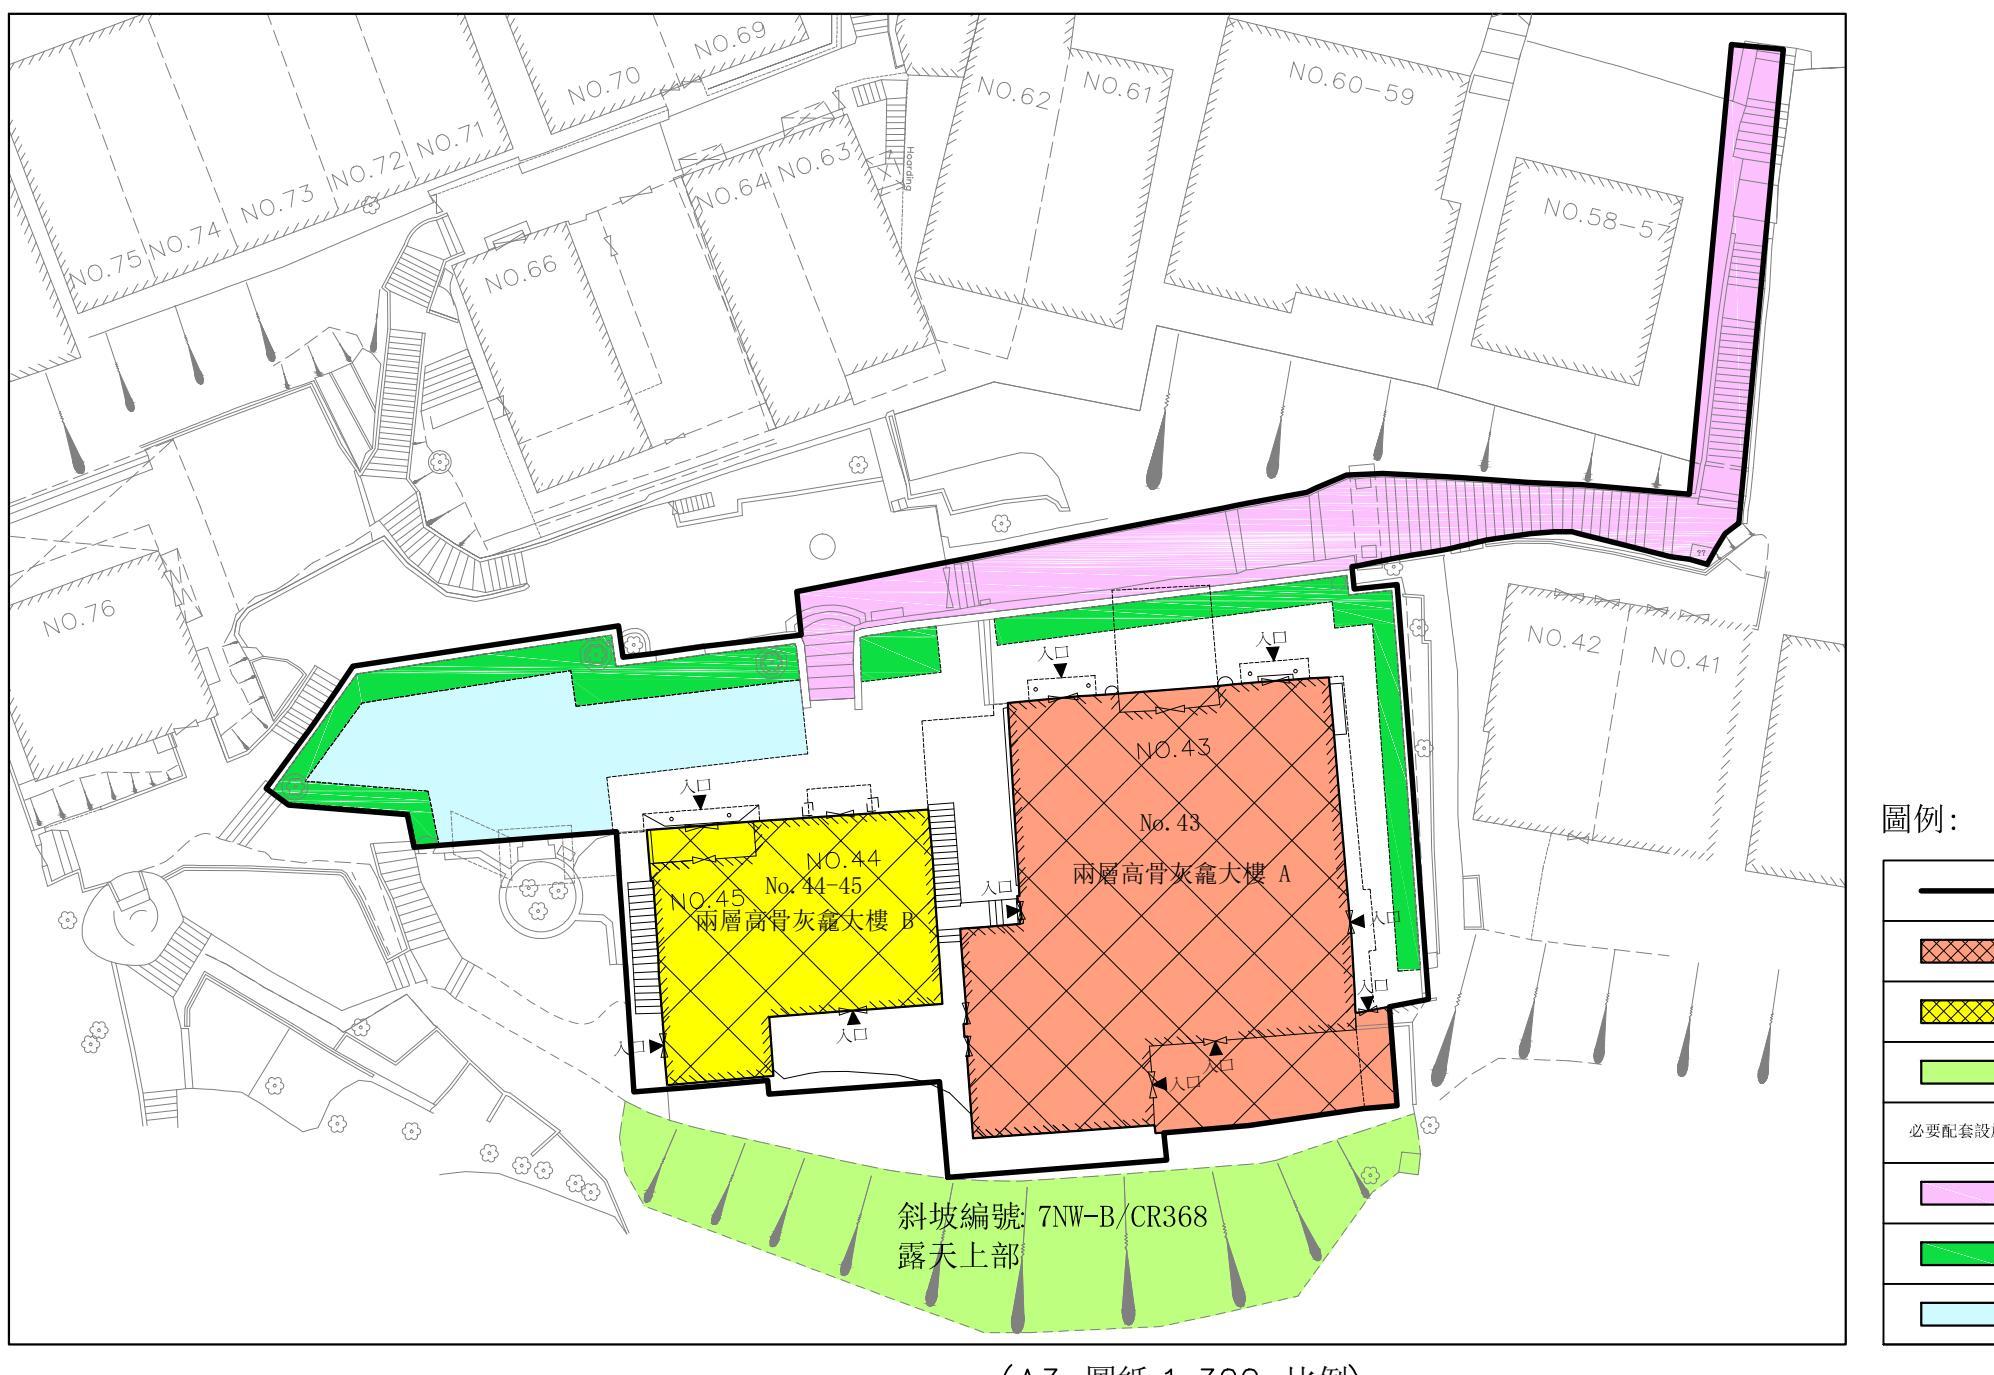
(A3 圖紙 1:300 比例) 建議布局圖 (圖則編號: 002)

- 1.4 Further to the previous rezoning application was withdrawn by the applicant, the Master Layout Plan (MLP) (i.e. the site boundary is revised) as shown in Figure 2 is to comply with the requirement of Private Columbaria Ordinance for proper planning control of a Pre-cut Columbarium Uses to the Temple.

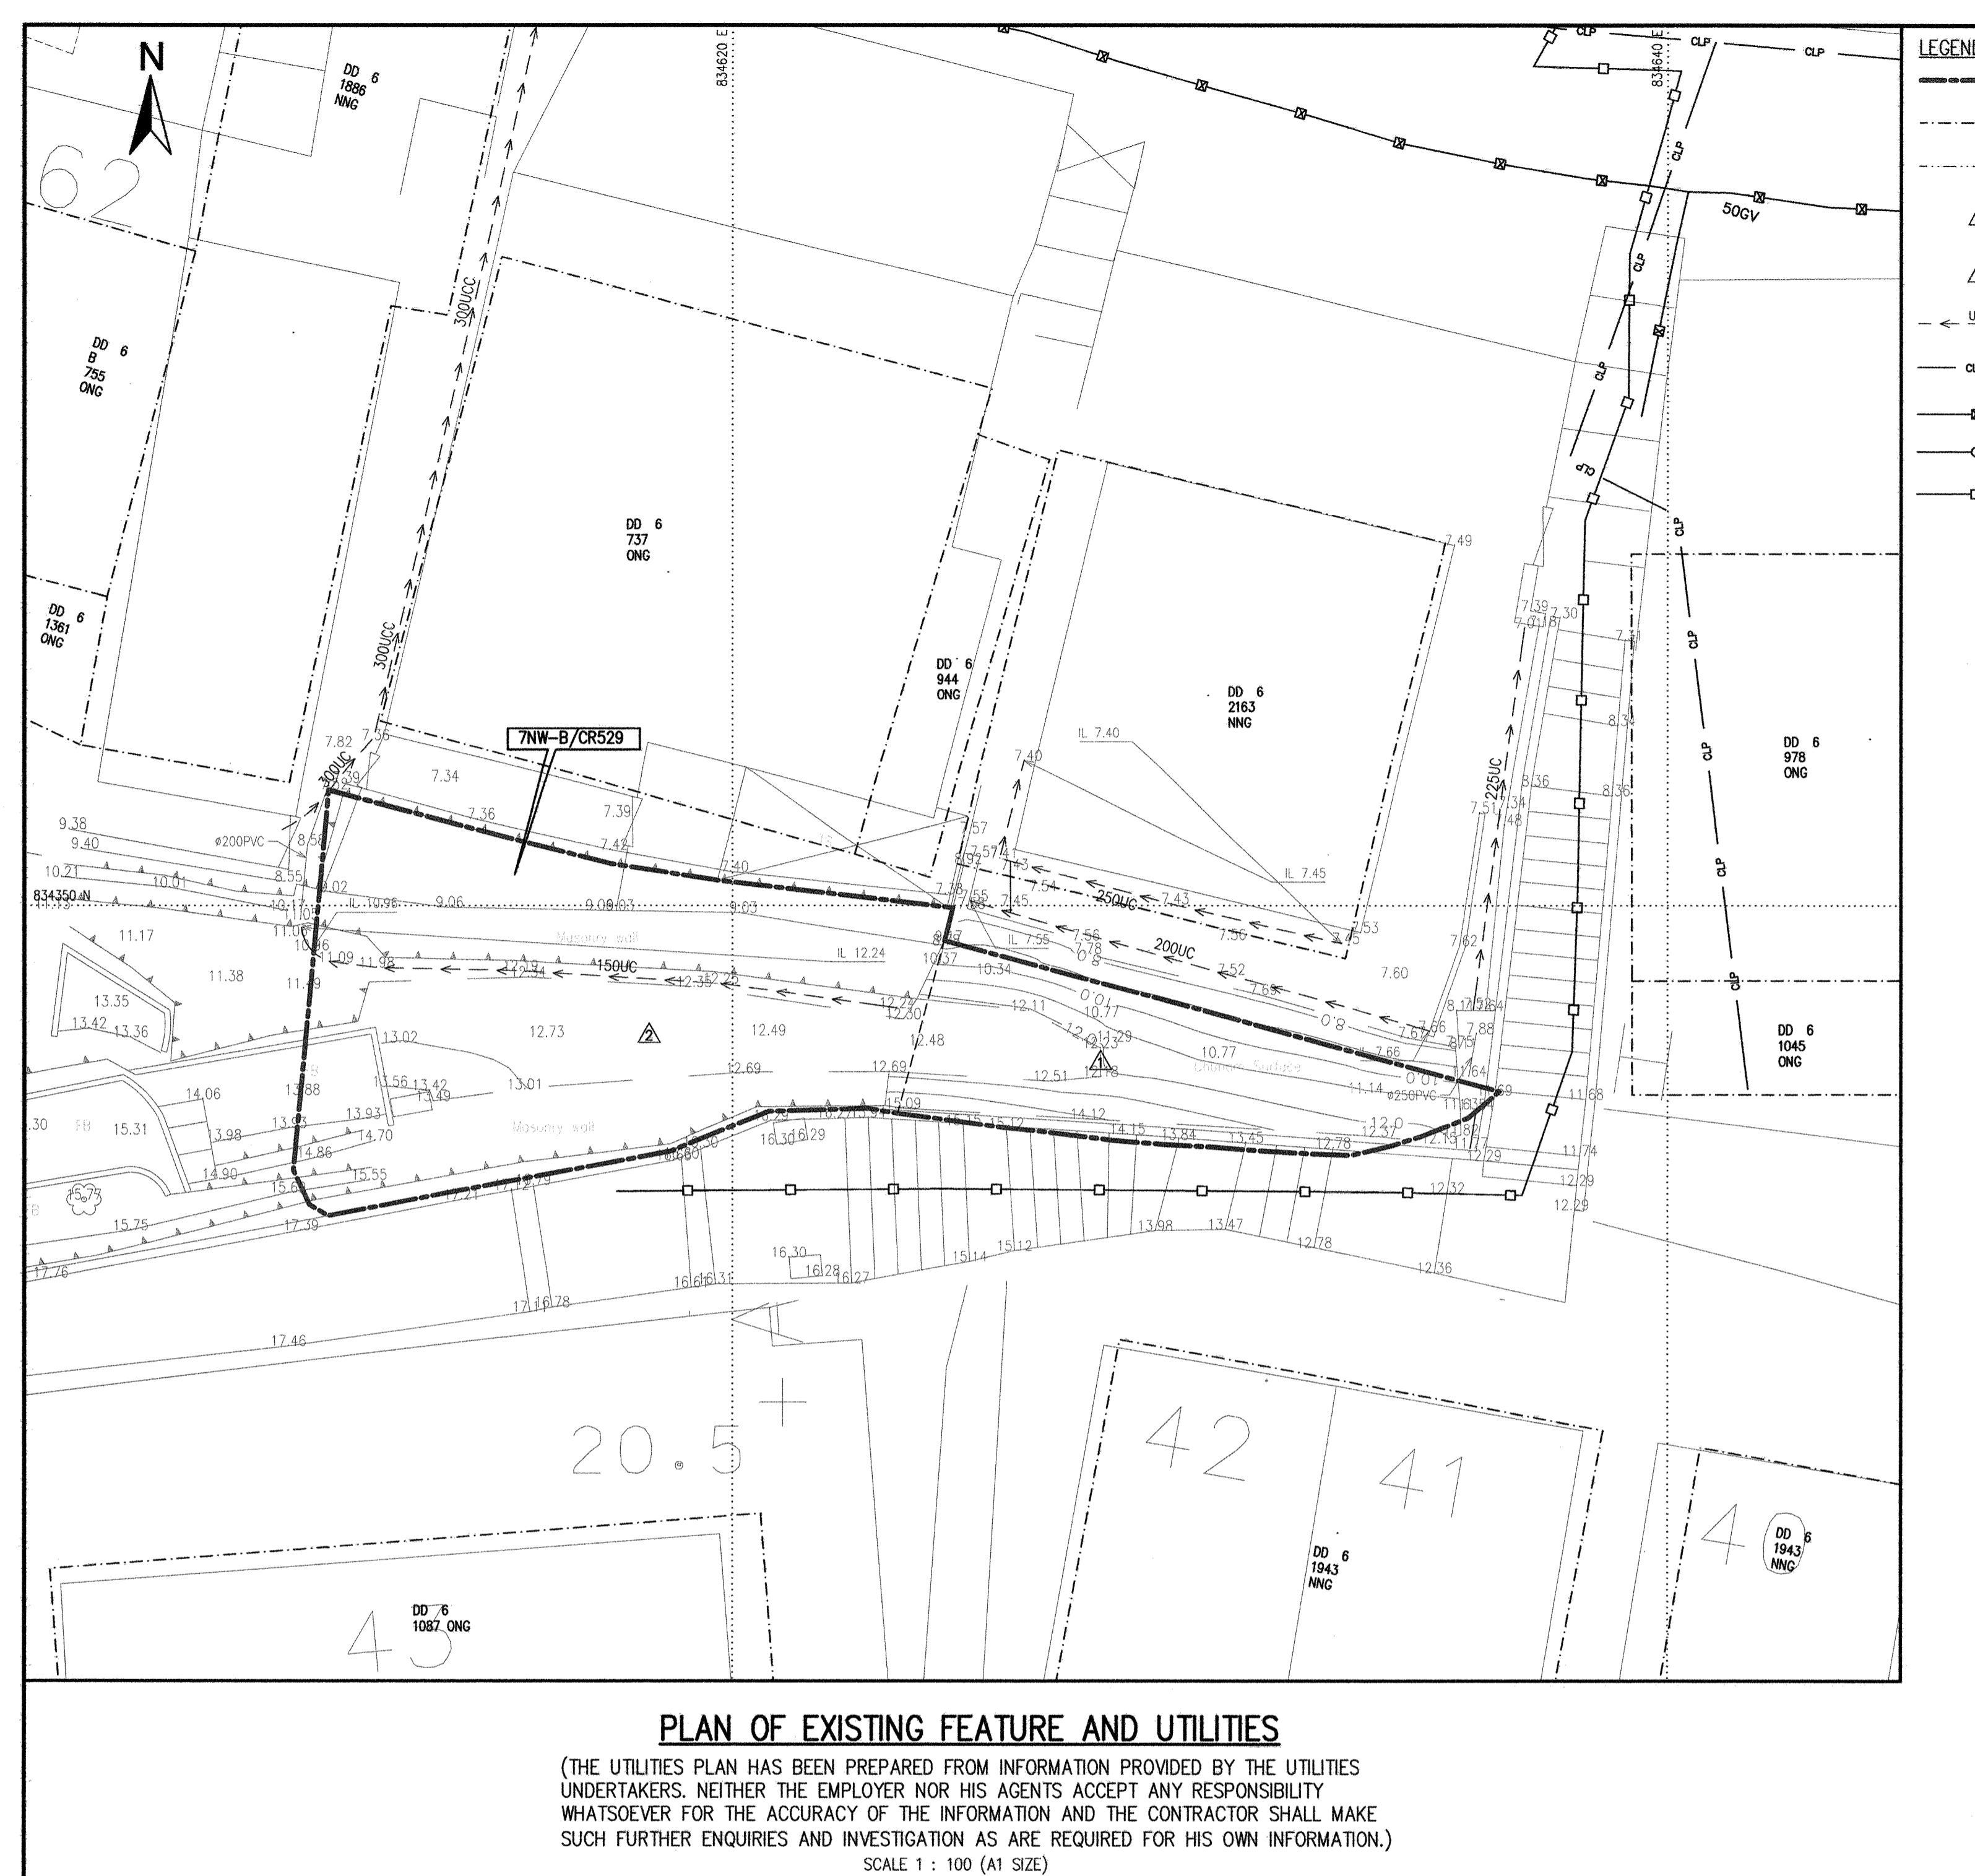
LPM1228/24/01 Location Plan of Works Site, Plan of Existing Feature and Utilities

Based on the information collected, a 200mm diameter foul sewer of Drainage Services Department is located underneath the existing staircase beyond the crest of the feature. The approximate locations of the observed utilities are shown on Drawing No. LPM1228/24/01.

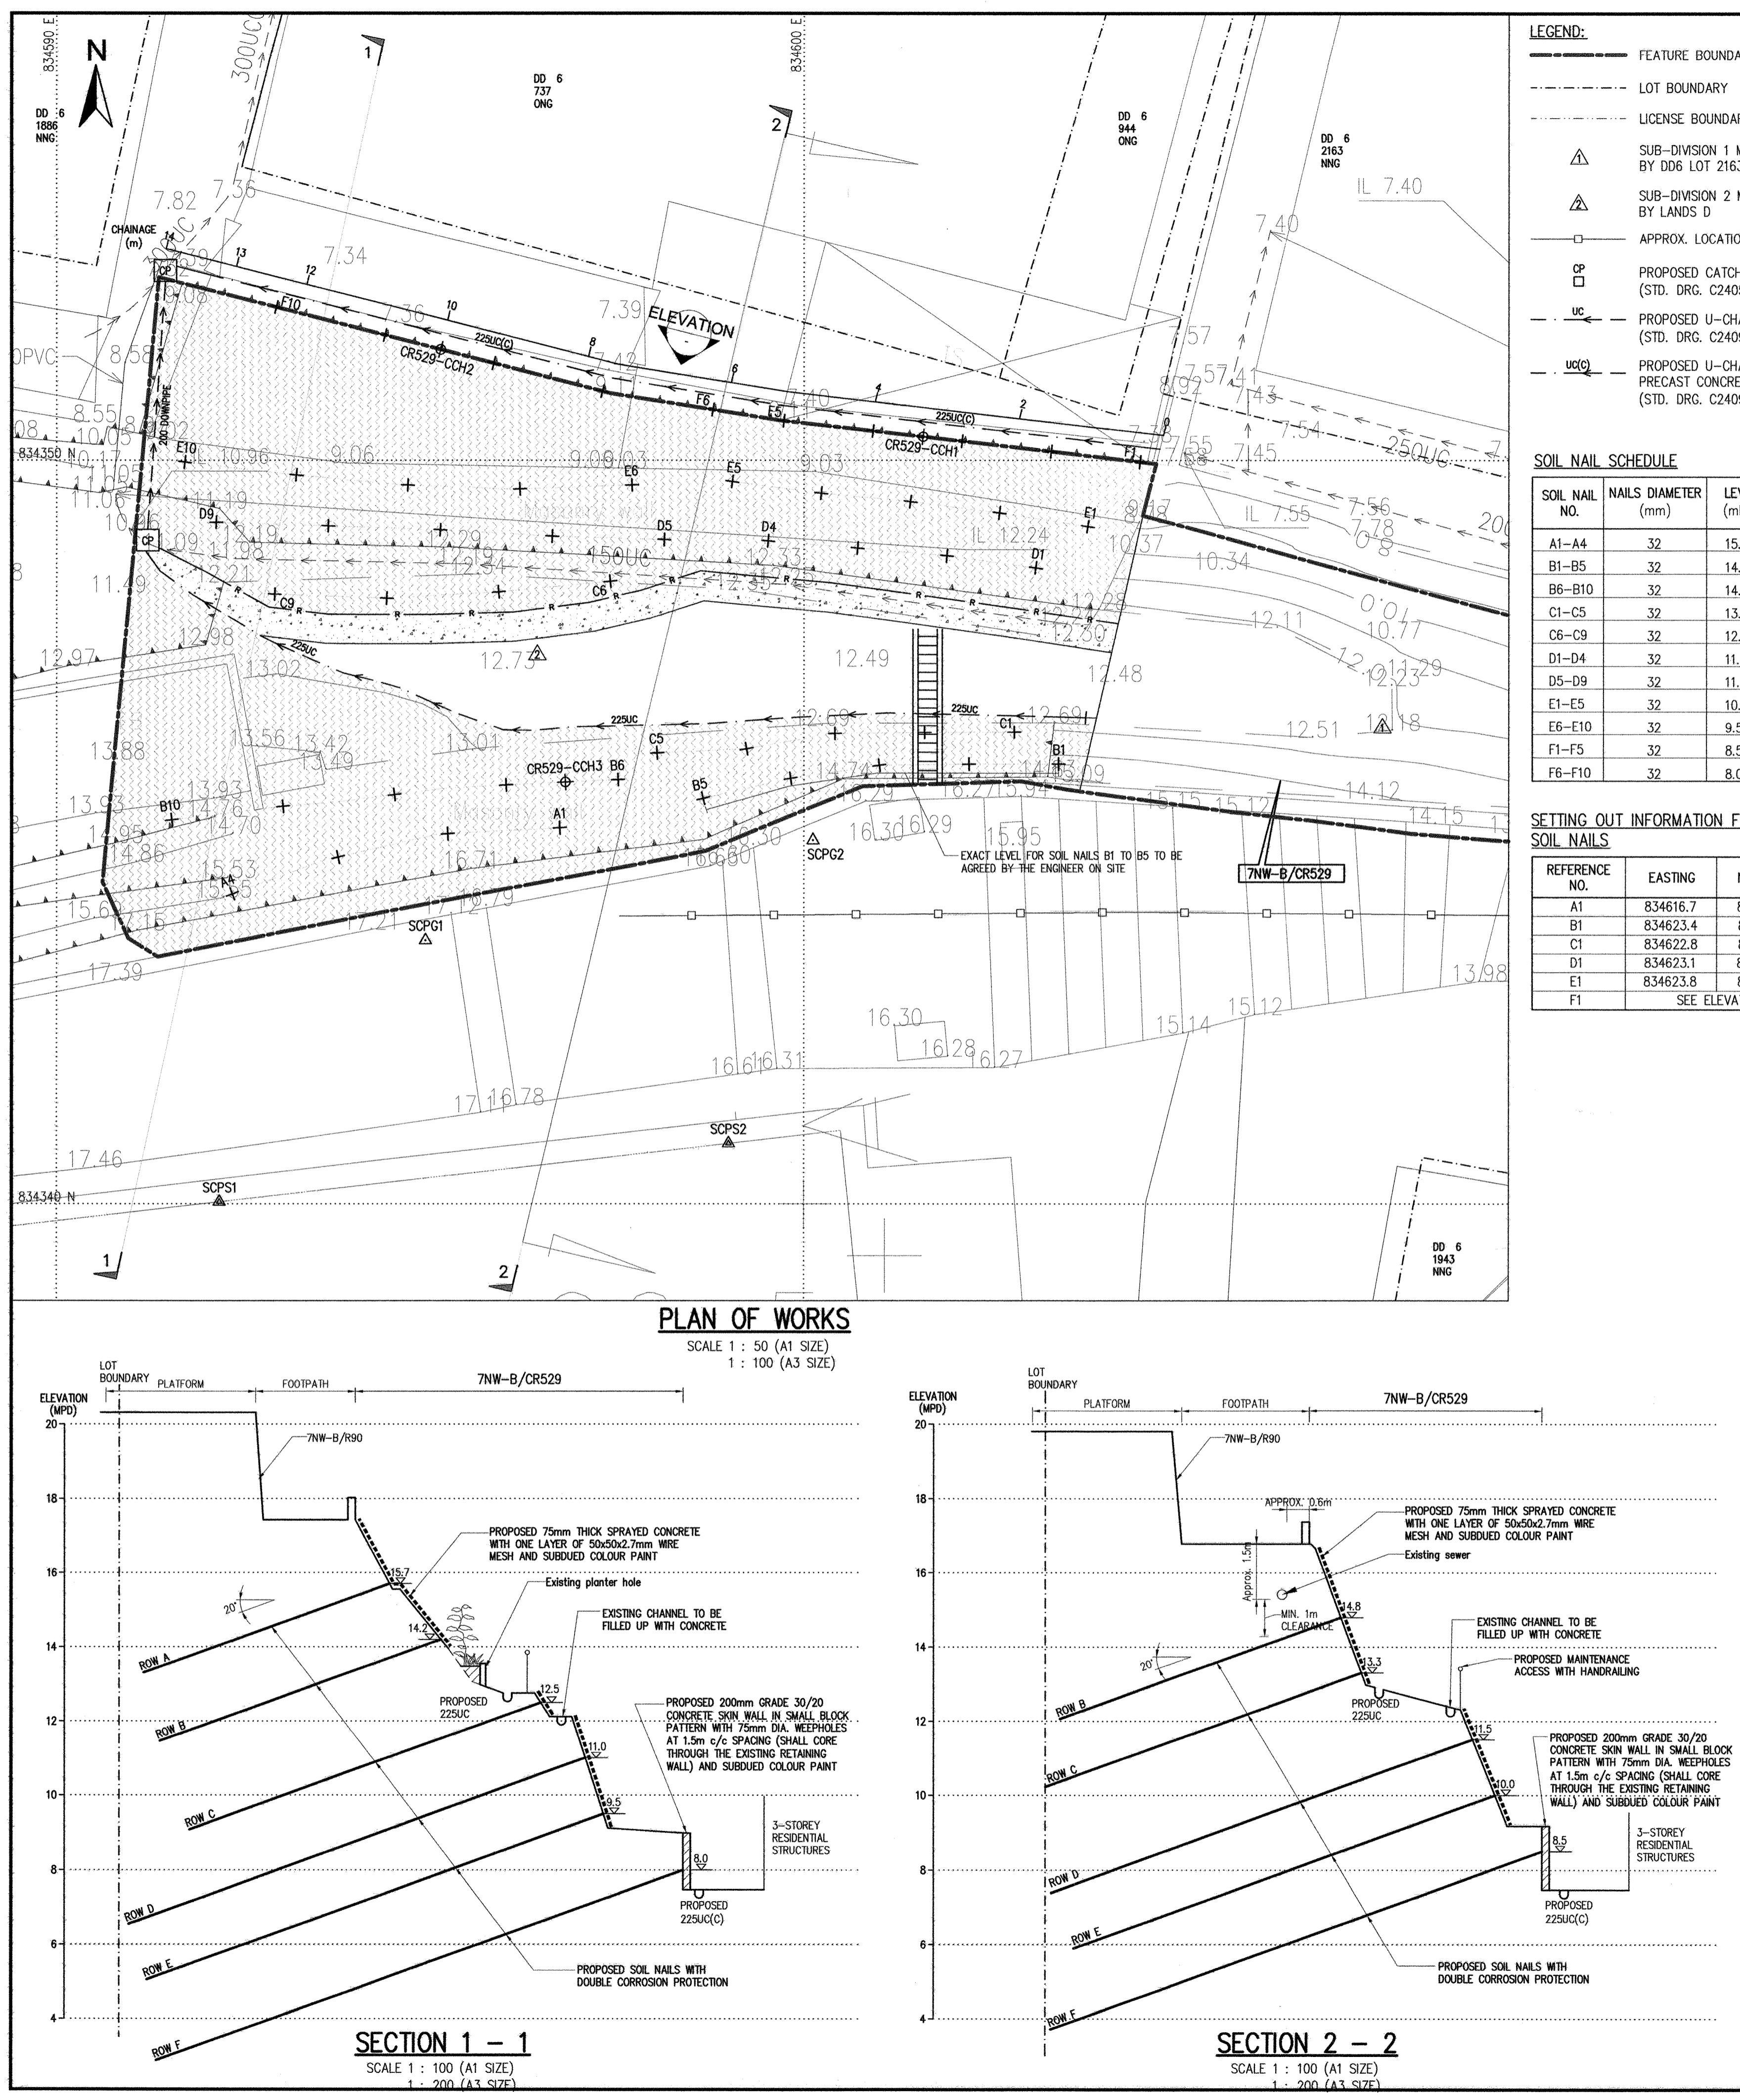
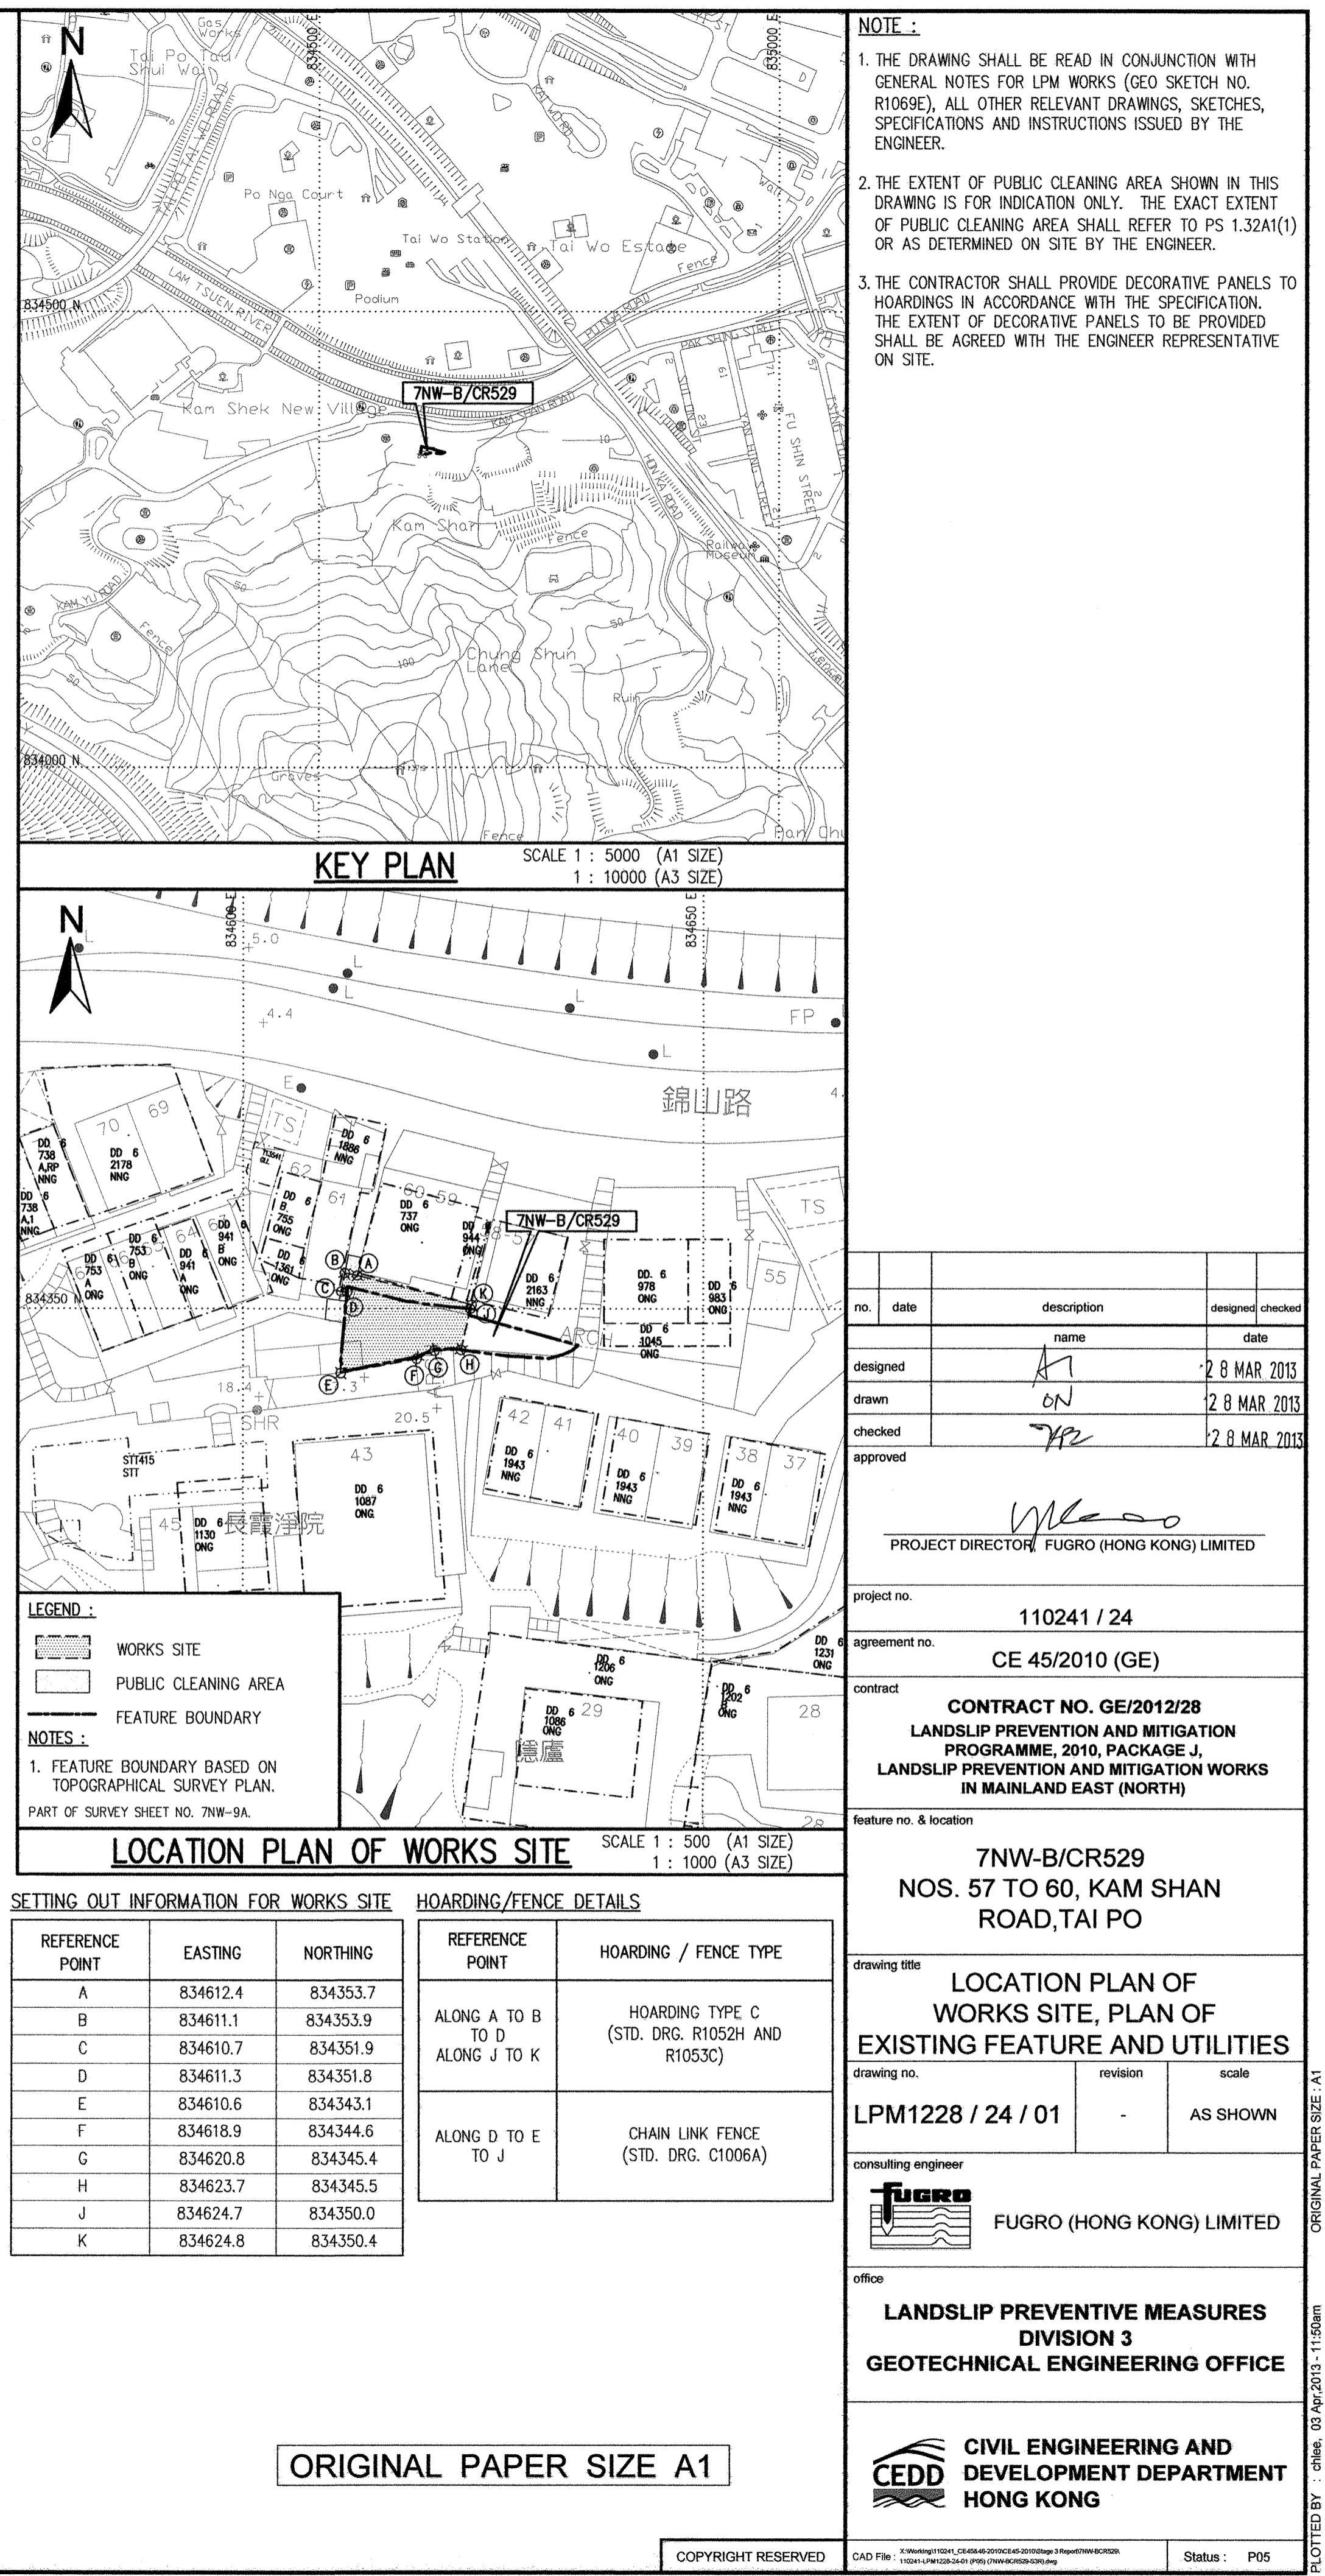
LPM1228/24/02 Plan of Works and Sections

- i) Installation of prescriptive soil nails with double corrosion protection and construction of concrete skin wall; and
- ii) Application of subdued colour paint to the surface of sprayed concrete and concrete skin wall.

It is recommended to provide a drainage channel along the mid-slope and the toe of the feature which connect to existing downpipe and drainage outlet respectively at the western end of the feature. The design of the surface drainage is presented in Appendix G and the layout of the proposed surface drainage system is shown on Drawing No. LPM1228/24/02.

To provide a safe access for inspection and maintenance of the feature, it is recommended to construct a new maintenance access with handrailing along the mid-slope of the feature. The layout of new maintenance access of the feature is shown in Drawing No. LPM1228/24/02.
