Project 項目名稱:
 Proposed Temporary Vehicle Repair Workshop and
 Associated Filling of Land for a Period of 3 Years at Lot
 1345 (Part) & 1321 RP in D.D.118, Yuen Long,
 New Territories

Layout Plan

Drawing Title 圖紙標題:
 Land Filling Plan

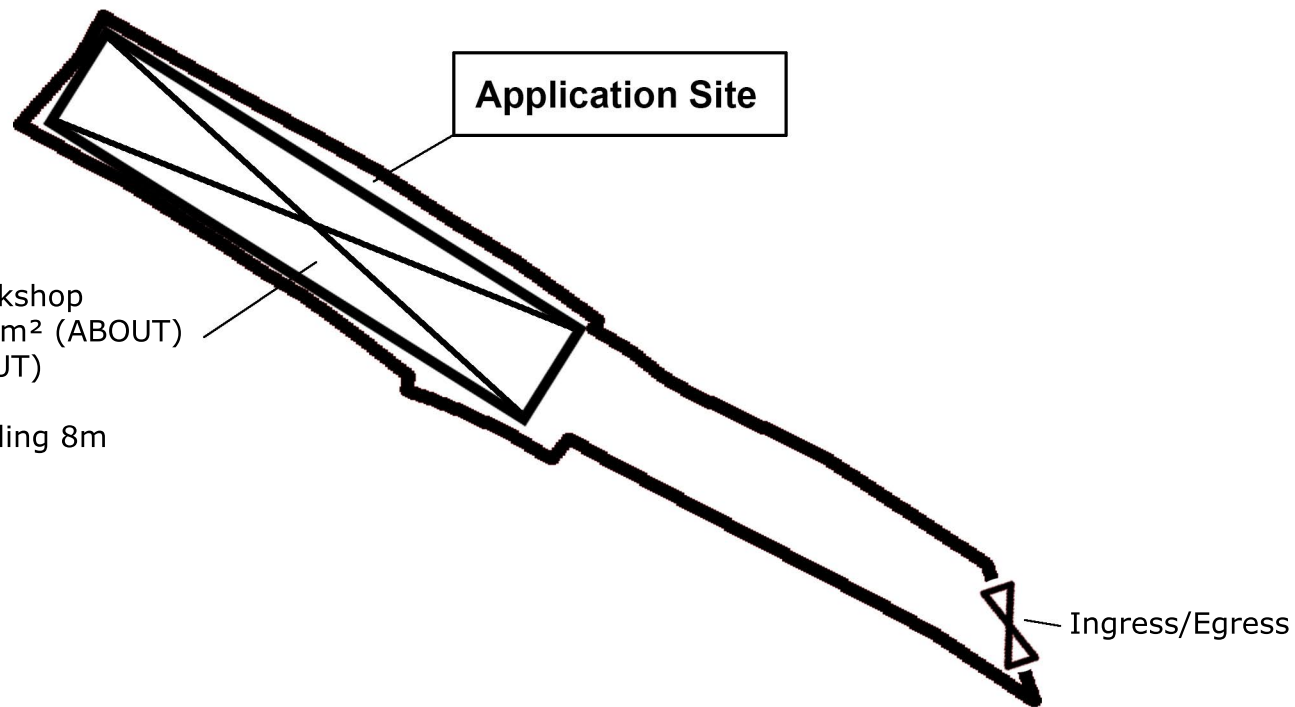
Structure 1

Vehicle Repair Workshop

Covered Area: 230m² (ABOUT)

GFA: 230m² (ABOUT)

No. of storey: 1

Height: Not exceeding 8m

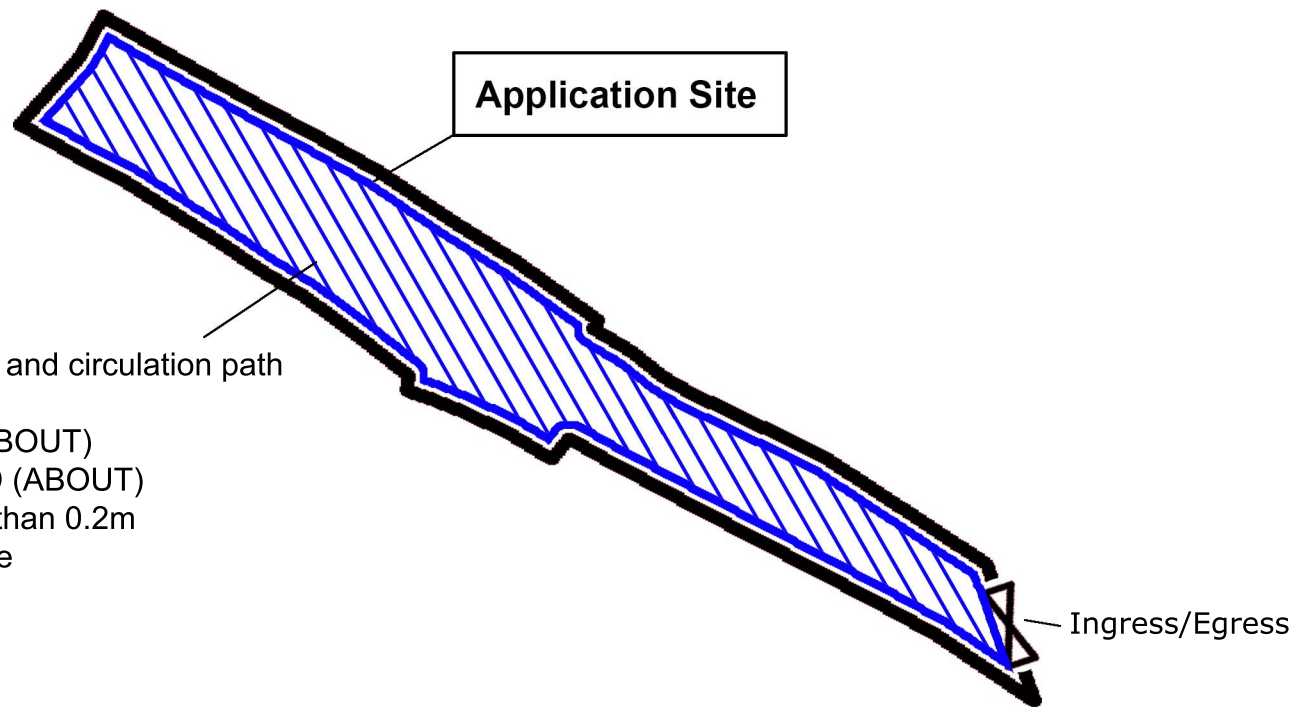
Land Filling Area

For site formation of structures and circulation path
 Area: 500m² (ABOUT)
 Existing site level: +22mPD (ABOUT)
 Proposed site level: +22.2mPD (ABOUT)
 Depth of land filling : No more than 0.2m
 Land Filling Materials: Concrete
