**Tree Preservation and Landscaping Proposal**  
**with Response-to-Comment**

**REZONING APPLICATION FROM “AGR” AND “GB” TO “OU (COLUMBARIUM)”**  
**ON VARIOUS LOTS IN D.D. 41 AND ADJOINING GOVERNMENT LAND,**  
**TONG TO, SHA TAU KOK, N.T.**

**Tree Preservation and Landscaping Proposal**

**Date: 29 December 2025**

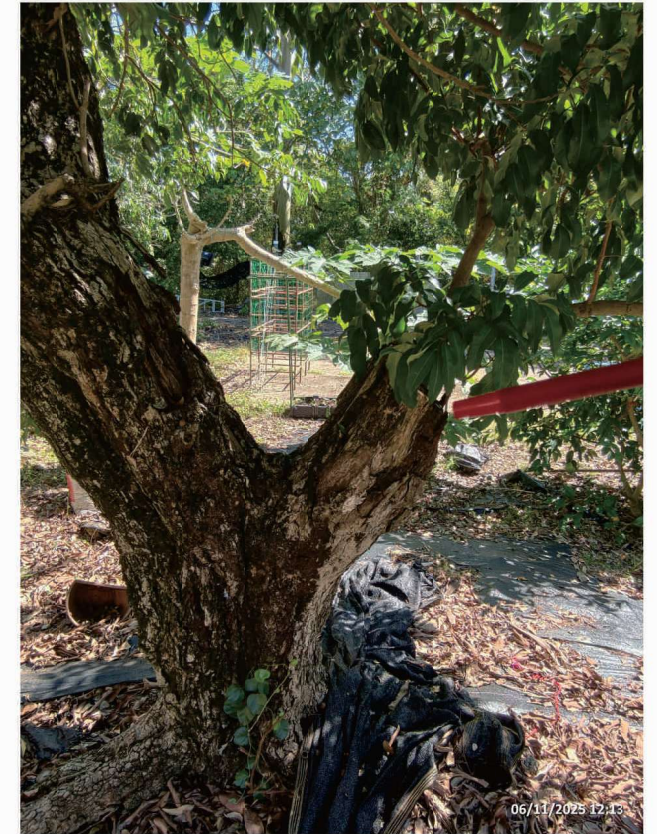
| Tree | Photo No. | Species | | | | | Proposed Treatment | Remark <sup>1</sup> |
|---|---|---|---|---|---|---|---|---|
| B10 | B10 | <i>Dimocarpus longan</i> | 龍眼 | 3.0 | 352 | 4.0 | Fell | restricted root, decay stub on trunk, decay in branches |

B10 (F) - Decay Stub in Trunk

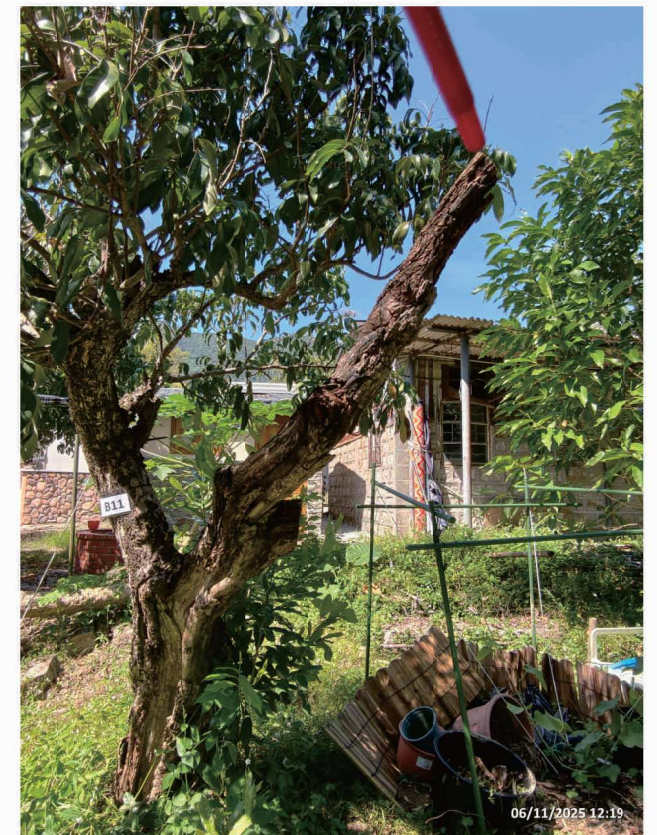
| Tree | Photo No. | Species | | | | | Proposed Treatment | Remark <sup>1</sup> |
|---|---|---|---|---|---|---|---|---|
| B11 | B11 | <i>Dimocarpus longan</i> | 龍眼 | 2.5 | 240 | 2.5 | Fell | decay trunk, decay branches |

B11 (F) - Decay Trunk

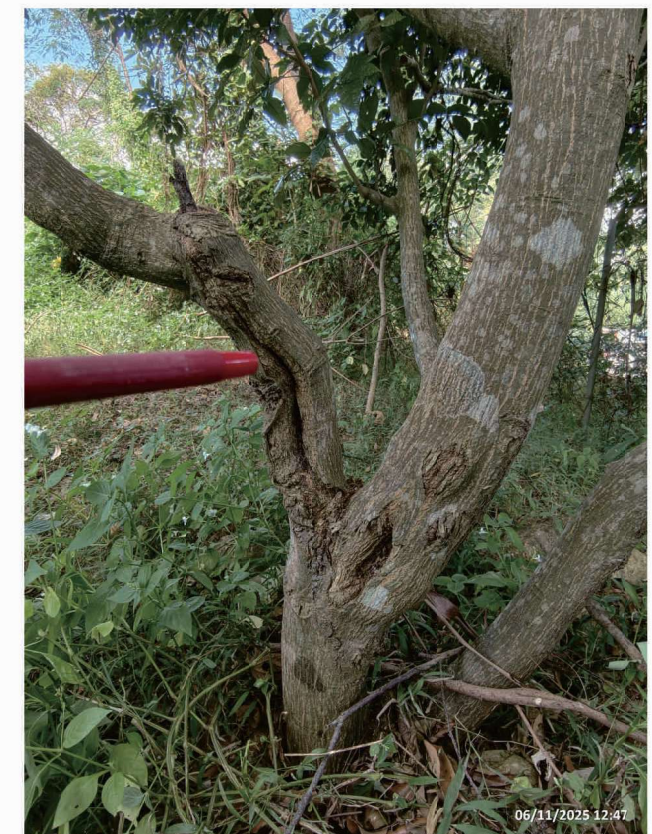
| Tree | Photo No. | Species | | | | | Proposed Treatment | Remark <sup>1</sup> |
|---|---|---|---|---|---|---|---|---|
| B16 | B16 | <i>Clausena lansium</i> | 黃皮 | 4.5 | 140 | 4.5 | Fell | multiple trunks, inrolled crack in trunk, decay in trunk |

B16 (F) - Inrolled Crack in Trunk

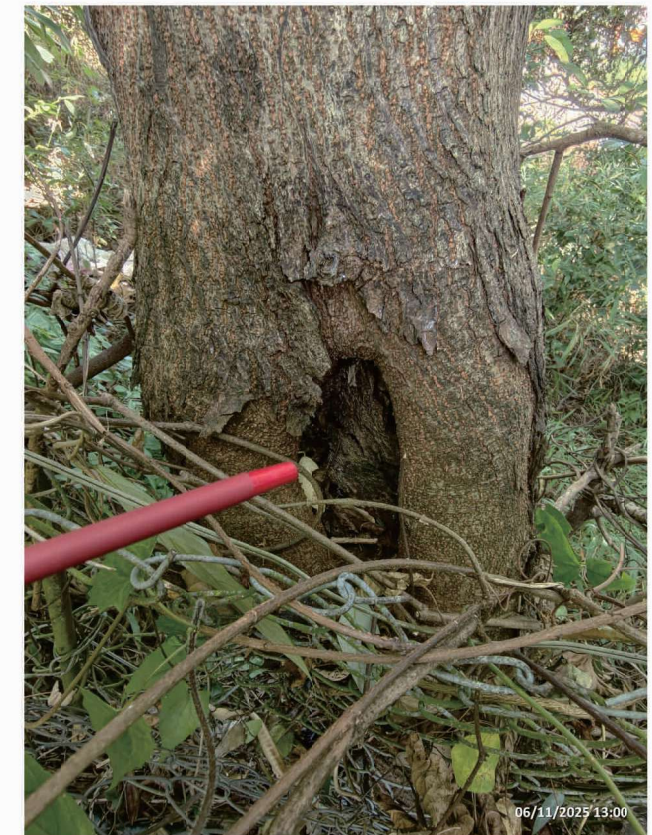
B17 (F)

| Tree | Photo No. | Species | | | | | Proposed Treatment | Remark <sup>1</sup> |
|---|---|---|---|---|---|---|---|---|
| B17 | B17 | <i>Leucaena leucocephala</i> | 銀合歡 | 11.0 | 350 | 9.0 | Fell | invasive species, leaning trunk, decay in trunk |

B17 - Decay in Trunk

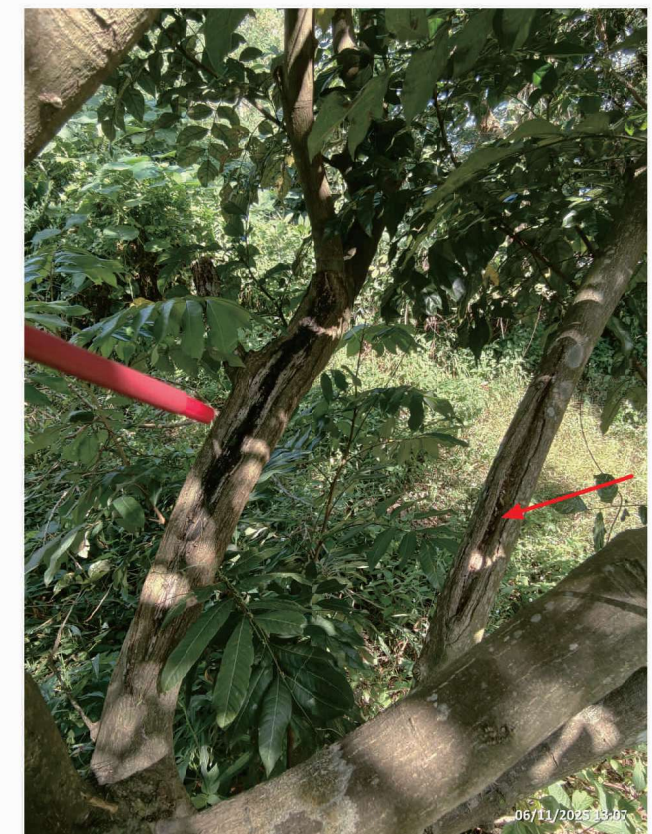
| Tree | Photo No. | Species | | | | | Proposed Treatment | Remark <sup>1</sup> |
|---|---|---|---|---|---|---|---|---|
| B18 | B18 | <i>Clausena lansium</i> | 黃皮 | 3.0 | 250 | 5.0 | Fell | multiple trunks, included bark, decay in branches |

B18 (F) - Decay in Branches

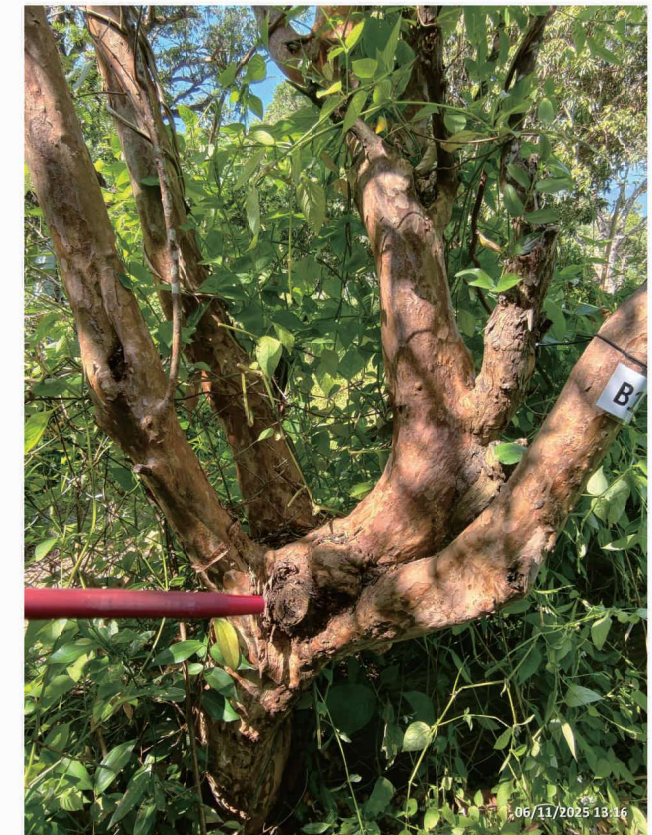
| Tree | Photo No. | Species | | | | | Proposed Treatment | Remark <sup>1</sup> |
|---|---|---|---|---|---|---|---|---|
| B19 | B19 | <i>Psidium guajava</i> | 番石榴 | 5.0 | 171 | 6.0 | Fell | restricted root, multiple trunks, decay stub in trunk, decay in branches |

B19 (F) - Decay Stub in Trunk

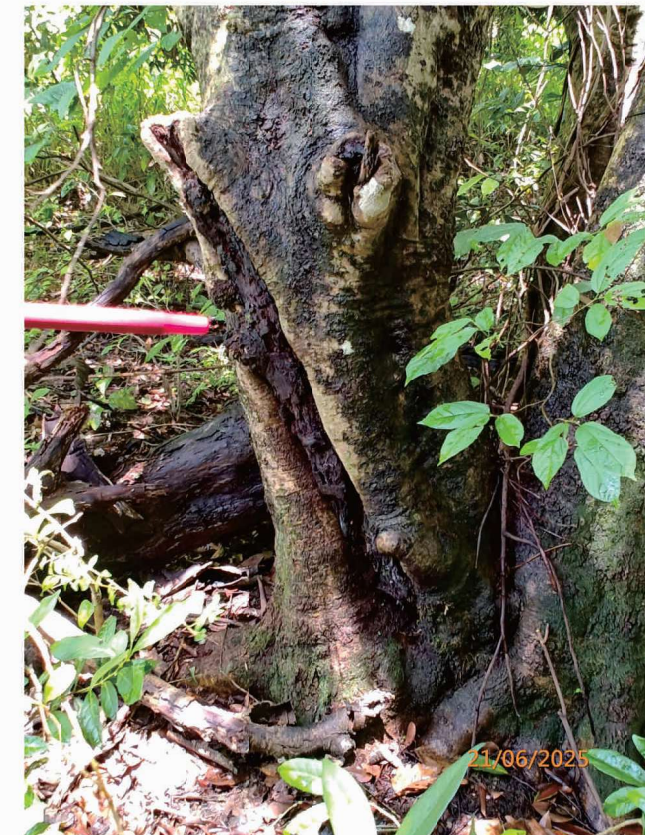
TE1D (F)

| Tree | Photo No. | Species | | | | | Proposed Treatment | Remark <sup>1</sup> |
|---|---|---|---|---|---|---|---|---|
| TE1D | TE1D | <i>Litchi chinensis</i> | 荔枝 | 8.0 | 635 | 9.0 | Fell | co-dominant trunk, dead branch, decay in trunk base, included bark, broken branch |

TE1D - Decay in Trunk Base (F)

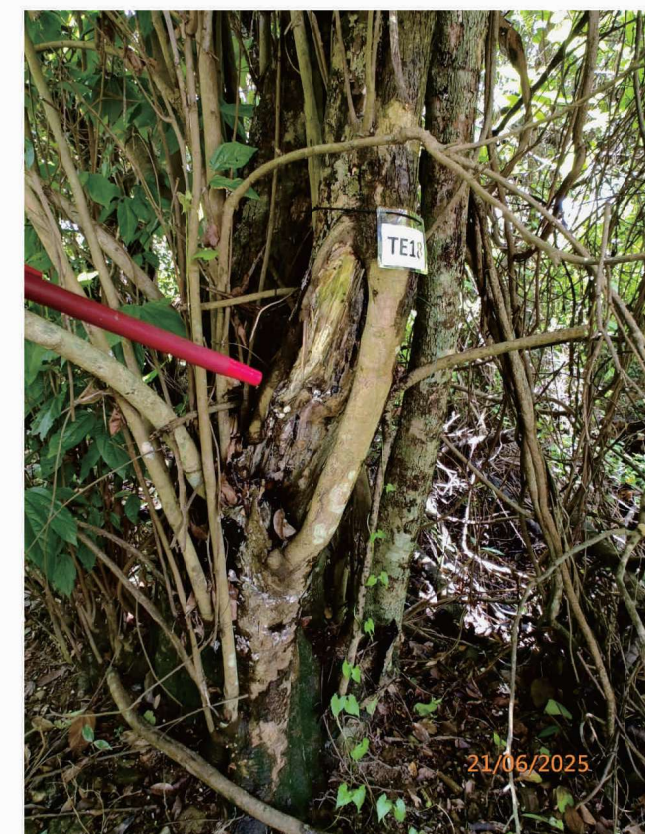
TE18 (F)

| Tree | Photo No. | Species | | | | | Proposed Treatment | Remark <sup>1</sup> |
|---|---|---|---|---|---|---|---|---|
| TE18 | TE18 | <i>Microcos nervosa</i> | 破布葉 | 7.0 | 245 | 9.0 | Fell | decay in trunk, cross branches, girdling root, multiple trunks |

TE18 - Decay in Trunk (F)

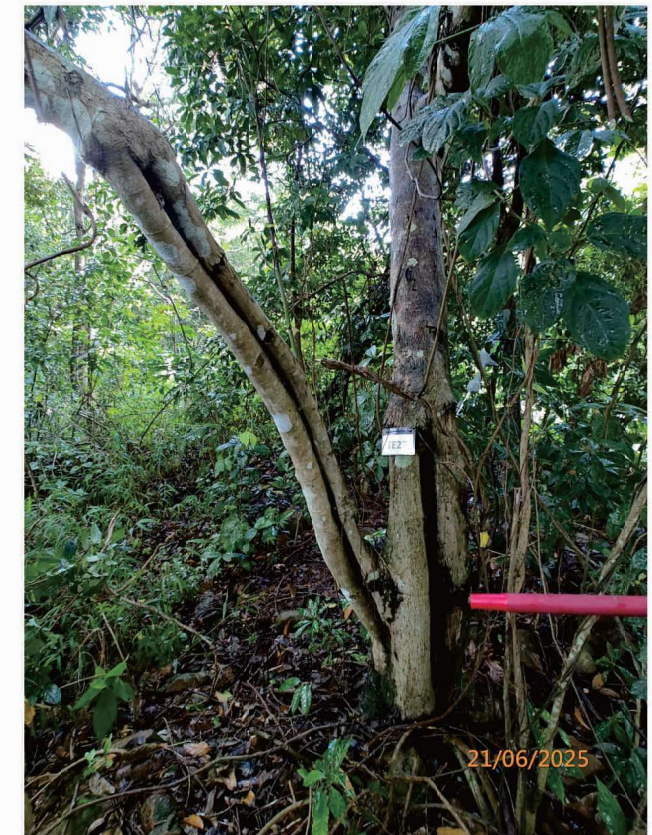
TE27 (F)

| Tree | Photo No. | Species | | | | | Proposed Treatment | Remark <sup>1</sup> |
|---|---|---|---|---|---|---|---|---|
| TE27 | TE27 | <i>Macaranga tanarius var. tomentosa</i> | 血桐 | 7.0 | 237 | 9.0 | Fell | inrolled crack at trunk base, imbalanced crown |

TE27 - Inrolled Crack at Trunk Base (F)

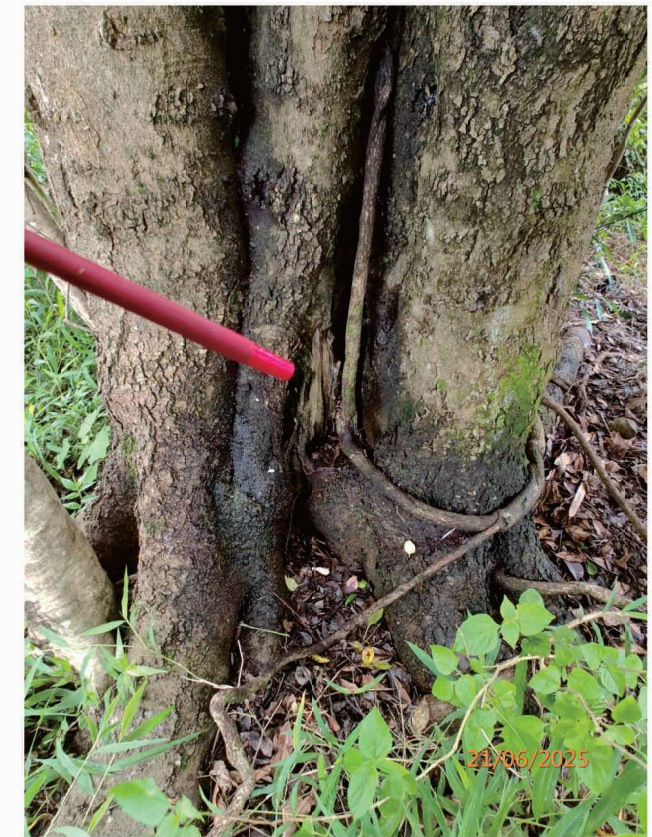
TE32 (F)

| Tree | Photo No. | Species | | | | | Proposed Treatment | Remark <sup>1</sup> |
|---|---|---|---|---|---|---|---|---|
| TE32 | TE32 | <i>Celtis sinensis</i> | 朴樹 | 11.0 | 730 | 14.0 | Fell | multiple trunks, included bark, heartwood damaged at trunk base |

TE32 - Heartwood Damaged at Trunk Base (F)

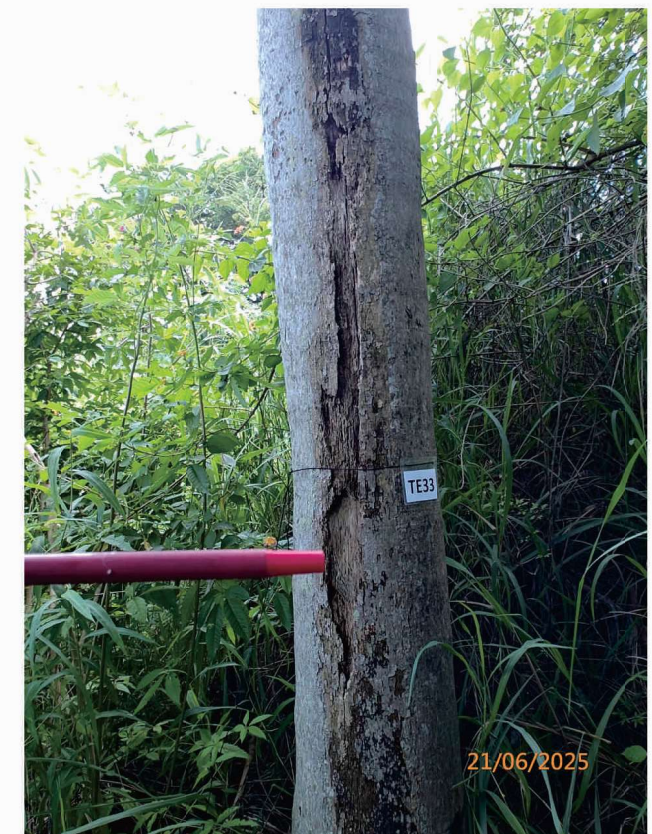
TE33 (F)

| Tree | Photo No. | Species | | | | | Proposed Treatment | Remark <sup>1</sup> |
|---|---|---|---|---|---|---|---|---|
| TE33 | TE33 | <i>Roystonea regia</i> | 王棕 | 7.0 | 305 | 6.0 | Fell | decay in trunk |

TE33 - Decay in Trunk (F)

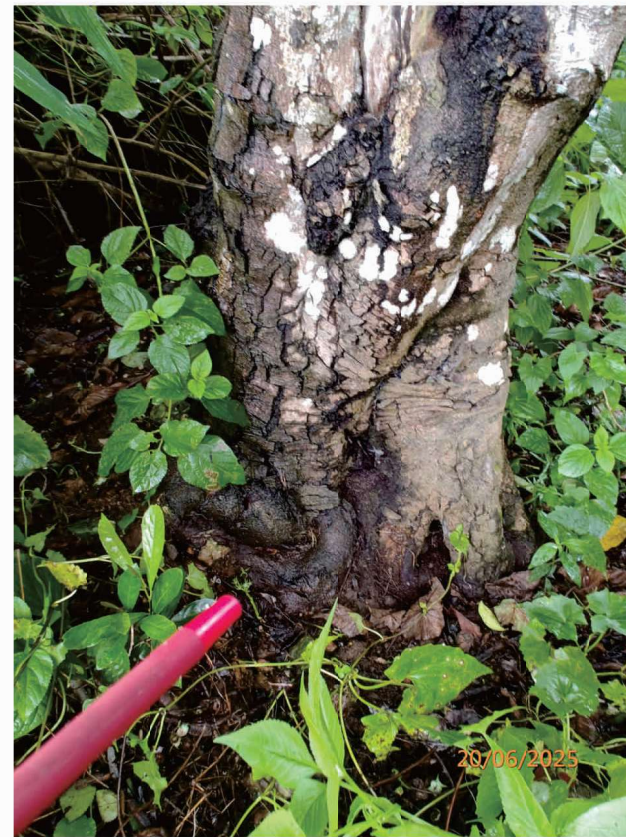
TE45 (F)

| Tree | Photo No. | Species | | | | | Proposed Treatment | Remark <sup>1</sup> |
|---|---|---|---|---|---|---|---|---|
| TE45 | TE45 | <i>Macaranga tanarius var. tomentosa</i> | 血桐 | 8.0 | 325 | 12.0 | Fell | decay in trunk base, abnormal bark crack on branch, cavity at branches |

TE45 - Decay in Trunk Base (F)

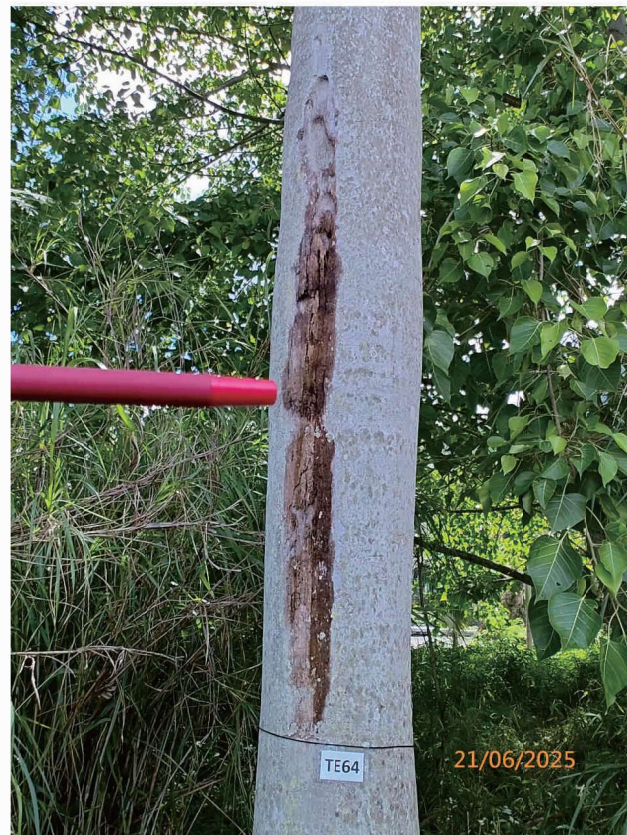
TE64 (F)

| Tree | Photo No. | Species | | | | | Proposed Treatment | Remark <sup>1</sup> |
|---|---|---|---|---|---|---|---|---|
| TE64 | TE64 | <i>Roystonea regia</i> | 王棕 | 7.5 | 366 | 5.0 | Fell | decay in trunk |

TE64 - Decay in Trunk (F)

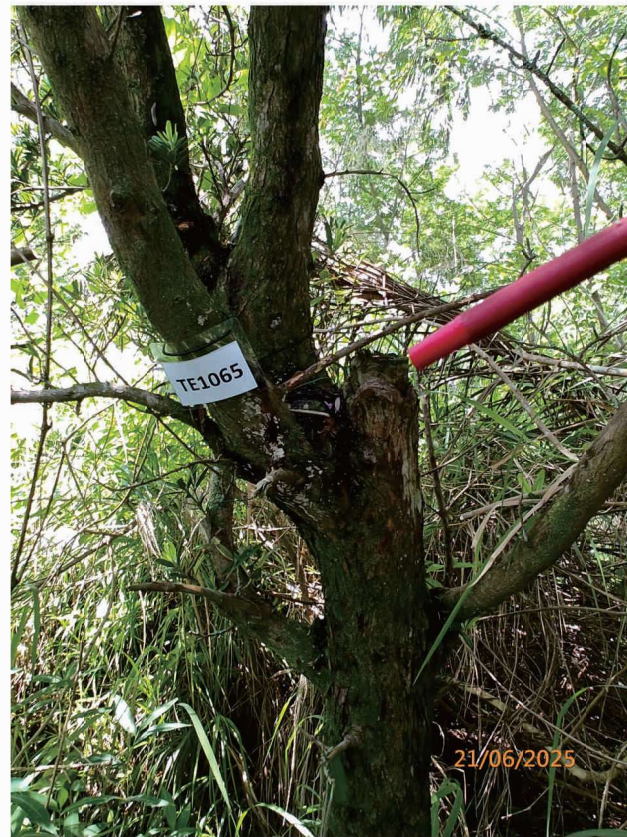
TE1065 (F)

| Tree | Photo No. | Species | | | | | Proposed Treatment | Remark <sup>1</sup> |
|---|---|---|---|---|---|---|---|---|
| TE1065 | TE1065 | <i>Podocarpus macrophyllus</i> | 羅漢松 | 4.0 | 177 | 4.0 | Fell | multiple attachments, cross branches, decay stub at trunk |

TE1065 - Decay Stub at Trunk (F)

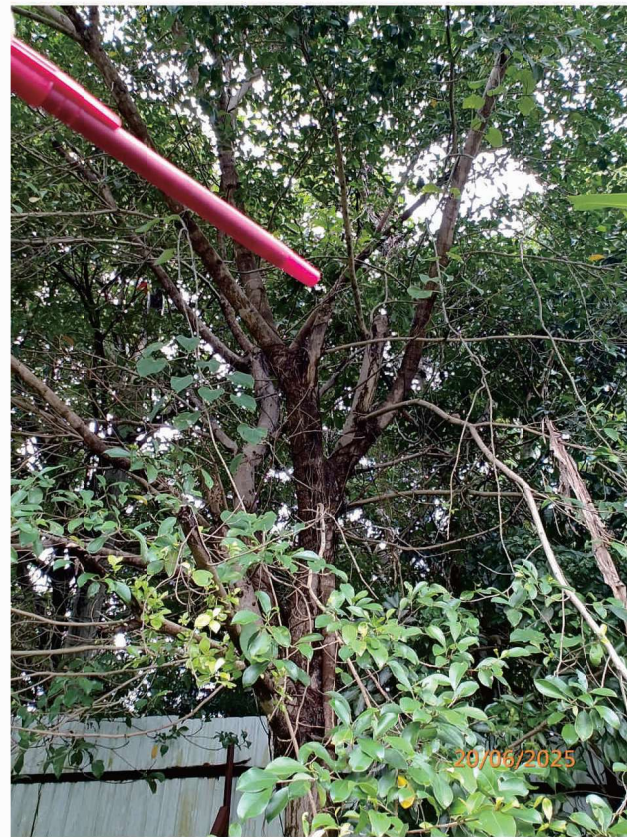
A01 (T)

A01 - Decay Branches (T)

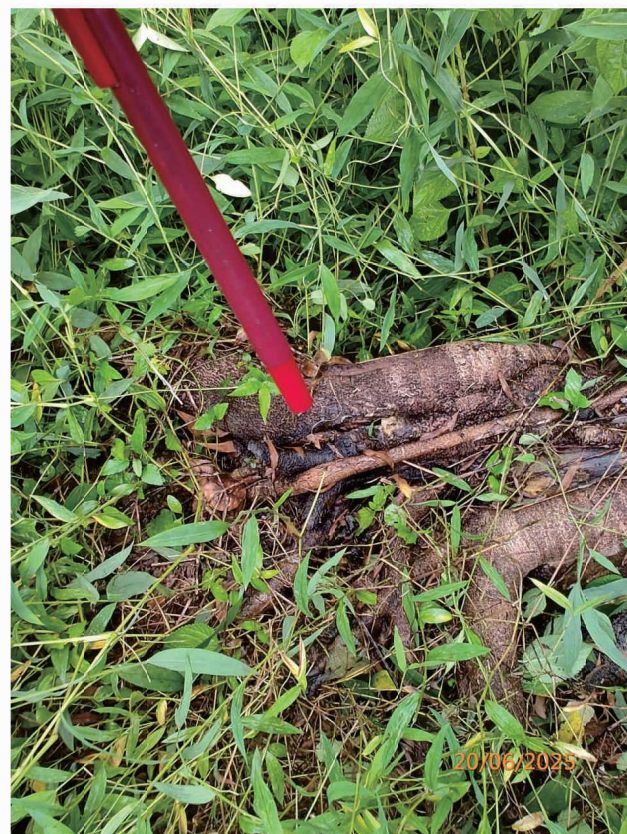
A02 (F)

| Tree | Photo No. | Species | | | | | Proposed Treatment | Remark <sup>1</sup> |
|---|---|---|---|---|---|---|---|---|
| A02 | A02 | <i>Ficus microcarpa</i> | 細葉榕 | 6.0 | 290 | 4.0 | Fell | decay in trunk base, uproot, dieback |

A02 - Decay in Trunk Base (F)

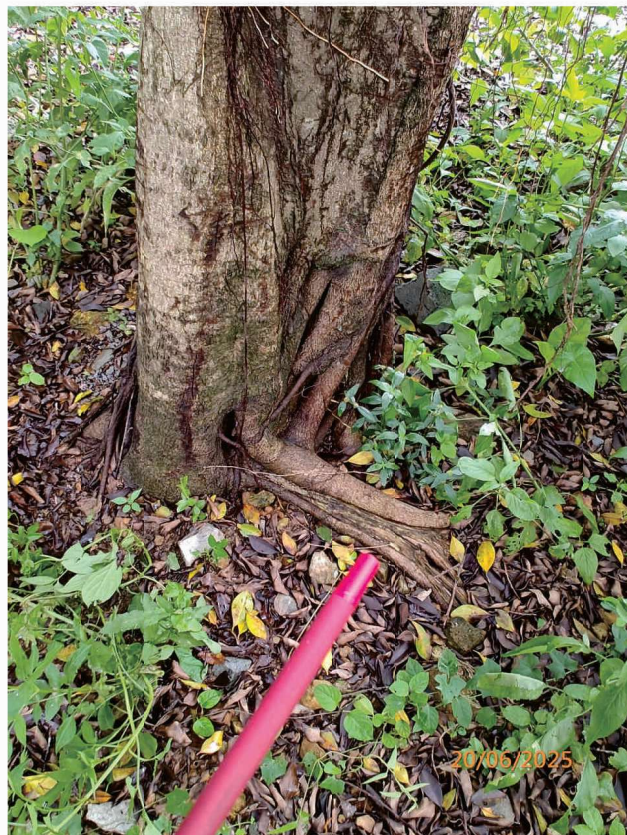
A08 (T)

| Tree | Photo No. | Species | | | | | Proposed Treatment | Remark <sup>1</sup> |
|---|---|---|---|---|---|---|---|---|
| A08 | A08 | <i>Ficus microcarpa</i> | 細葉榕 | 8.0 | 325 | 8.0 | Transplant | girdling root, damaged root |

A08 - Damaged Root (T)

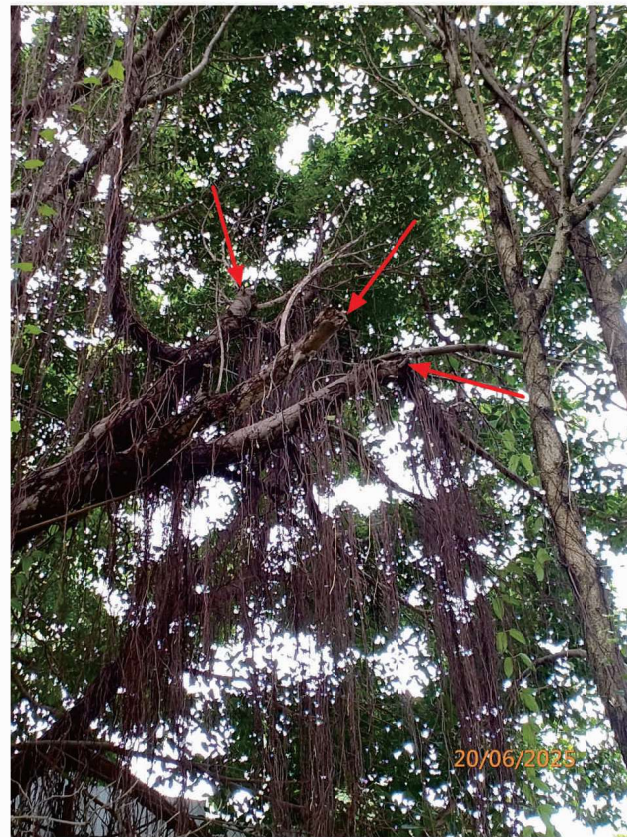
A13 (T)

| Tree | Photo No. | Species | | | | | Proposed Treatment | Remark <sup>1</sup> |
|---|---|---|---|---|---|---|---|---|
| A13 | A13 | <i>Ficus microcarpa</i> | 細葉榕 | 7.0 | 338 | 6.0 | Transplant | decay branches |

A13 - Decay Branches (T)

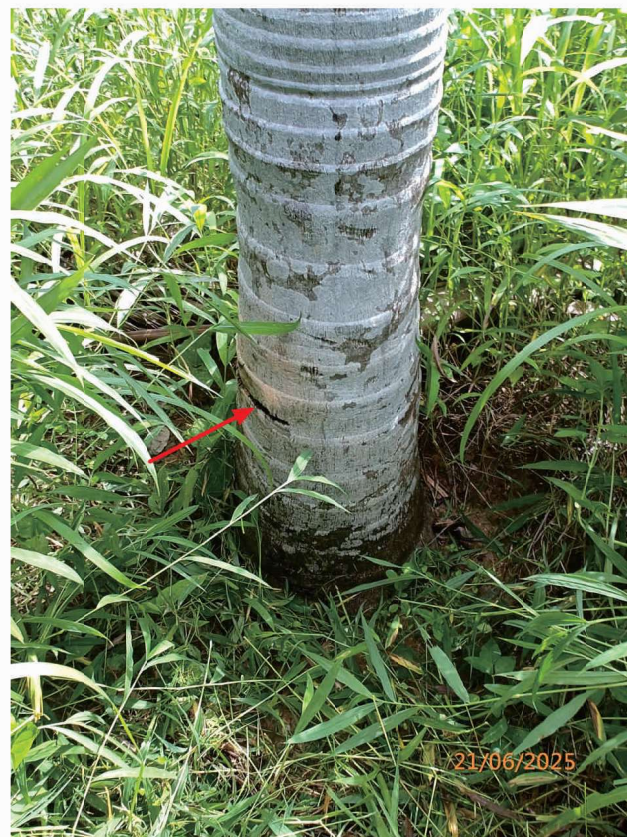
A25 (F)

| Tree | Photo No. | Species | | | | | Proposed Treatment | Remark <sup>1</sup> |
|---|---|---|---|---|---|---|---|---|
| A25 | A25 | <i>Roystonea regia</i> | 王棕 | 4.5 | 207 | 4.0 | Fell | decay in trunk |

A25 - Decay in Trunk (F)

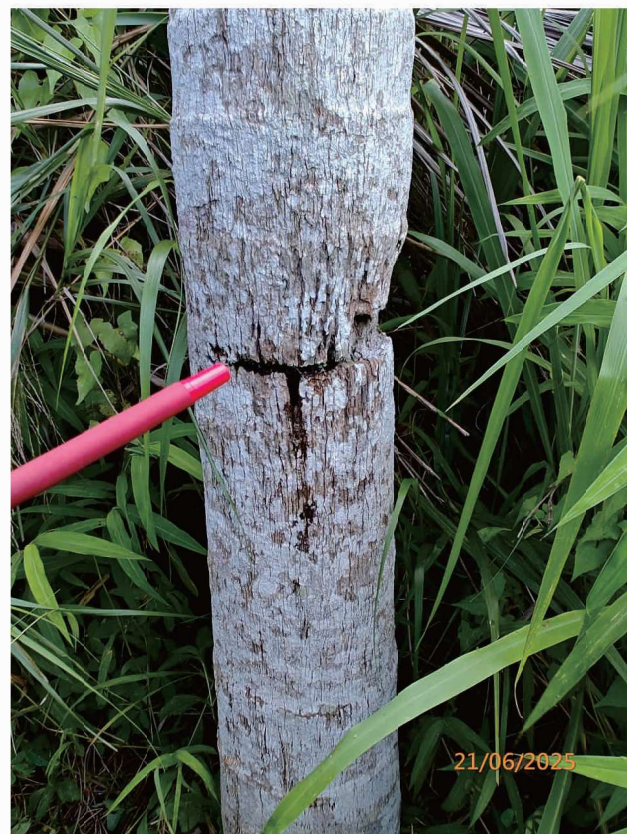
A33 (F)

| Tree | Photo No. | Species | | | | | Proposed Treatment | Remark <sup>1</sup> |
|---|---|---|---|---|---|---|---|---|
| A33 | A33 | <i>Roystonea regia</i> | 王棕 | 3.0 | 178 | 4.0 | Fell | decay in trunk |

A33 - Decay in Trunk (F)

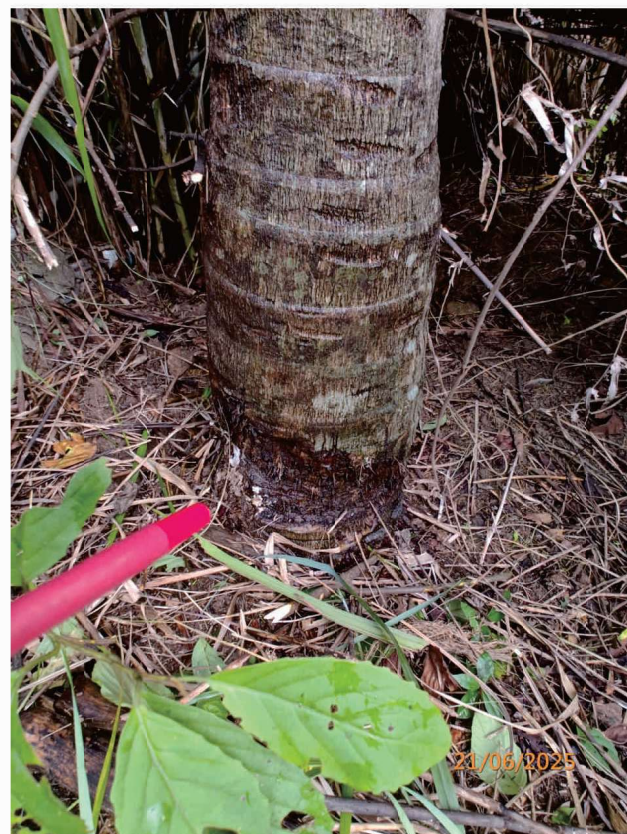
A35 (F)

| Tree | Photo No. | Species | | | | | Proposed Treatment | Remark <sup>1</sup> |
|---|---|---|---|---|---|---|---|---|
| A35 | A35 | <i>Roystonea regia</i> | 王棕 | 3.0 | 170 | 4.0 | Fell | damaged trunk base |

A35 - Damaged Trunk Base (F)

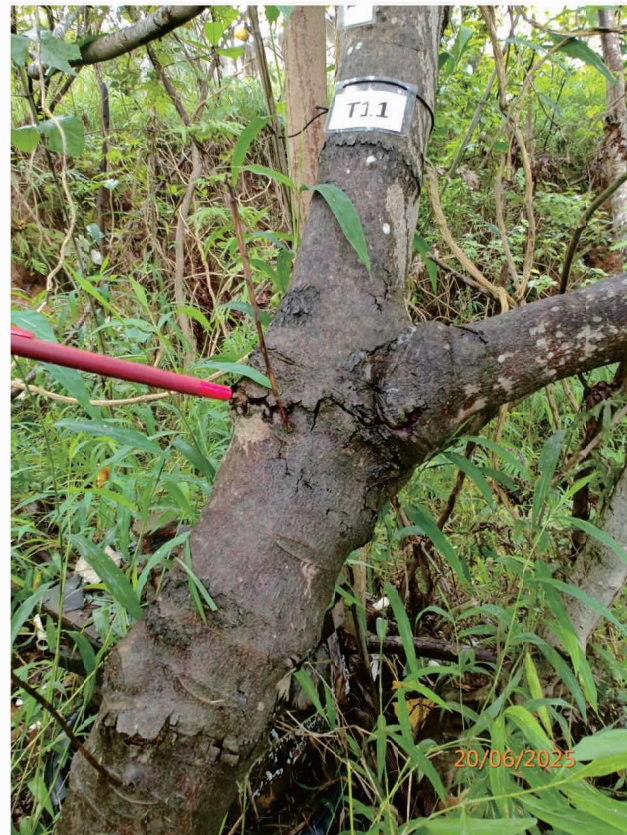
T11 (F)

| Tree | Photo No. | Species | | | | | Proposed Treatment | Remark <sup>1</sup> |
|---|---|---|---|---|---|---|---|---|
| T11 | T11 | <i>Macaranga tanarius</i> var. <i>tomentosa</i> | 血桐 | 5.0 | 145 | 6.0 | Fell | on steep slope, leaning, abnormal bark crack at trunk |

T11 - Abnormal Bark Crack at Trunk (F)

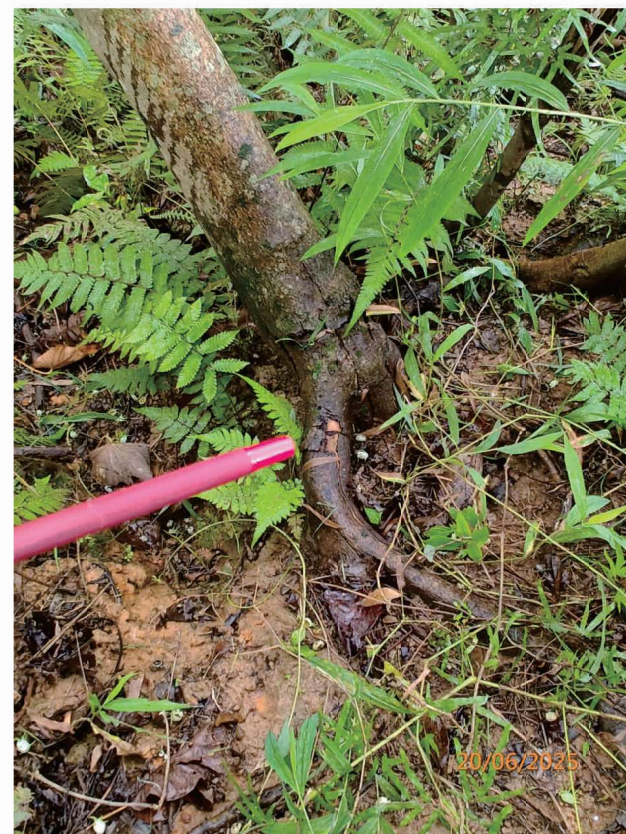
T14 (F)

| Tree | Photo No. | Species | | | | | Proposed Treatment | Remark <sup>1</sup> |
|---|---|---|---|---|---|---|---|---|
| T14 | T14 | <i>Macaranga tanarius</i> var. <i>tomentosa</i> | 血桐 | 6.5 | 97 | 3.0 | Fell | on steep slope, leaning, abnormal bark crack on root |

T14 - Abnormal Bark Crack at Root (F)

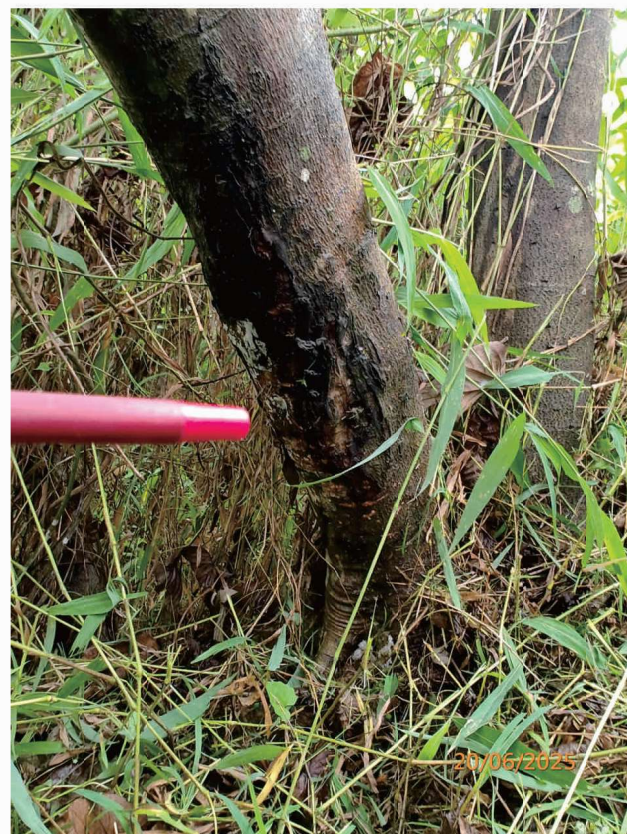
T35 (F)

| Tree | Photo No. | Species | | | | | Proposed Treatment | Remark <sup>1</sup> |
|---|---|---|---|---|---|---|---|---|
| T35 | T35 | <i>Macaranga tanarius</i> var. <i>tomentosa</i> | 血桐 | 6.0 | 197 | 8.0 | Fell | co-dominant trunks, included bark, decay in trunk |

T35 - Decay in Trunk (F)

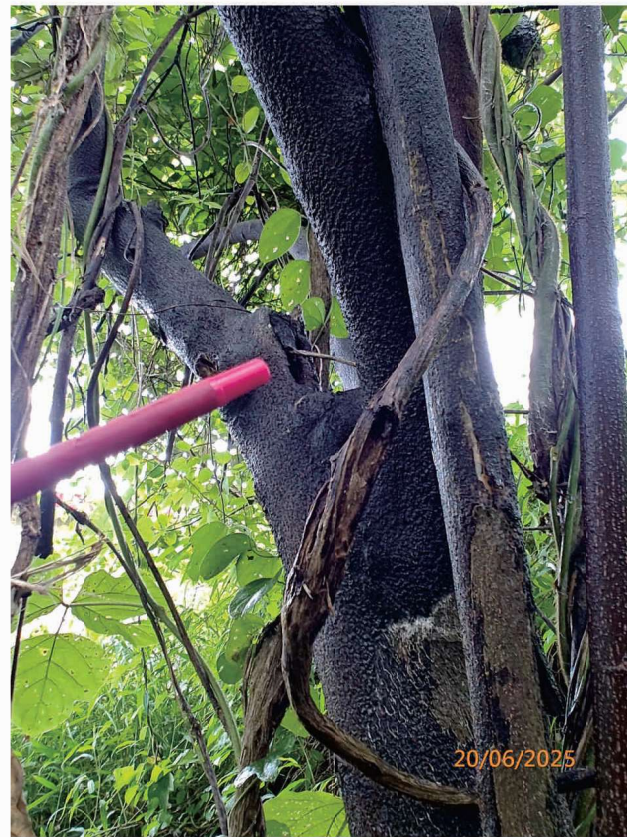
T37 (F)

| Tree | Photo No. | Species | | | | | Proposed Treatment | Remark <sup>1</sup> |
|---|---|---|---|---|---|---|---|---|
| T37 | T37 | <i>mallotus paniculatus</i> | 白楸 | 5.0 | 193 | 4.0 | Fell | co-dominant trunks, trunk crooked, decay in branch |

T37 - Decay in Branch (F)

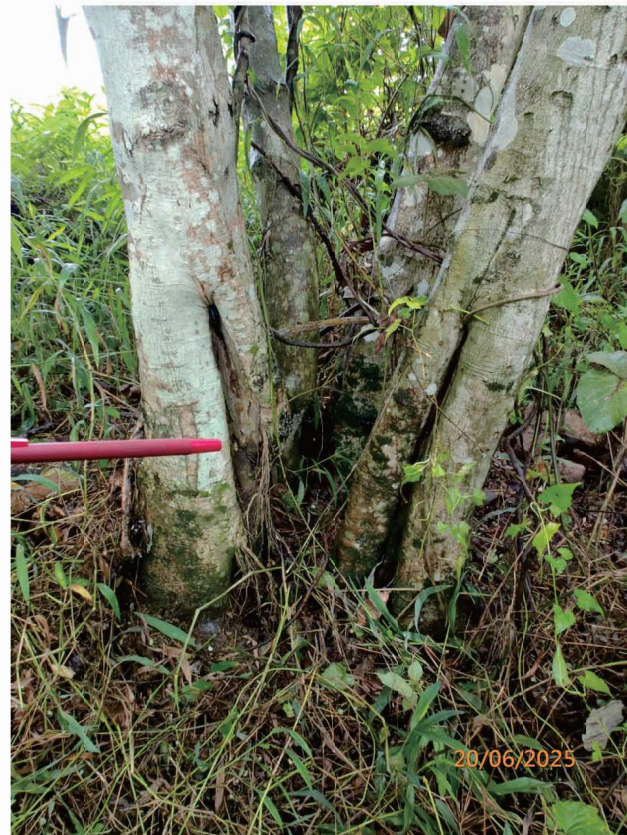
T70 (F)

| Tree | Photo No. | Species | | | | | Proposed Treatment | Remark <sup>1</sup> |
|---|---|---|---|---|---|---|---|---|
| T70 | T70 | <i>Macaranga tanarius</i> var. <i>tomentosa</i> | 血桐 | 5.0 | 346 | 7.0 | Fell | multiple trunks, inrolled crack at trunk base |

T70 - Inrolled Crack at Trunk Base (F)

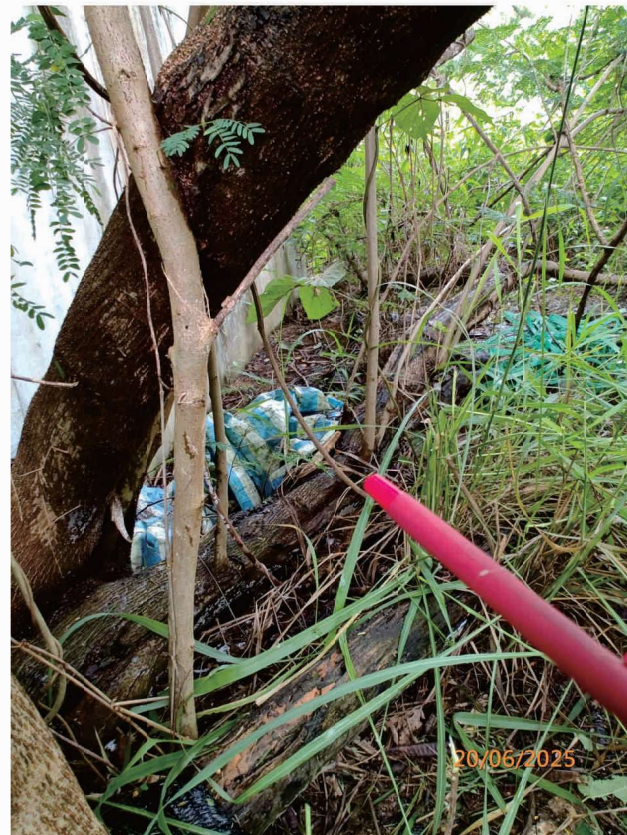
T76 (F)

| Tree | Photo No. | Species | | | | | Proposed Treatment | Remark <sup>1</sup> |
|---|---|---|---|---|---|---|---|---|
| T76 | T76 | <i>Leucaena leucocephala</i> | 銀合歡 | 7.0 | 178 | 7.0 | Fell | invasive species, restricted root, multiple trunks, included bark, decay trunk, cross trunks |

T76 - Decay Trunk (F)
