### **Tree Preservation and Removal Proposal**

**Proposed Development at  
Fanling Sheung Shui Town Lot No. 245,  
On Kui Street, Fanling, New Territories**

**TREE PRESERVATION AND REMOVAL PROPOSAL  
(PINK AREA)  
RE-SUBMISSION**

**Oriental Landscapes Limited**  
**東方綠化有限公司**

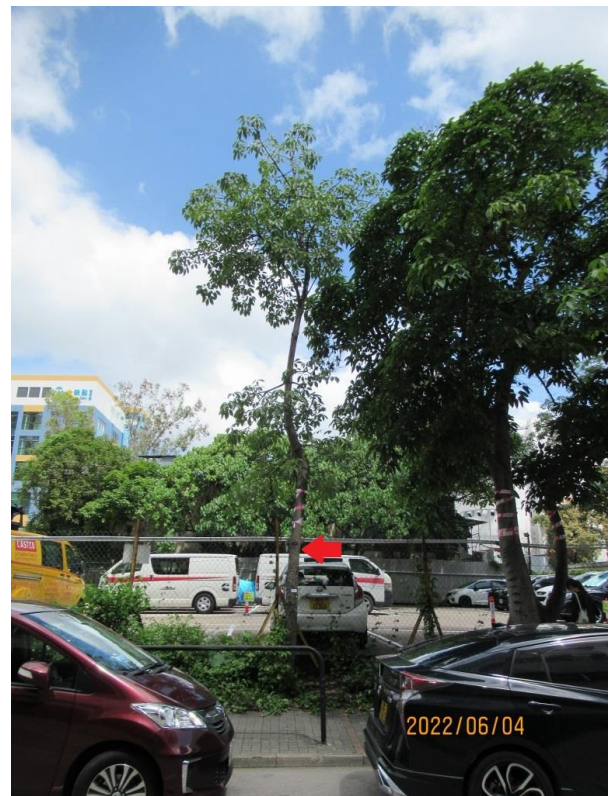
T1 Cavity on Trunk - **FELL**  
(under separation submission)

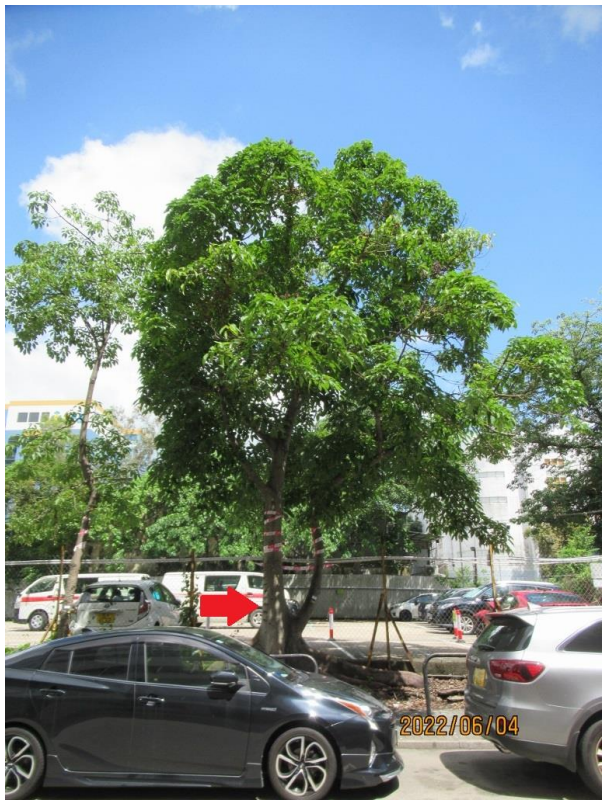
T2 Lower Trunk & Ground Condition - FELL

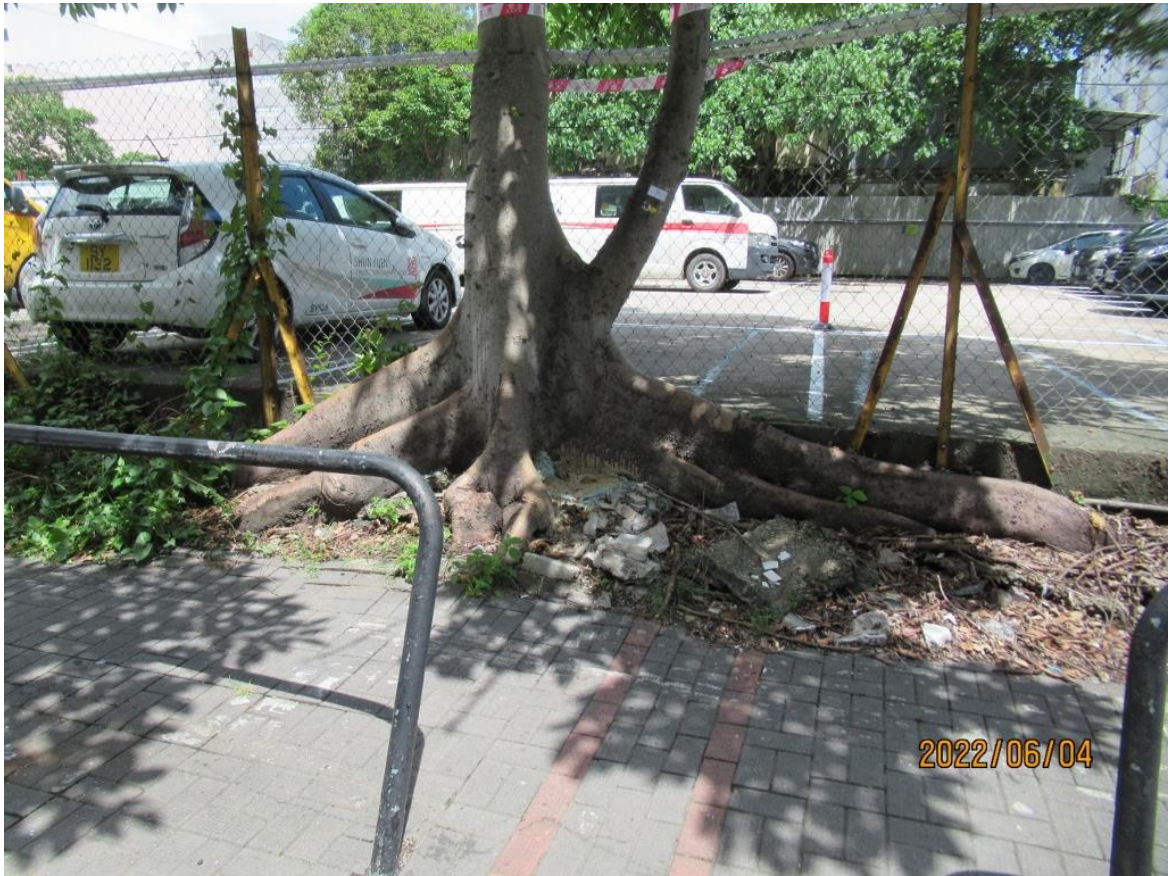
T3 Overall View - FELL

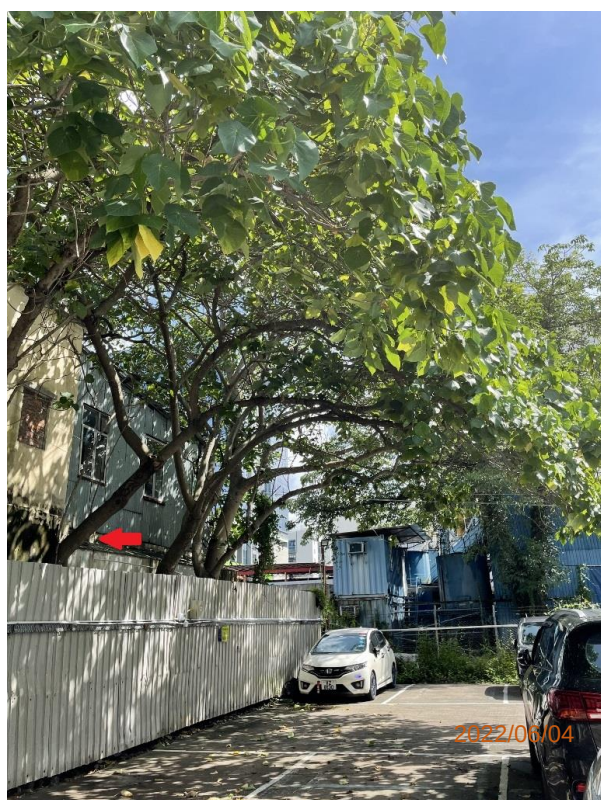
T6 Wound on Branch - **FELL**

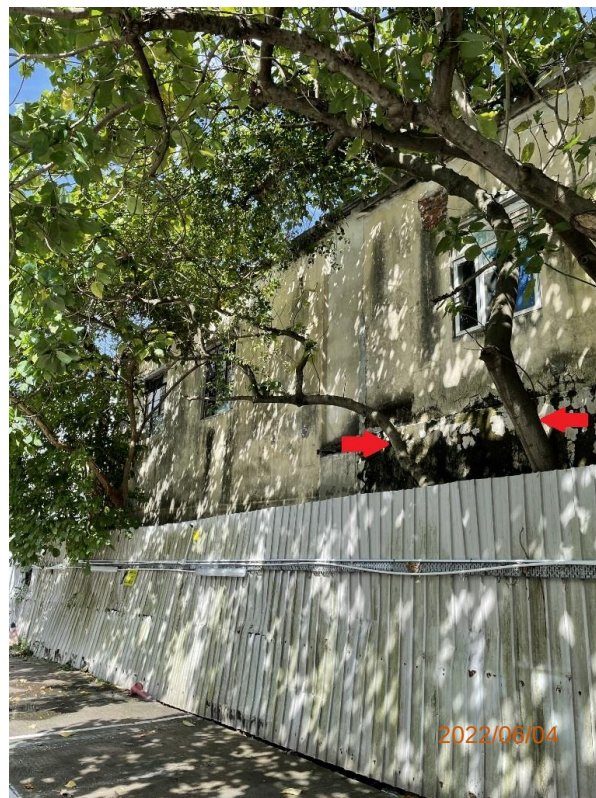
T8 Wound on Branch - **FELL**

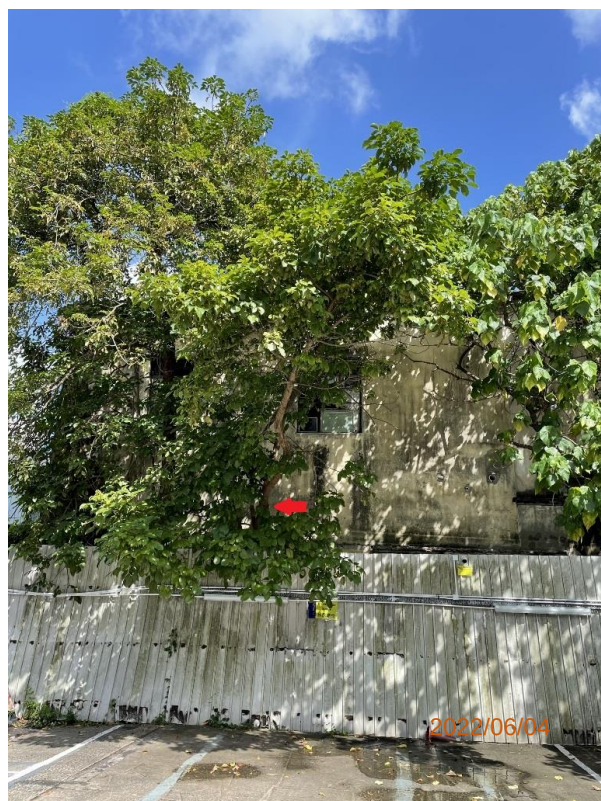
T9 Cavity on Trunk - **FELL**

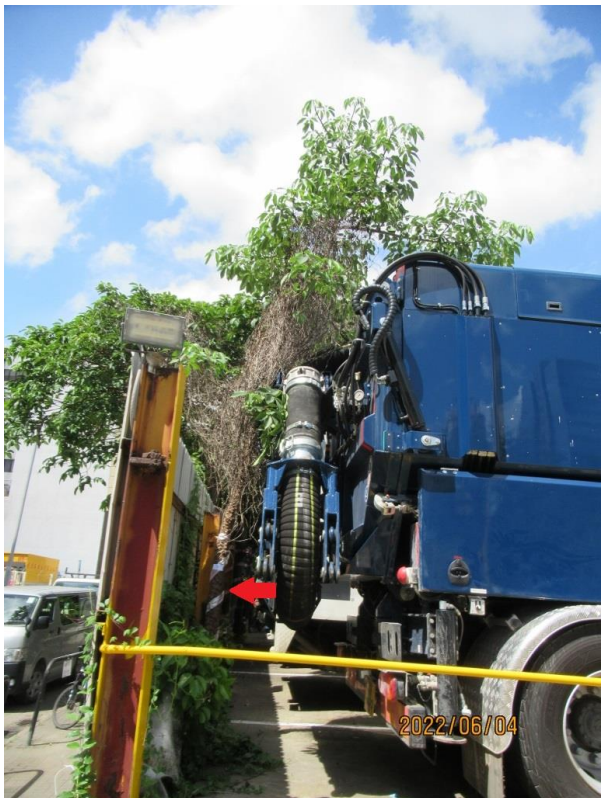
T11 Trunk Condition - **FELL**

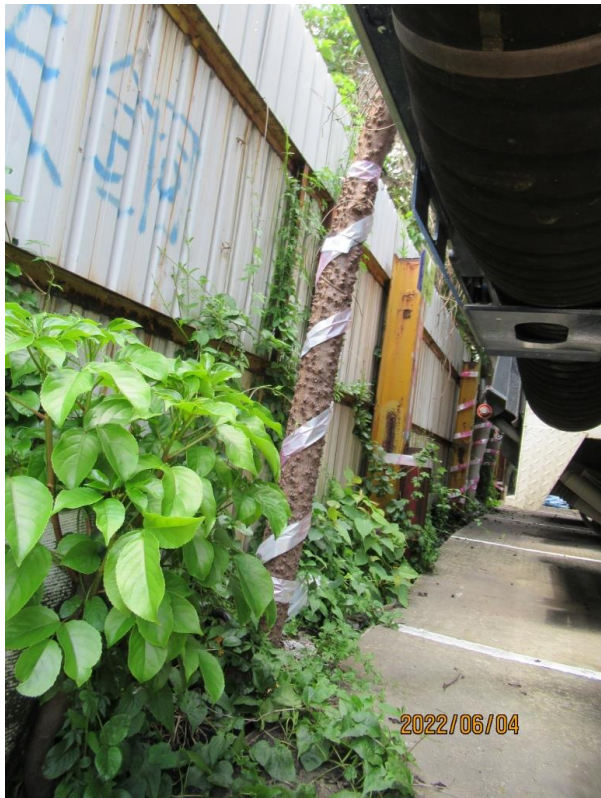
T12 Overall view - FELL

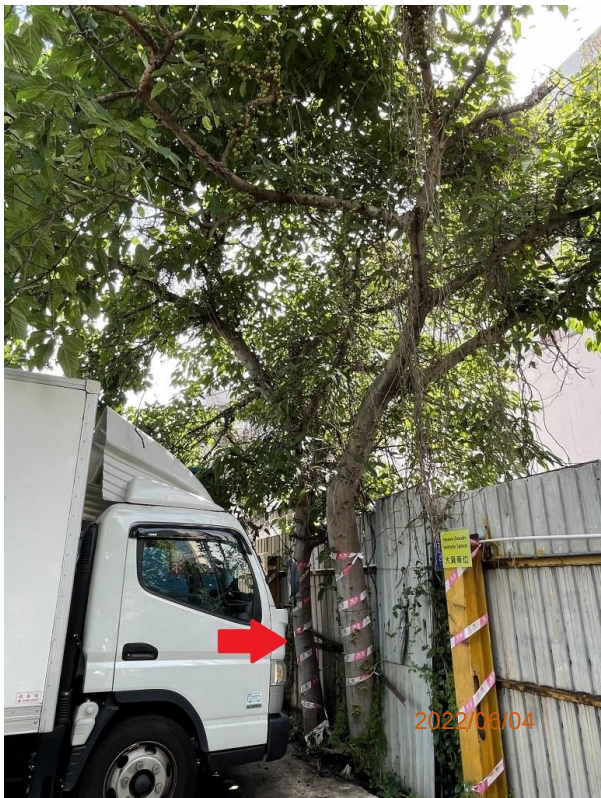
T12 Lower Trunk & Ground Condition - FELL

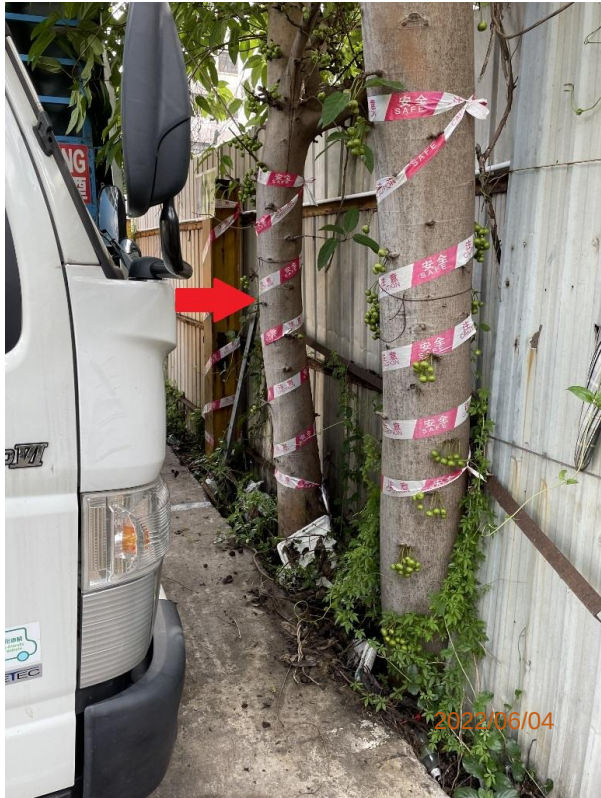
T13 Overall view - FELL

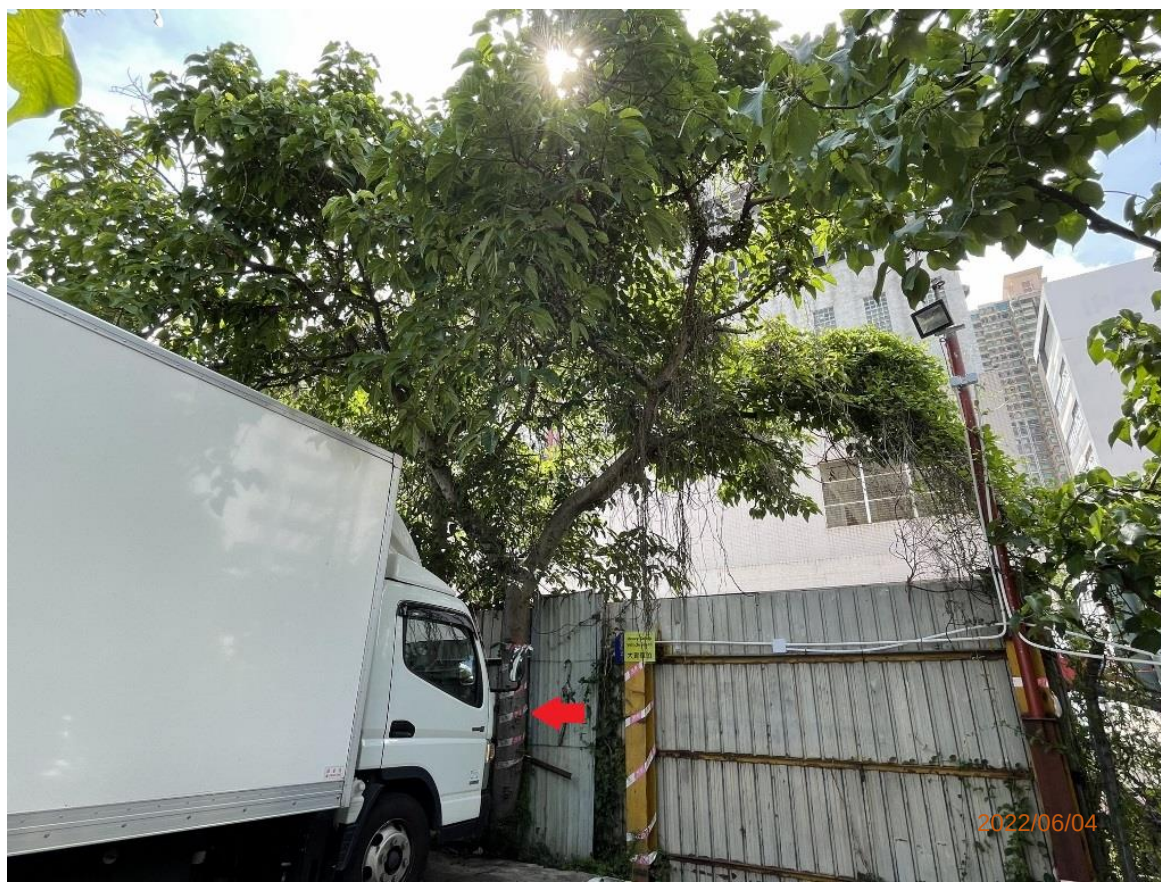
T13 Lower Trunk & Ground Condition - FELL

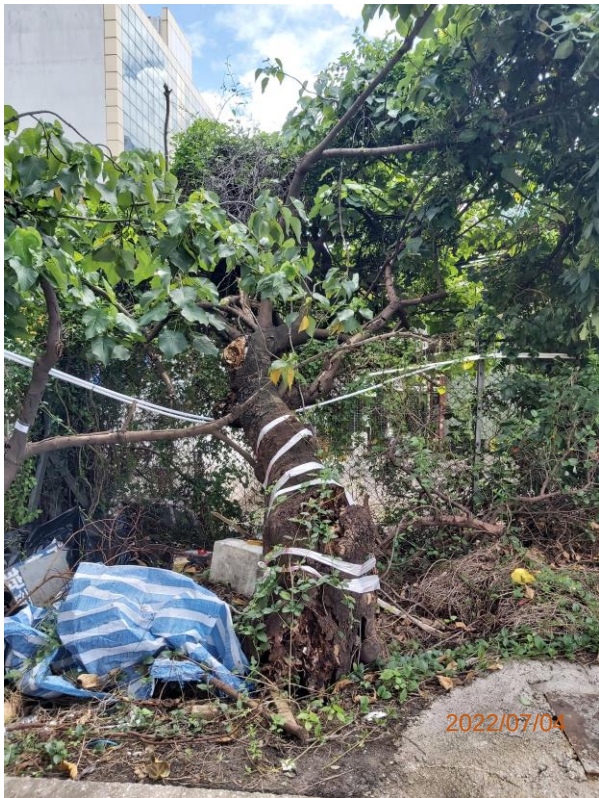
T14 Lower Tree Trunk & Ground Condition - **FELL**

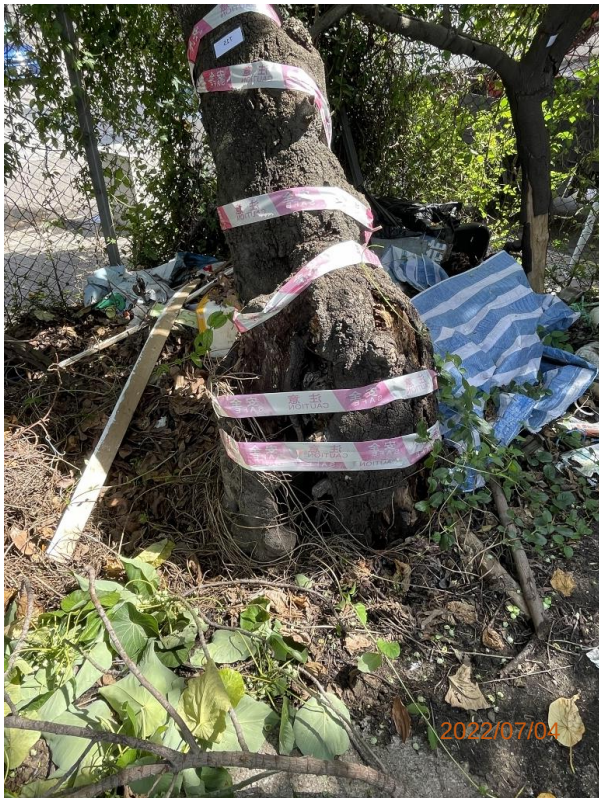
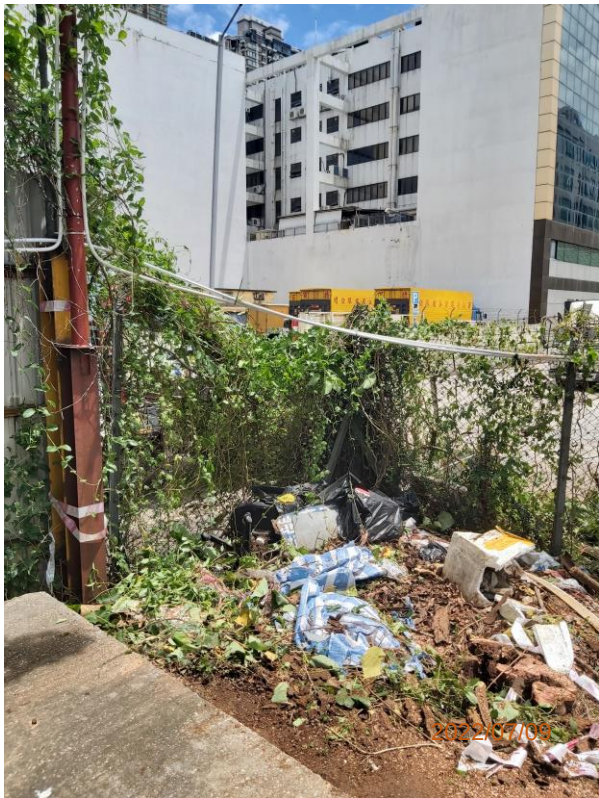
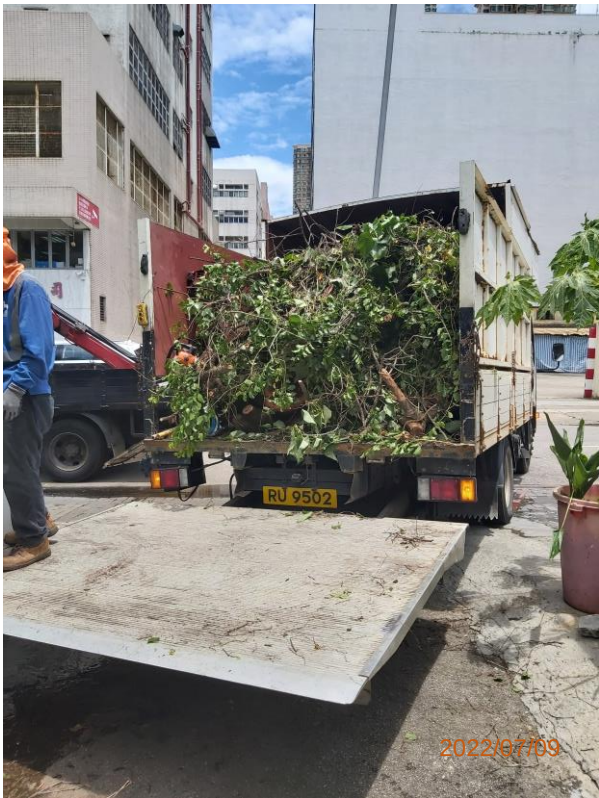
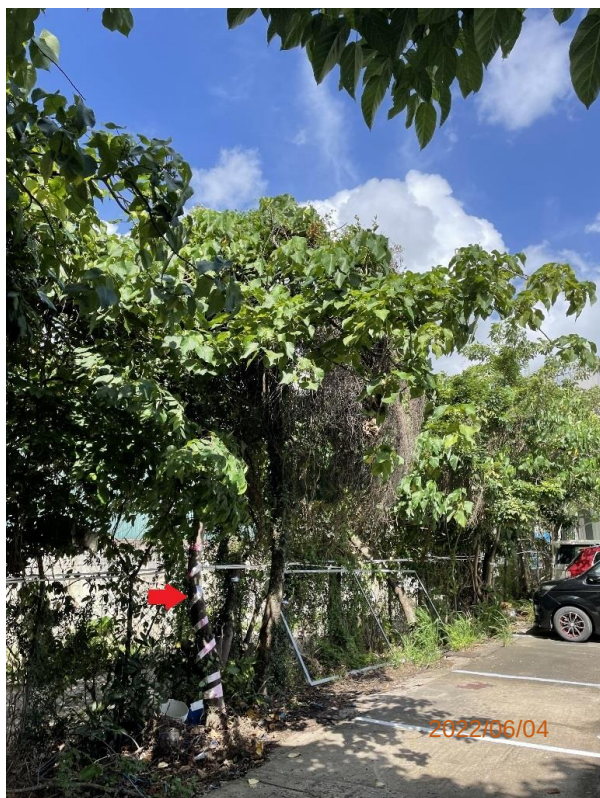
**T15 – EMERGENCY FELLED**  
on 9 July 2022 and was submitted to DLO on 15 July 2022

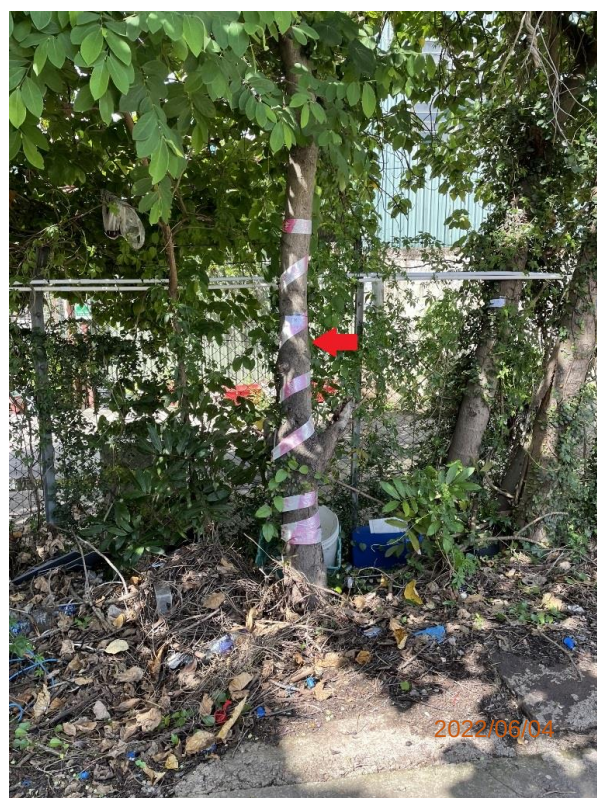
T16 Overall view - **FELL**

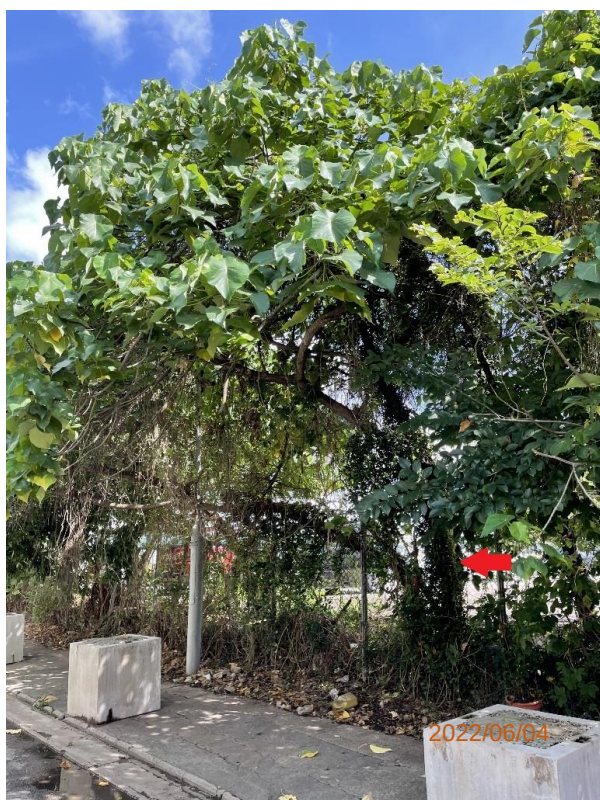
T16 Lower Trunk & Ground Condition - **FELL**

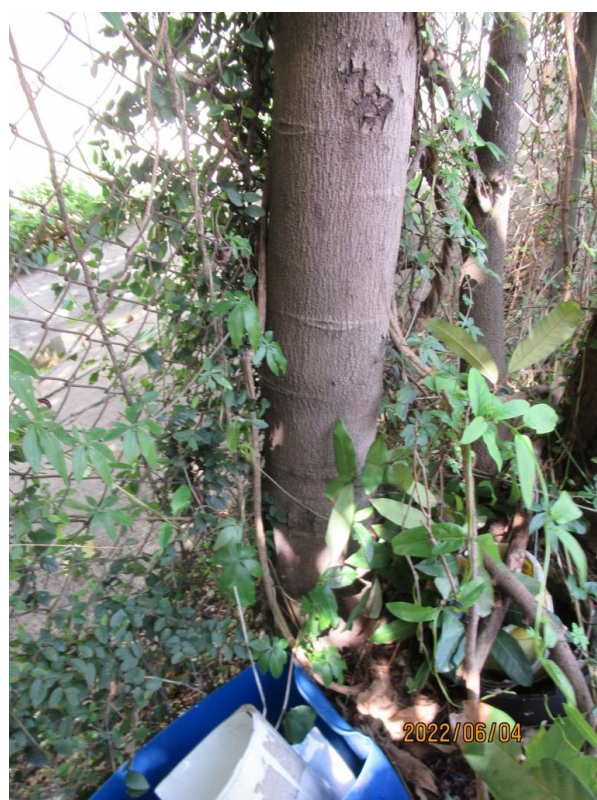
T17 Overall view - **FELL**

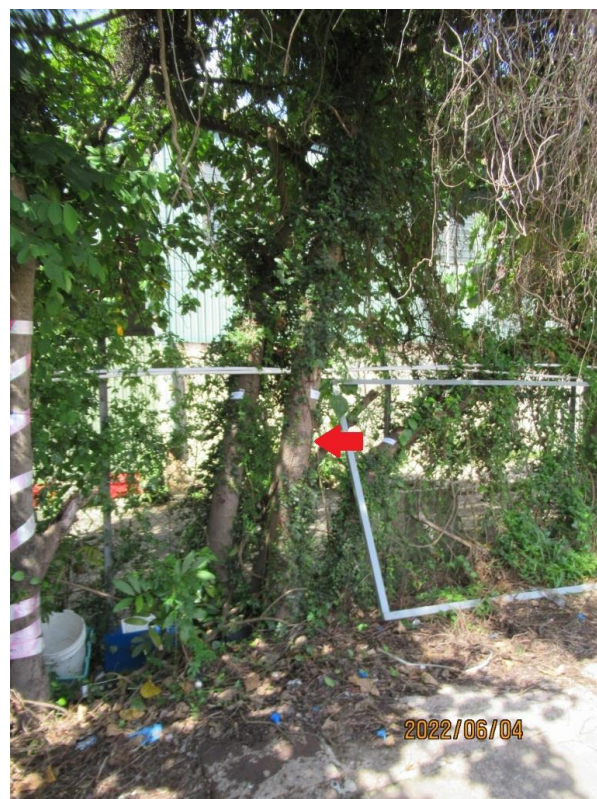
T18 Overall view - **FELL**

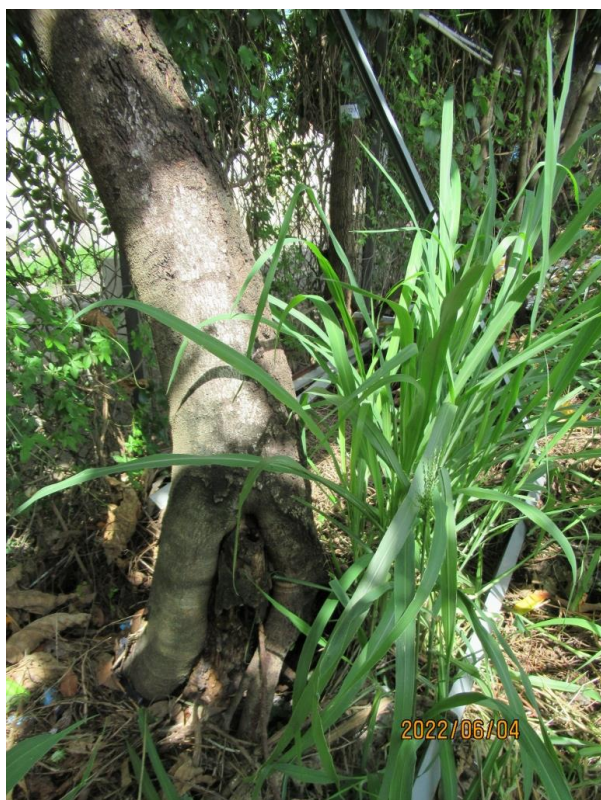
T19 Overall view - **FELL**

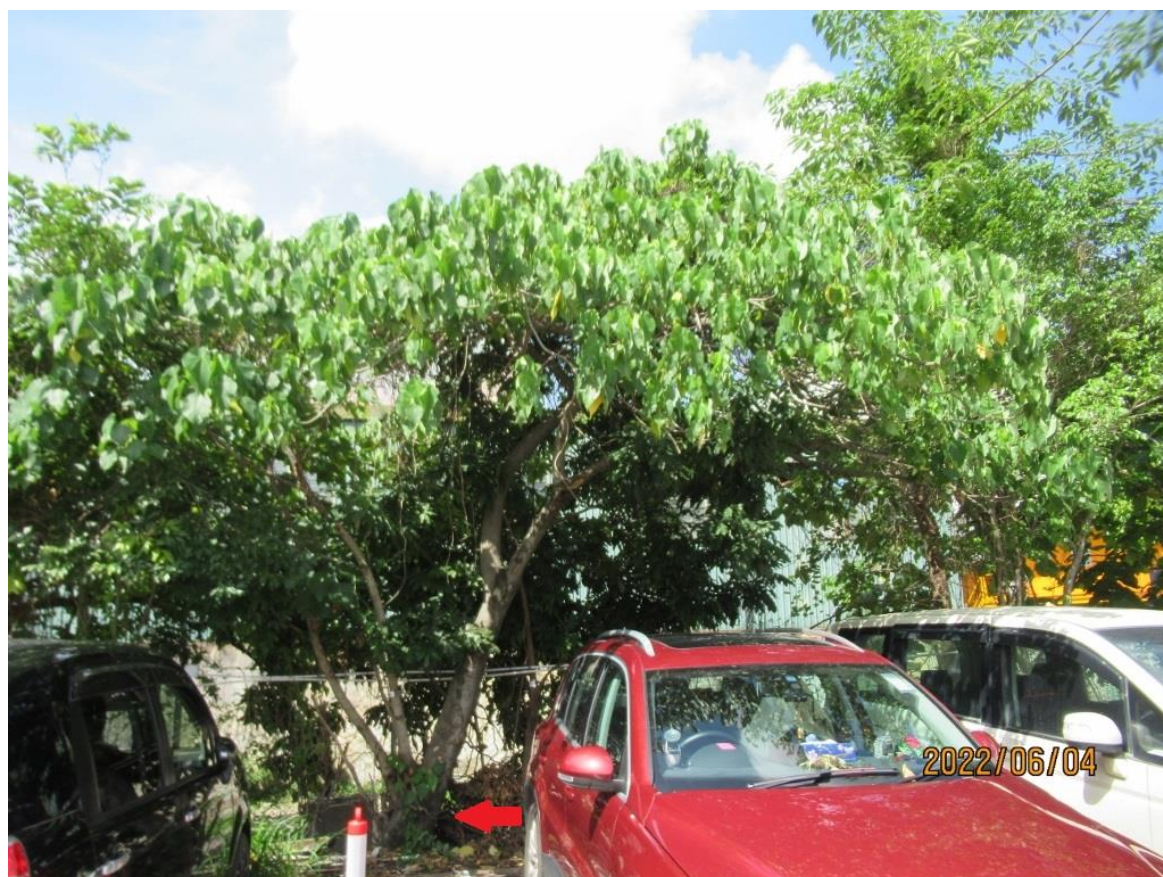
T19 Cavity on Root Crown - **FELL**

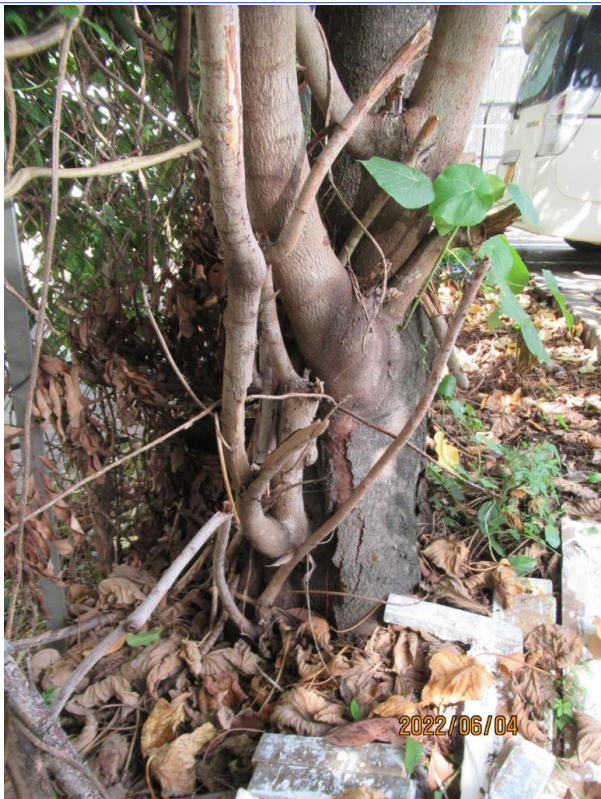
T21 Overall view - **FELL**

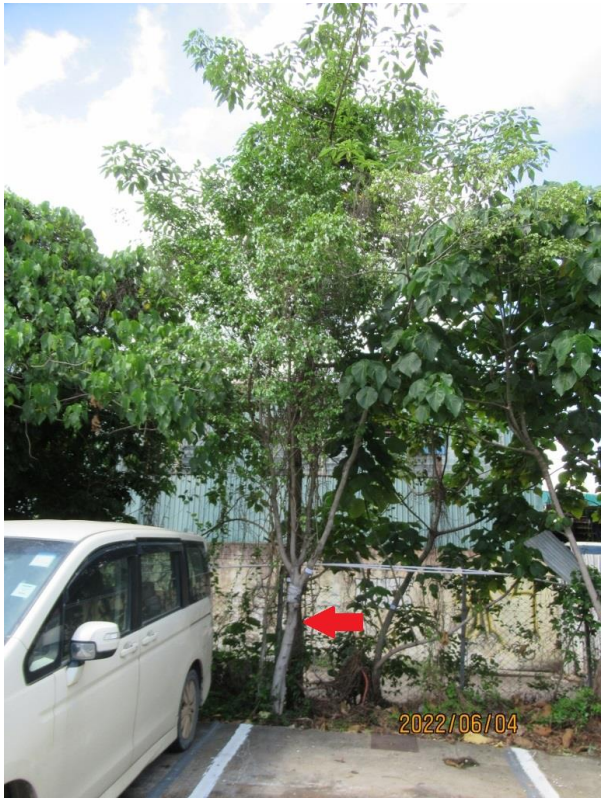
T21 Trunk Condition - FELL

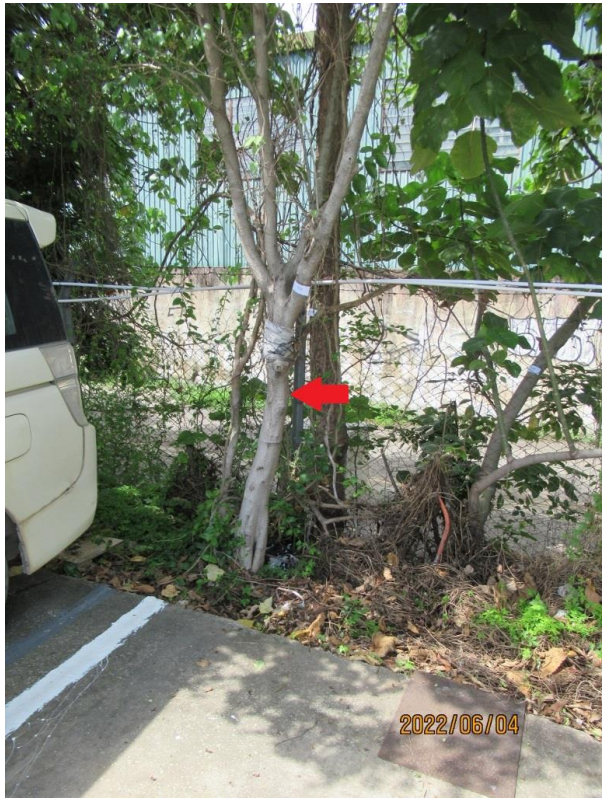
T22 Overall view - FELL

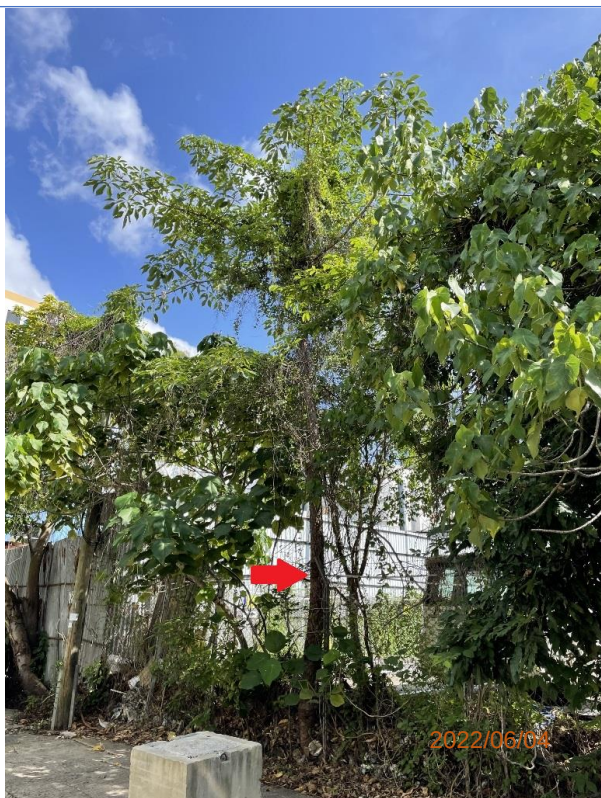
T22 Lower Trunk & Ground Condition - FELL

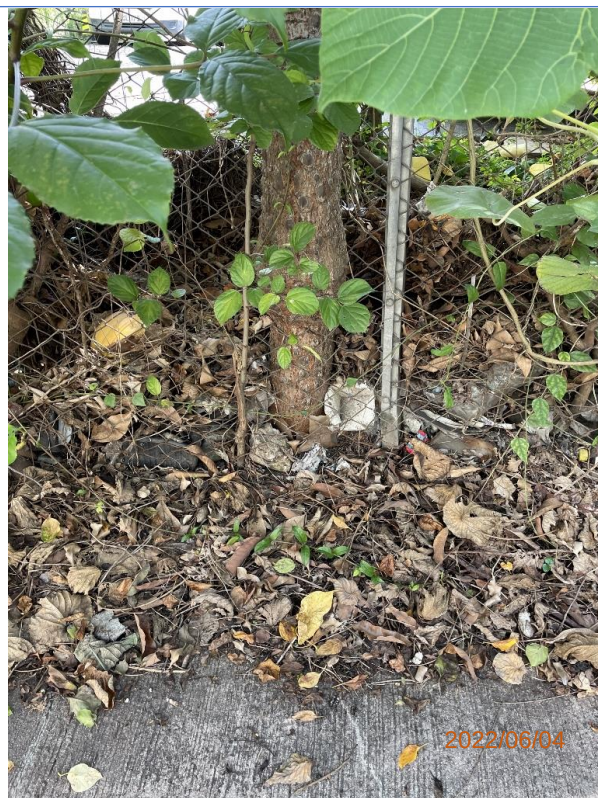
T23 Overall view - **FELL**

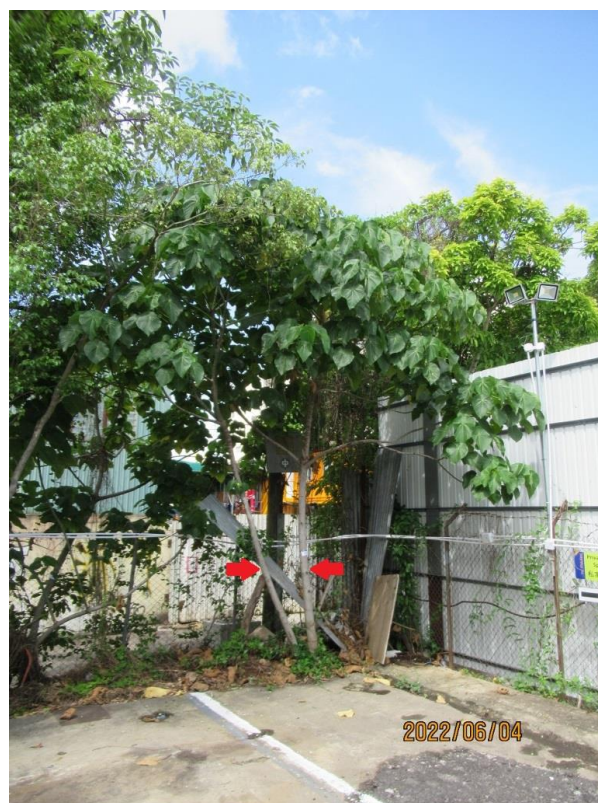
T23 Wire Enveloped in Trunk - **FELL**

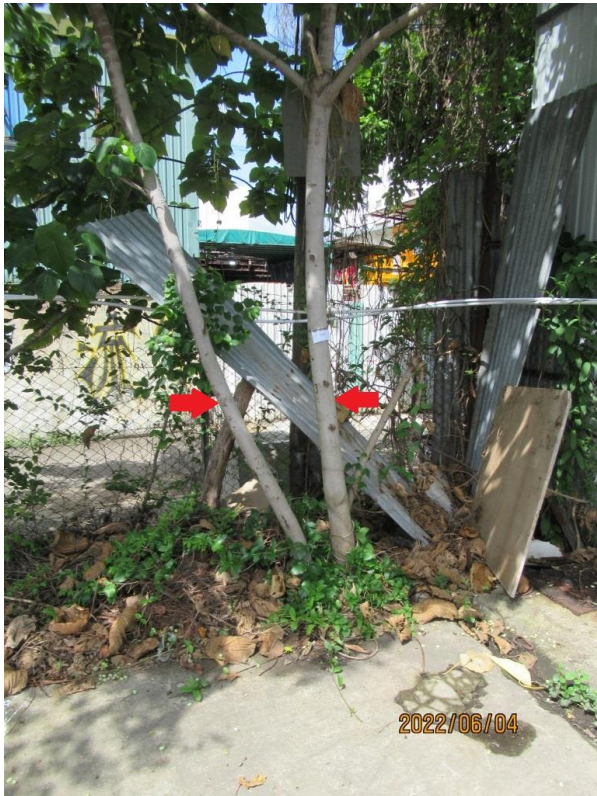
T24 Overall view - **FELL**

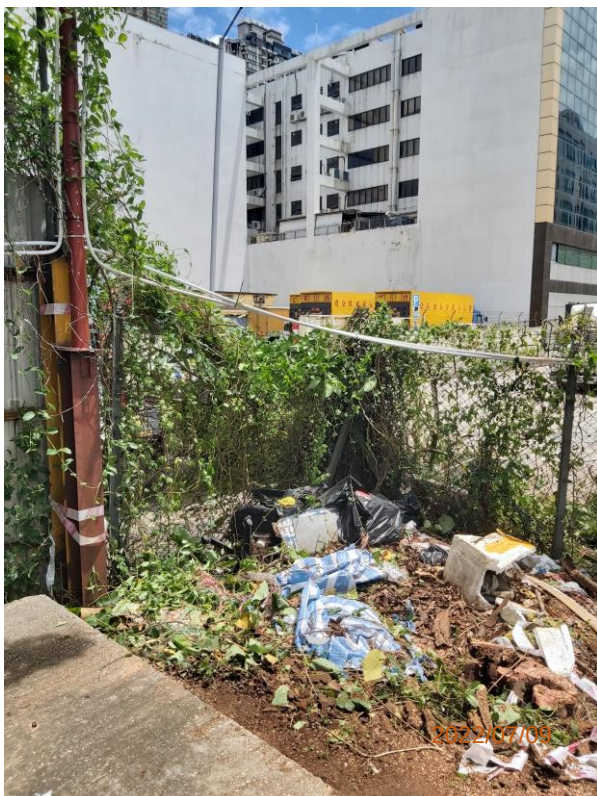
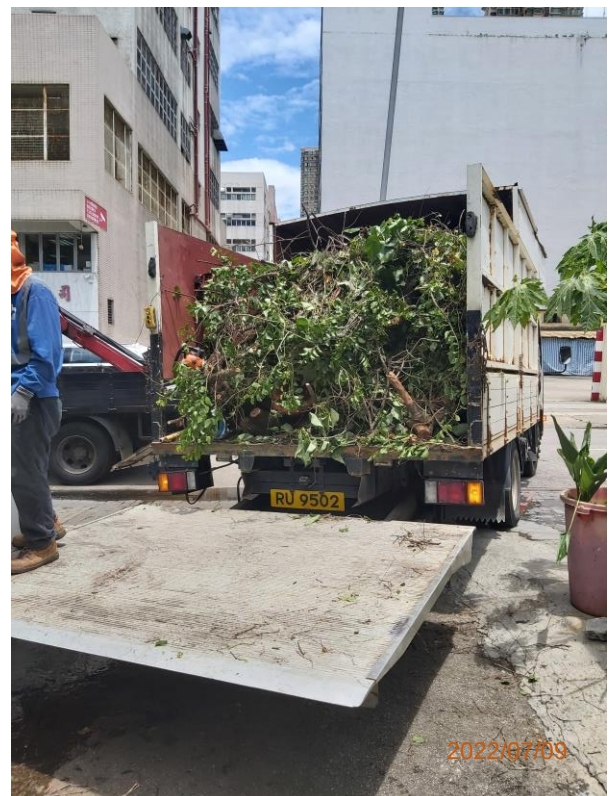
T24 Lower Trunk & Ground Condition - **FELL**

T25 – **EMERGENCY FELLED**  
on 9 July 2022 and was submitted to DLO on 15 July 2022

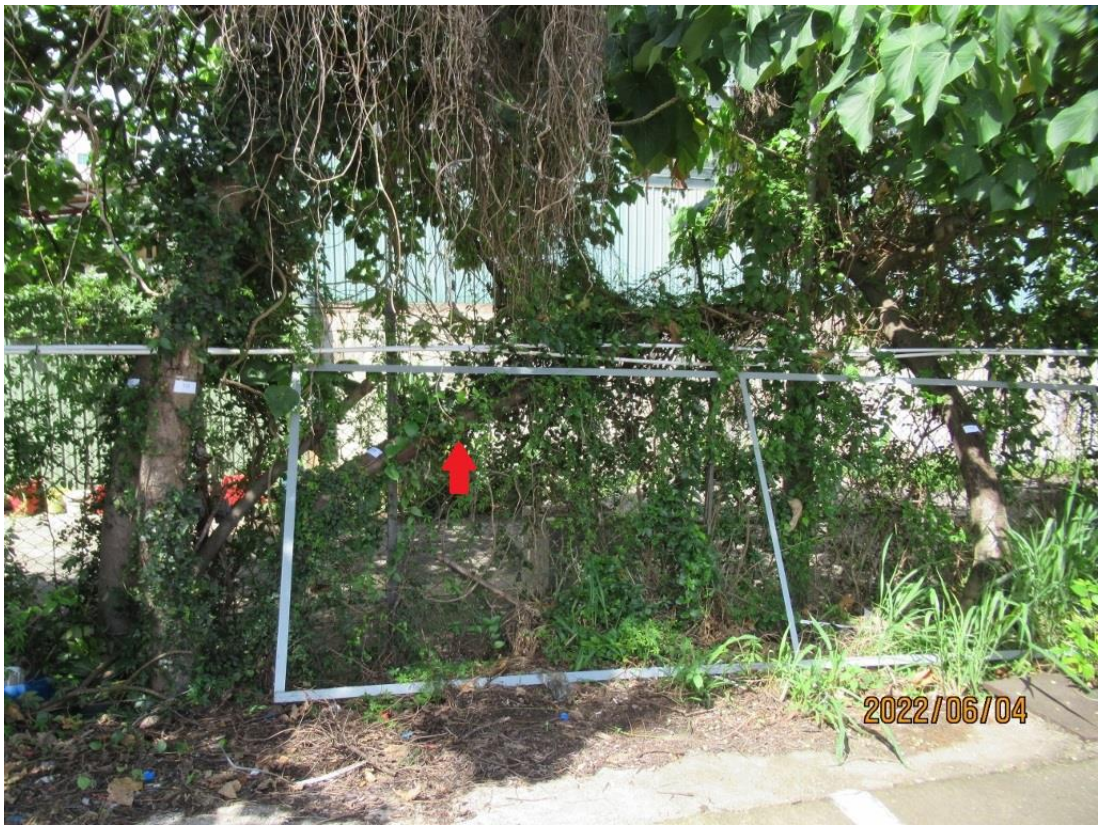
T25 – **EMERGENCY FELLED**  
on 9 July 2022 and was submitted to DLO on 15 July 2022

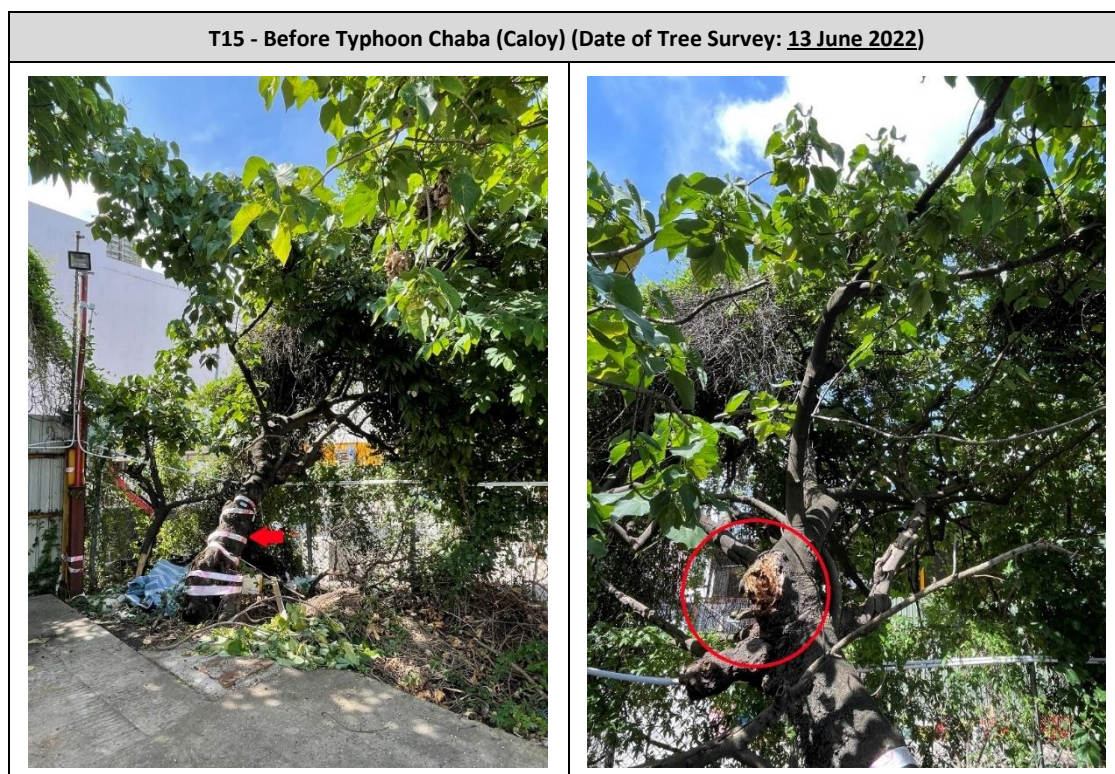
Date of Inspection: 4<sup>th</sup> July 2022

Cause: Due to Typhoon Chaba (Caloy) on 1<sup>st</sup> and 2<sup>nd</sup> July 2022, inclement weather such as heavy raining and gust wind might cause soil loss or impaired the stability of the tree. The tree was found to collapsed towards the public pedestrian pathway at On Kui Street, emergency removal of the tree is recommended by the Landscape Consultant and Landscape Contractor.

Tree Condition of T15 before Typhoon Chaba (Caloy)

Leaning, heavily vined, cavity with decay at root crown, dead branches, wound on main trunk, root restricted by pavement

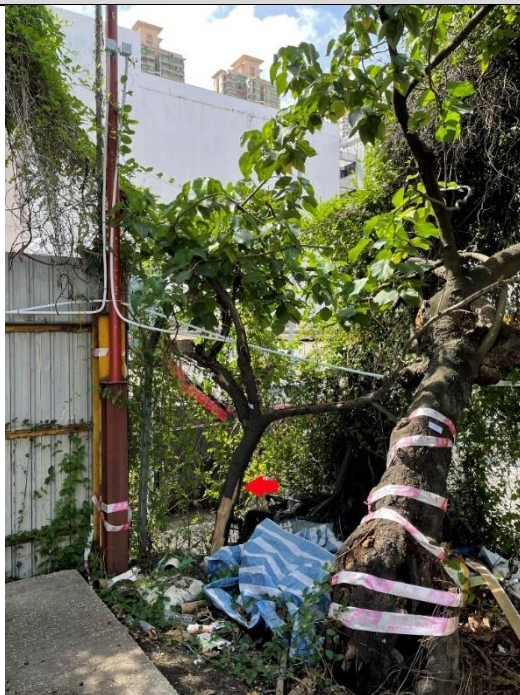
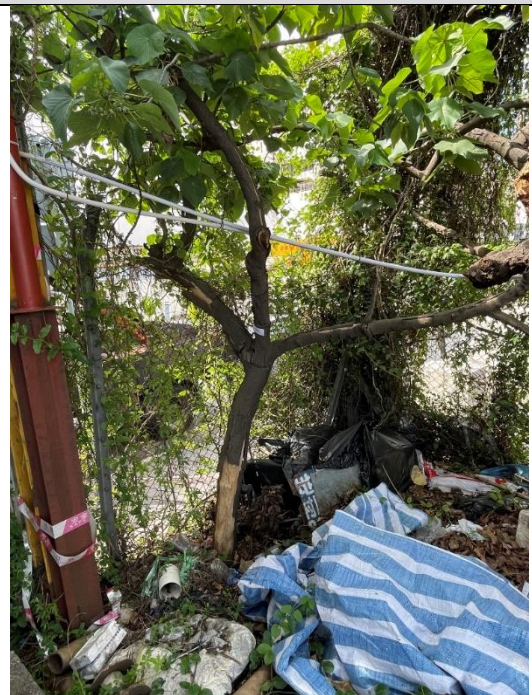
**T25 - Before Typhoon Chaba (Caloy) (Date of Tree Survey: 13 June 2022)**

| | <p>Tree Condition of T25 before Typhoon Chaba (Caloy)</p> <p>It is a dead tree and leaning</p> |

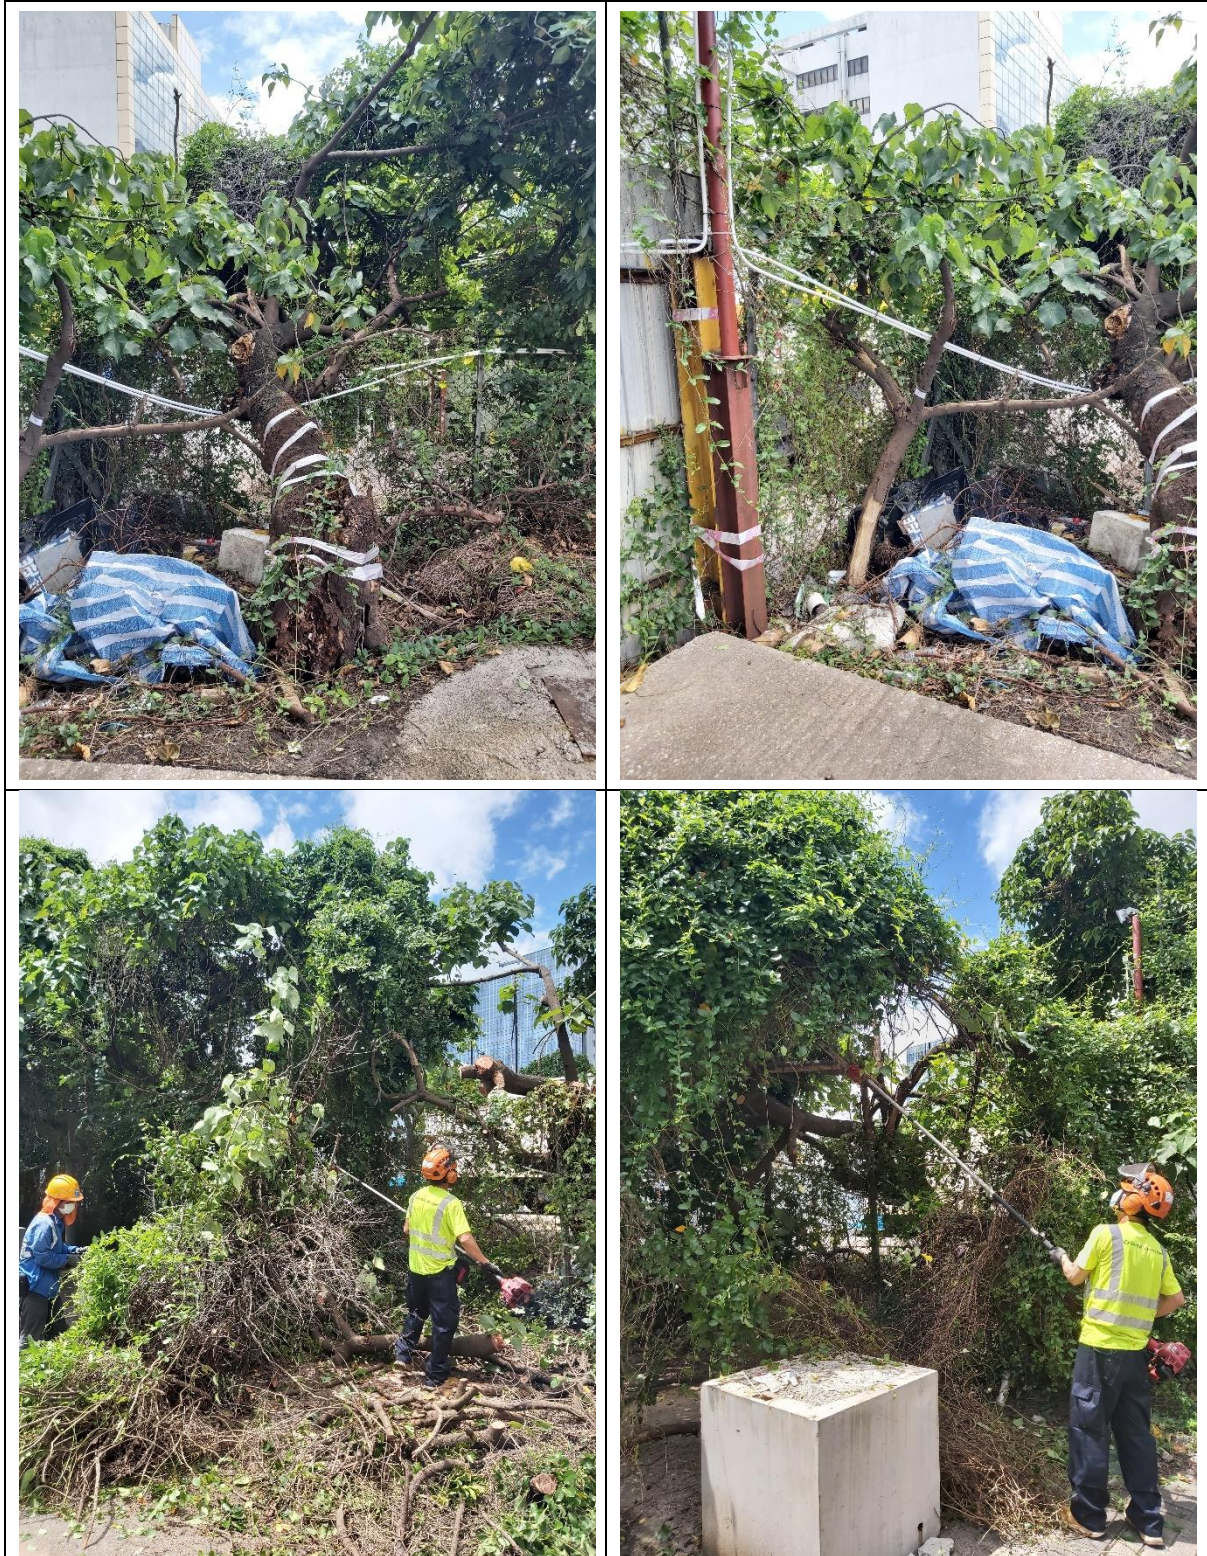
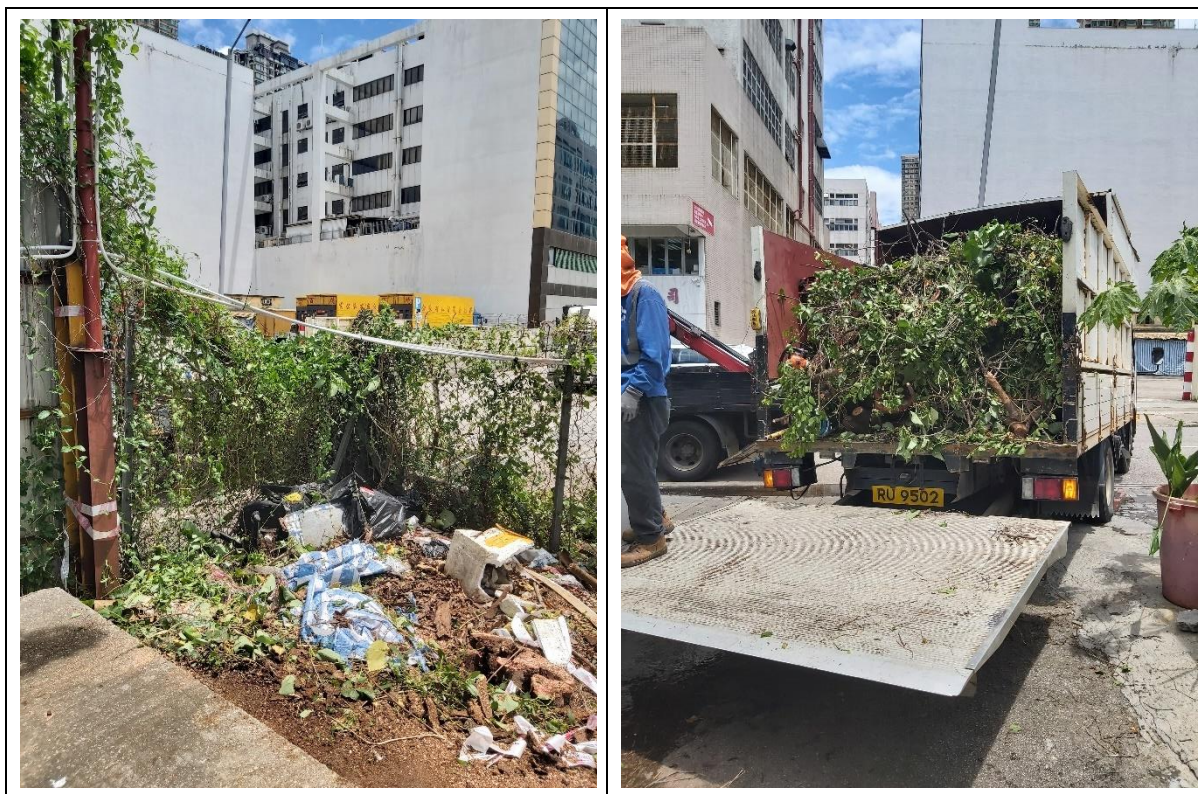
Date of Removal of Hazard Trees T15 & T25: 9 July 2022

Hazardous trees T15 and T25 were emergency removed from the site in consideration of potential risk of public safety as these 2 nos. of hazard trees are closed to the public pedestrian pathway at On Kui Street. Below photographic records indicate the sequence of tree removal works.
