**PLANNING APPLICATION FOR
PROPOSED UTILITY INSTALLATION FOR PRIVATE PROJECT
AT GOVERNMENT LAND ADJOINING 44 STANLEY VILLAGE ROAD,
STANLEY, HON KONG**

Tree Survey Report

Date: 13 November 2025

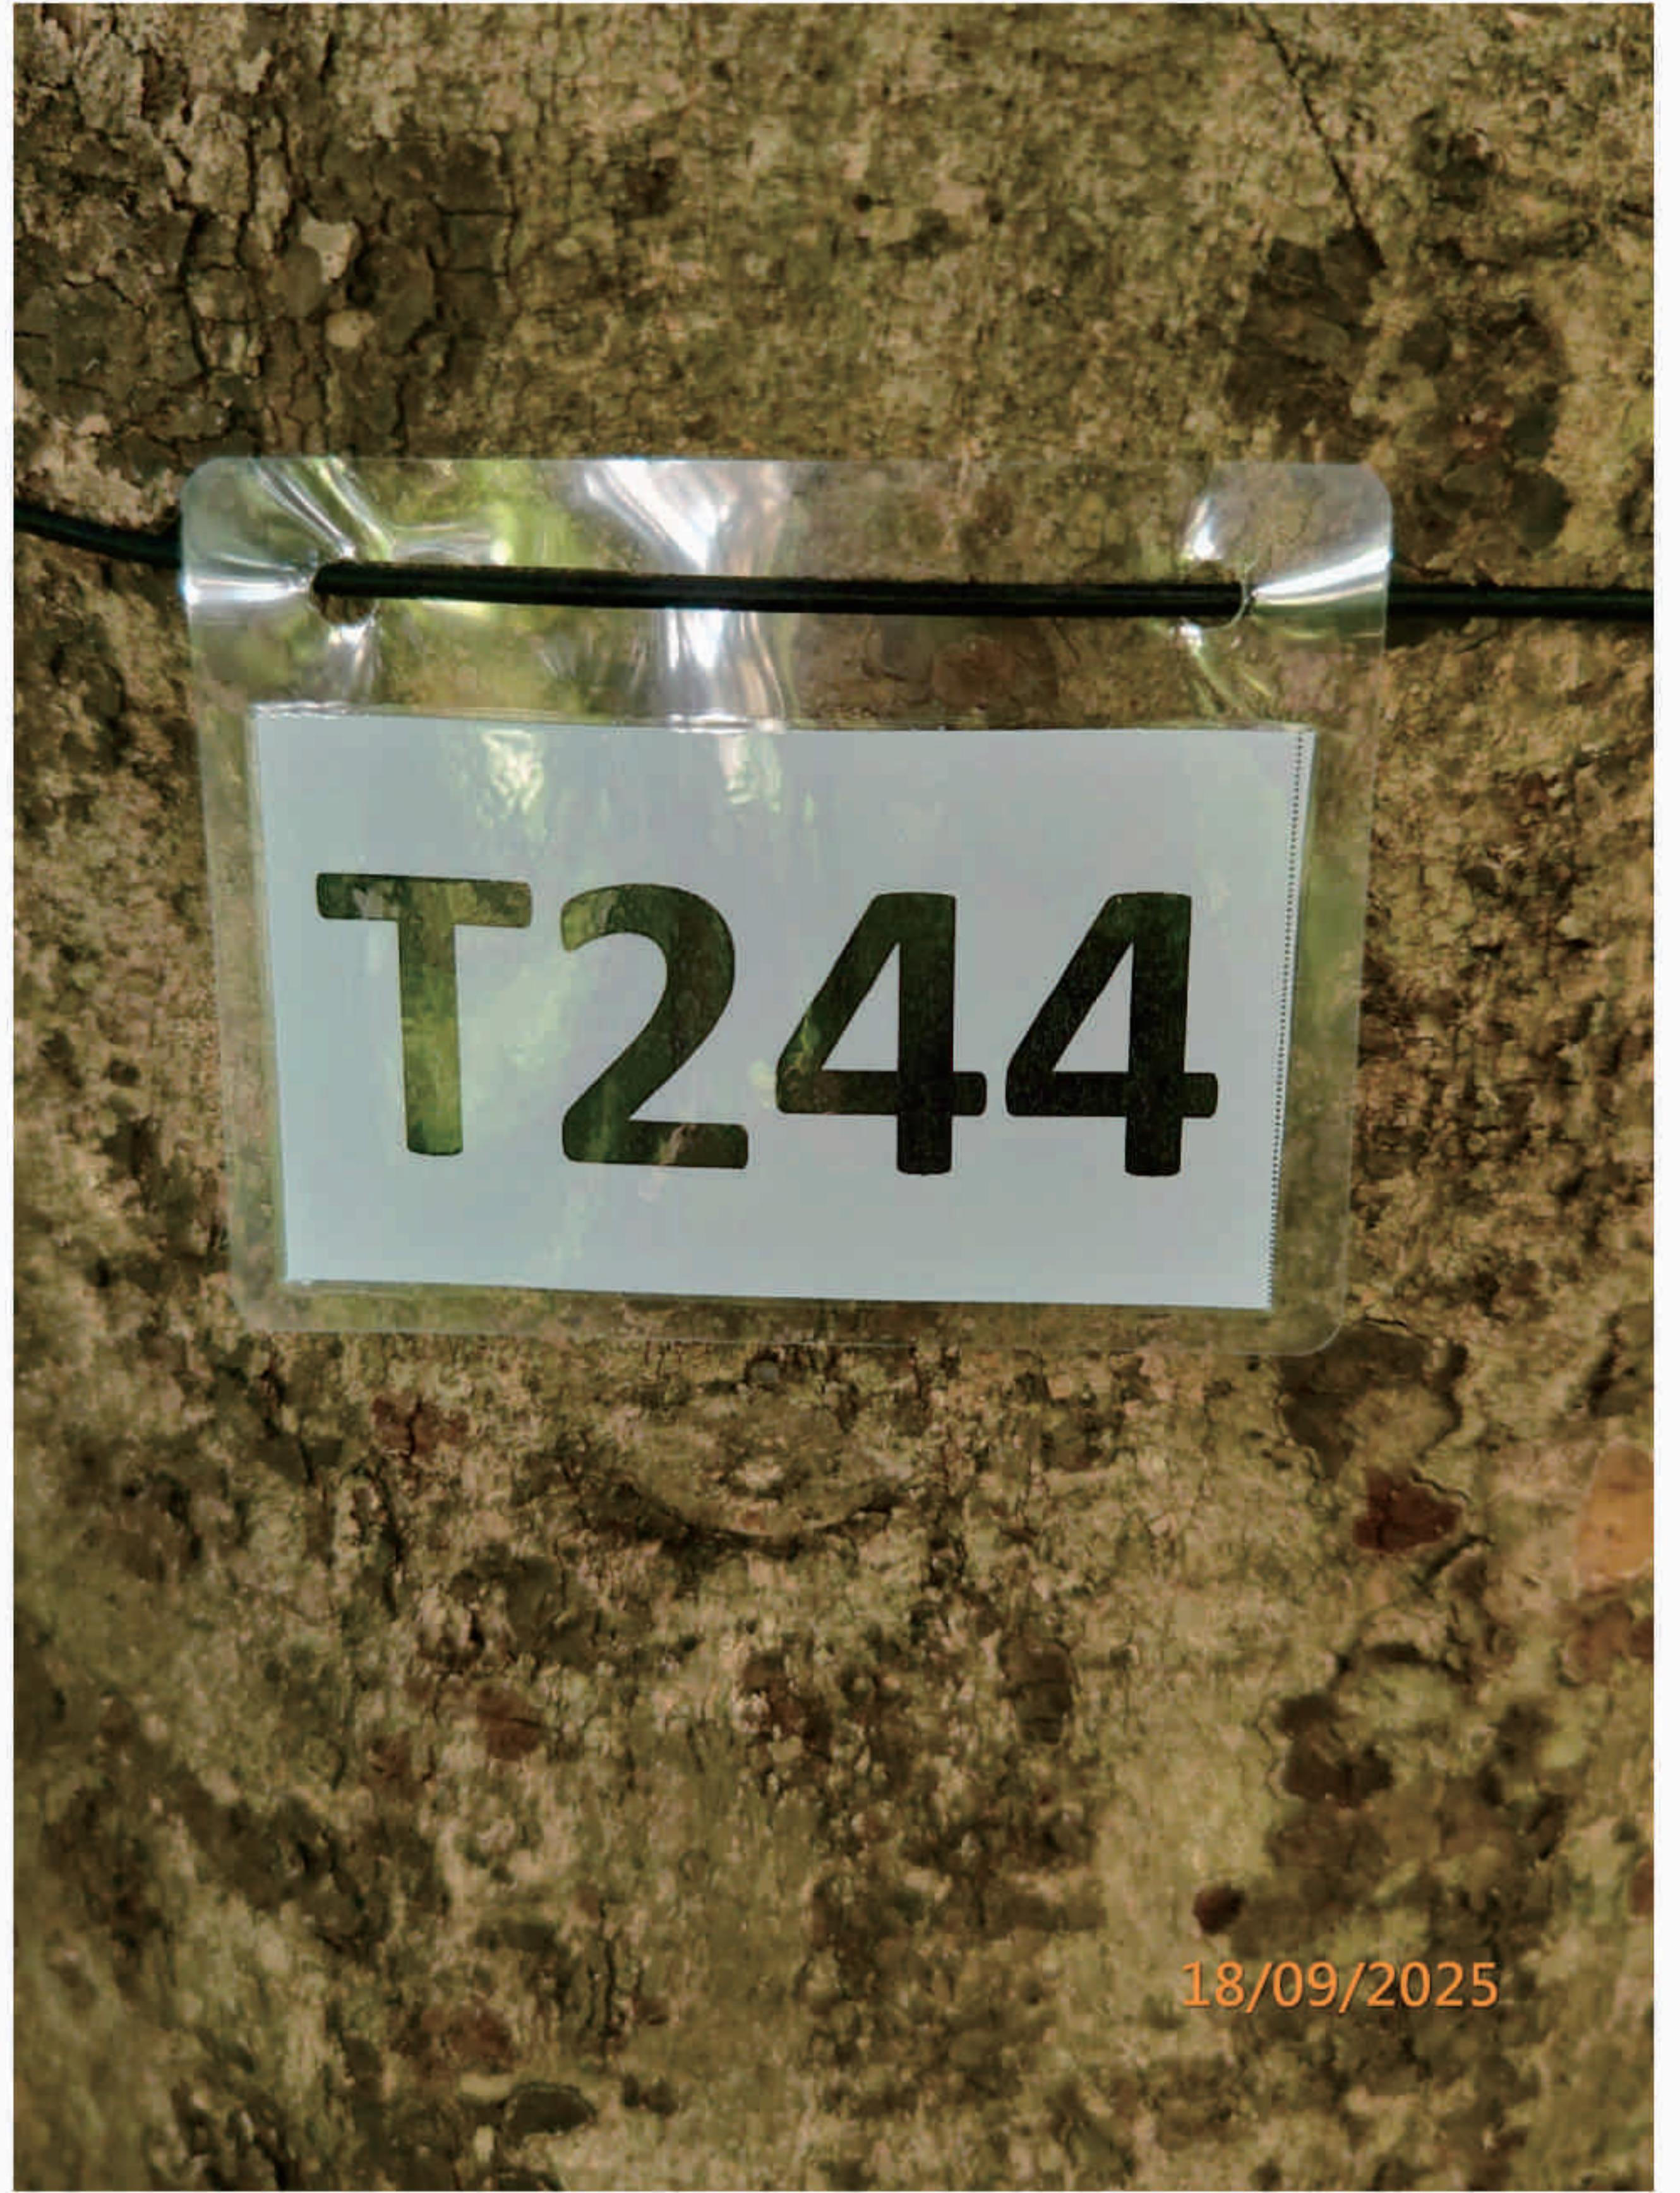
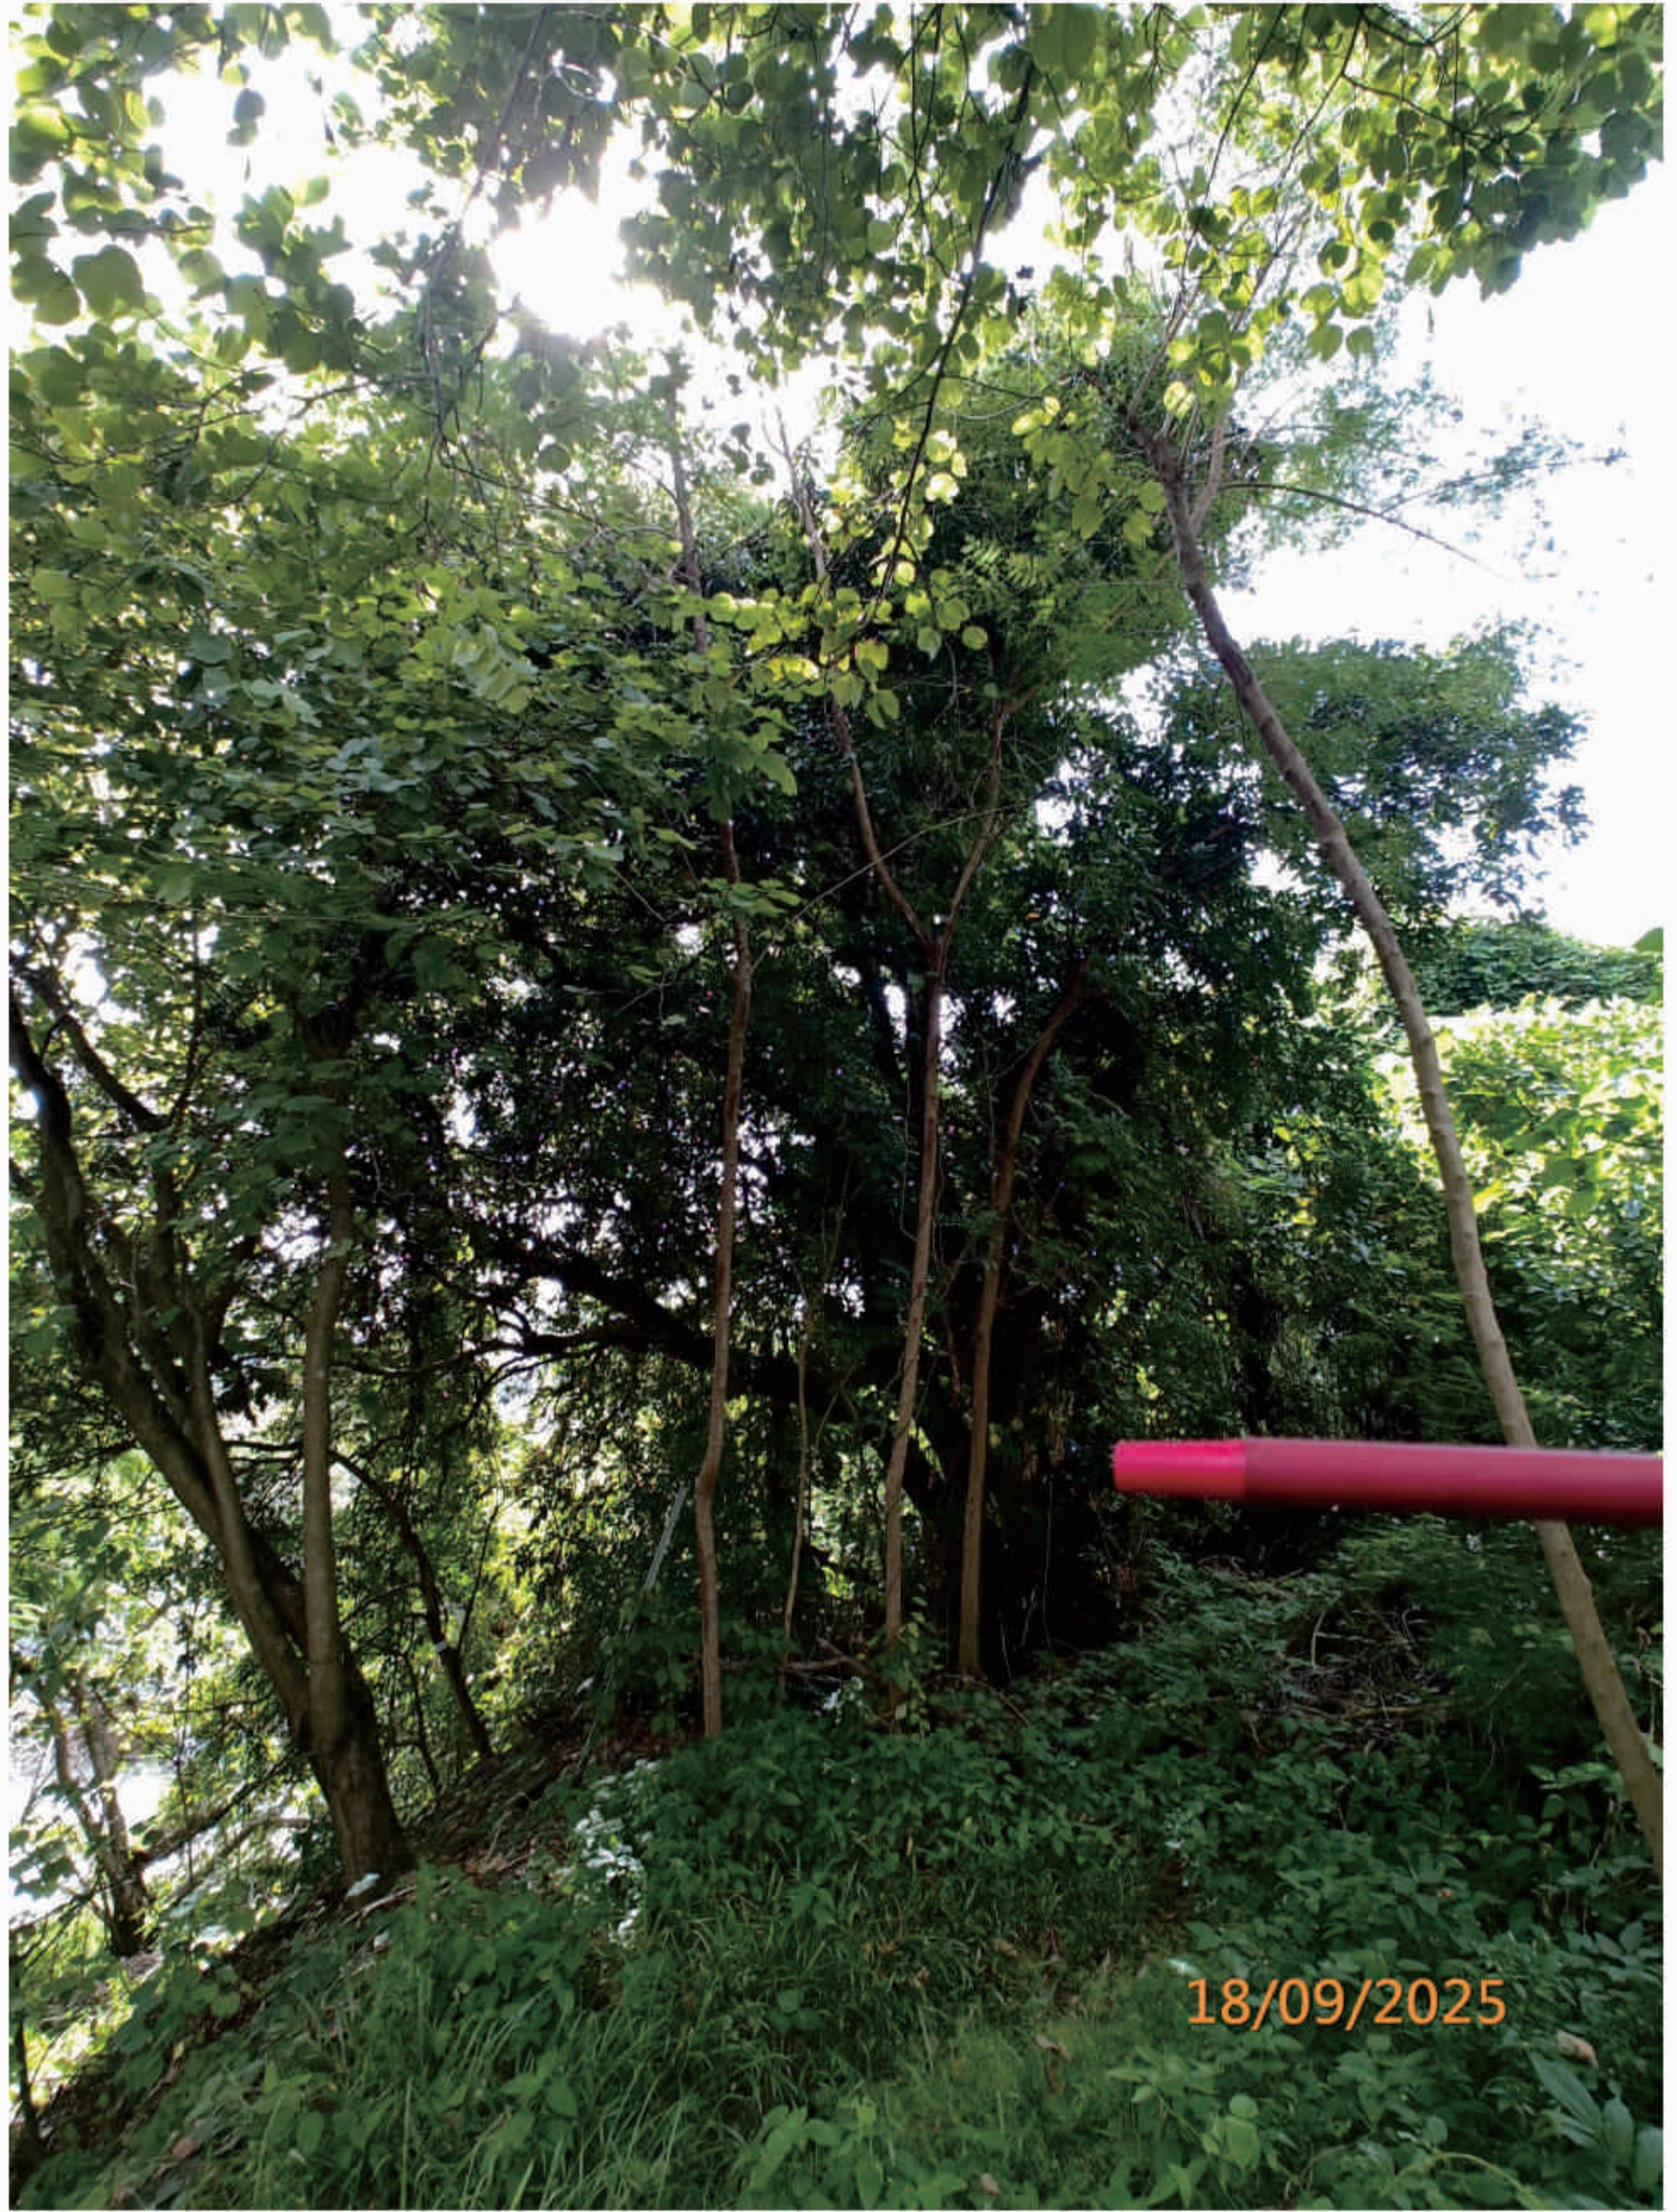
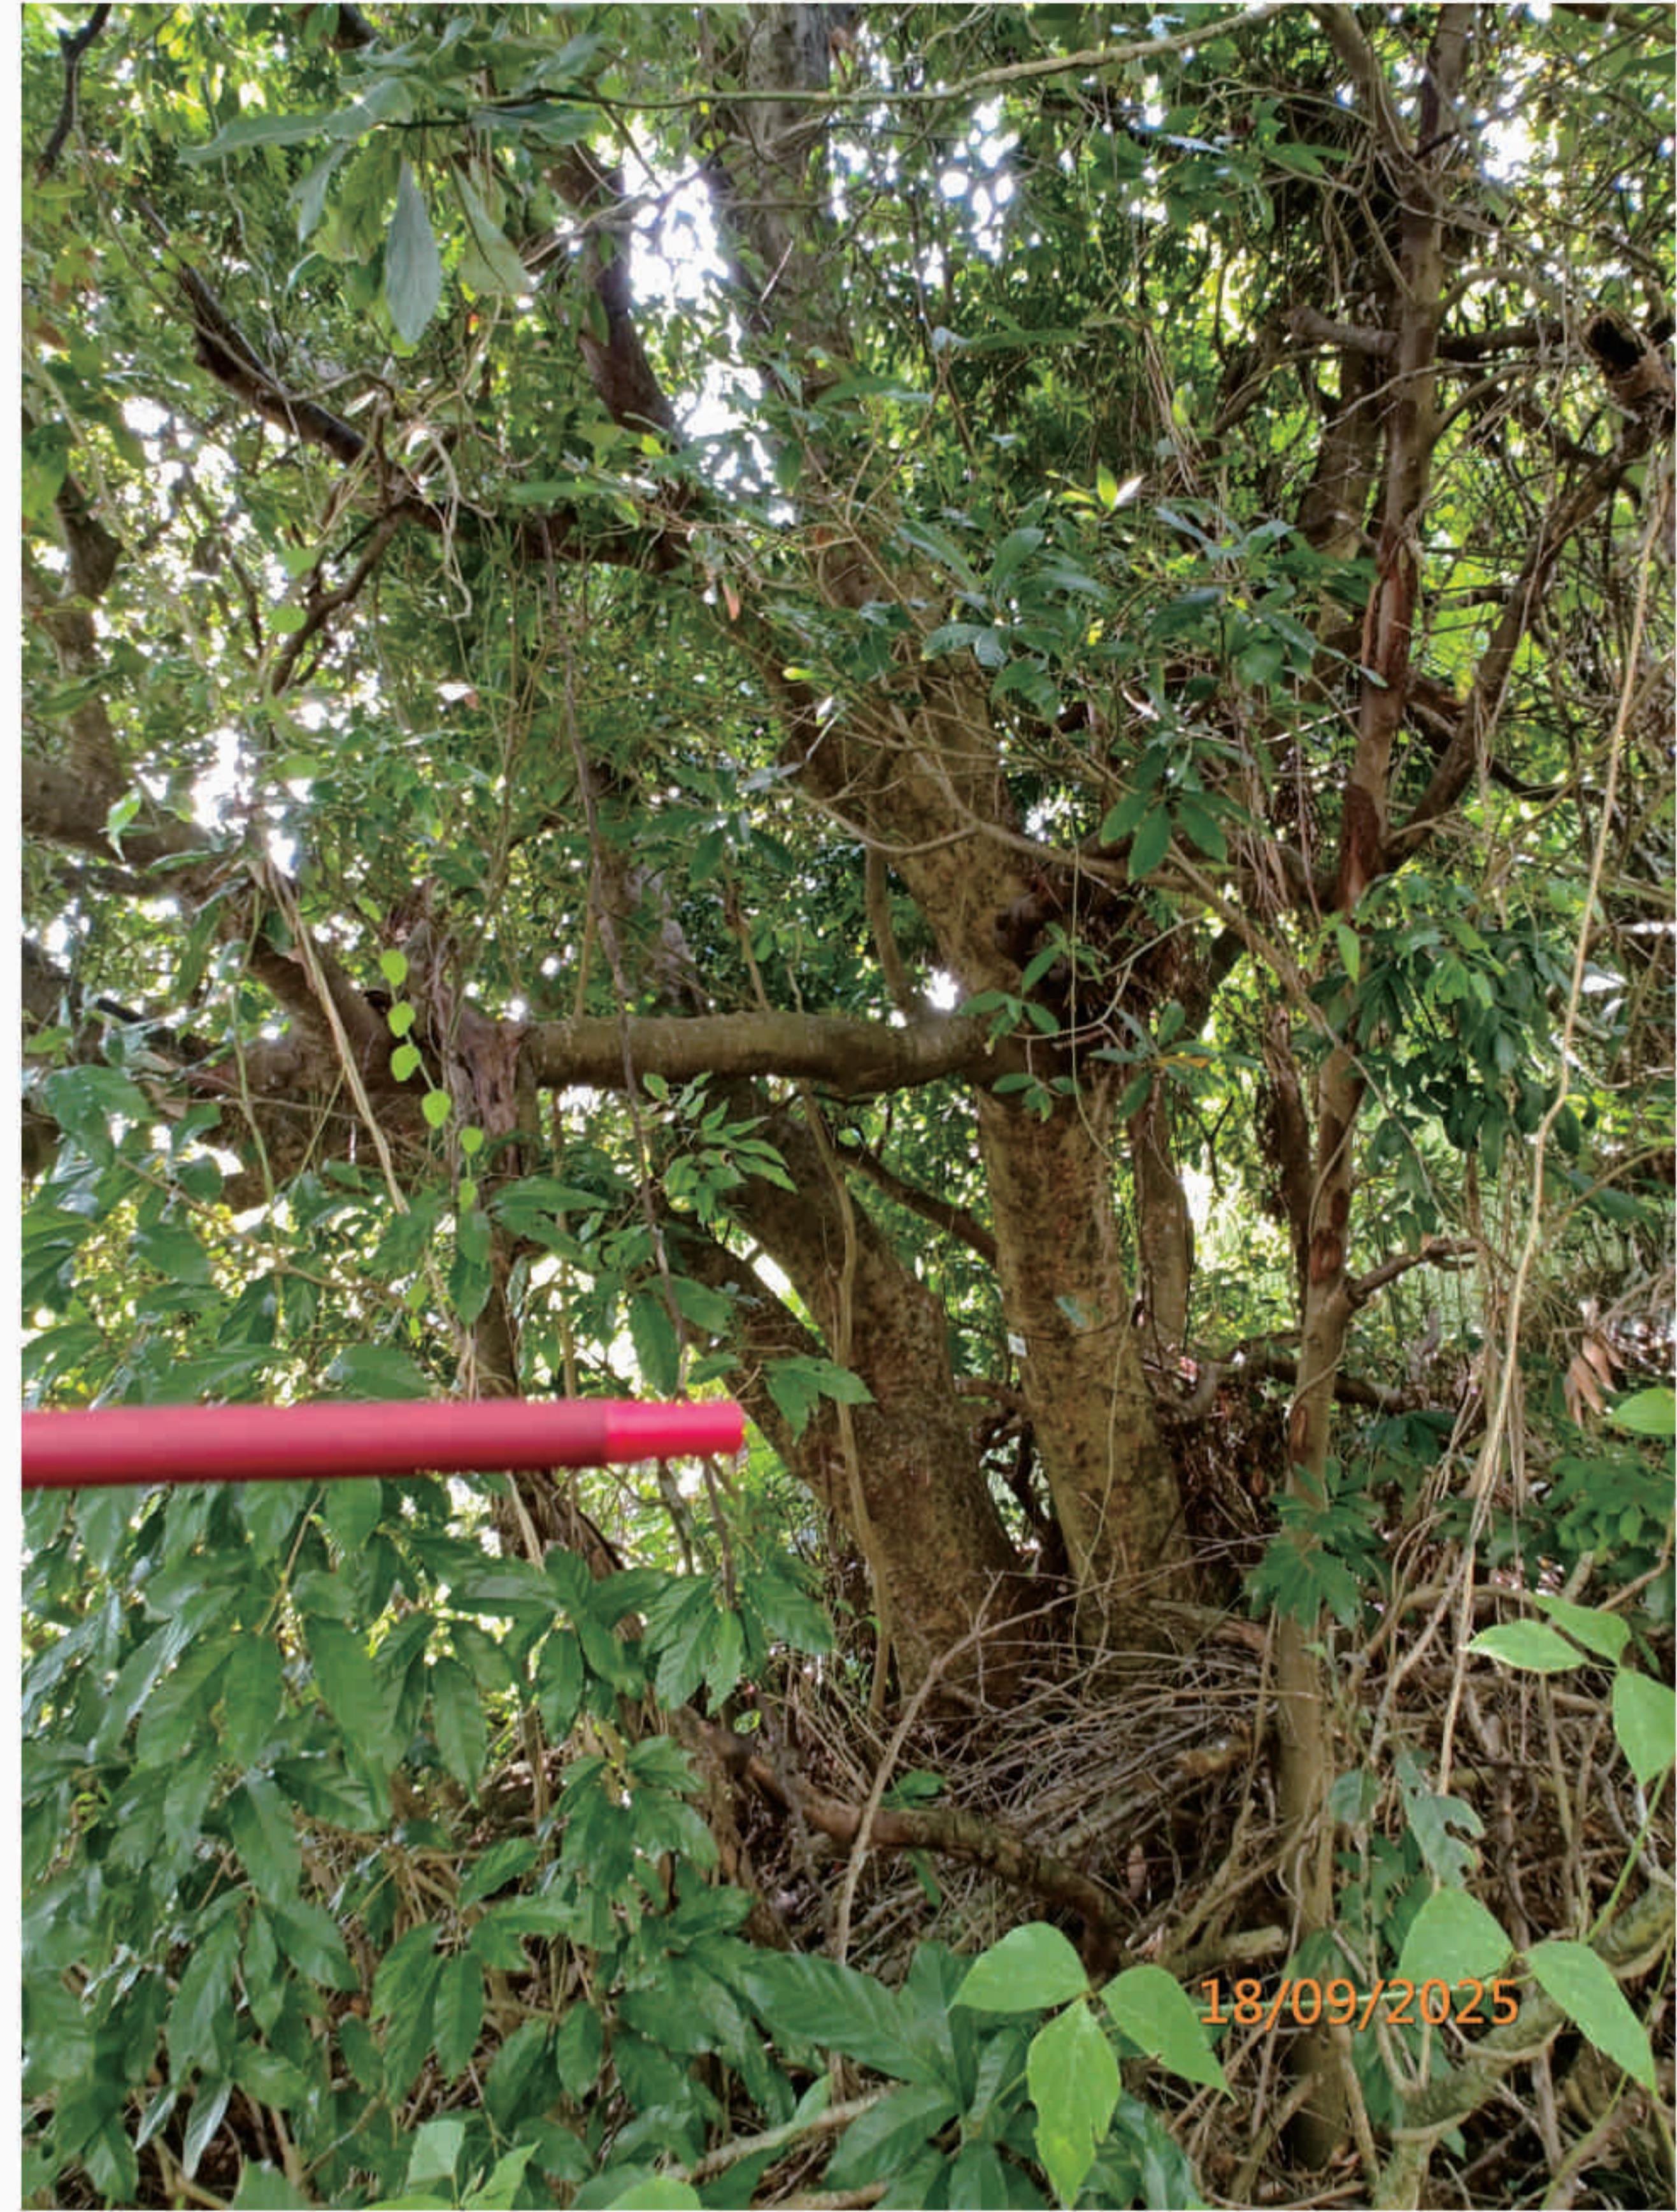
T244 - Overview (F)

T244 - Trunk (F)

T244 - Decay Branch (F)

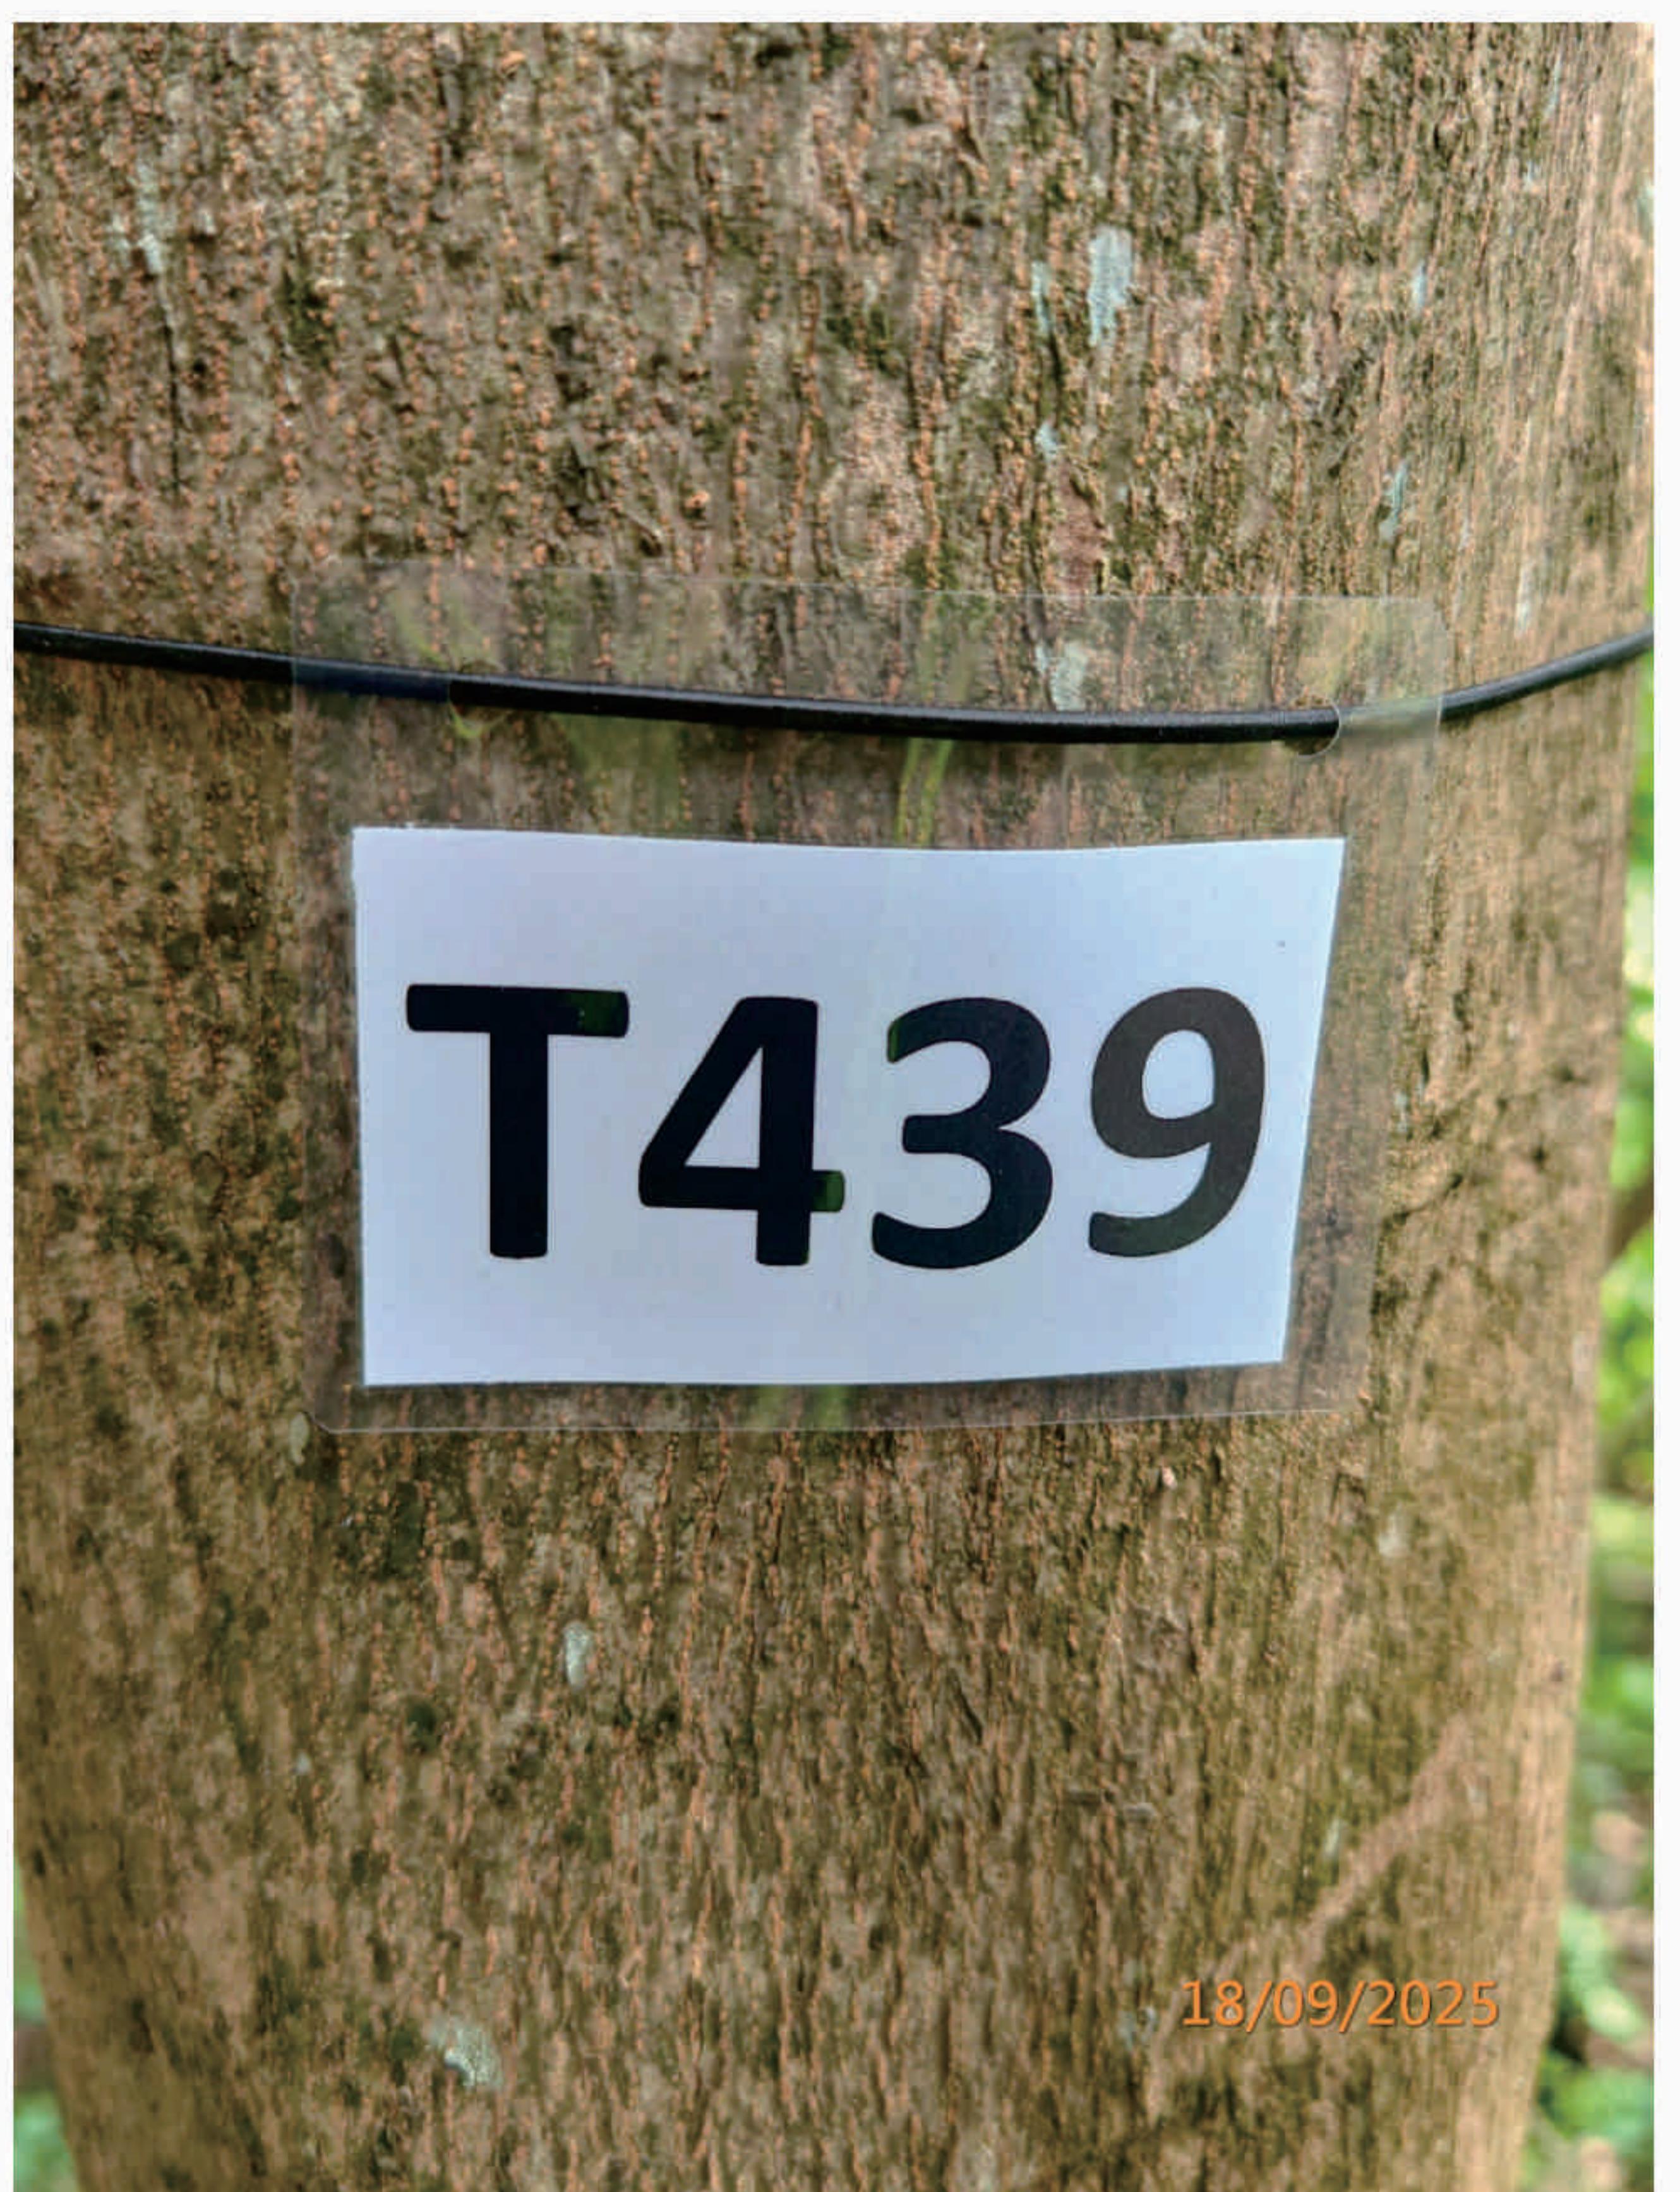
T439 - Label (F)

4.10 Another **8** disturbed trees, namely **T434**, **A08**, **A09** – *Bauhinia purpurea*, **T439**, **T441**, **A06** – *Delonix regia* and **T440**, **T442** – *Lagerstroemia speciosa* have exhibited poor tree form or health conditions. Transplanting these trees would require significant deformation, which would likely result in irreversible damage to their form. It is proposed to fell these trees and compensate by planting high-quality replacements.

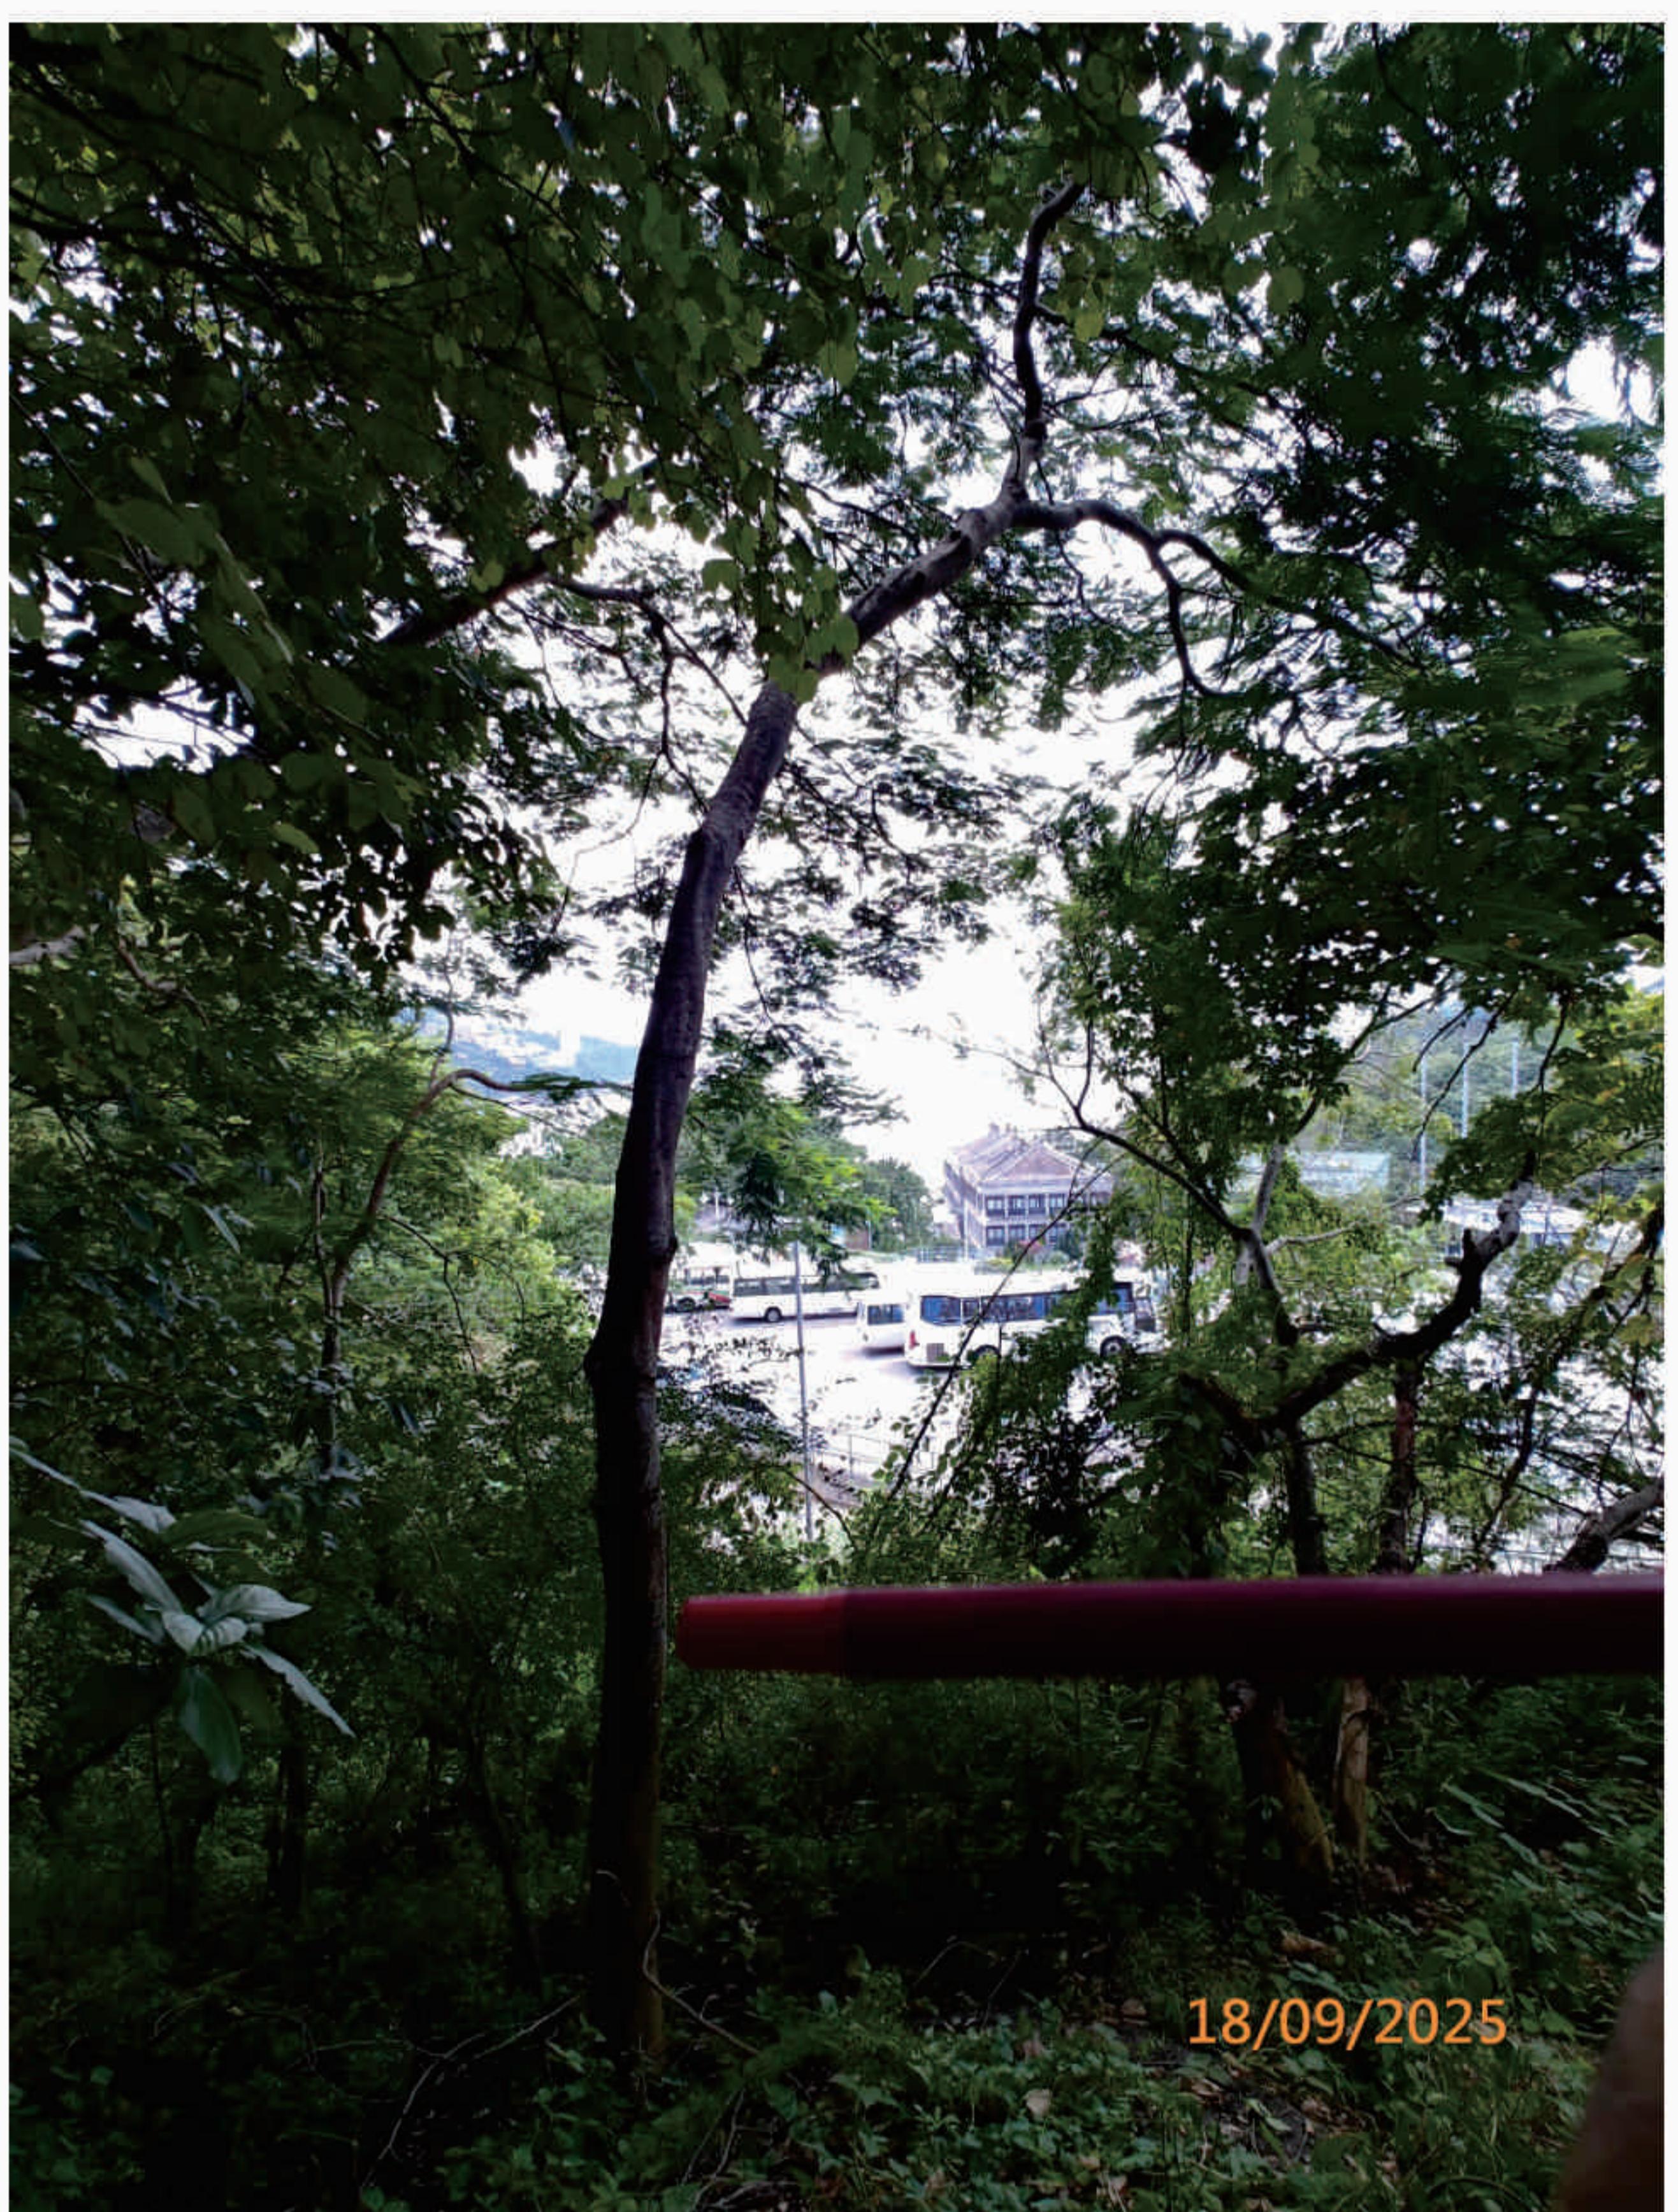
T439 - Overview (F)

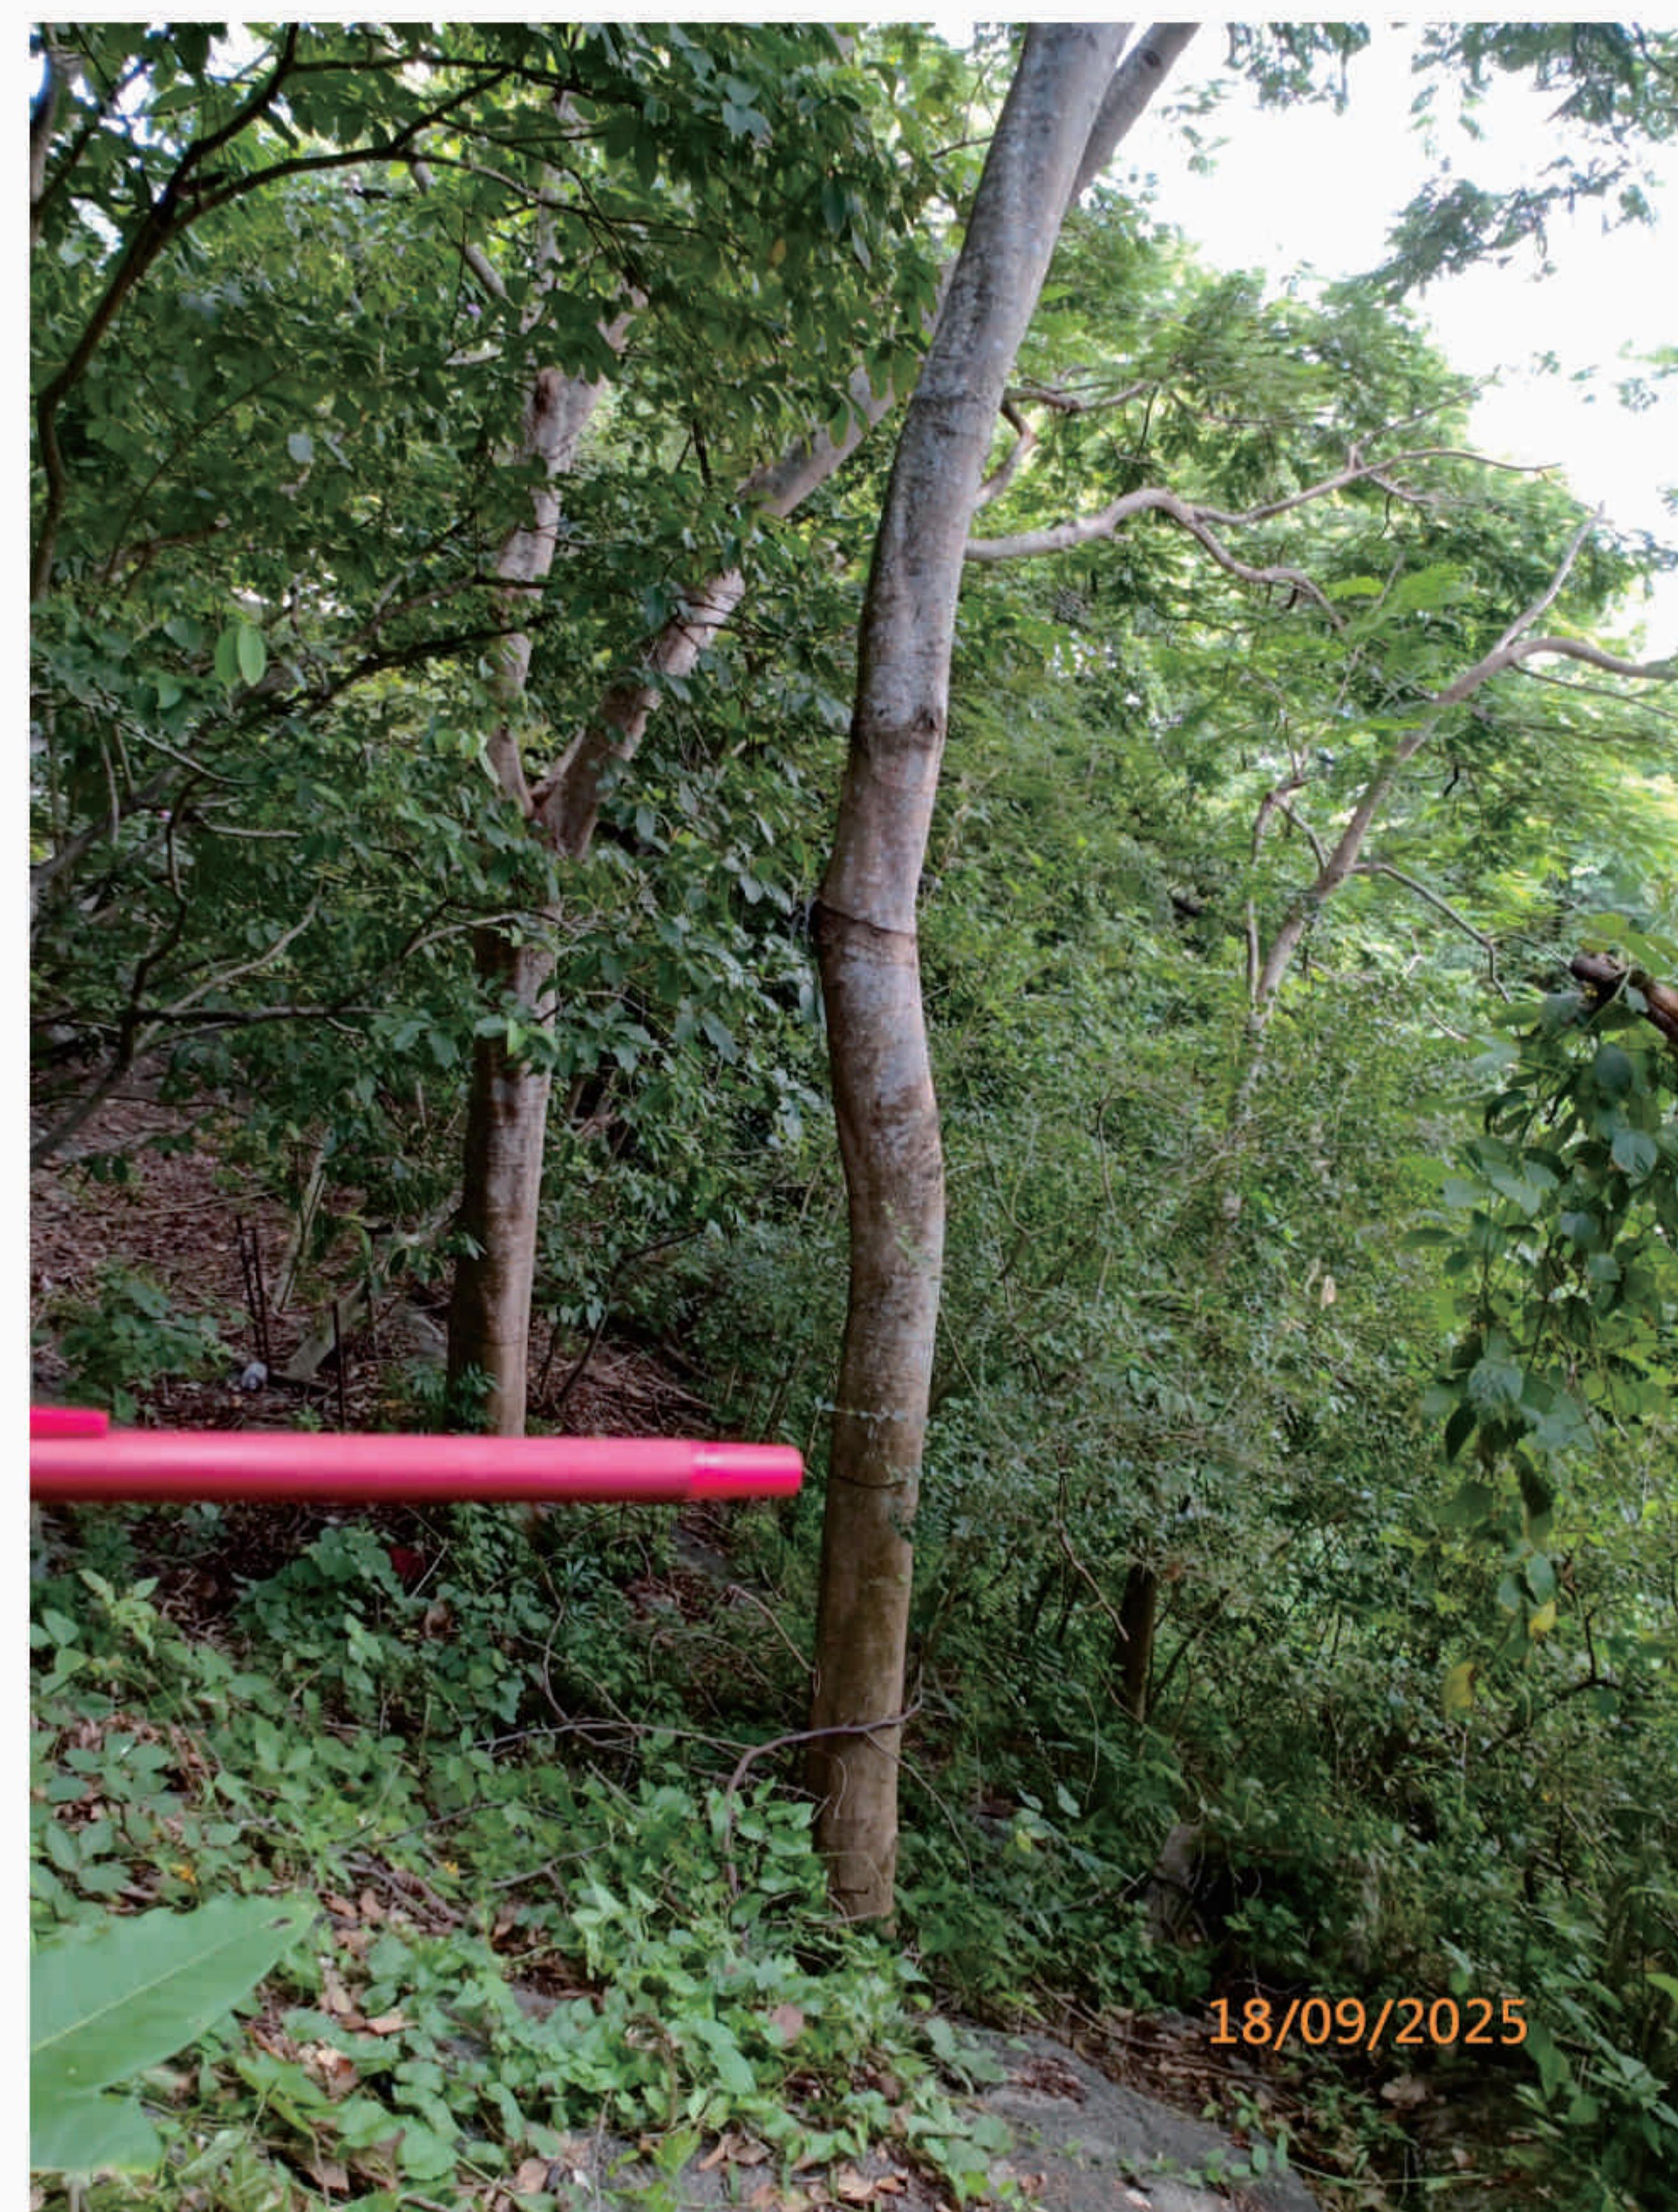
T439 - Trunk (F)
