**PLANNING APPLICATION FOR
PROPOSED UTILITY INSTALLATION FOR PRIVATE PROJECT
AT GOVERNMENT LAND ADJOINING 44 STANLEY VILLAGE ROAD,
STANLEY, HON KONG**

Tree Survey Report

Date: 13 November 2025

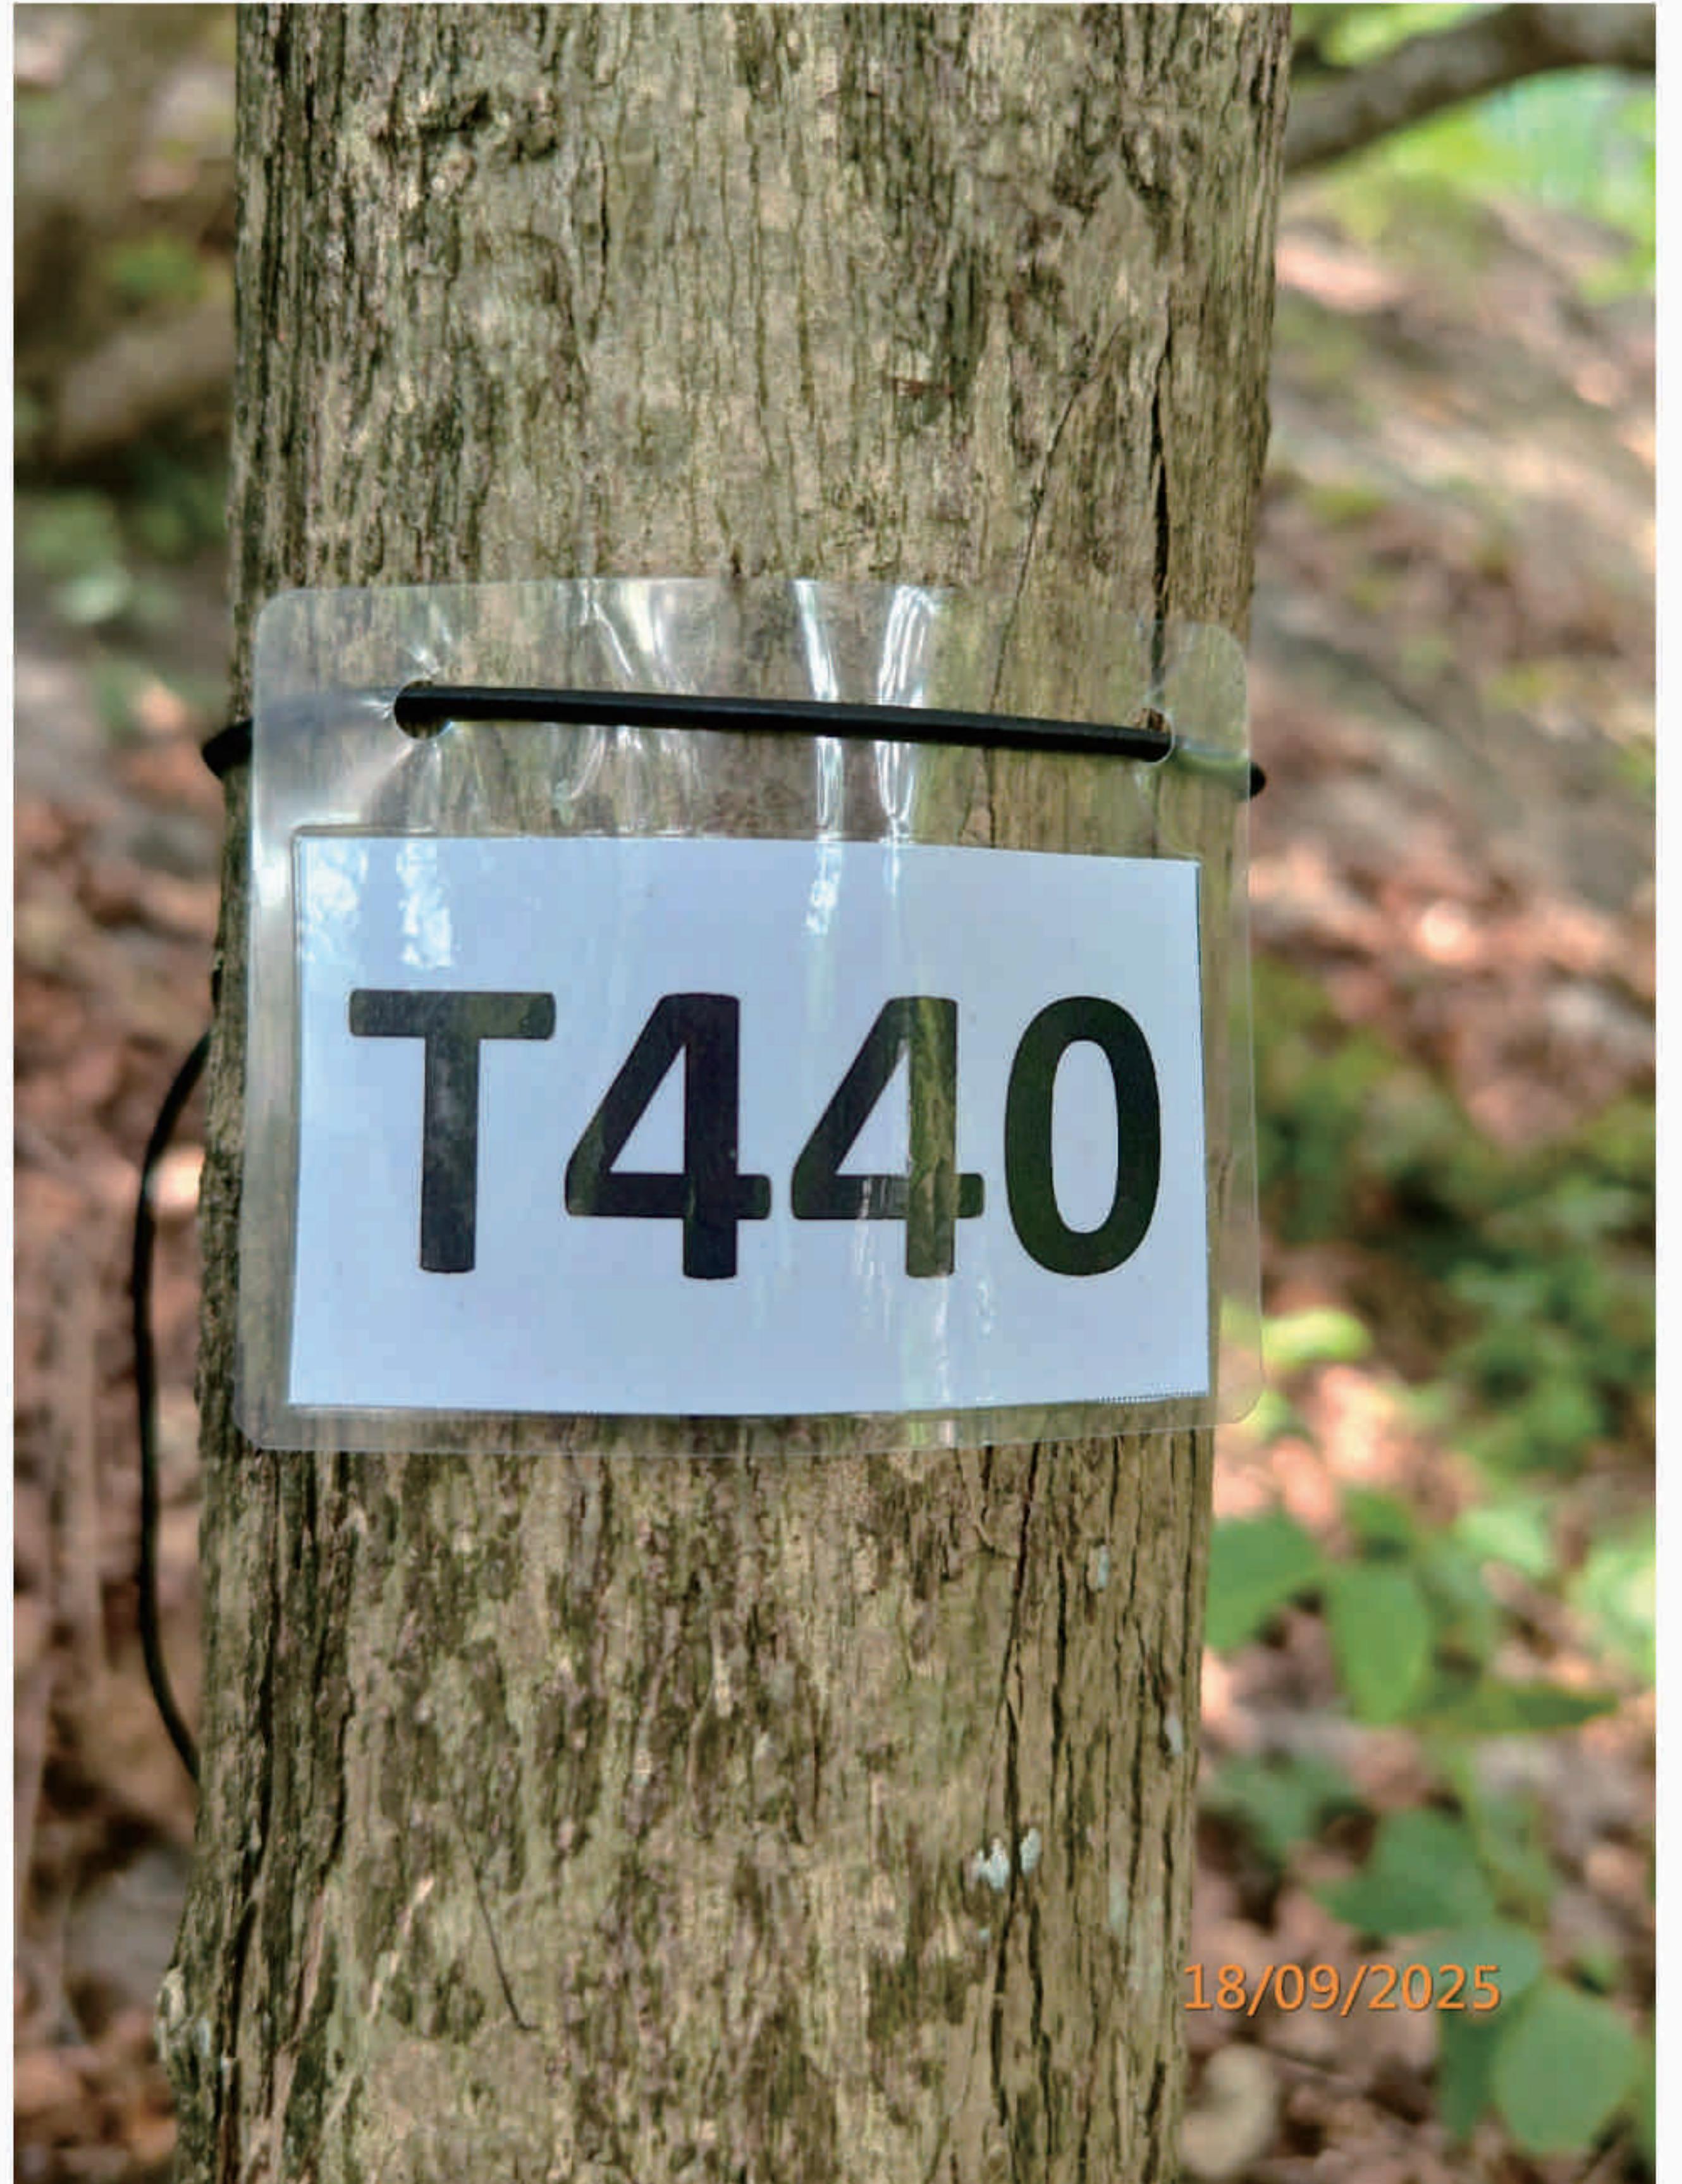
T440 - Label (F)

4.10 Another **8** disturbed trees, namely **T434**, **A08**, **A09** – *Bauhinia purpurea*, **T439**, **T441**, **A06** – *Delonix regia* and **T440**, **T442** – *Lagerstroemia speciosa* have exhibited poor tree form or health conditions. Transplanting these trees would require significant deformation, which would likely result in irreversible damage to their form. It is proposed to fell these trees and compensate by planting high-quality replacements.

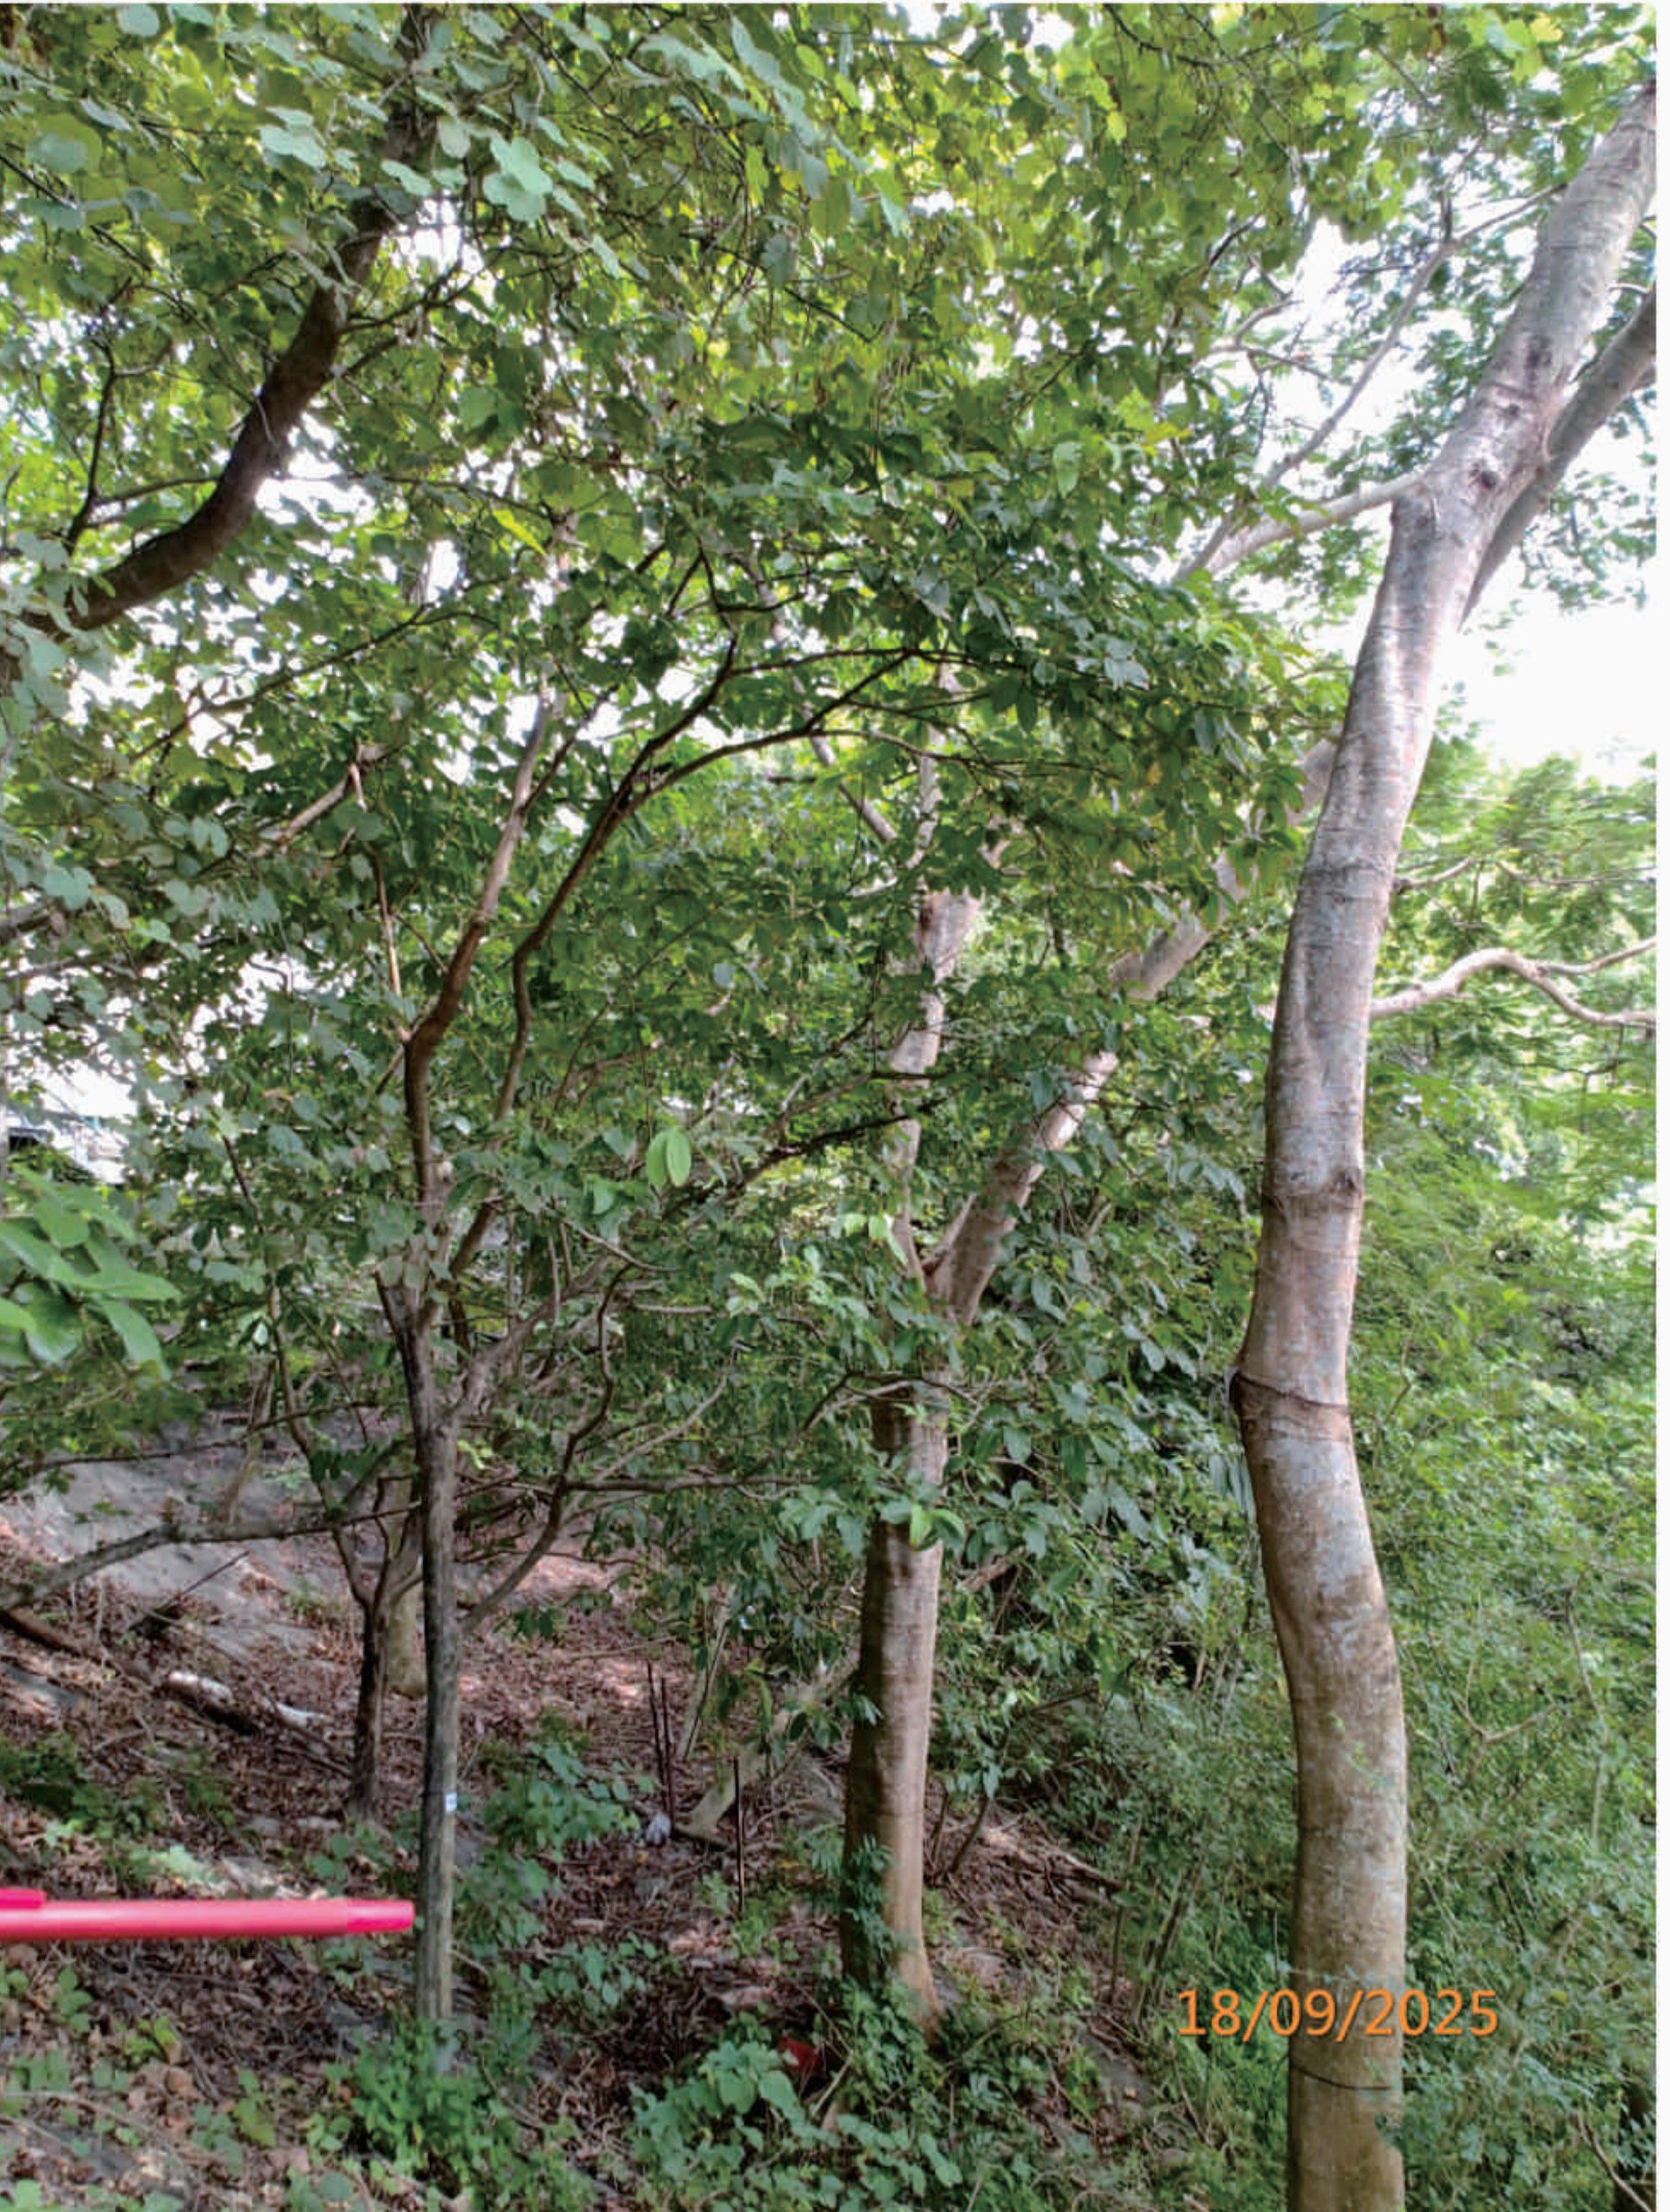
T440 - Overview (F)

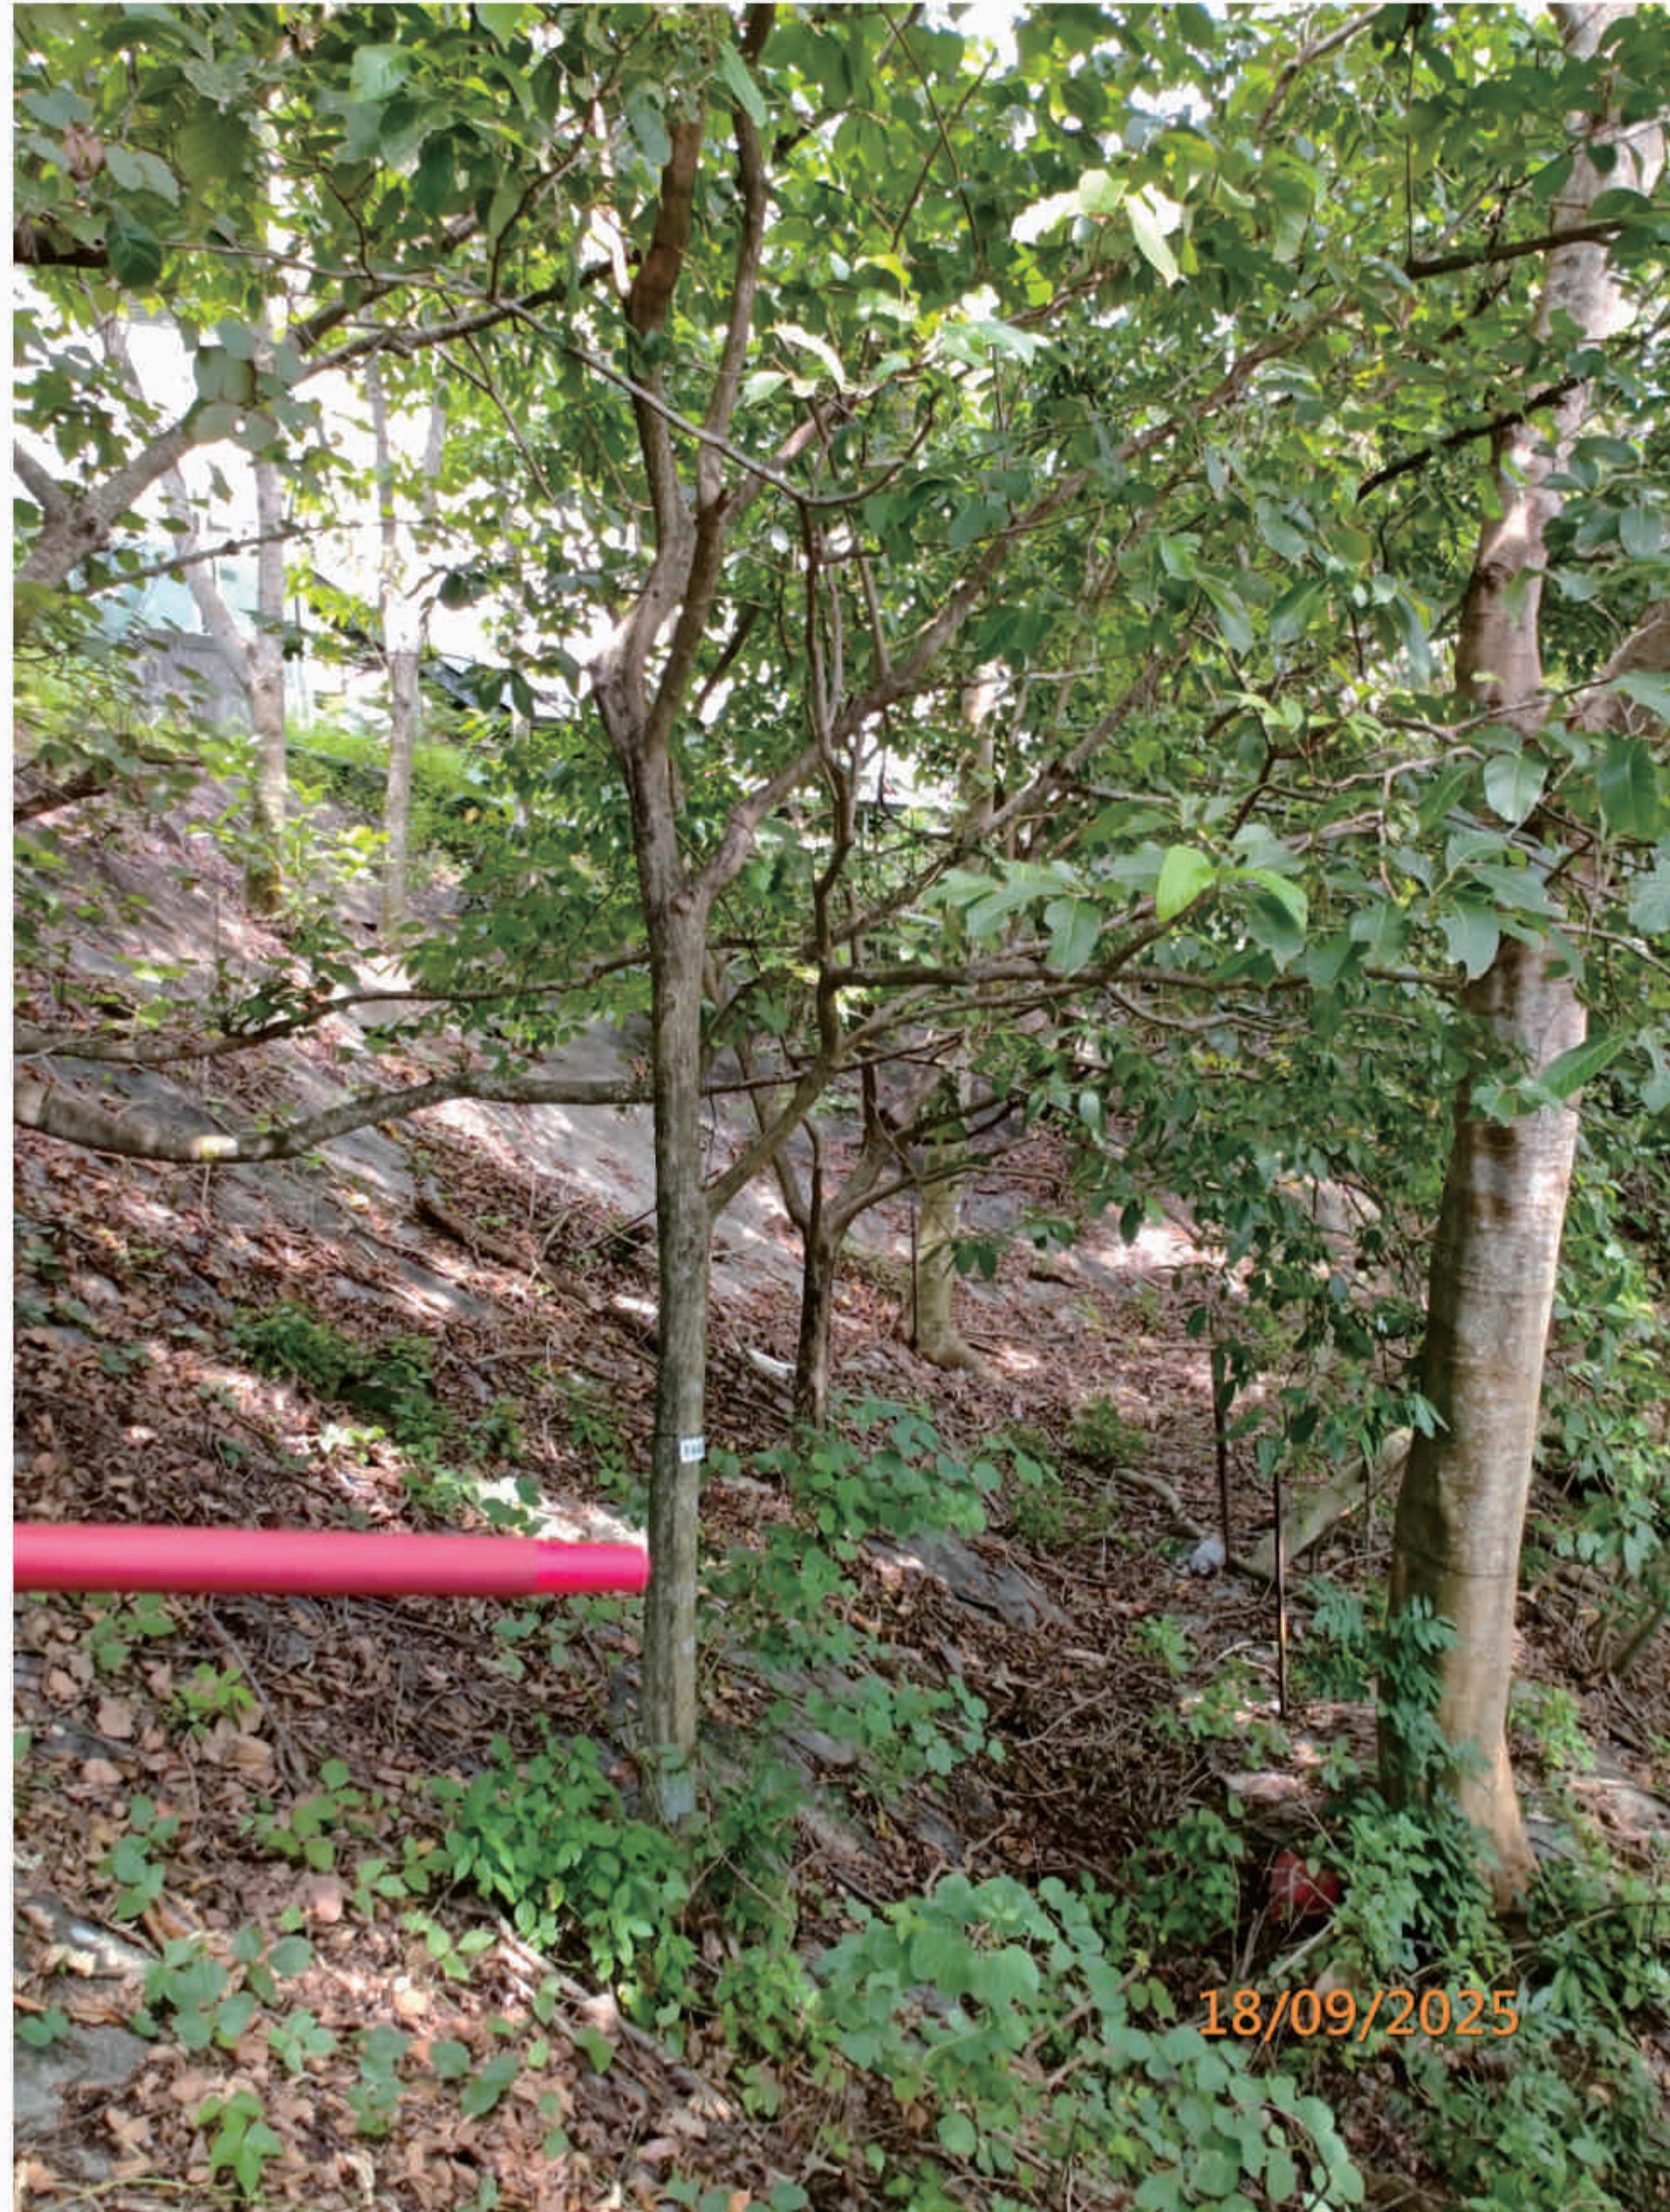
T440 - Trunk (F)

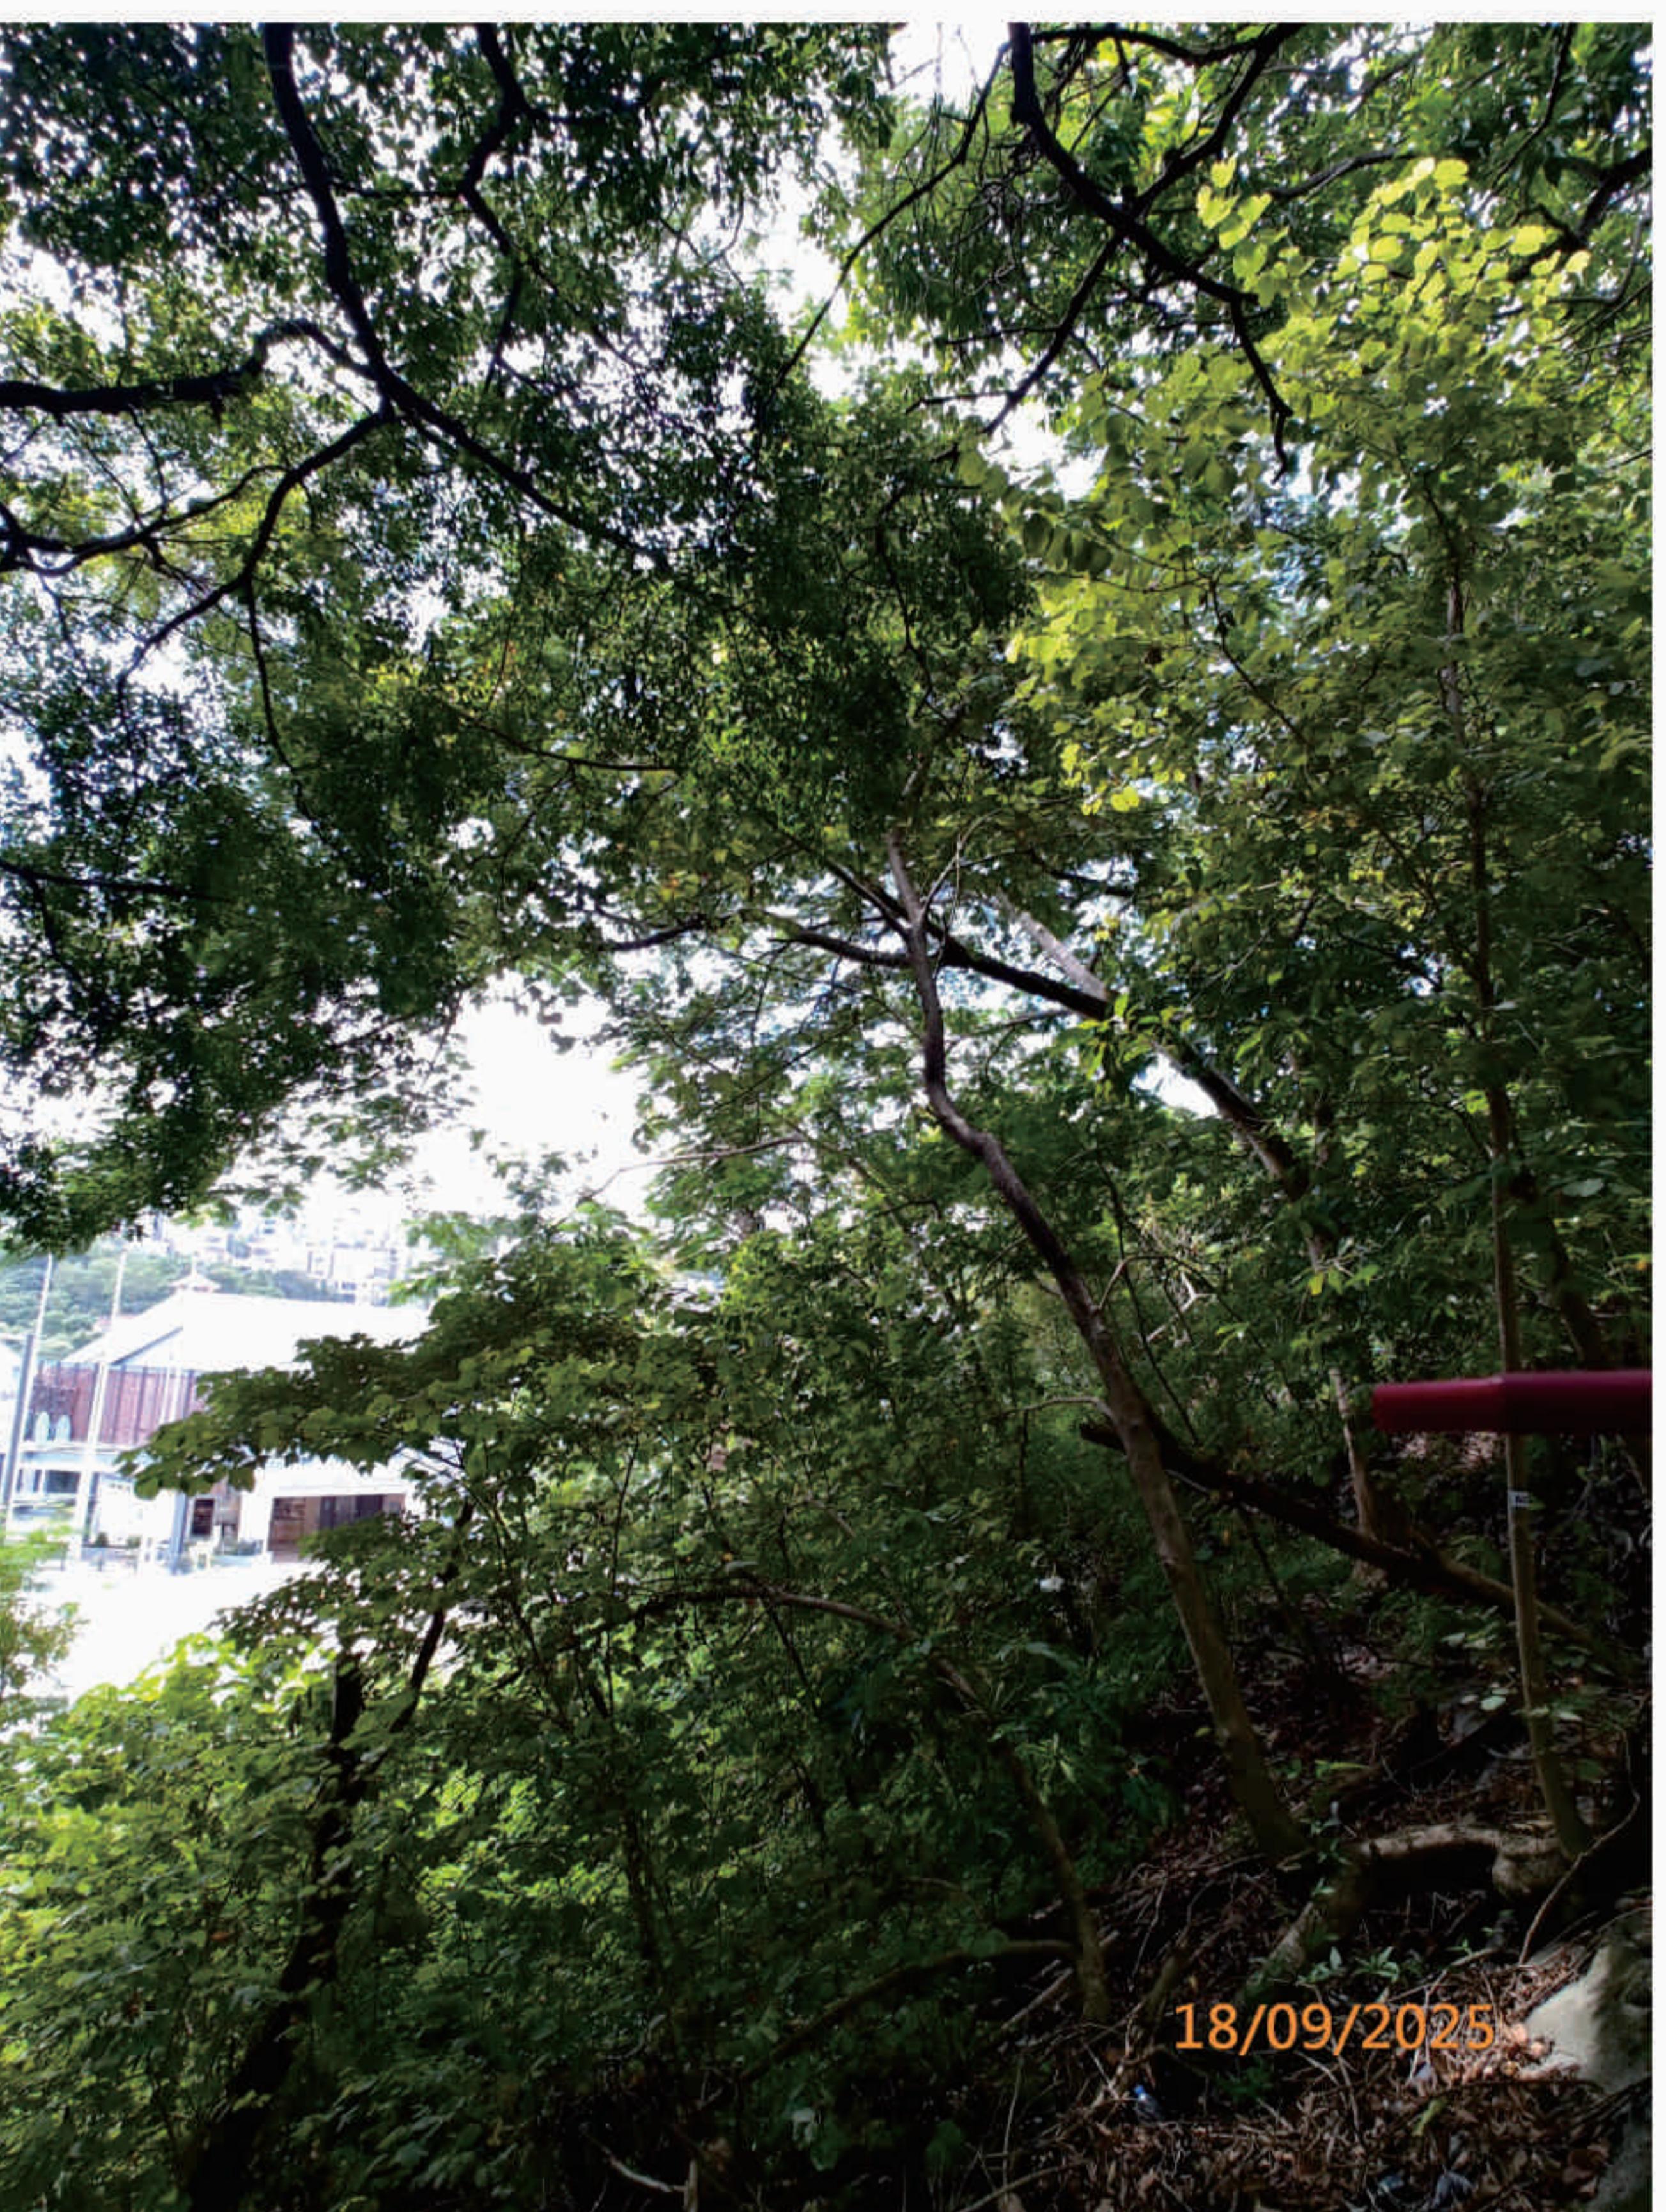
T441 - Overview (F)

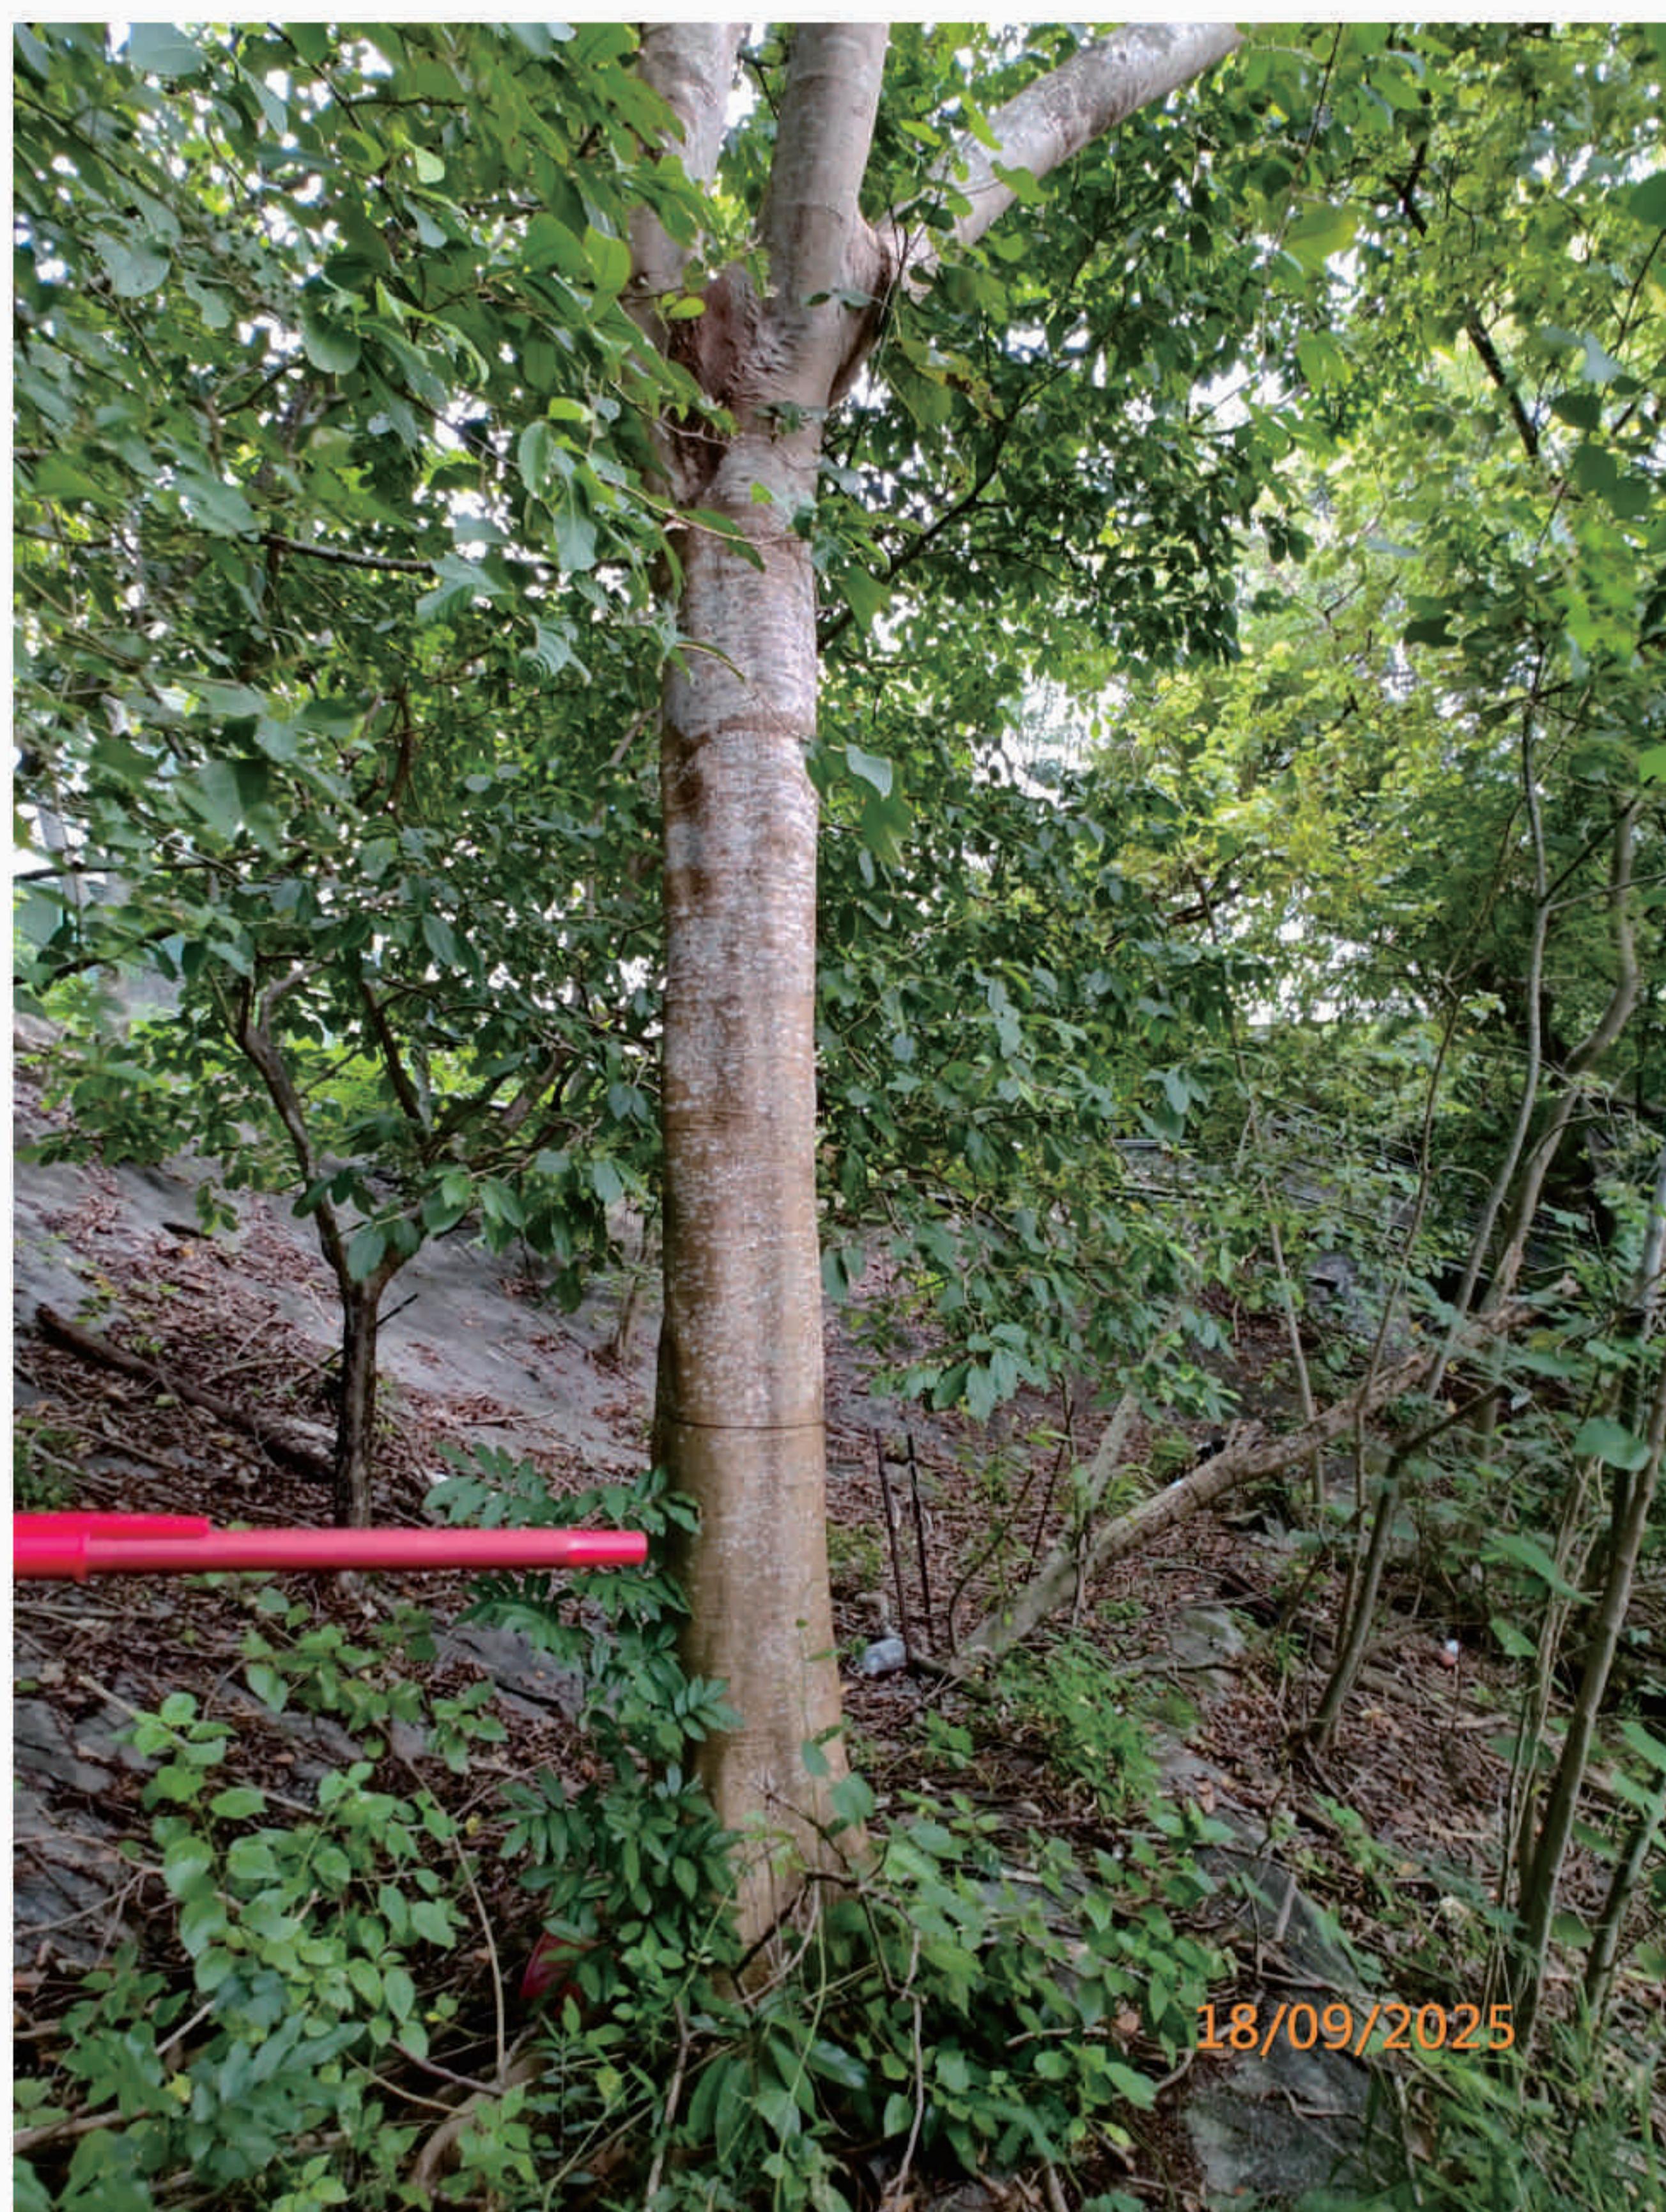
T441 - Trunk (F)

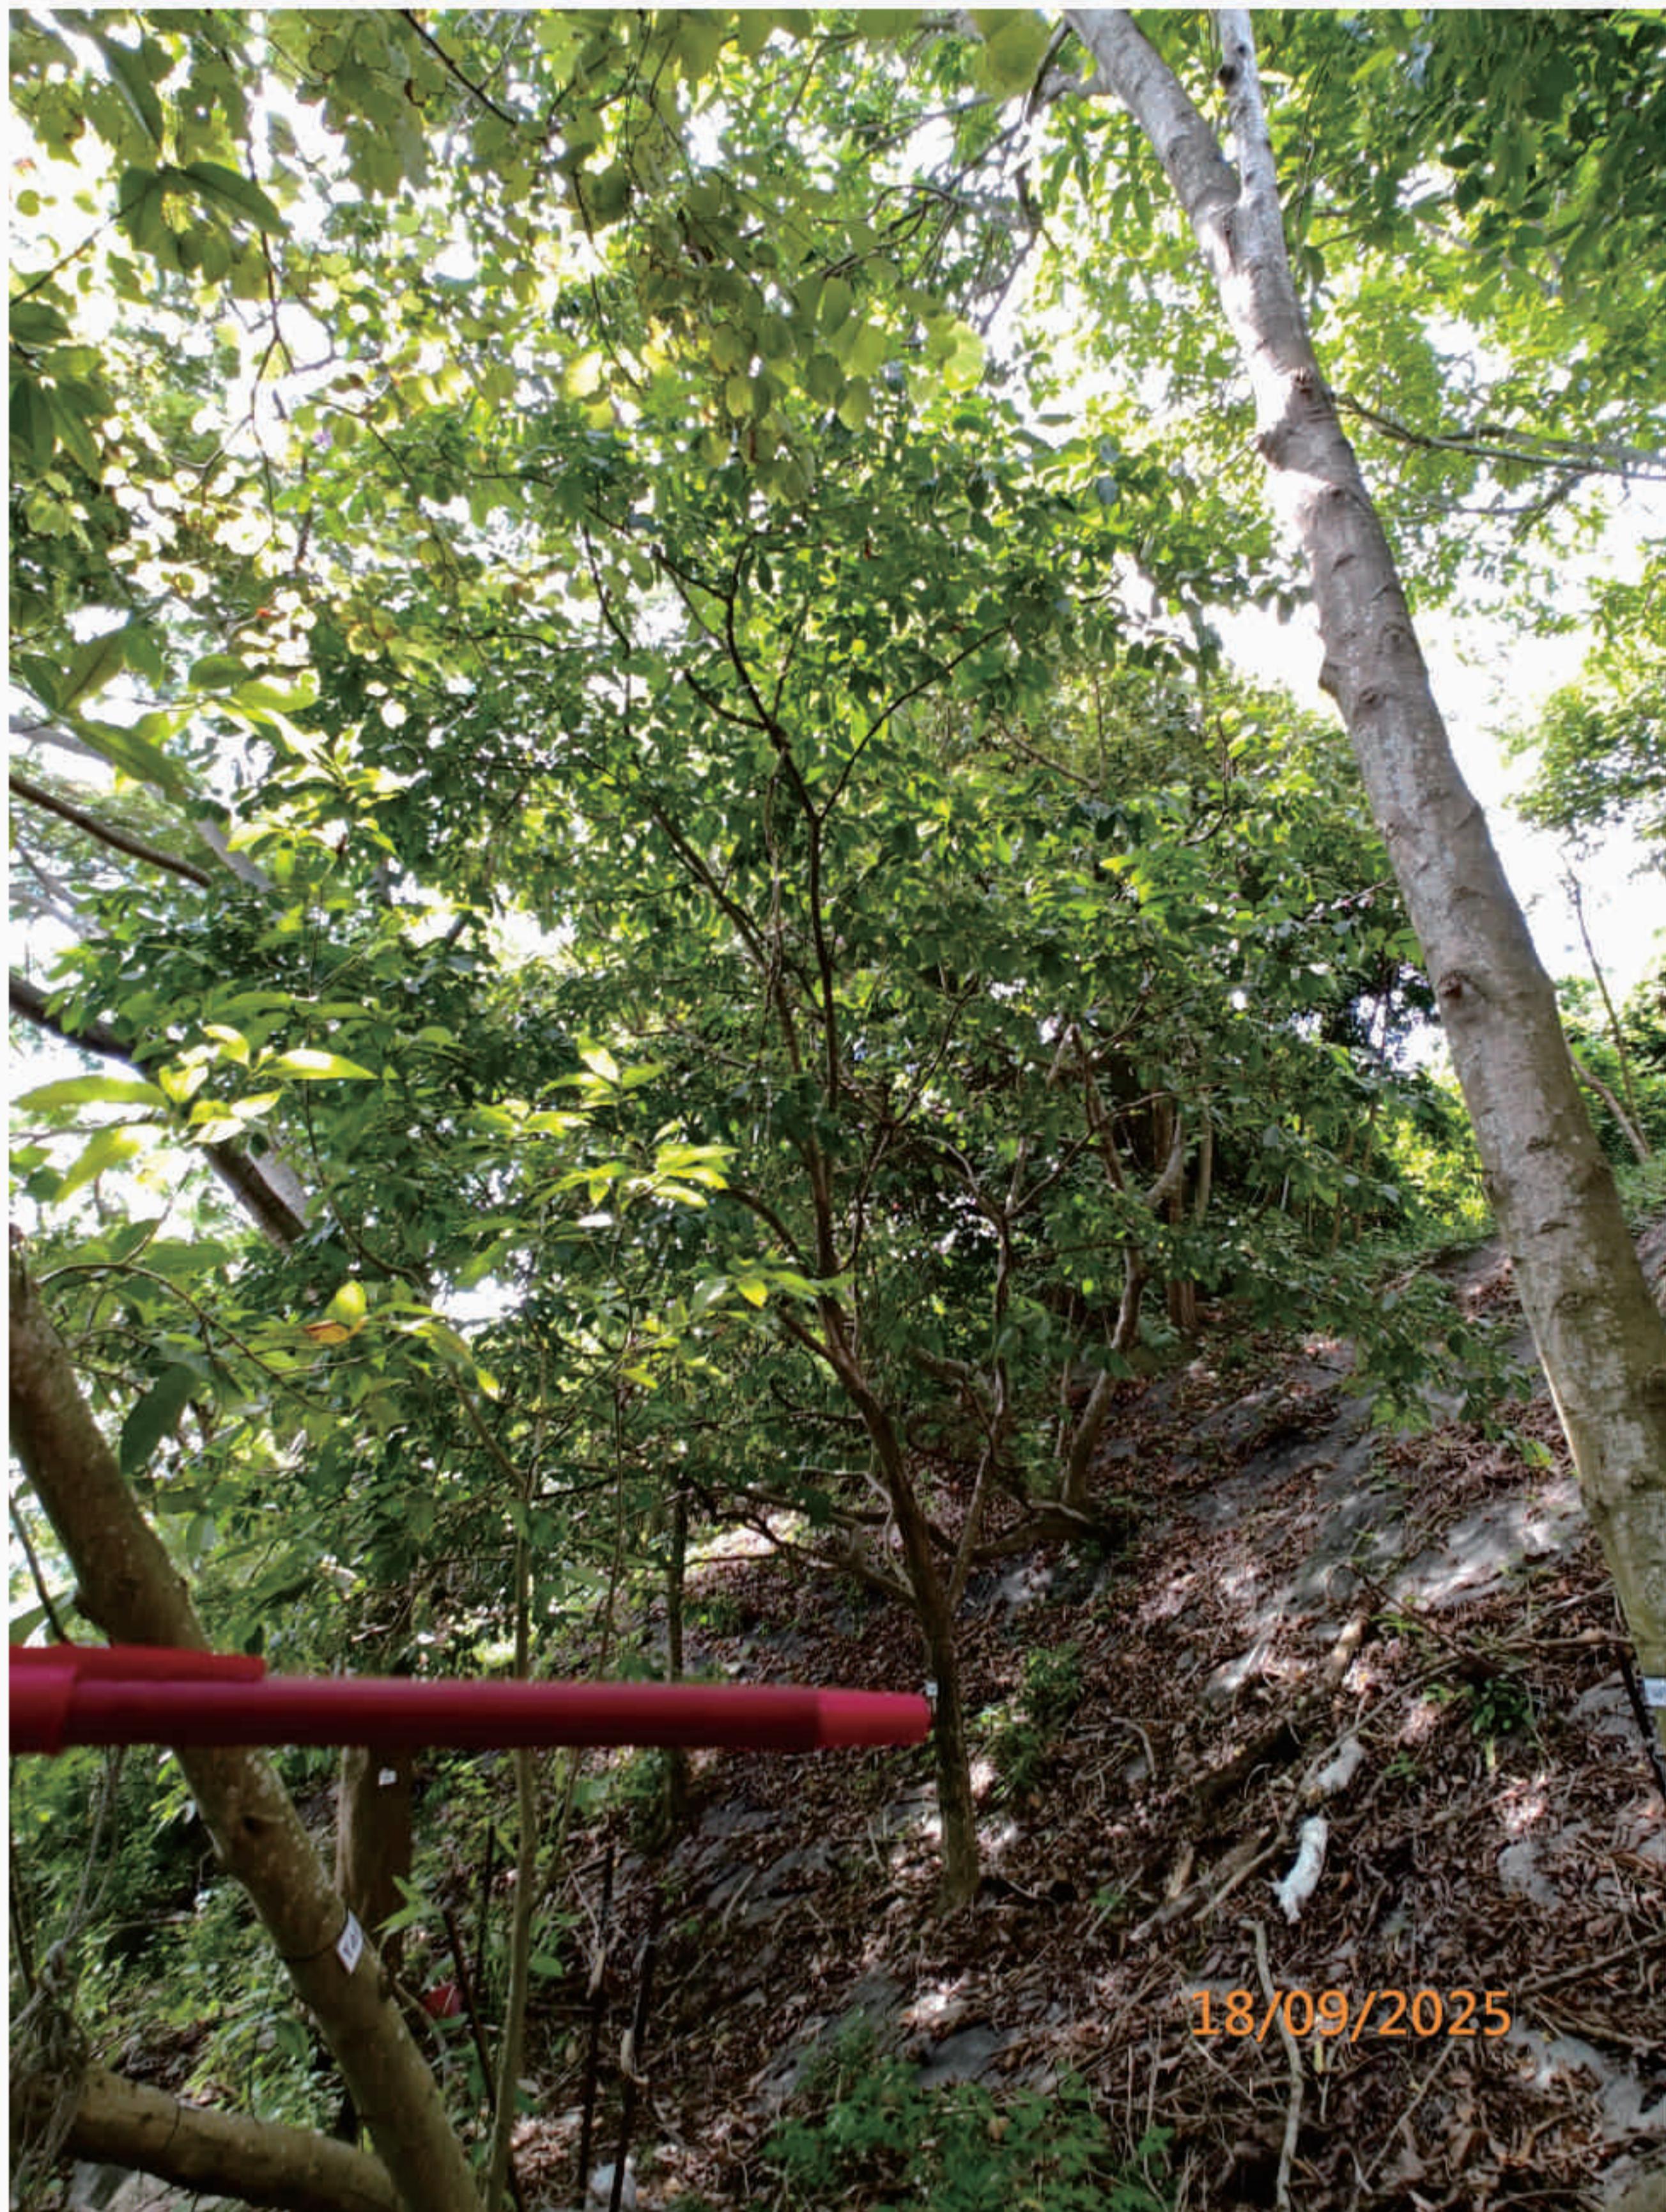
T442 - Overview (F)
