**PLANNING APPLICATION FOR
PROPOSED UTILITY INSTALLATION FOR PRIVATE PROJECT
AT GOVERNMENT LAND ADJOINING 44 STANLEY VILLAGE ROAD,
STANLEY, HON KONG**

Tree Survey Report

Date: 13 November 2025

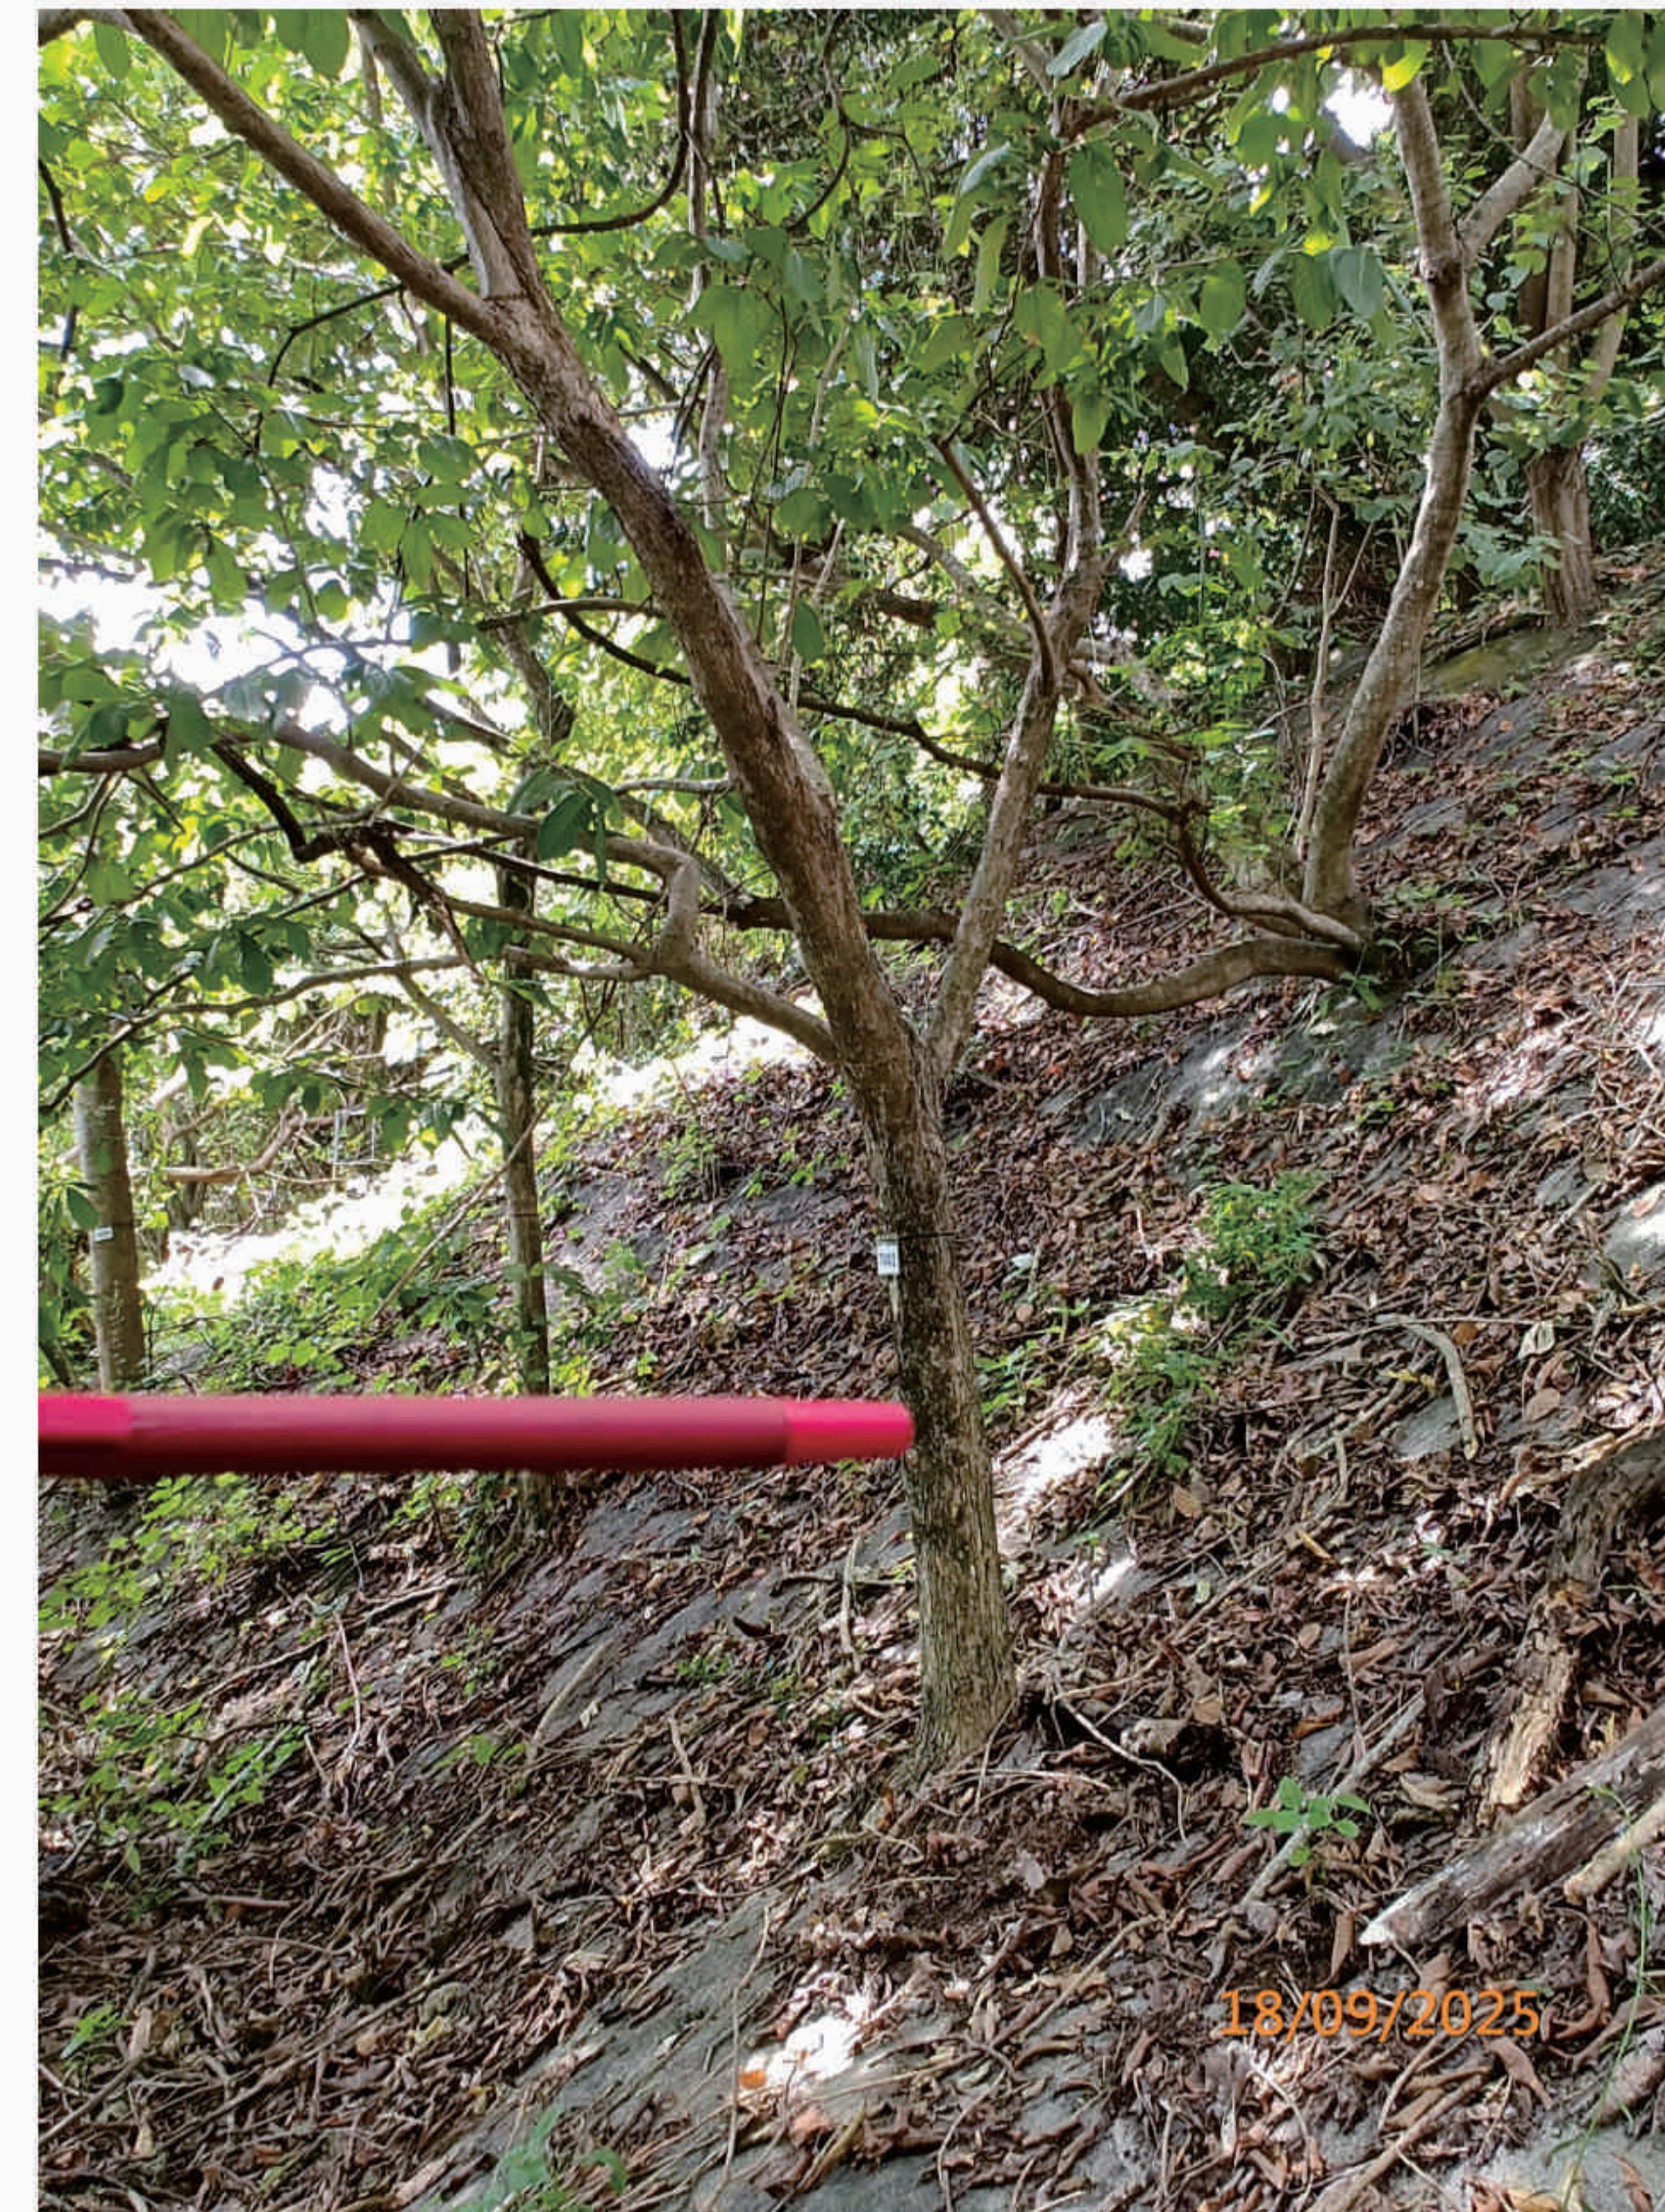
T442 - Trunk (F)

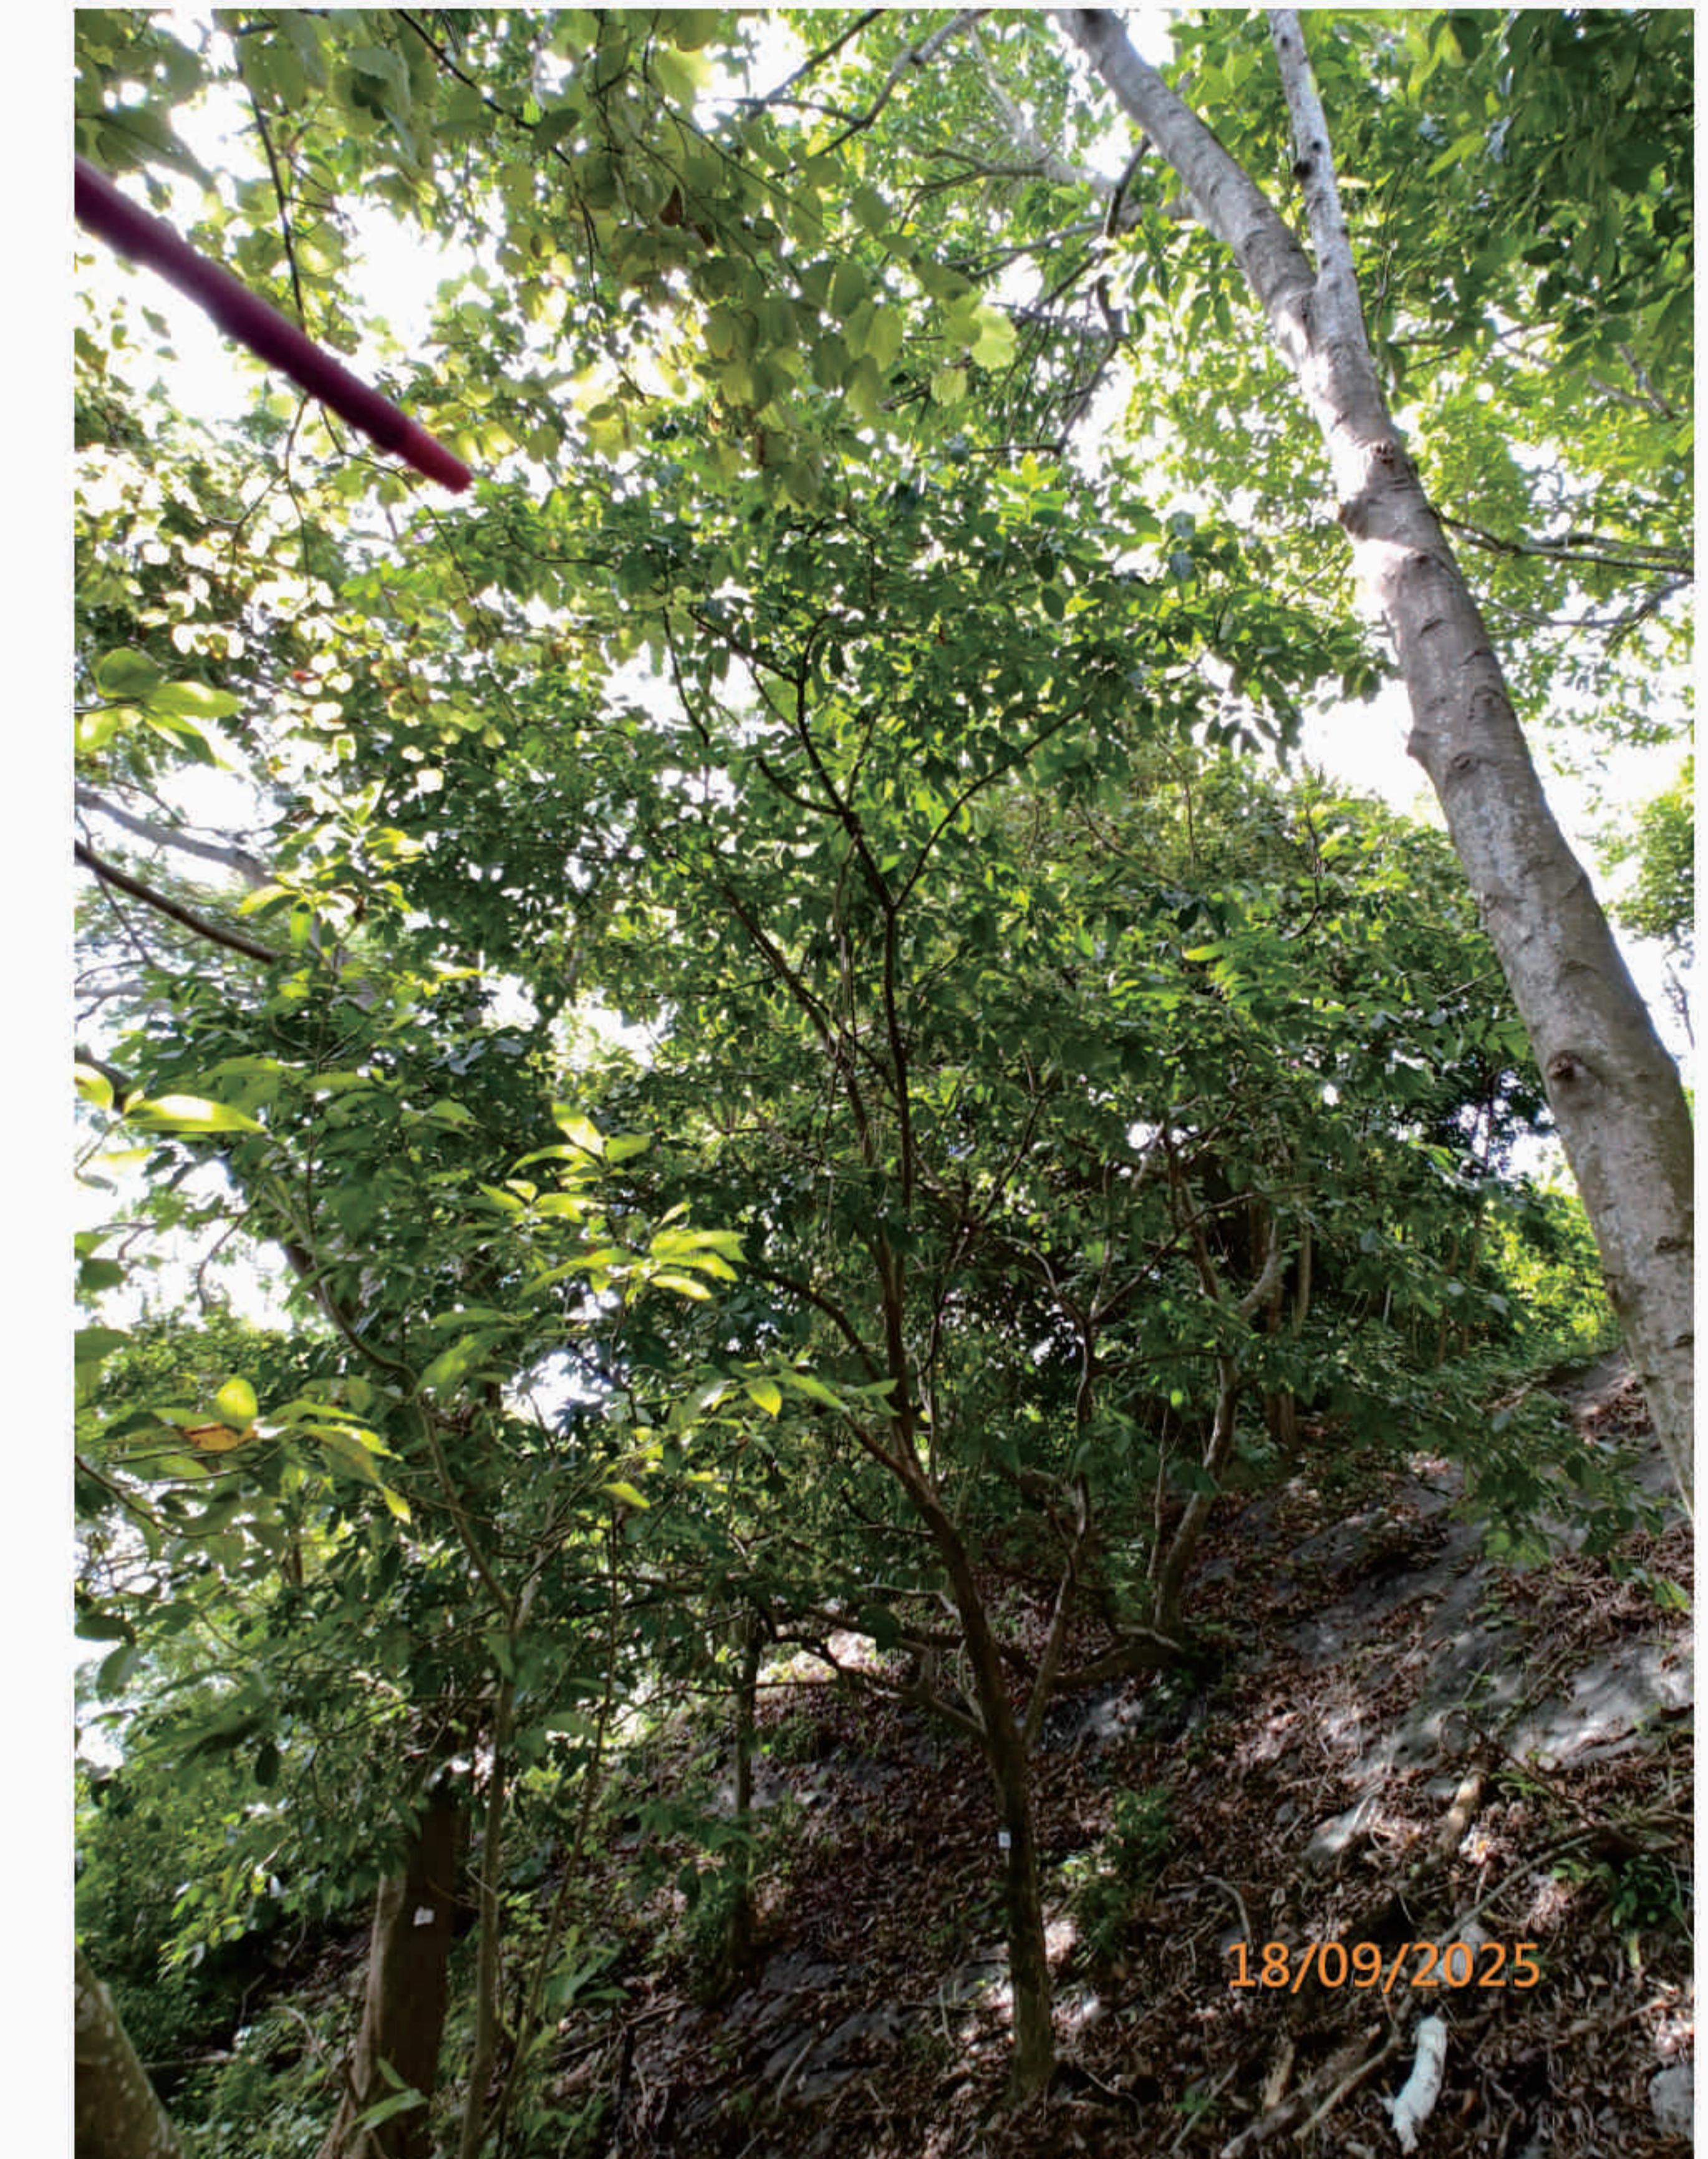
T442 - Crown (F)

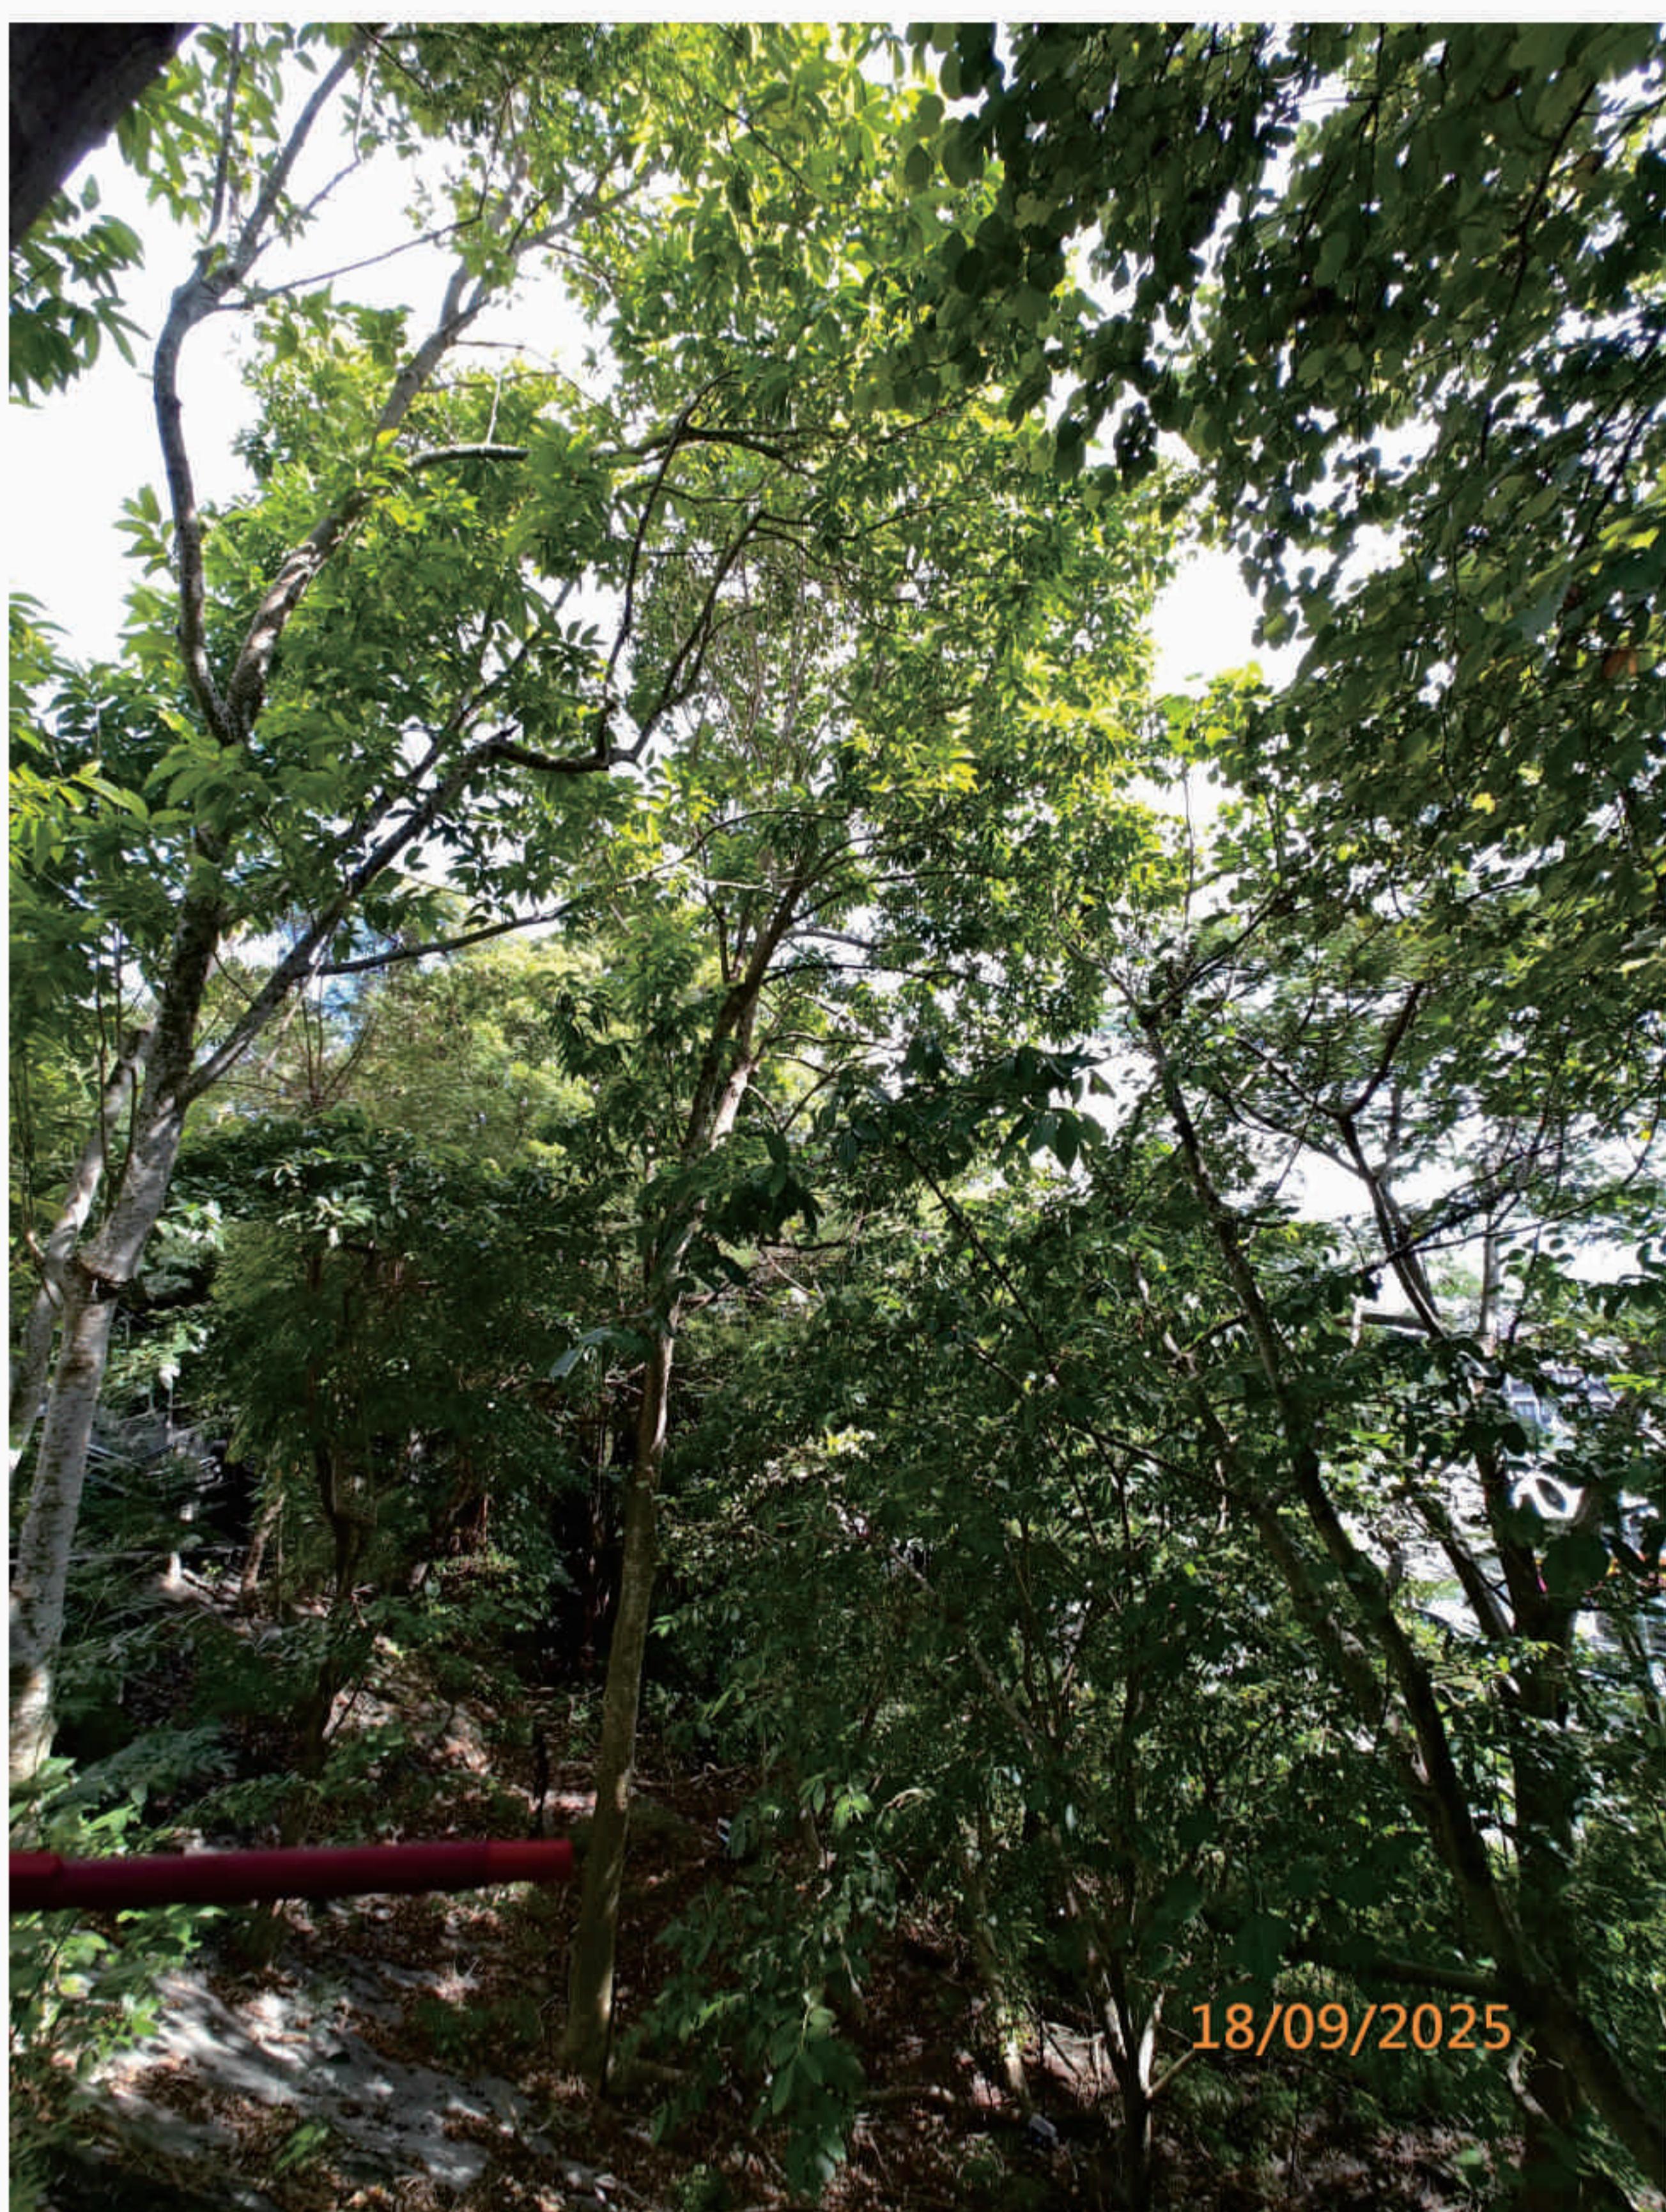
T445 - Overview (R)

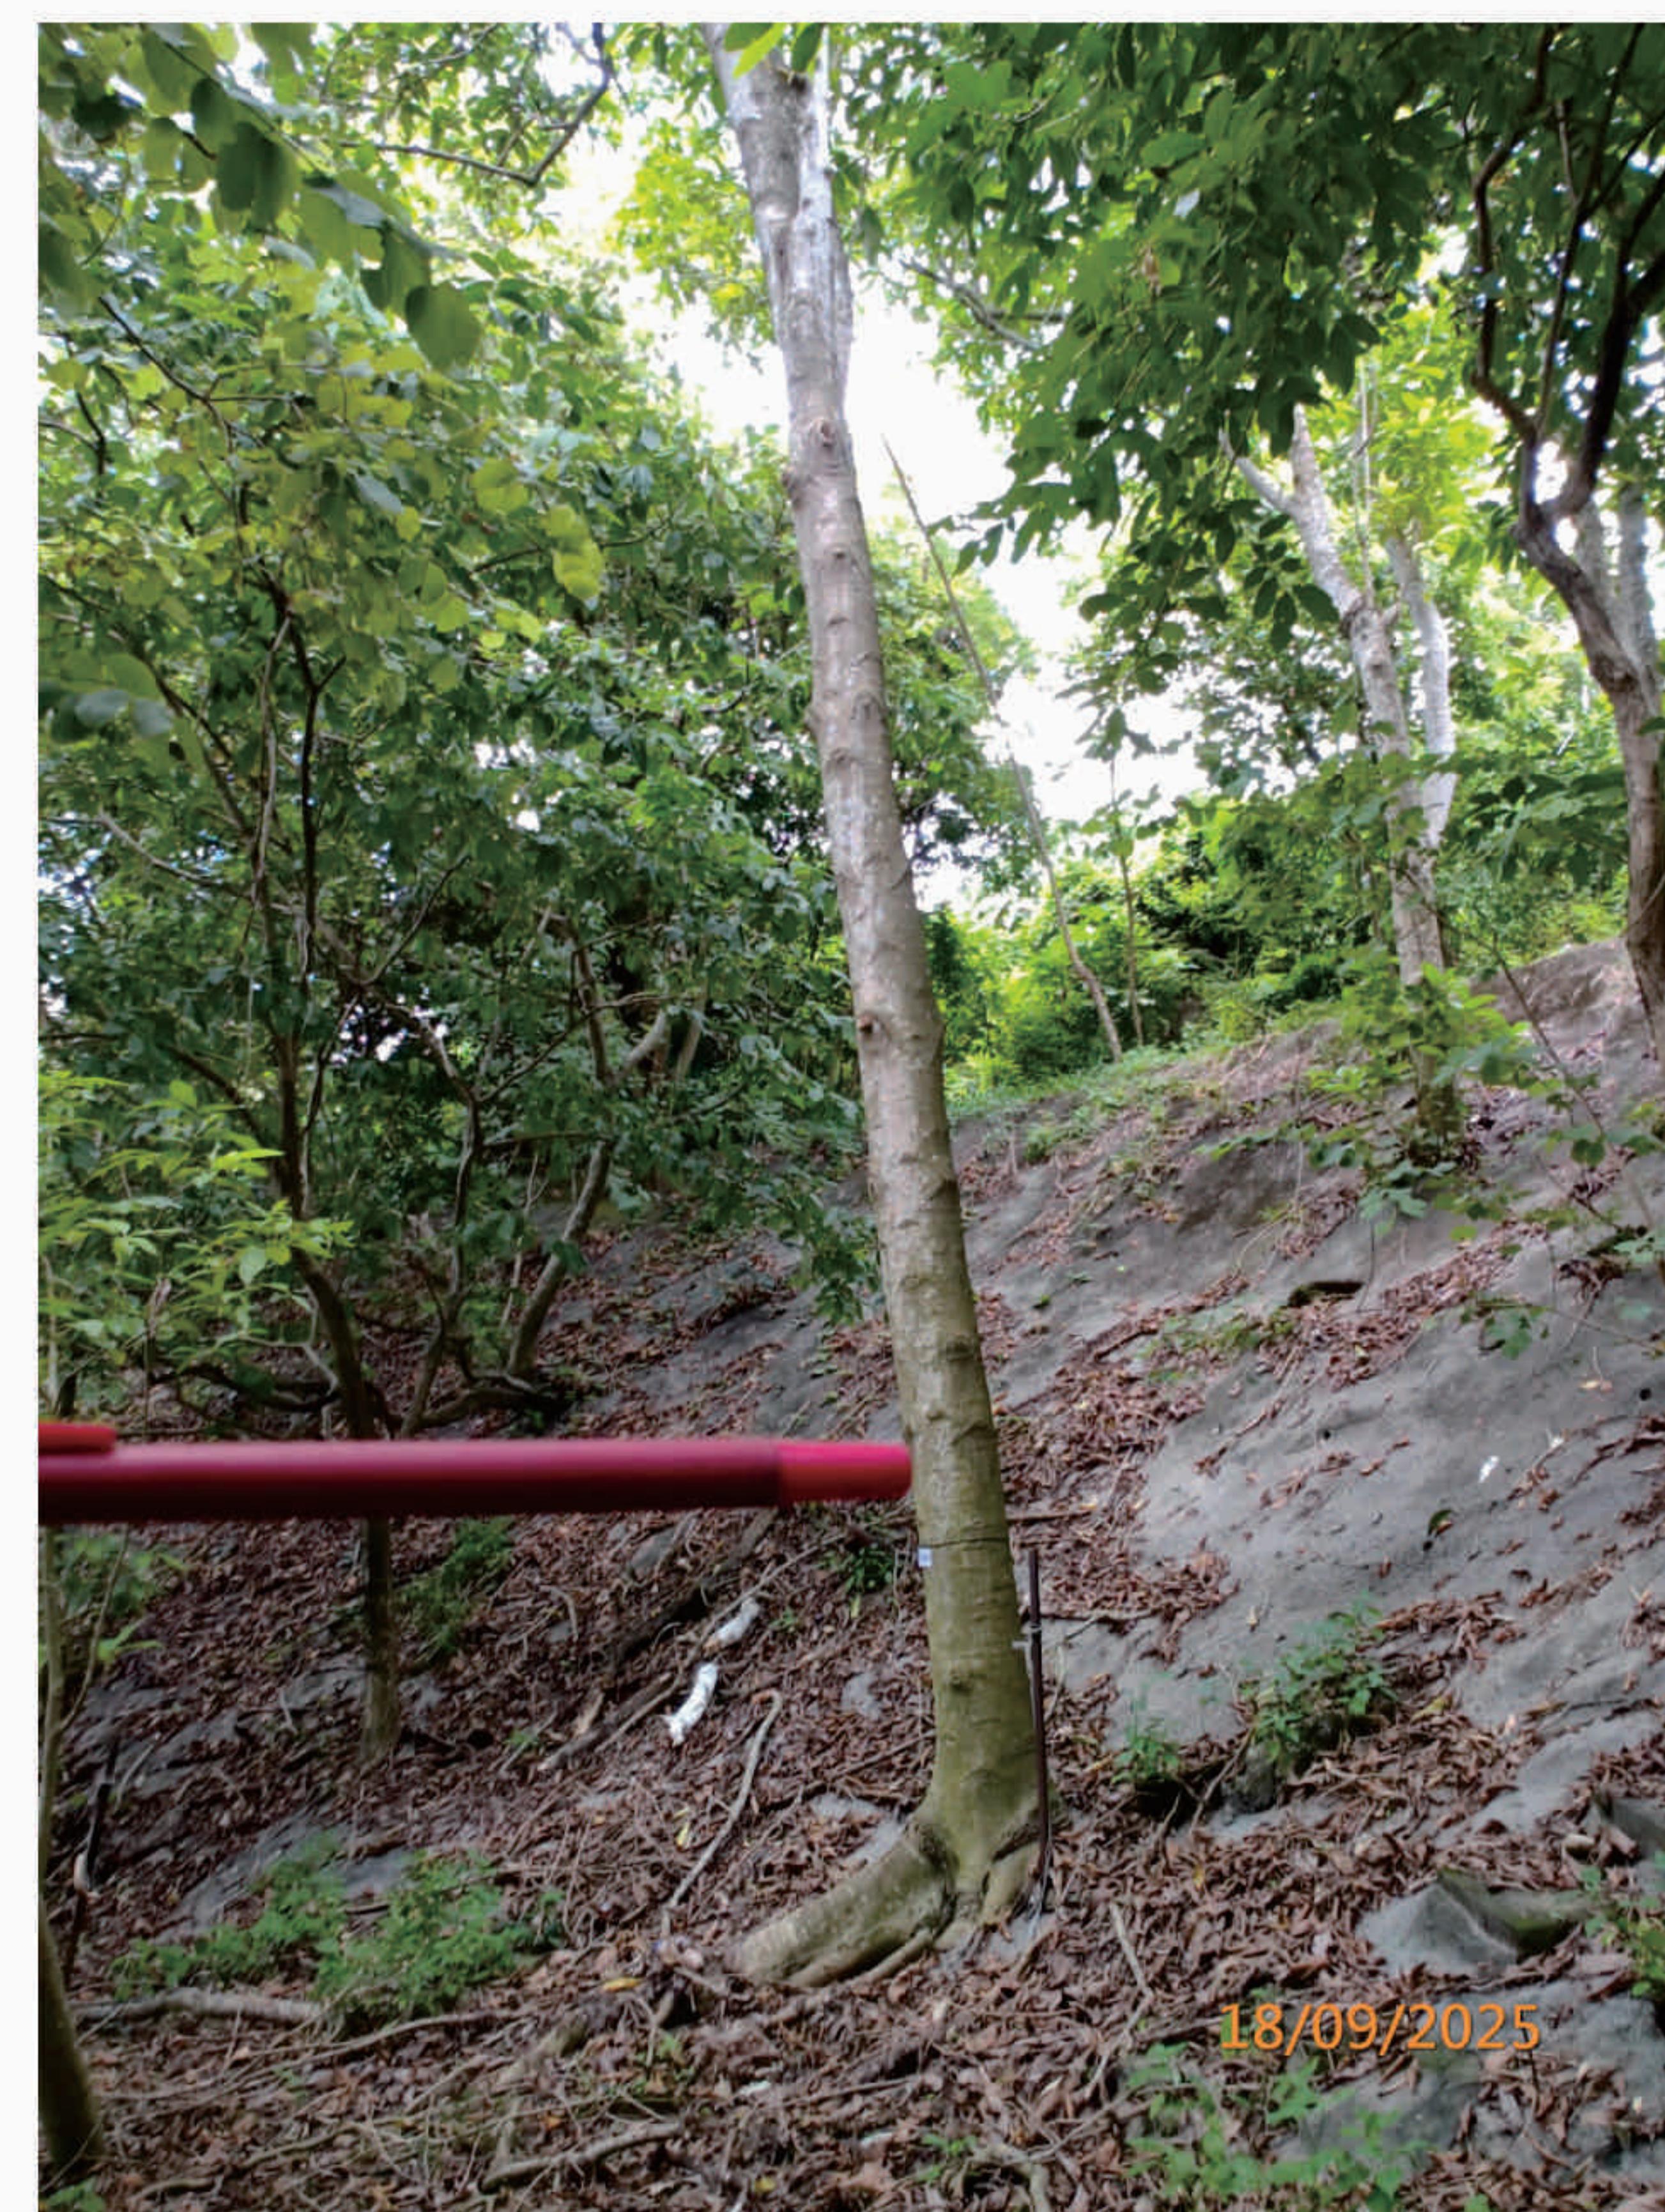
T445 - Trunk (R)

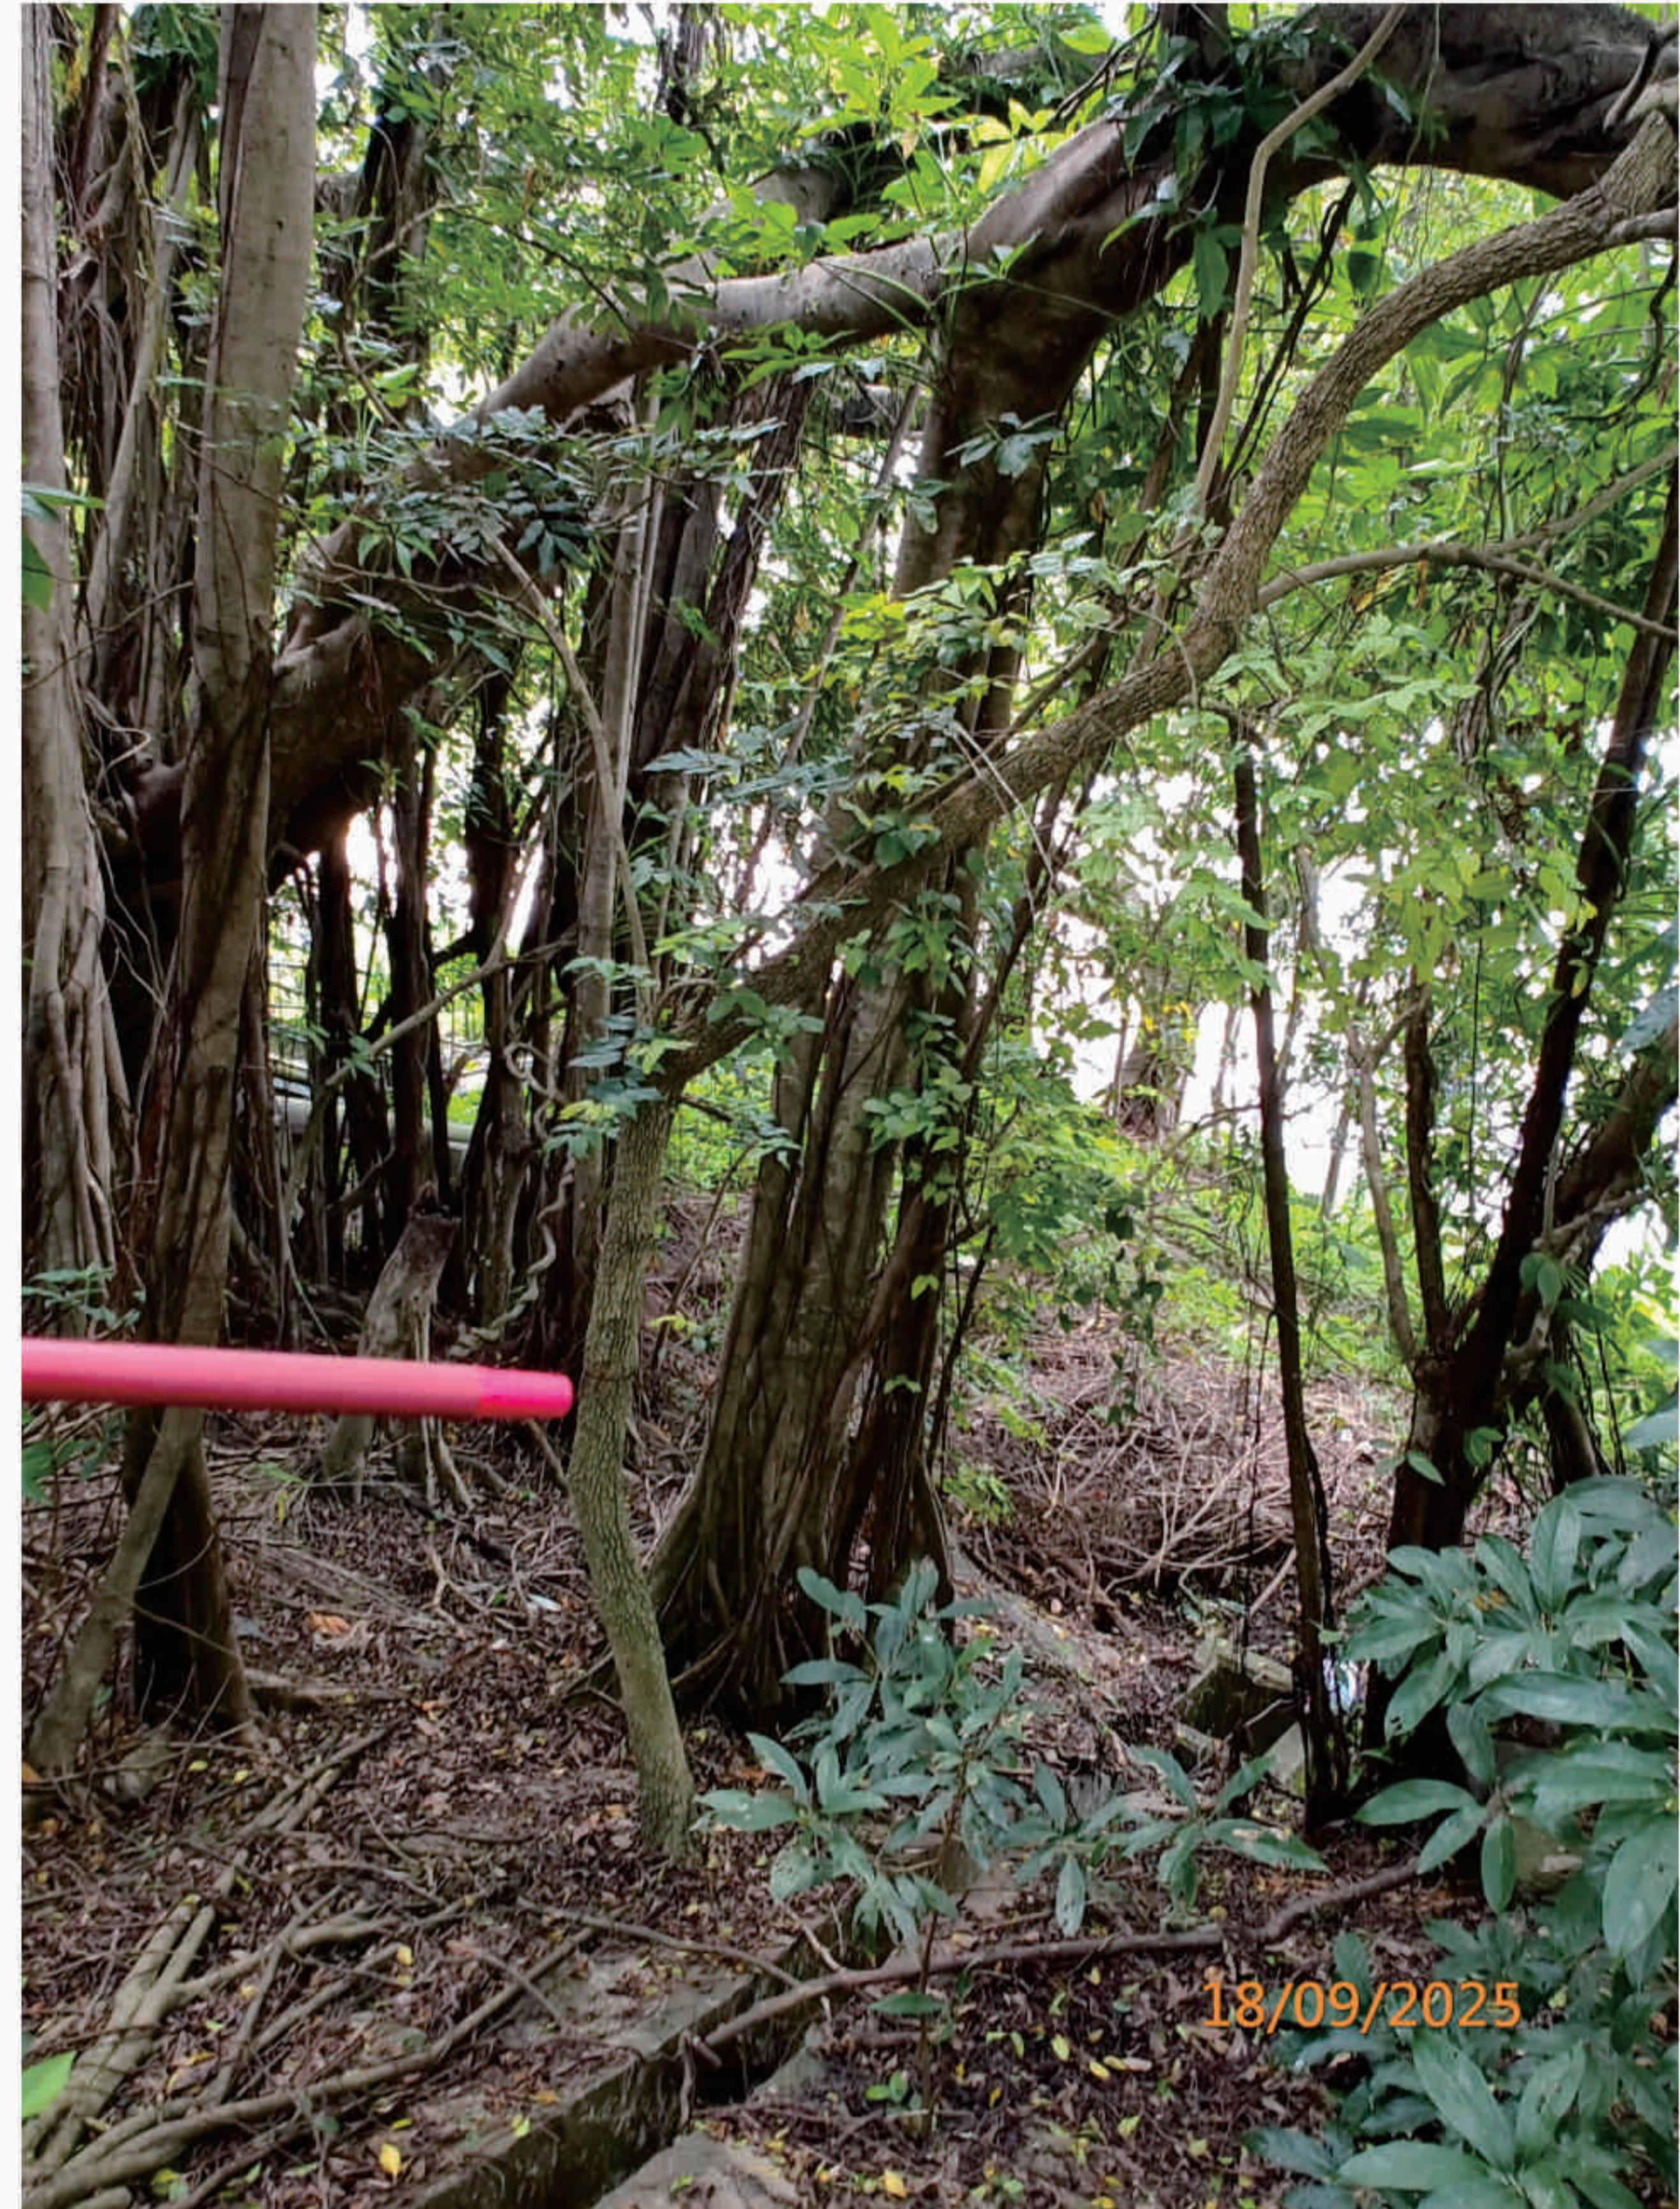
T459 - Trunk (R)

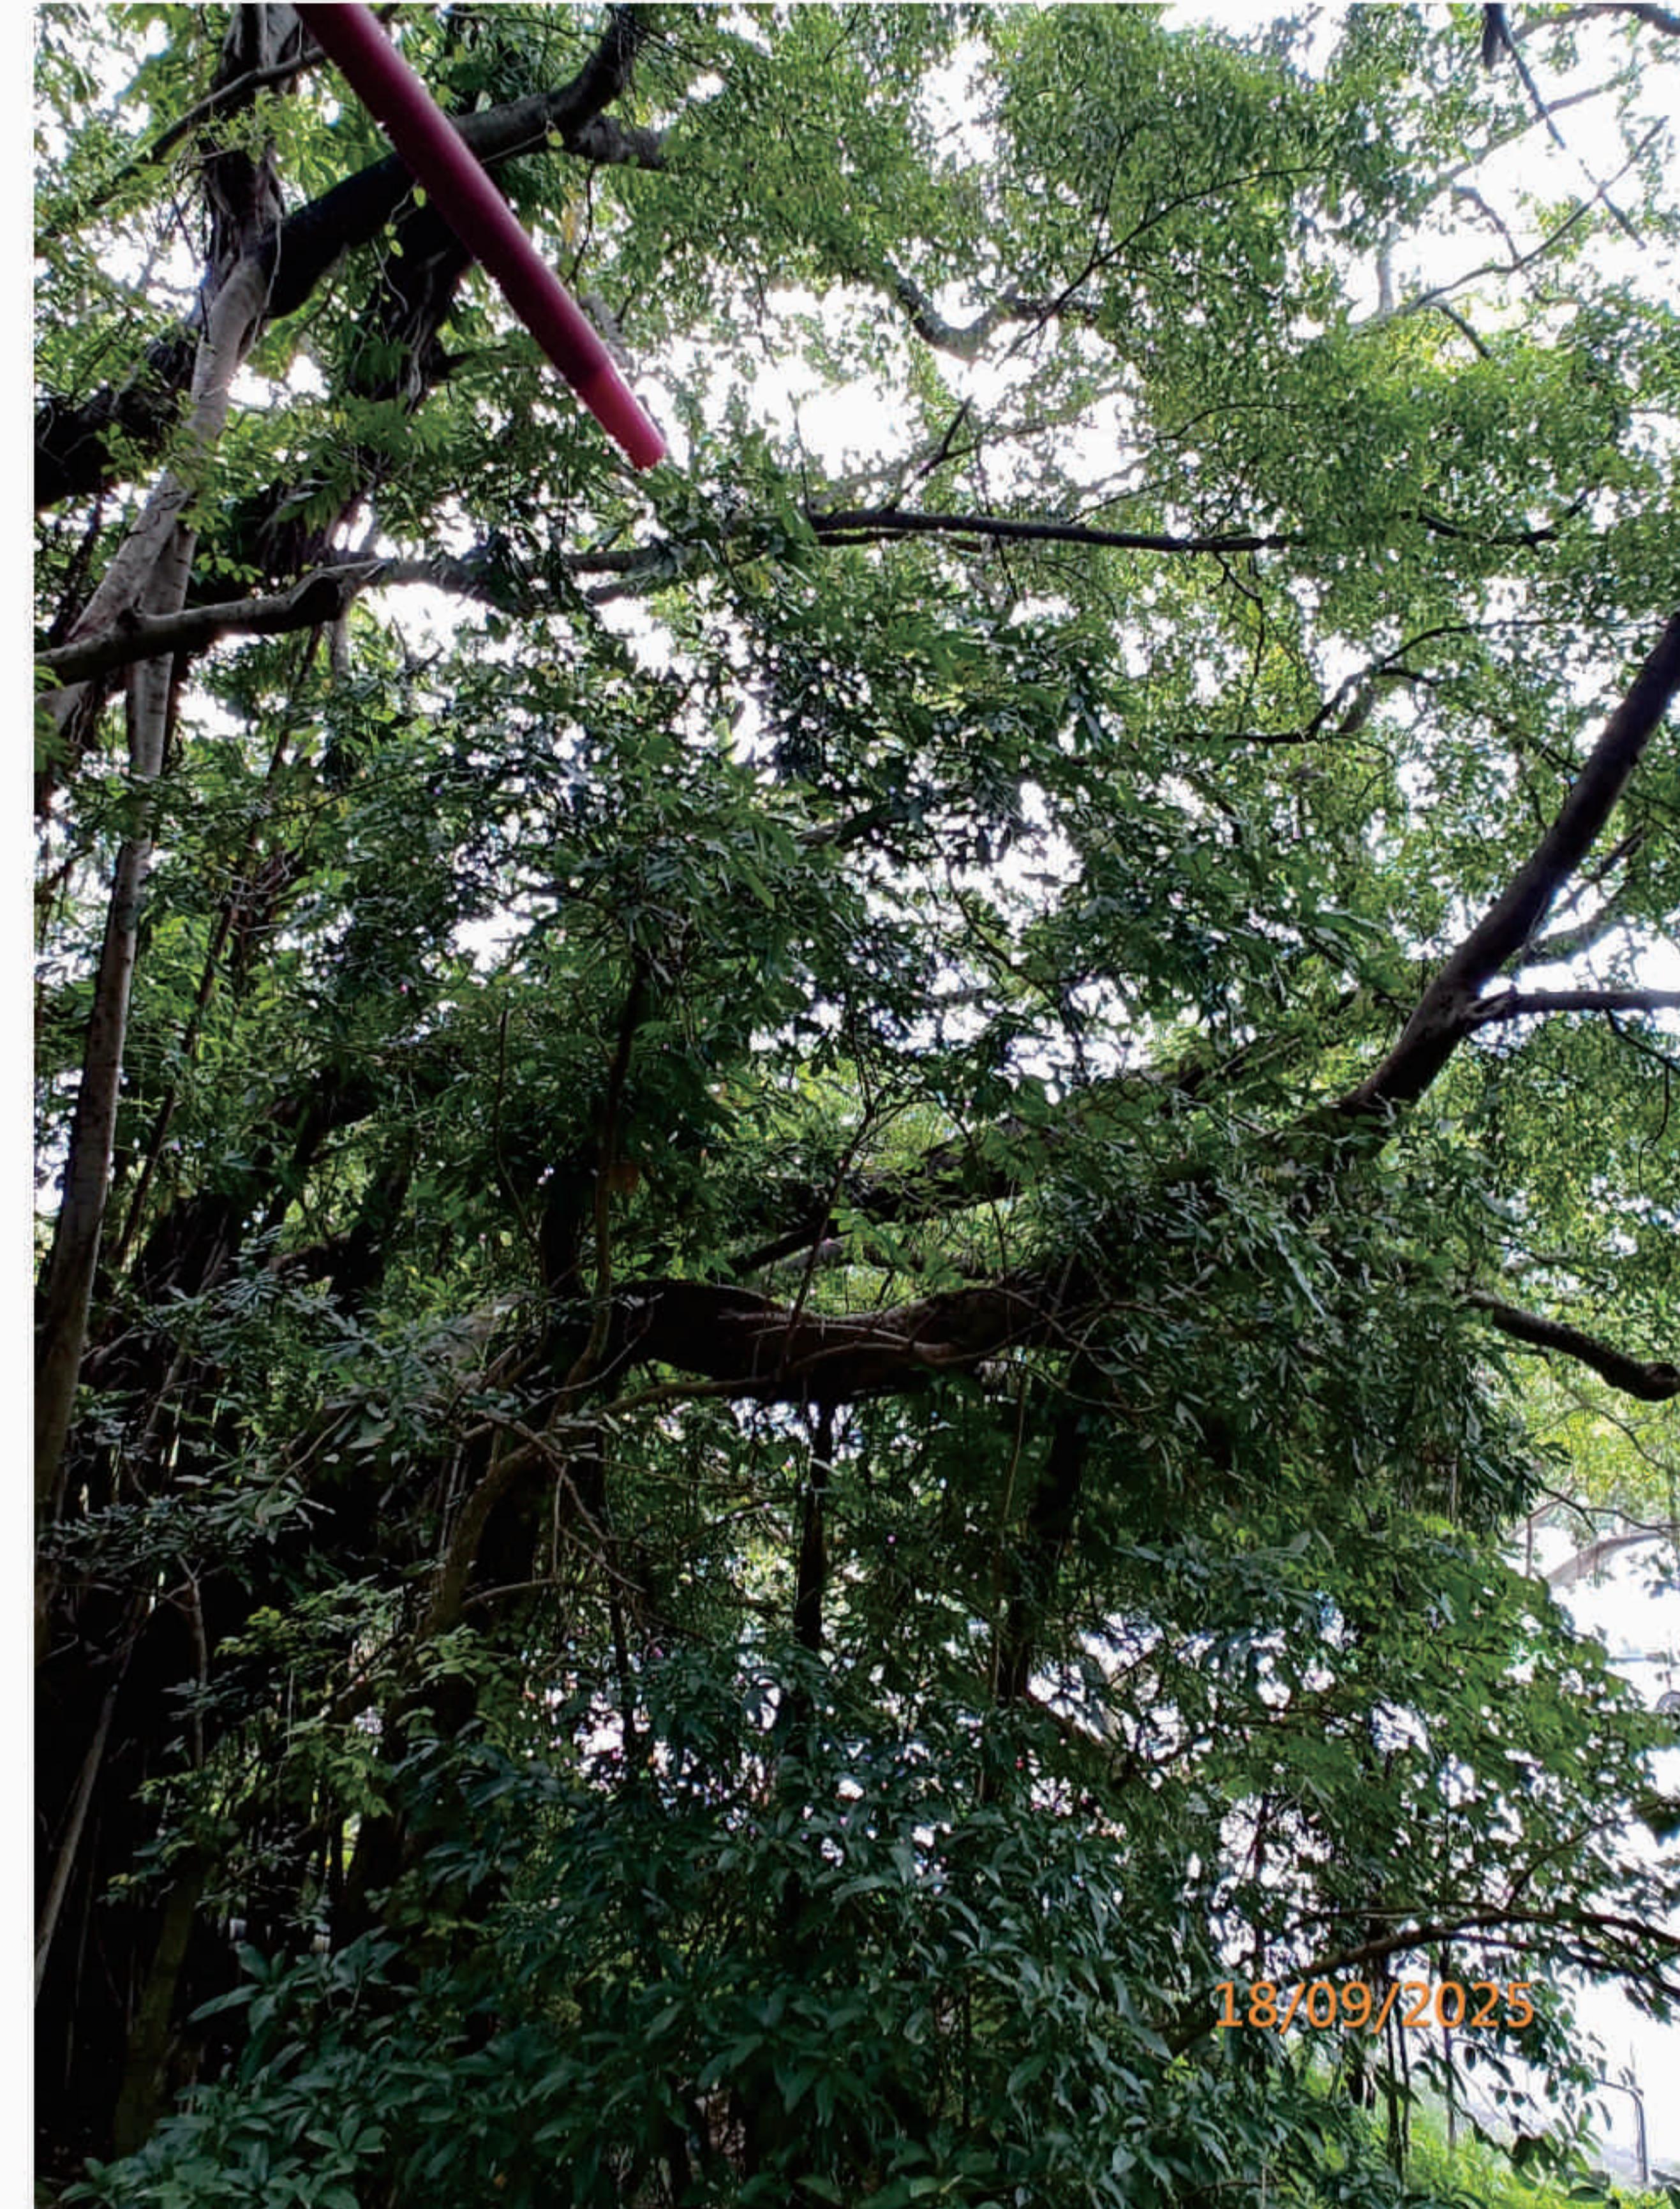
T459 - Crown (R)
