**PLANNING APPLICATION FOR
PROPOSED UTILITY INSTALLATION FOR PRIVATE PROJECT
AT GOVERNMENT LAND ADJOINING 44 STANLEY VILLAGE ROAD,
STANLEY, HON KONG**

Tree Survey Report

Date: 13 November 2025

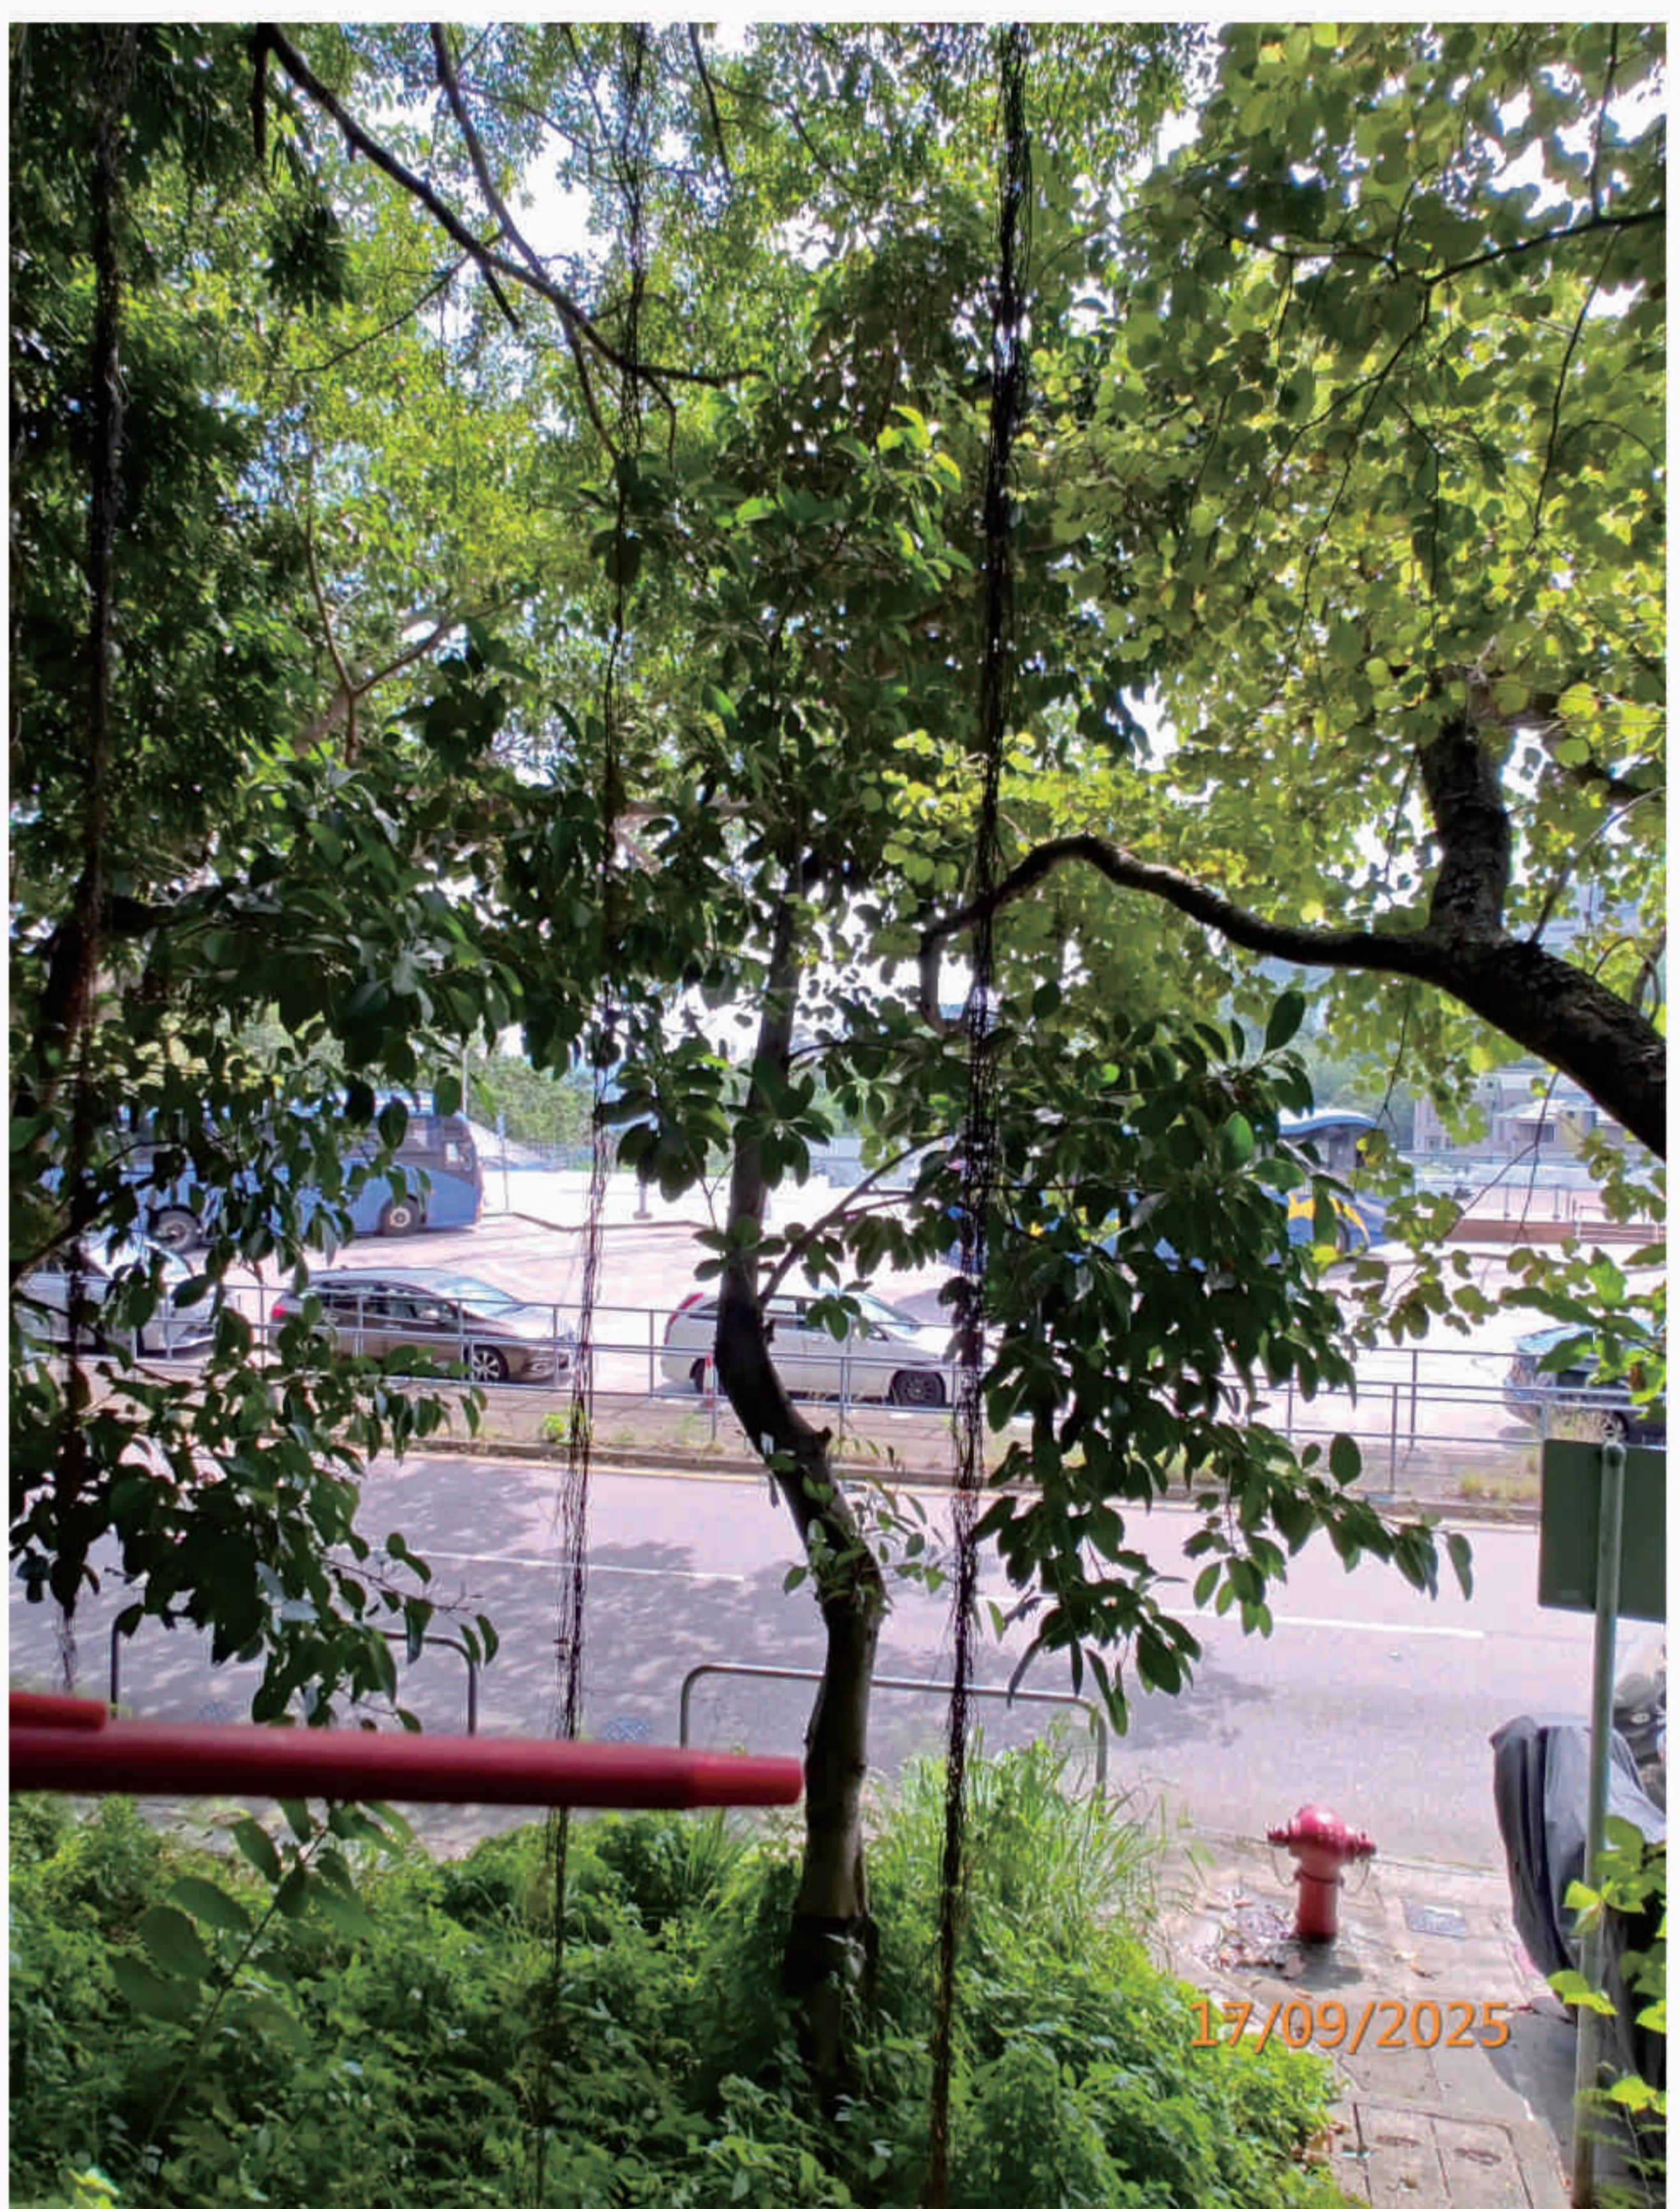
T466 - Overview (F)

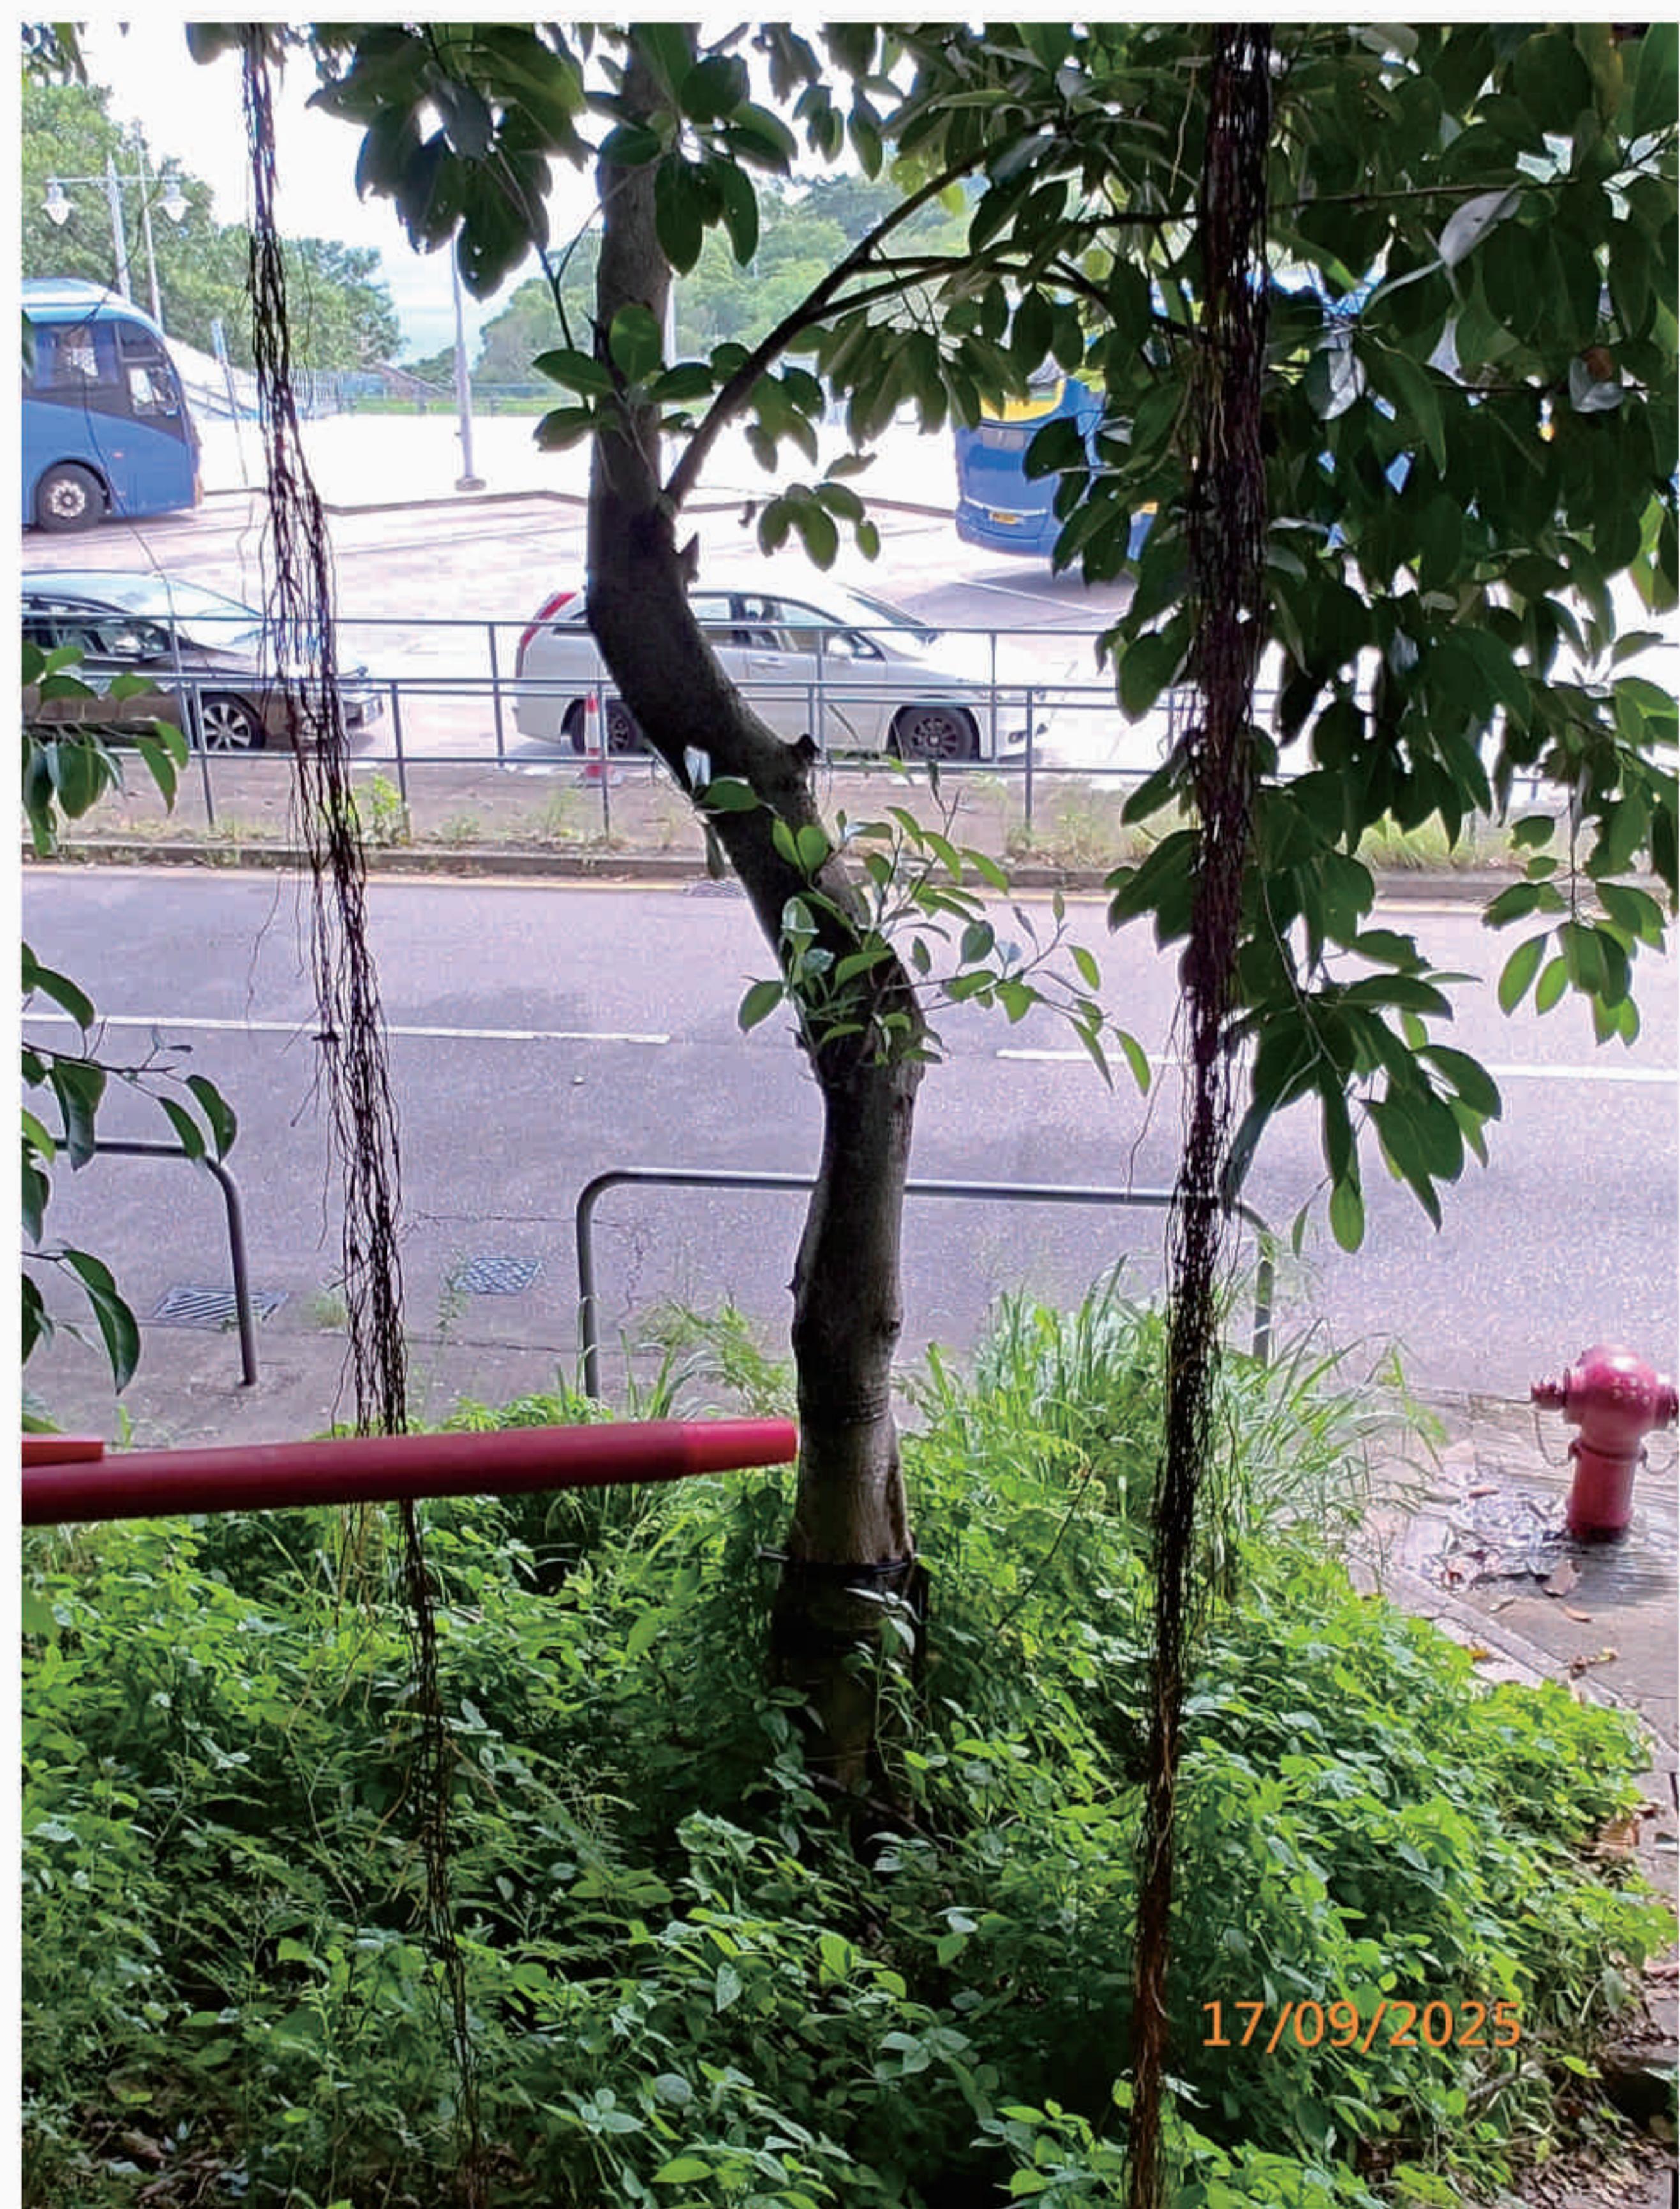
T466 - Trunk (F)

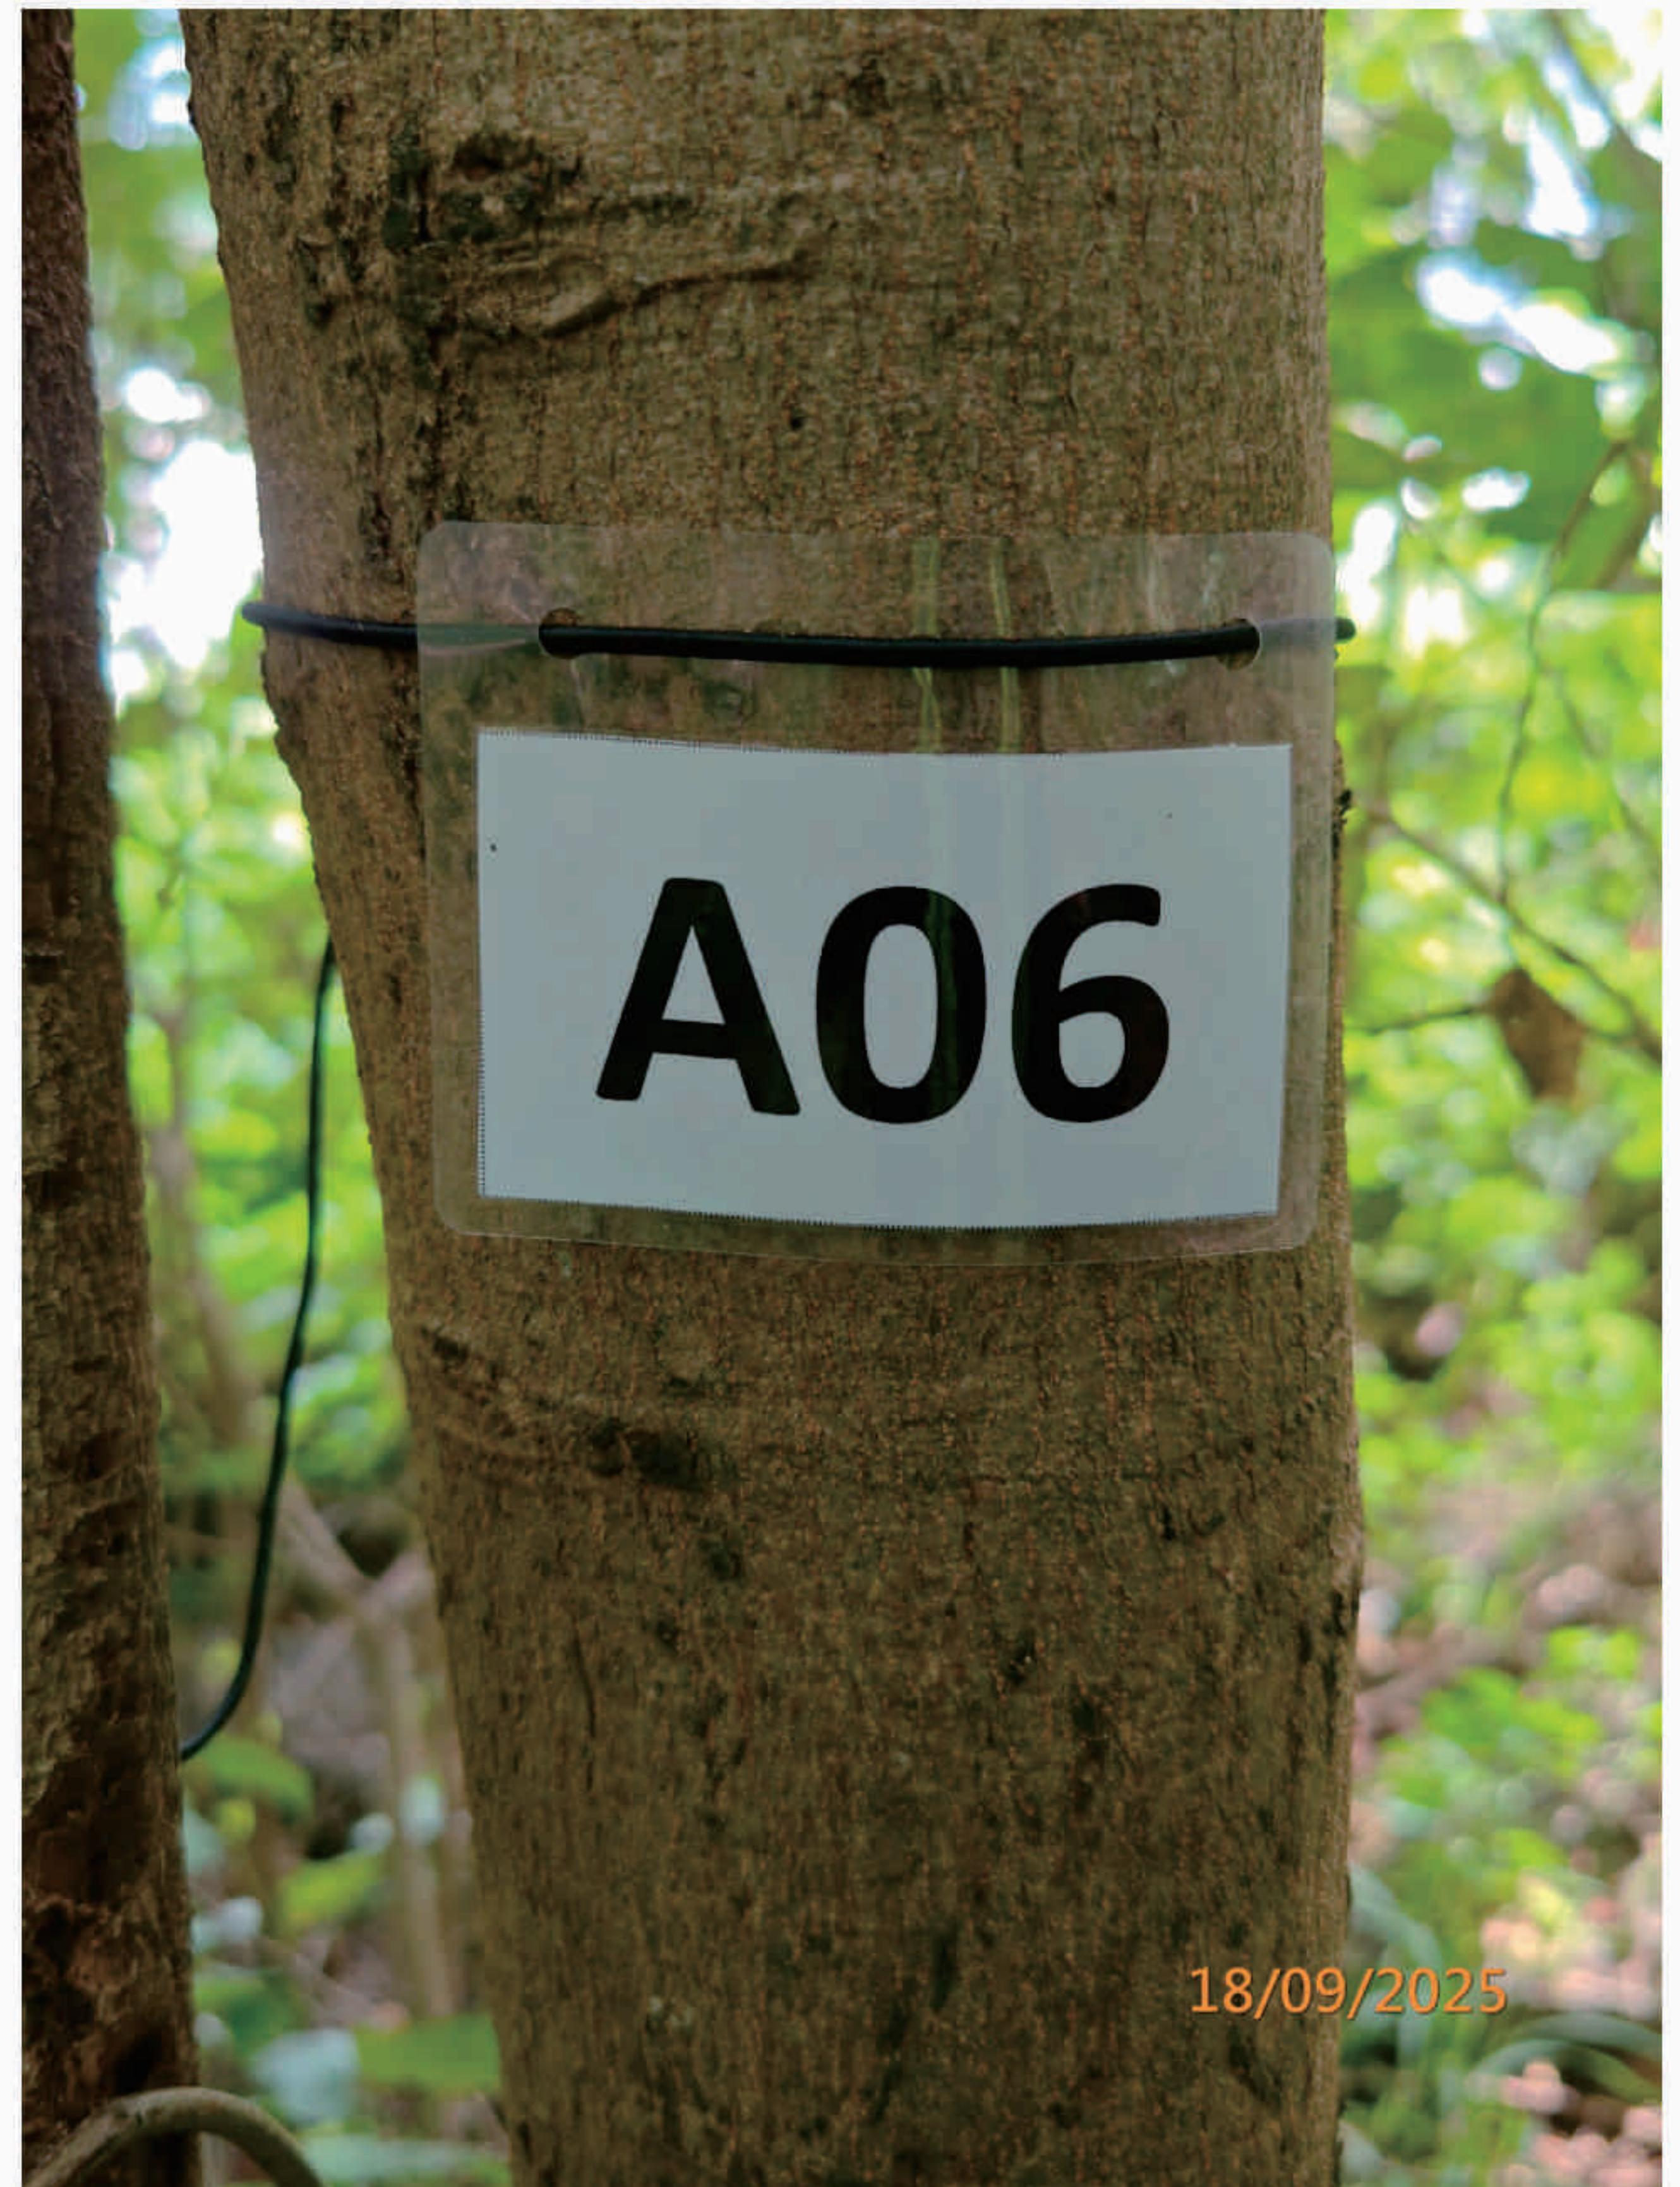
A06 - Label (F)

4.10 Another **8** disturbed trees, namely **T434**, **A08**, **A09** – *Bauhinia purpurea*, **T439**, **T441**, **A06** – *Delonix regia* and **T440**, **T442** – *Lagerstroemia speciosa* have exhibited poor tree form or health conditions. Transplanting these trees would require significant deformation, which would likely result in irreversible damage to their form. It is proposed to fell these trees and compensate by planting high-quality replacements.

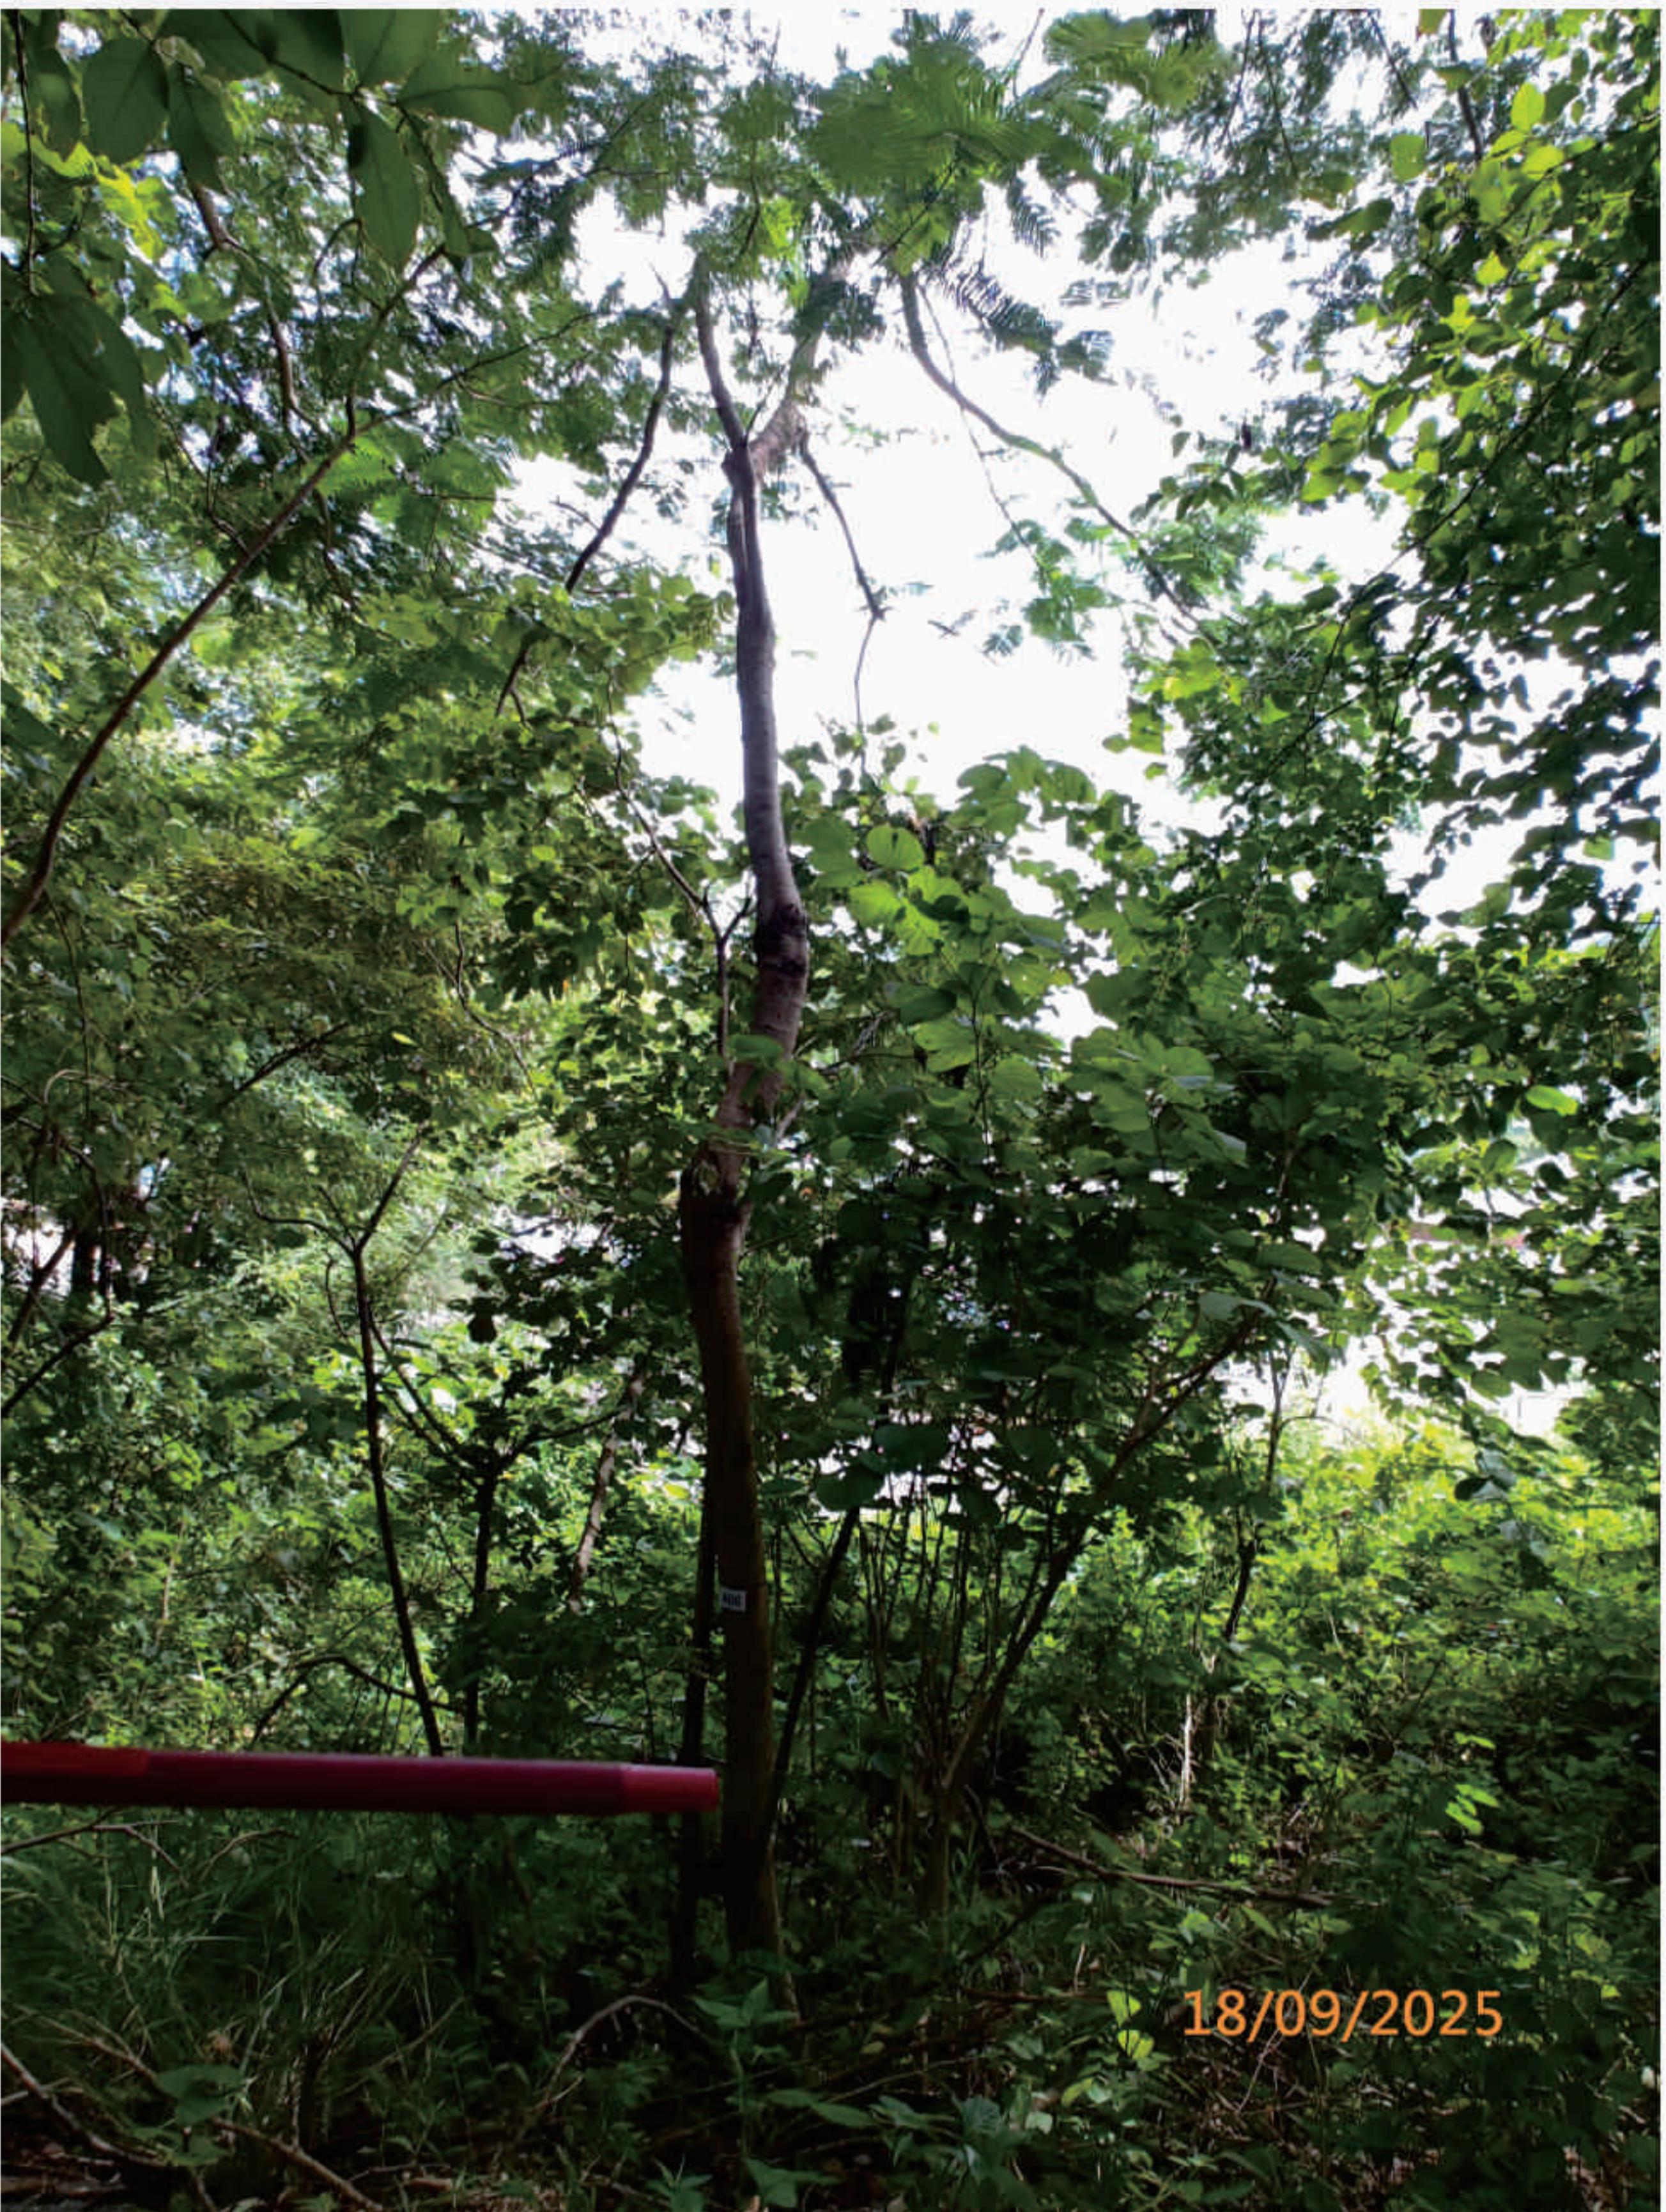
A06 - Overview (F)

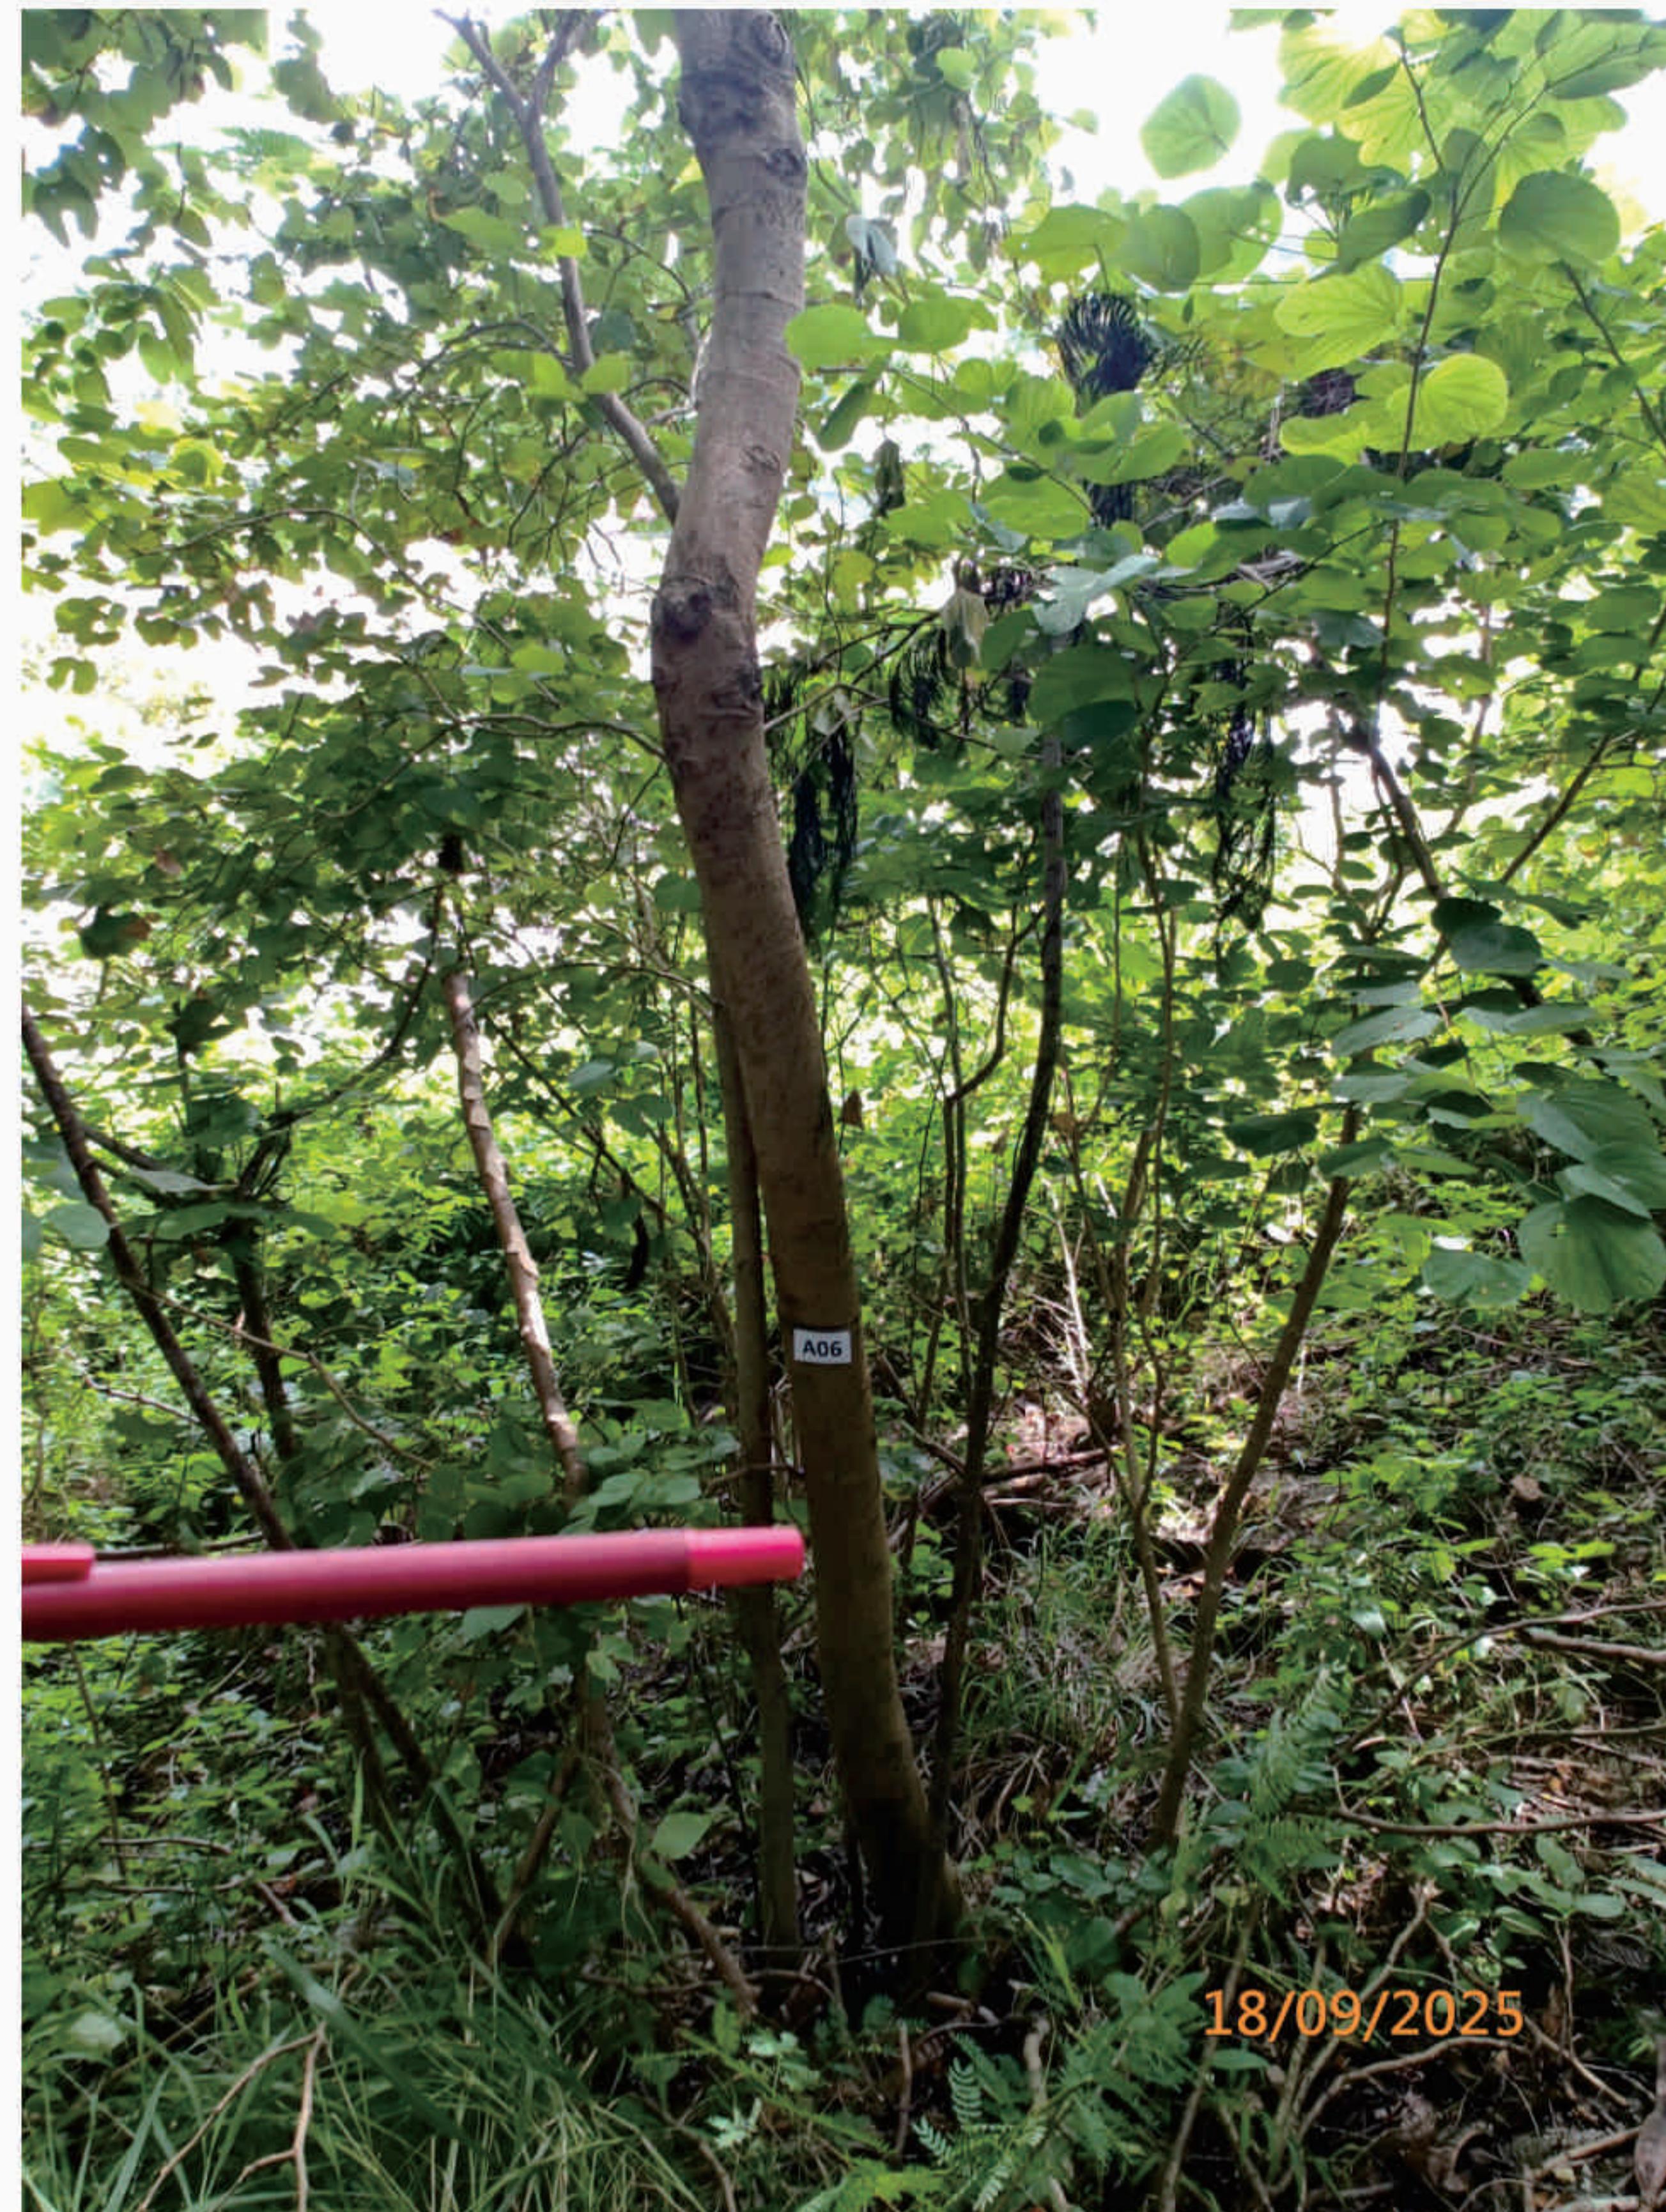
A06 - Trunk (F)

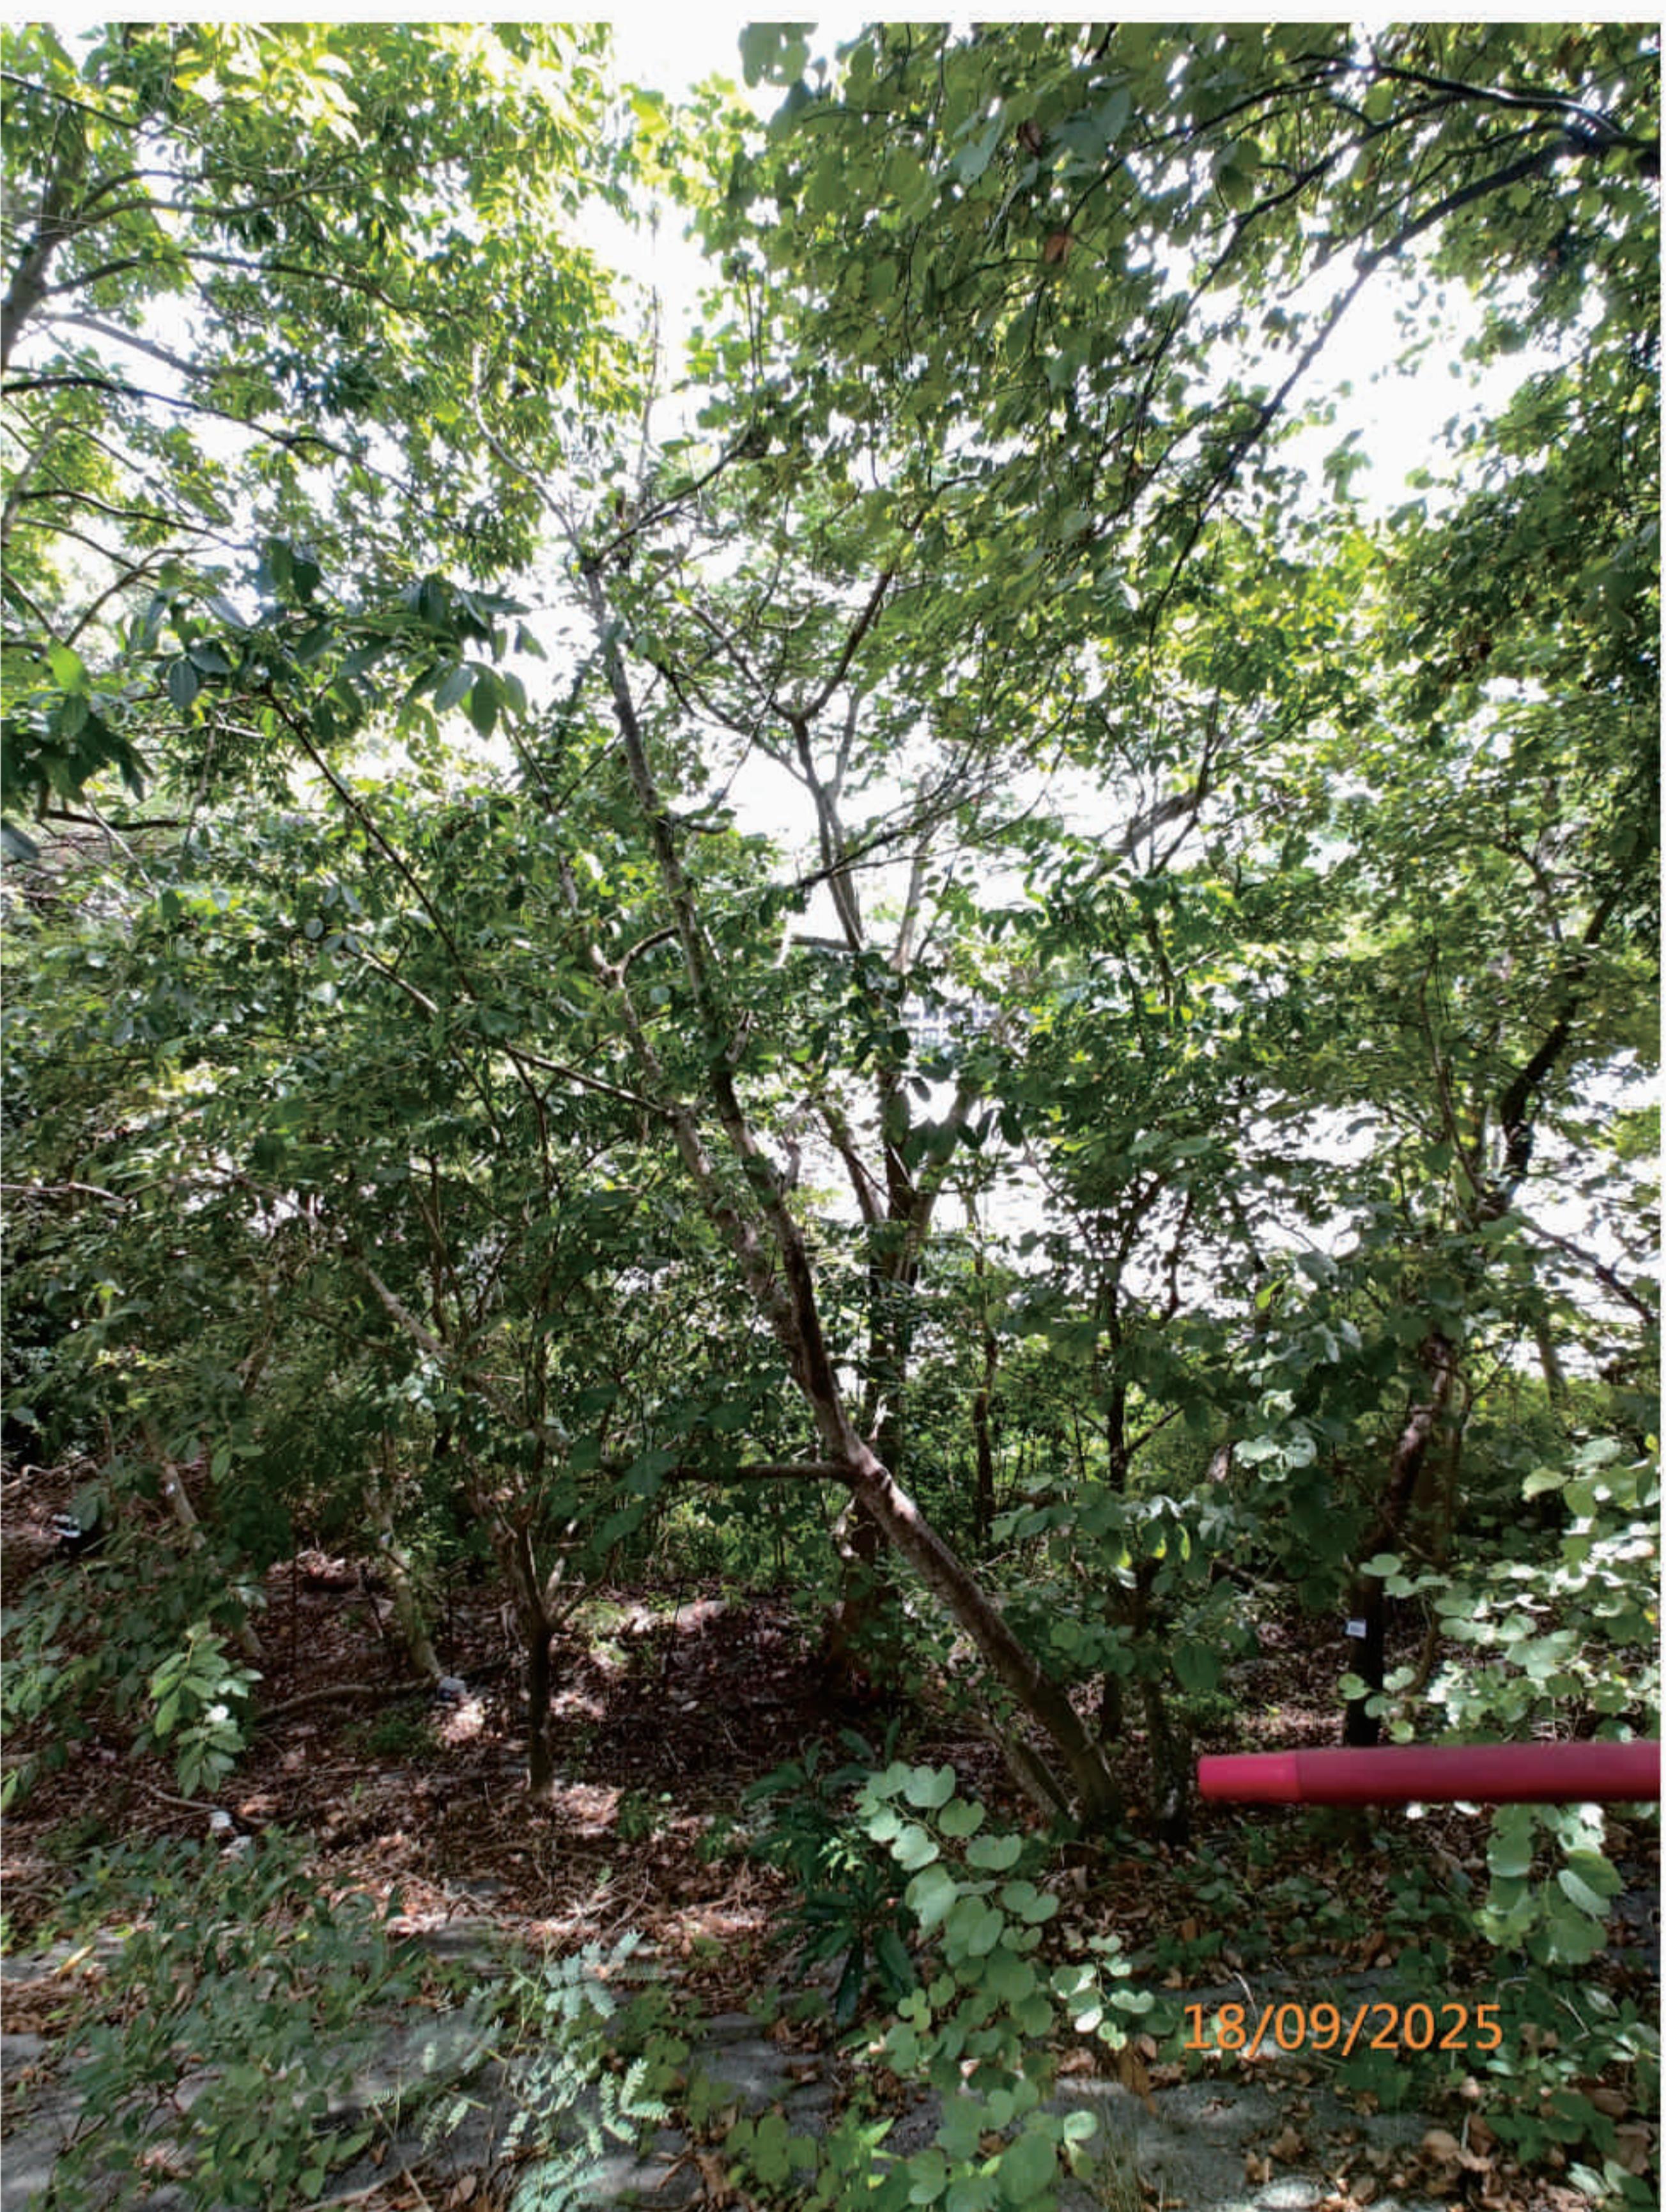
A07 - Overview (F)
