**PLANNING APPLICATION FOR
PROPOSED UTILITY INSTALLATION FOR PRIVATE PROJECT
AT GOVERNMENT LAND ADJOINING 44 STANLEY VILLAGE ROAD,
STANLEY, HON KONG**

Tree Survey Report

Date: 13 November 2025

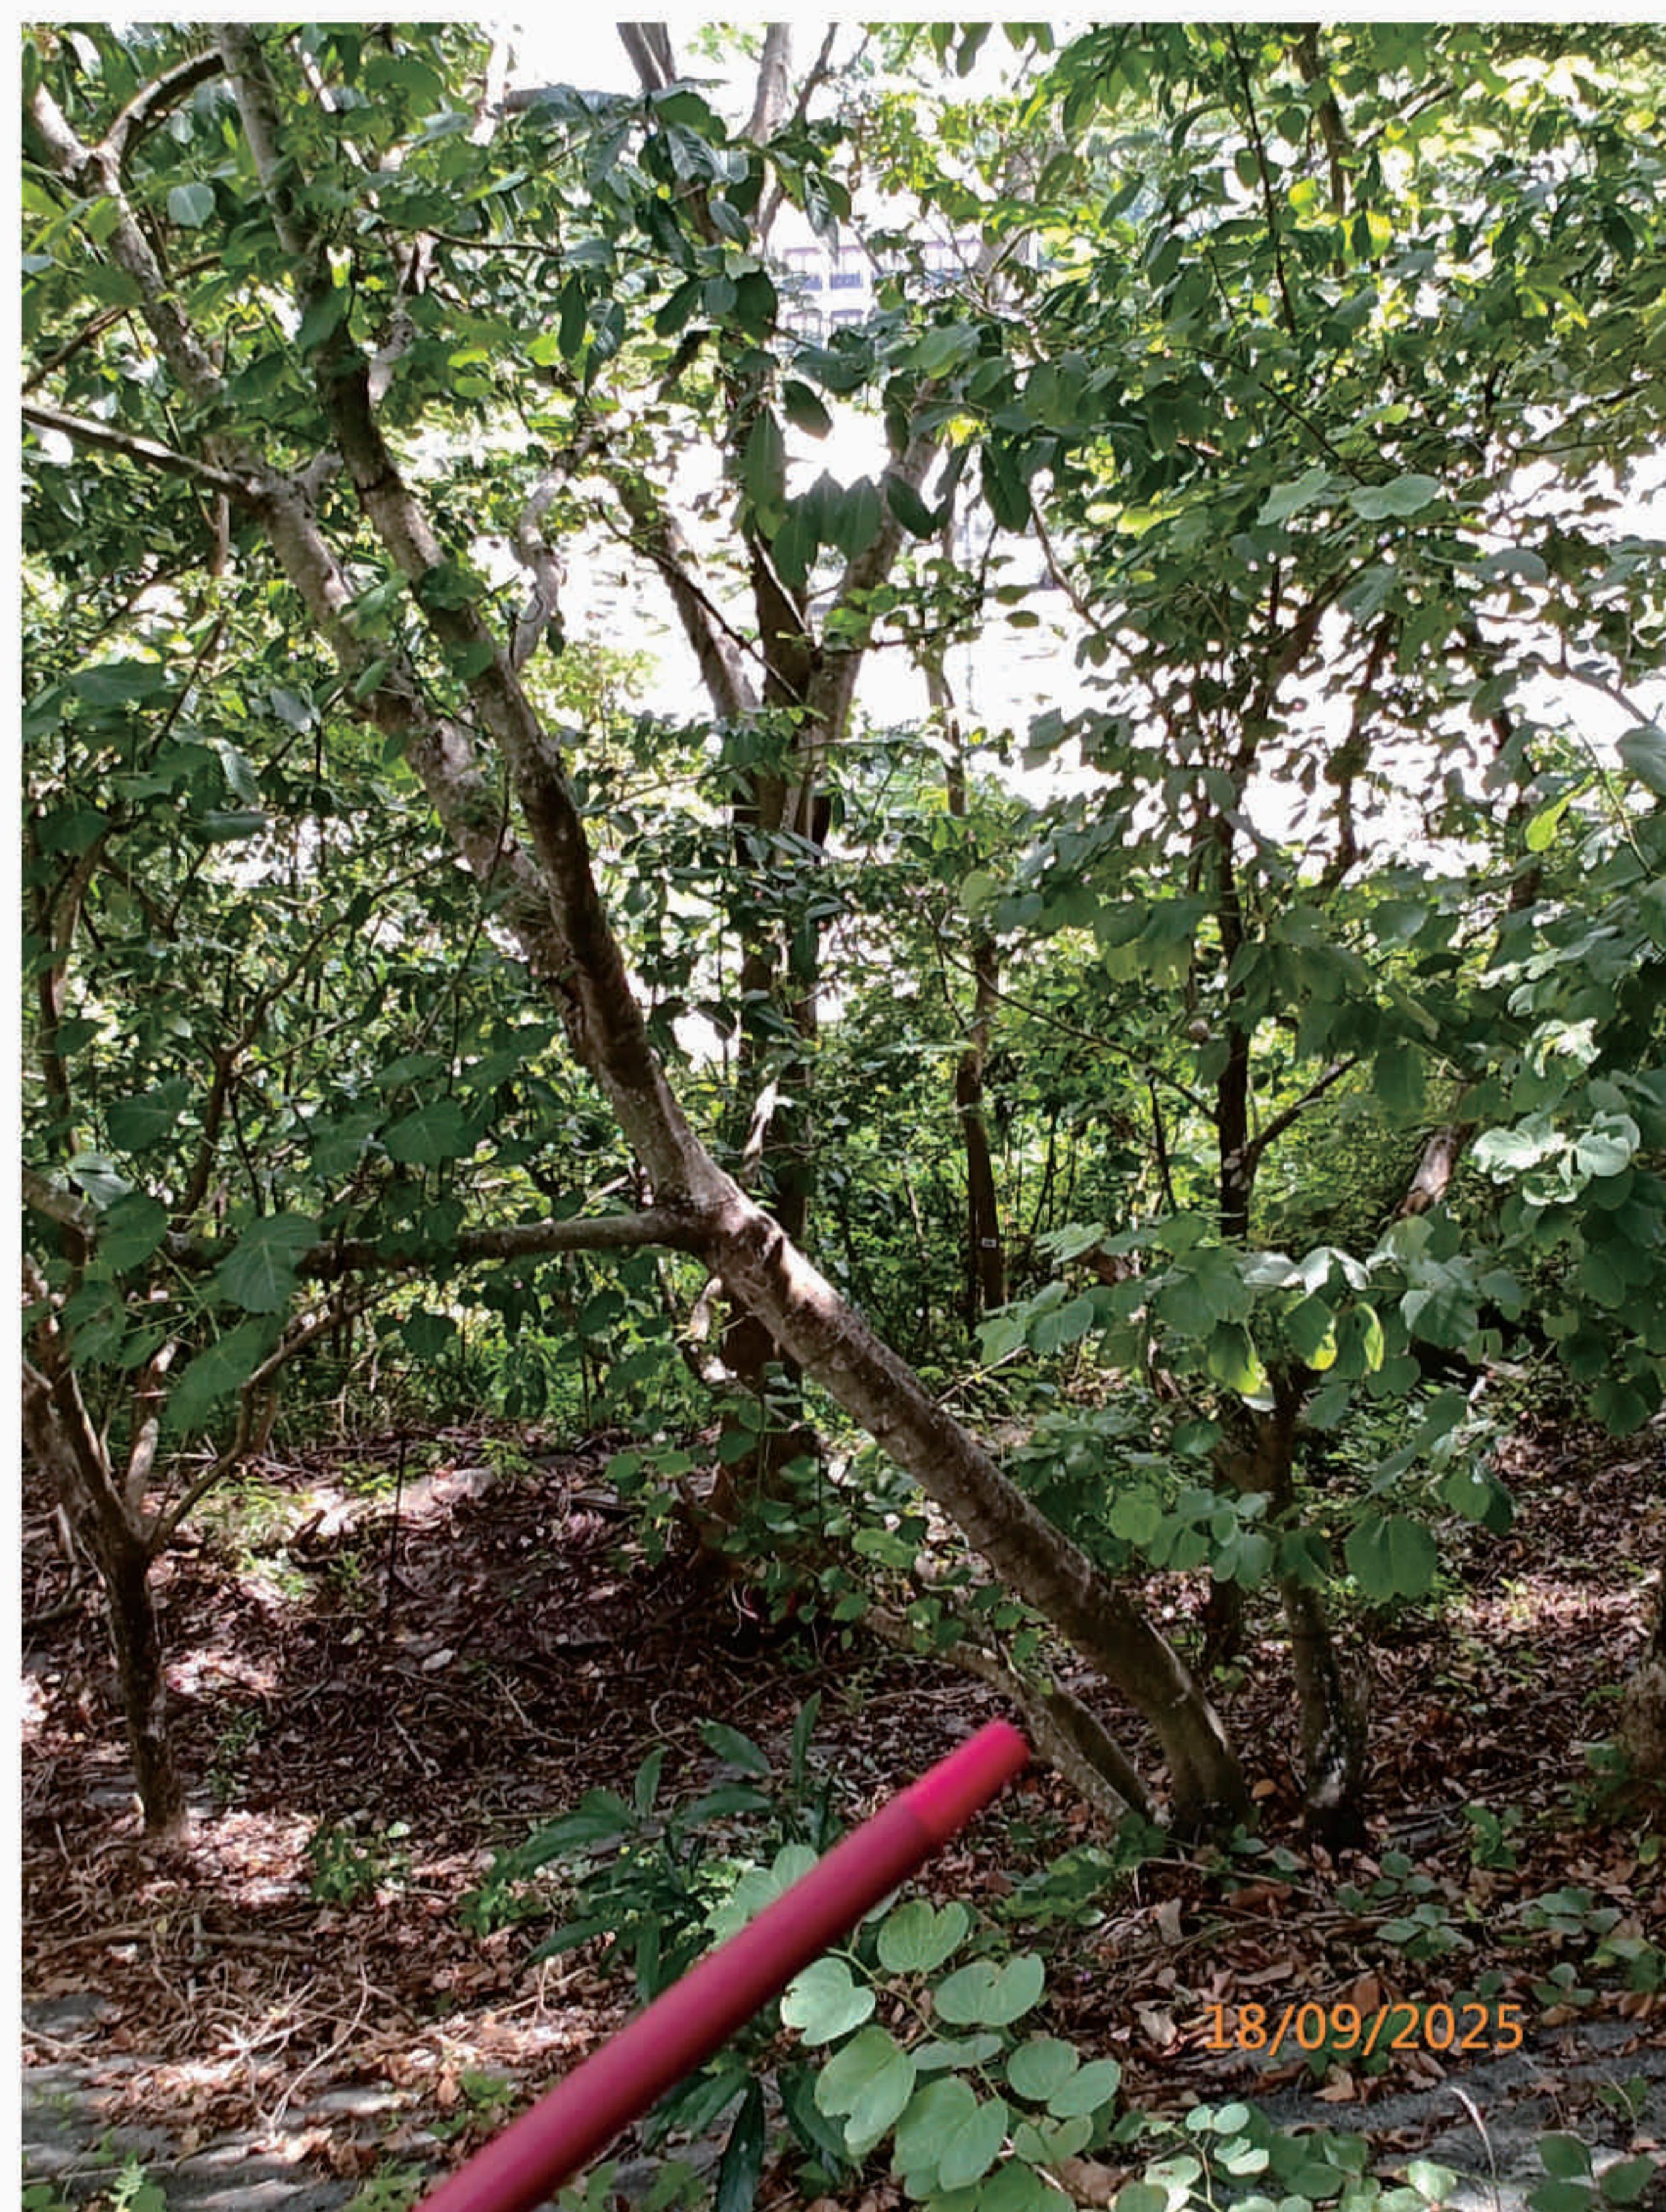
A07 - Trunk (F)
