**Geotechnical Planning Review Report  
for the columbaria license  
s.16 application,  
at Ten Thousand Buddhas Monastery,  
No. 221 Pai Tau Village,  
Sha Tin, New Territories,  
Hong Kong**

Job No.: HA971

Document No.: HA971/R05

Date: 24 July 2025

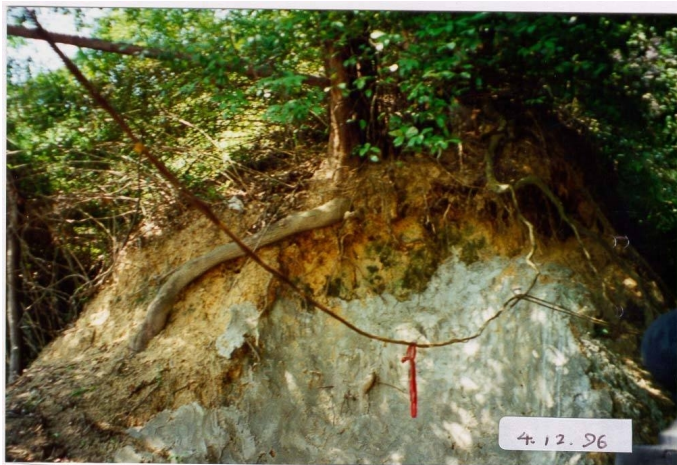
7SW-B/C113

DISTRESS (EROSION)

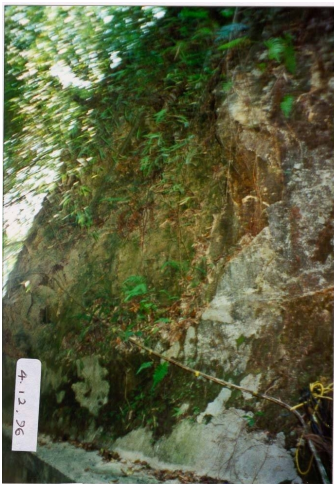
7SW-B/C113

GENERAL VIEW

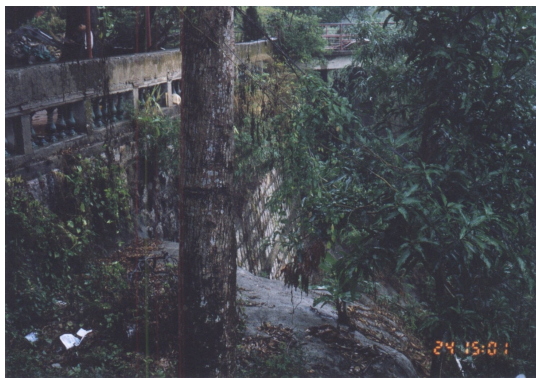
7SW-B/FR 7

Photo 1 : General View

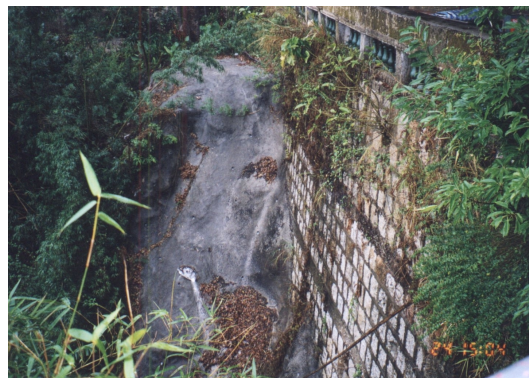
7SW-B/FR 7

Photo 2 : General View

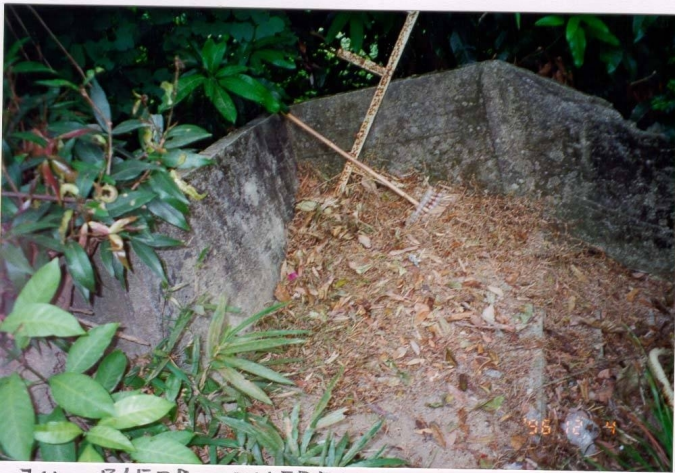
7SW-B/FR9 DISTRESS

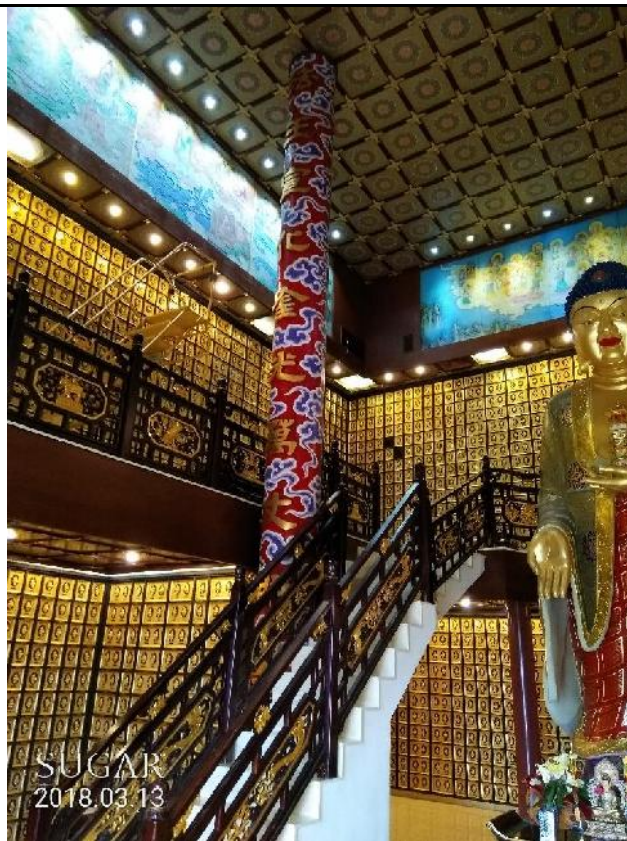
| Photo No.:<br>3 | Title: Interior View of Mei Tor Din Showing Two Columns | Photo Date:<br>13/3/2018 |

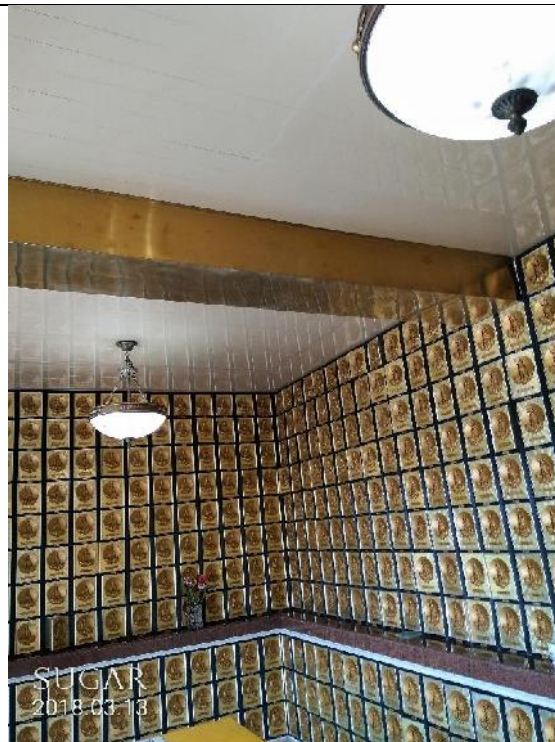
| Photo No.:<br>2 | Title: Interior of Lung Wah Kok Showing a Roof Beam | Photo Date:<br>13/3/2018 |

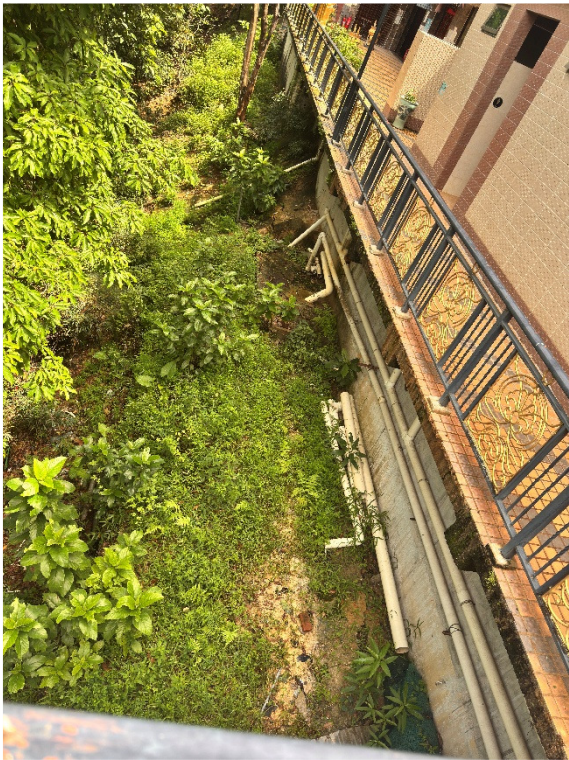
**Plate 1.1** (23/07/2025)  
General view of the feature

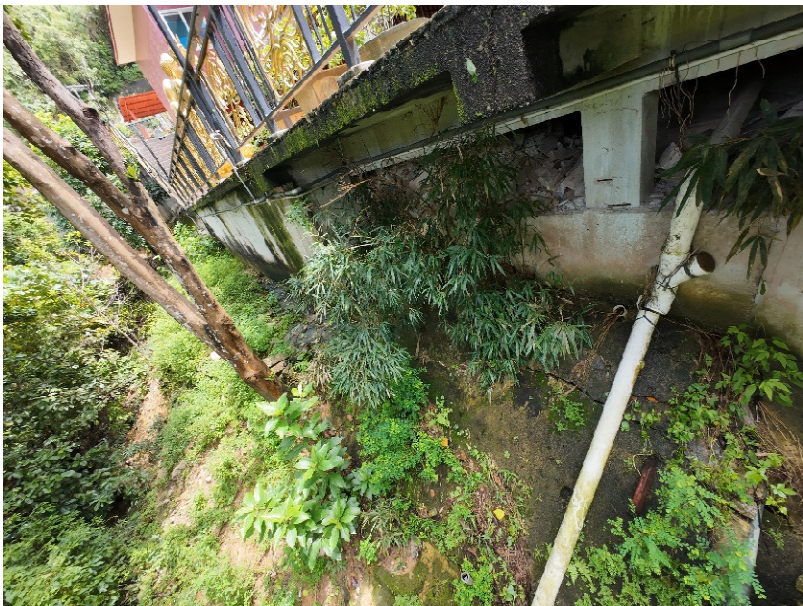
**Plate 1.2** (23/07/2025)  
General view of the feature

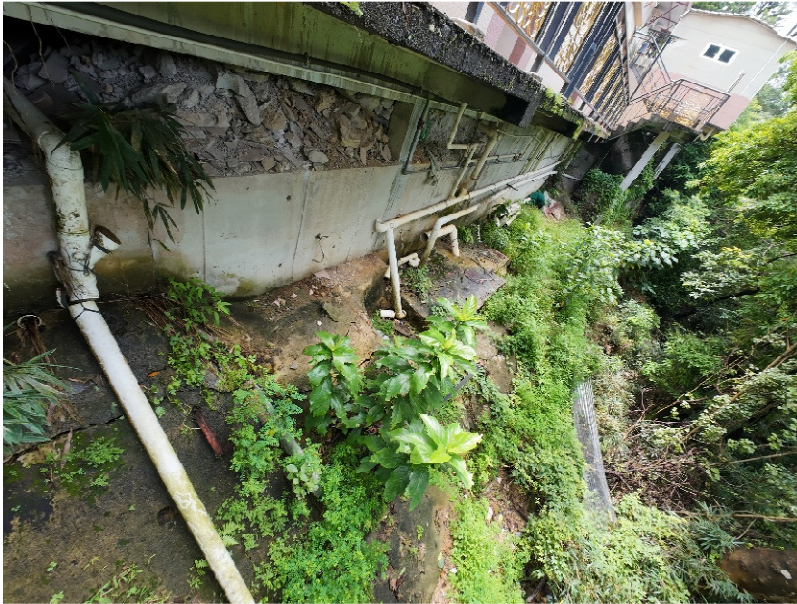
**Plate 1.3** (23/07/2025)

General view of the feature

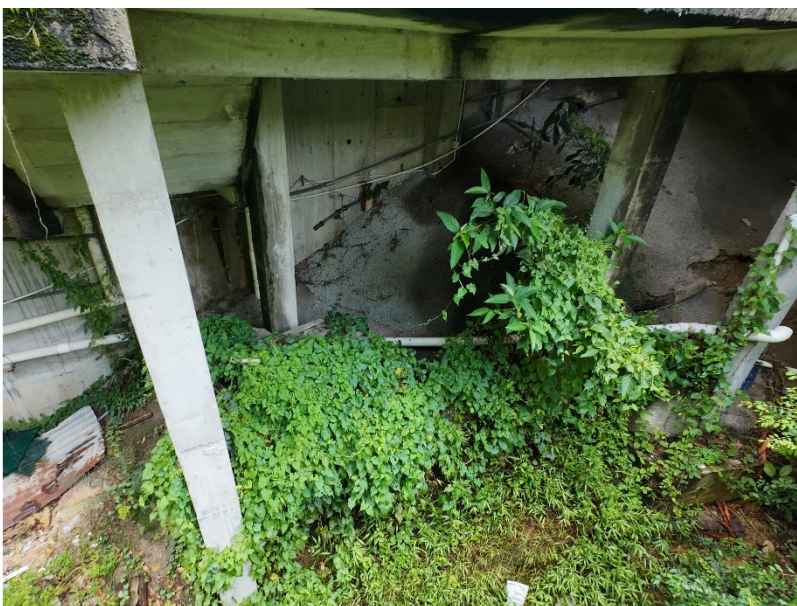
**Plate 1.4** (23/07/2025)

General view of the feature

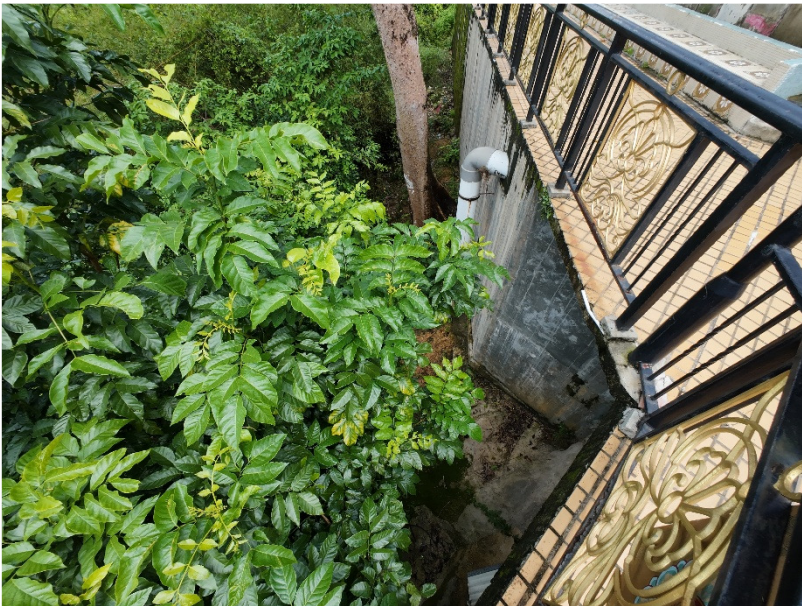
**Plate 2.1** (23/07/2025)  
General view of the feature

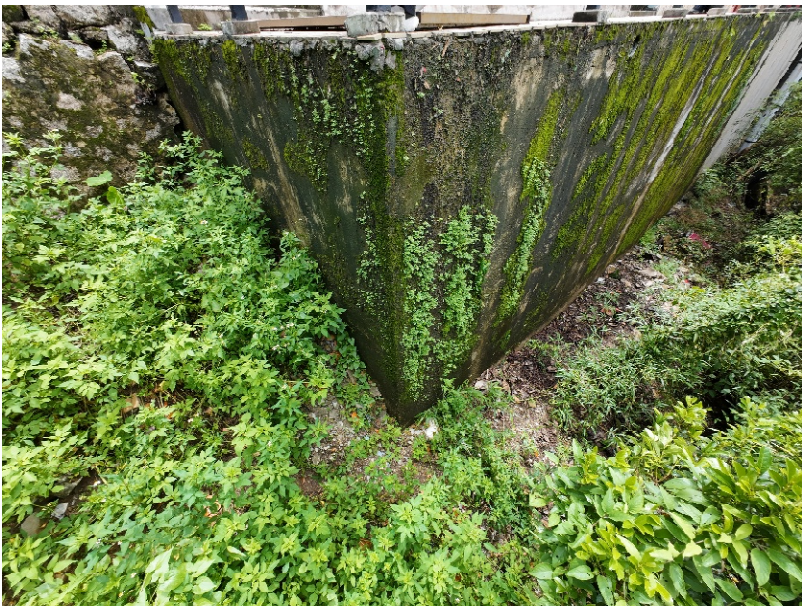
**Plate 2.2** (23/07/2025)  
General view of the feature
