Various Lots in D.D. 107, Fung Kat Heung, Kam Tin, Yuen Long, New Territories

(AYL-KTN/1031)  
(Drainage Proposal)

**Proposed Temporary Warehouse (Excluding Dangerous Goods Godown)  
for a Period of Three Years and Associated Filling of Land in "Agriculture" Zone, Various  
Lots in D.D. 107, Fung Kat Heung, Kam Tin, Yuen Long, New Territories**  
**(Application No. A/YL-KTN/1031)**

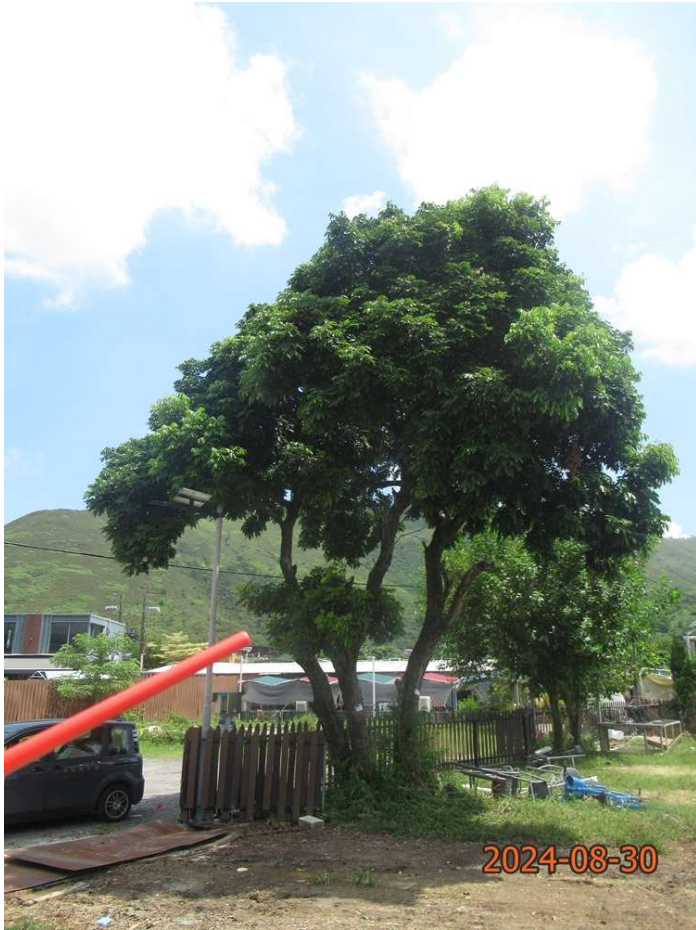
T1 (Overview)

| Tree No. | Tree Species | | Tree Size Measurements | | | Amenity Value | Form | Health Condition | Structural Condition | Suitability for Transplanting | Remarks |
|---|---|---|---|---|---|---|---|---|---|---|---|
| T1 | <i>Dimocarpus longan</i> | 龍眼 | 9.0 | 420 | 5.0 | Low | Poor | Fair | Poor | Low | Co-dominant trunks forked at the base, dead broken branches, pruned wound with epicormics, pruned wound with exposed decay wood, tree wound with exposed dead and decay wood |

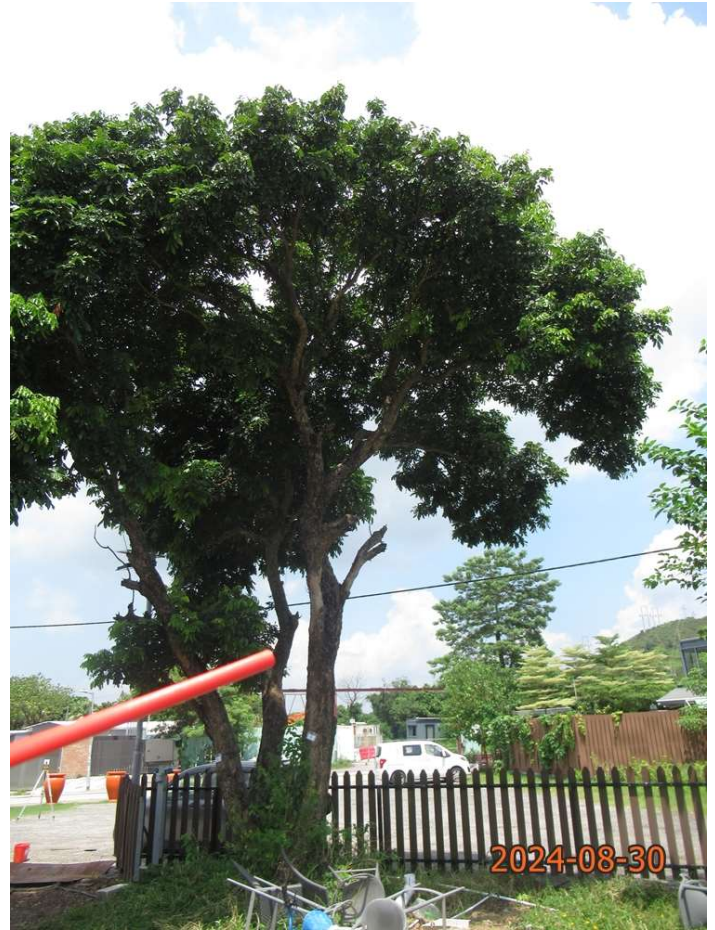
T2 (Overview)

| Tree No. | Tree Species | | Tree Size Measurements | | | Amenity Value | Form | Health Condition | Structural Condition | Suitability for Transplanting | Remarks |
|---|---|---|---|---|---|---|---|---|---|---|---|
| T2 | <i>Dimocarpus longan</i> | 龍眼 | 8.0 | 359 | 4.0 | Low | Fair | Fair | Poor | Low | Broken stub on trunk, dead broken branches with dead and decay wood |

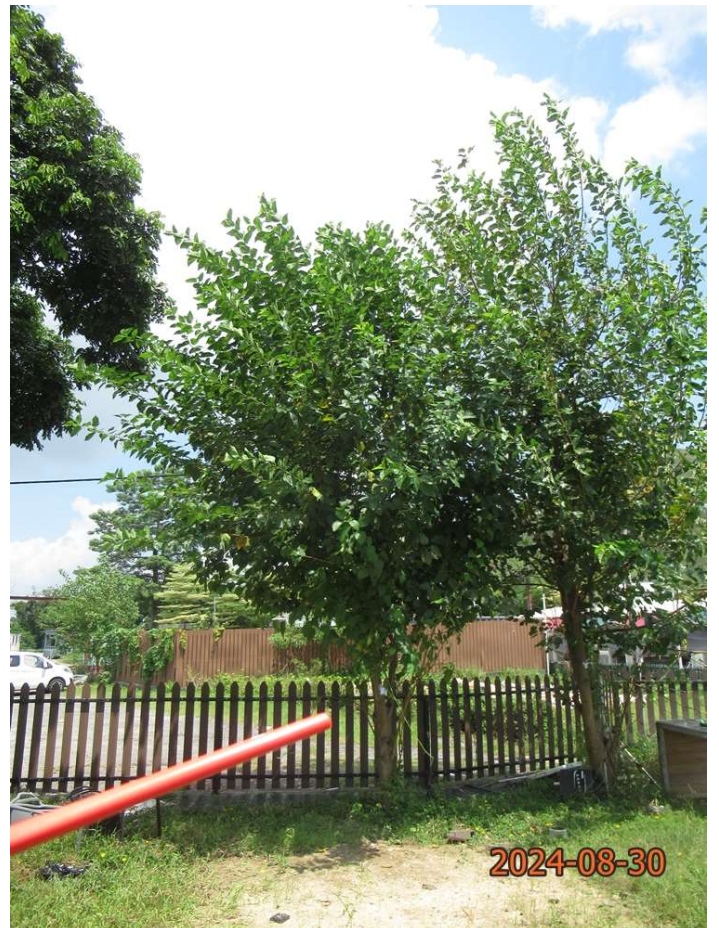
T3 (Overview)

| Tree No. | Tree Species | | Tree Size Measurements | | | Amenity Value | Form | Health Condition | Structural Condition | Suitability for Transplanting | Remarks |
|---|---|---|---|---|---|---|---|---|---|---|---|
| T3 | <i>Broussonetia papyrifera</i> | 構樹 | 6.0 | 150 | 3.0 | Low | Fair | Fair | Poor | Low | Broken stub and epicormics on trunk, co-dominant trunks forked at the base, tree wound on branch, tree wound with decay wood on branch |

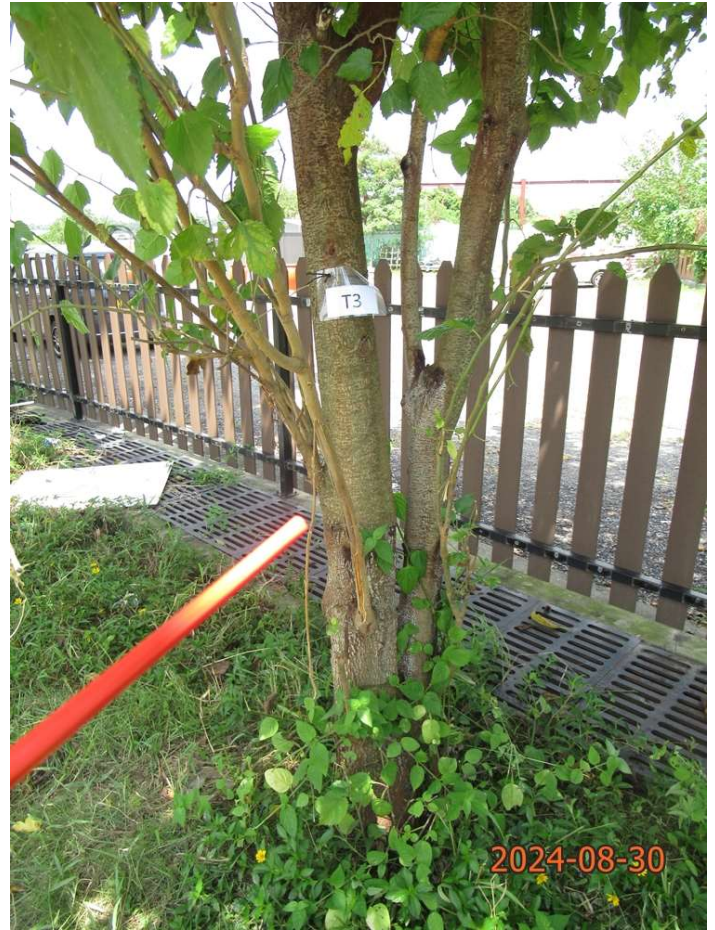
T3 Codominant trunk forked at the base

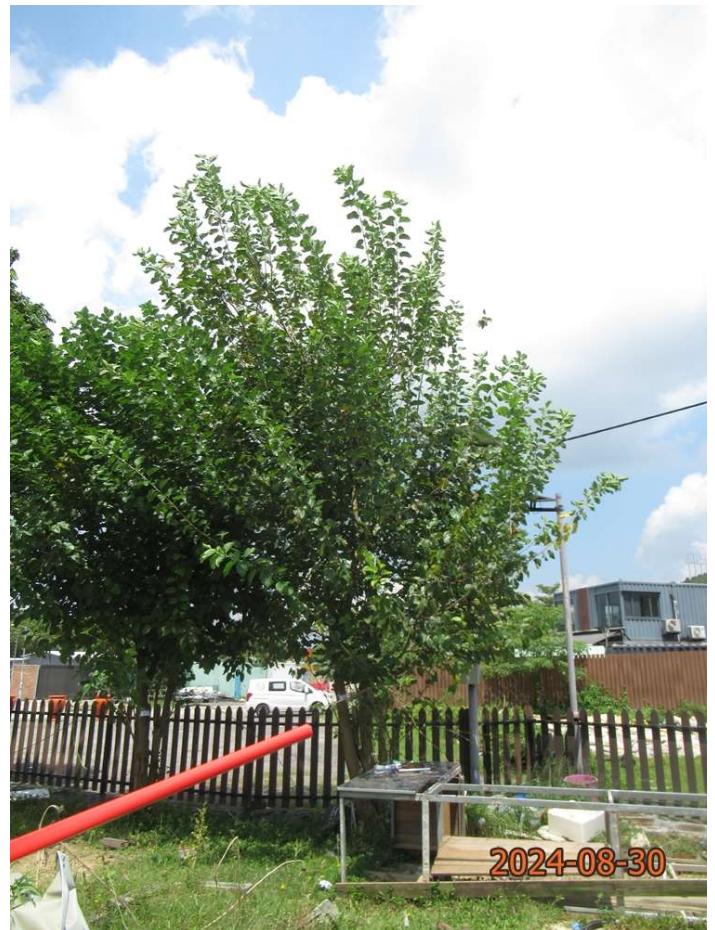
T3 Tree wound with decay wood on branch

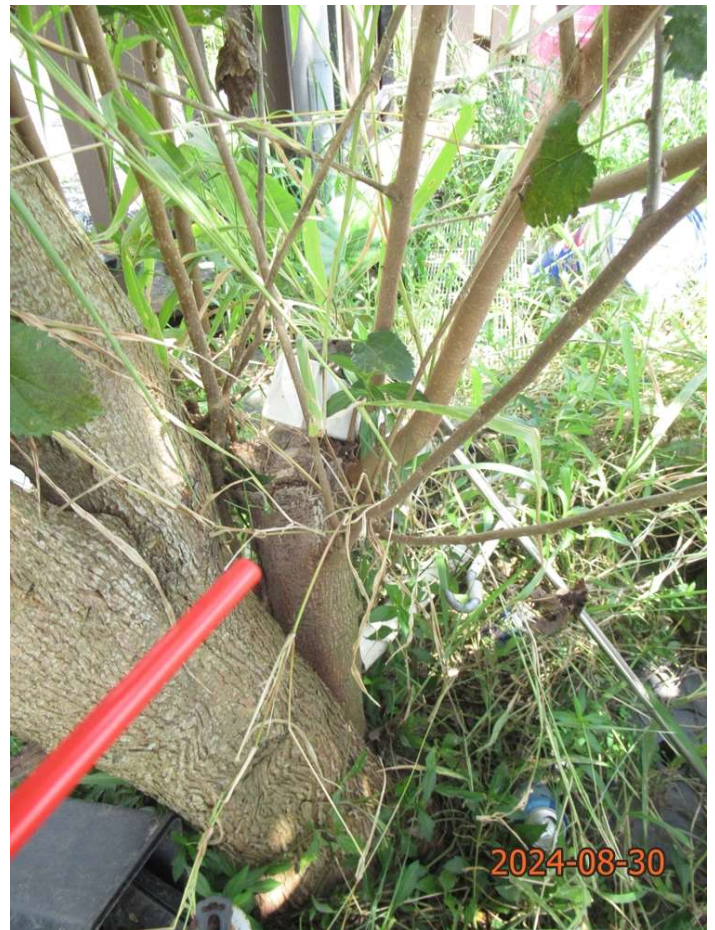
| Tree No. | Tree Species | | Tree Size Measurements | | | Amenity Value | Form | Health Condition | Structural Condition | Suitability for Transplanting | Remarks |
|---|---|---|---|---|---|---|---|---|---|---|---|
| T4 | <i>Broussonetia papyrifera</i> | 構樹 | 5.0 | 210 | 3.0 | Low | Fair | Fair | Poor | Low | Broken branch with decay wood and epicormics on trunk, co-dominant trunks, topped branch with epicormics |

T4 Codominant trunk

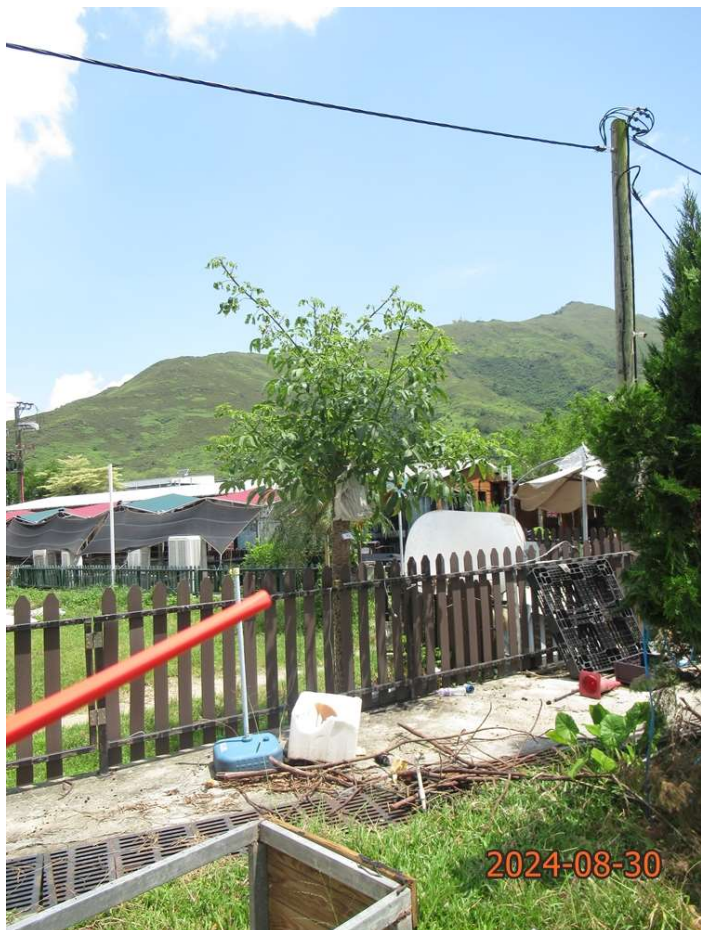
T4 Topped branch with epicormics

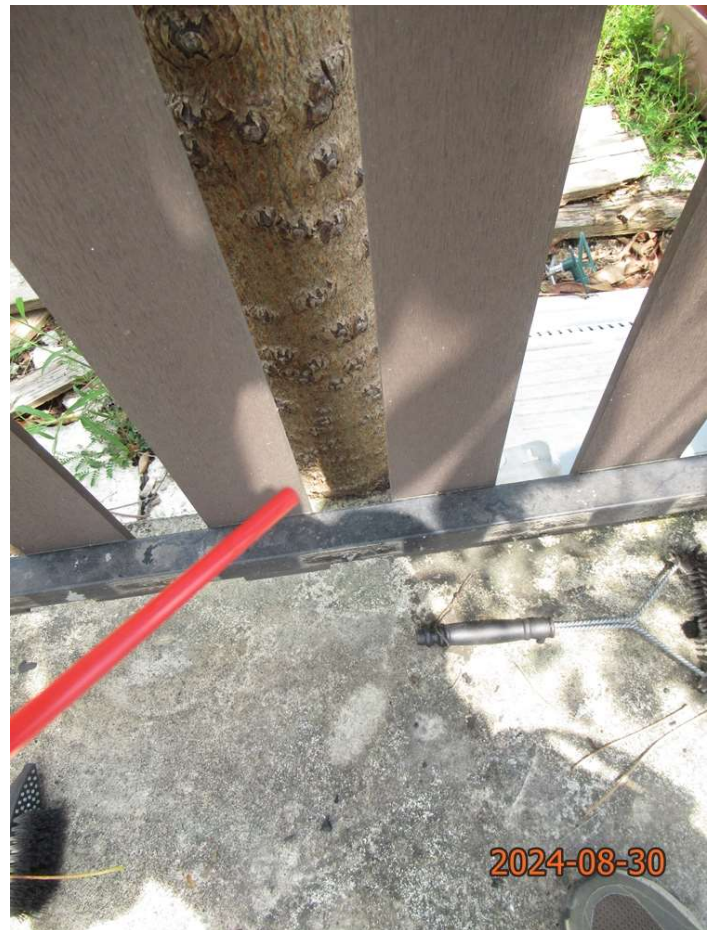
T5 Topped trunk with epicormics

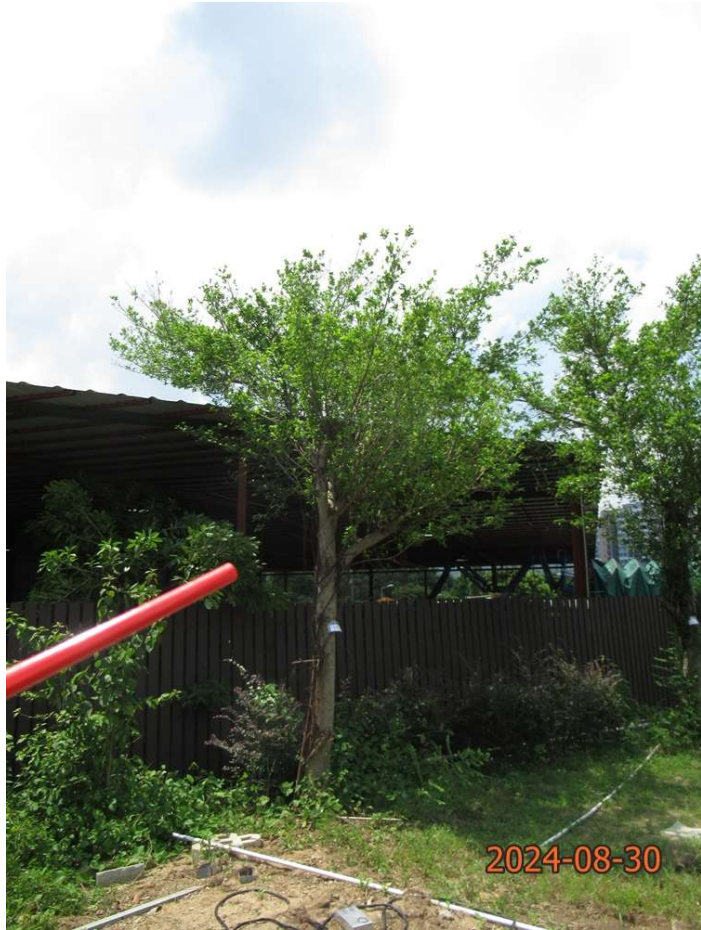
T5 Tree base embedded to concrete structure

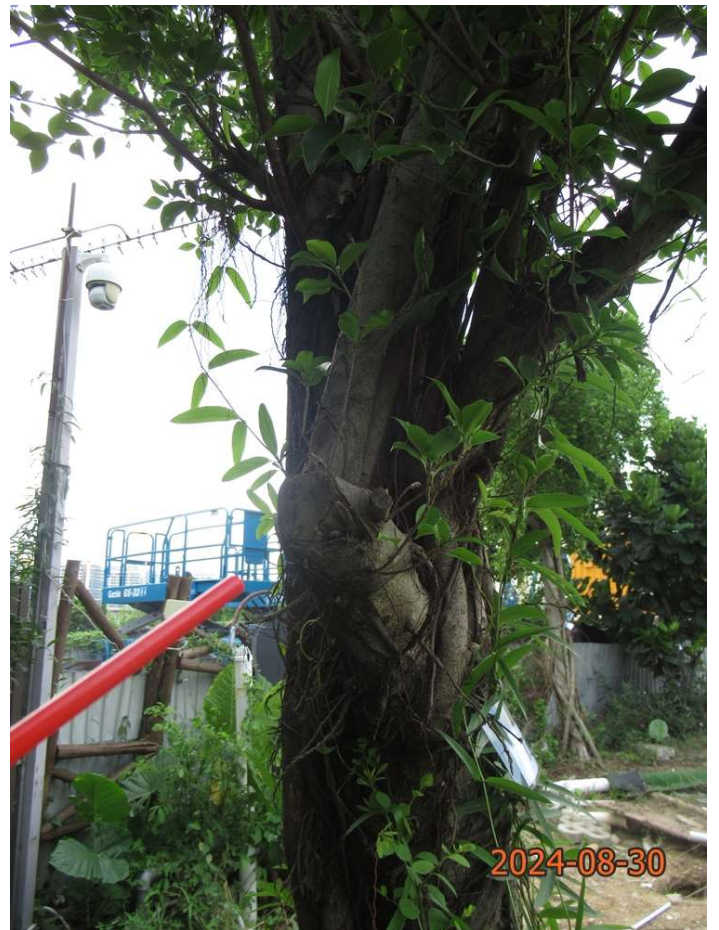
T7 Topped branch with epicormics

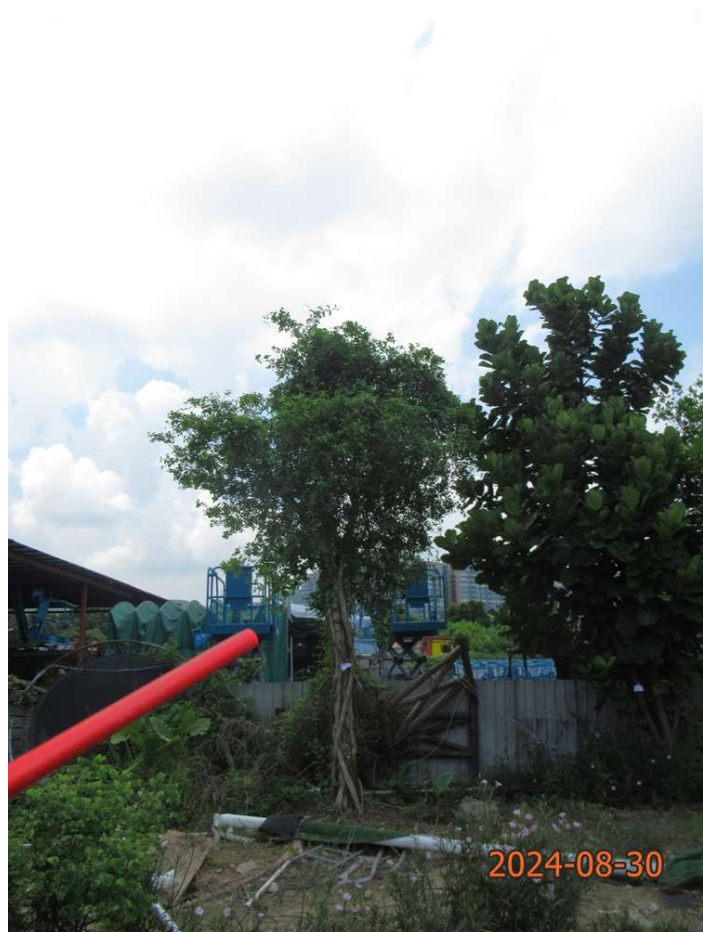
T7 Topped branches

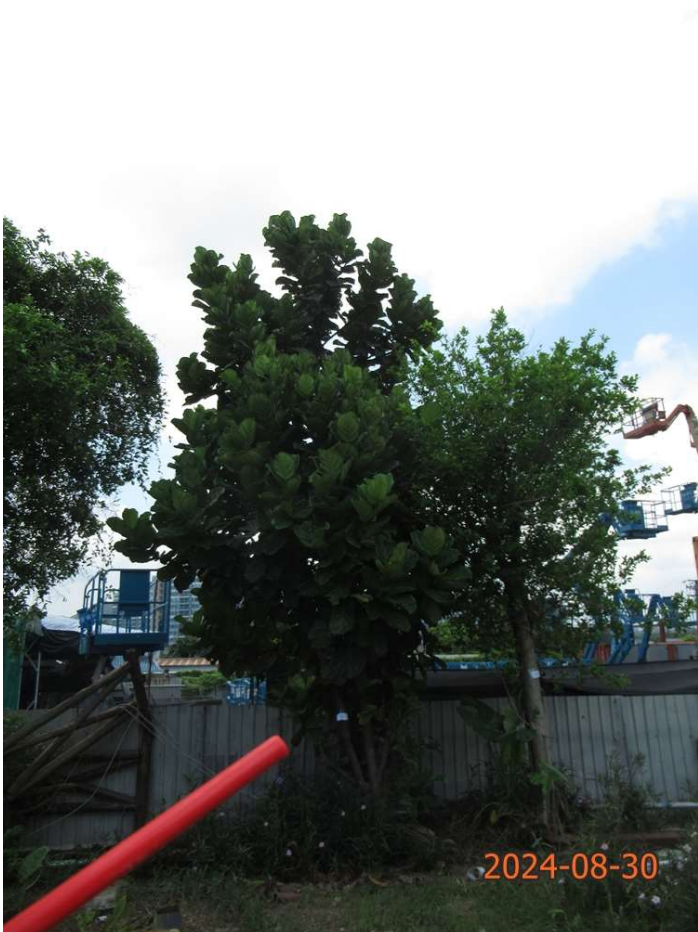
| Tree No. | Tree Species | | Tree Size Measurements | | | Amenity Value | Form | Health Condition | Structural Condition | Suitability for Transplanting | Remarks |
|---|---|---|---|---|---|---|---|---|---|---|---|
| T8 | <i>Ficus microcarpa</i> | 榕樹（細葉榕） | 5.0 | 250 | 2.0 | Low | Fair | Fair | Poor | Low | Broken branch with epicormics, topped branches |

T8 Topped branches

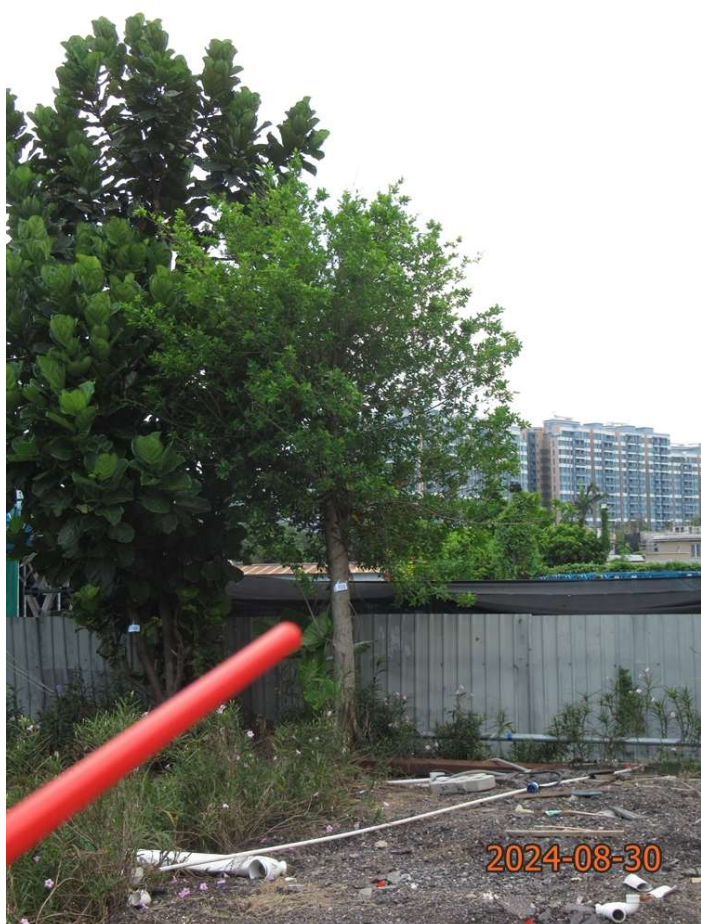
| Tree No. | Tree Species | | Tree Size Measurements | | | Amenity Value | Form | Health Condition | Structural Condition | Suitability for Transplanting | Remarks |
|---|---|---|---|---|---|---|---|---|---|---|---|
| T9 | <i>Ficus lyrata</i> | 大琴葉榕 | 6.0 | 200 | 4.0 | Low | Fair | Fair | Poor | Low | Broken branch, broken stub, forked trunk, tree wound on branch |

T9 Tree wound on branch

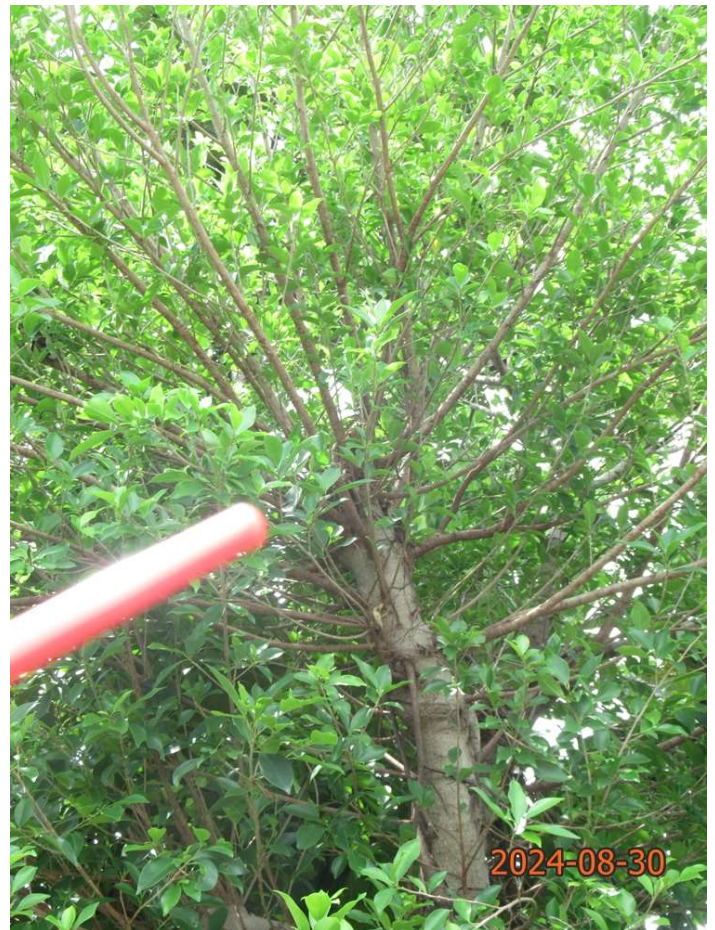
T10 Pruned wound with epicormics

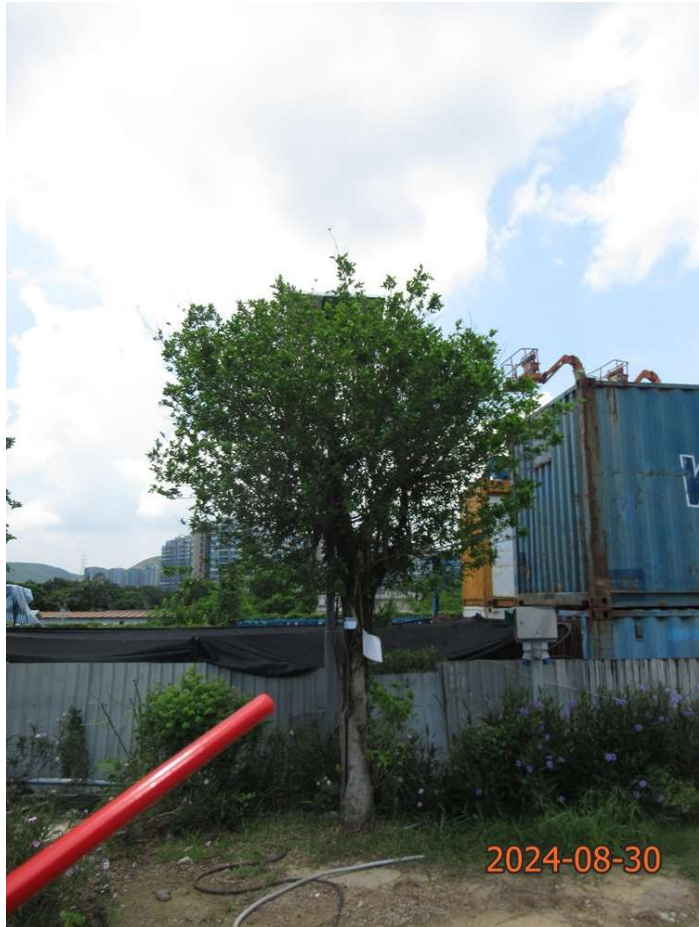
T10 Topped branch with epicormics

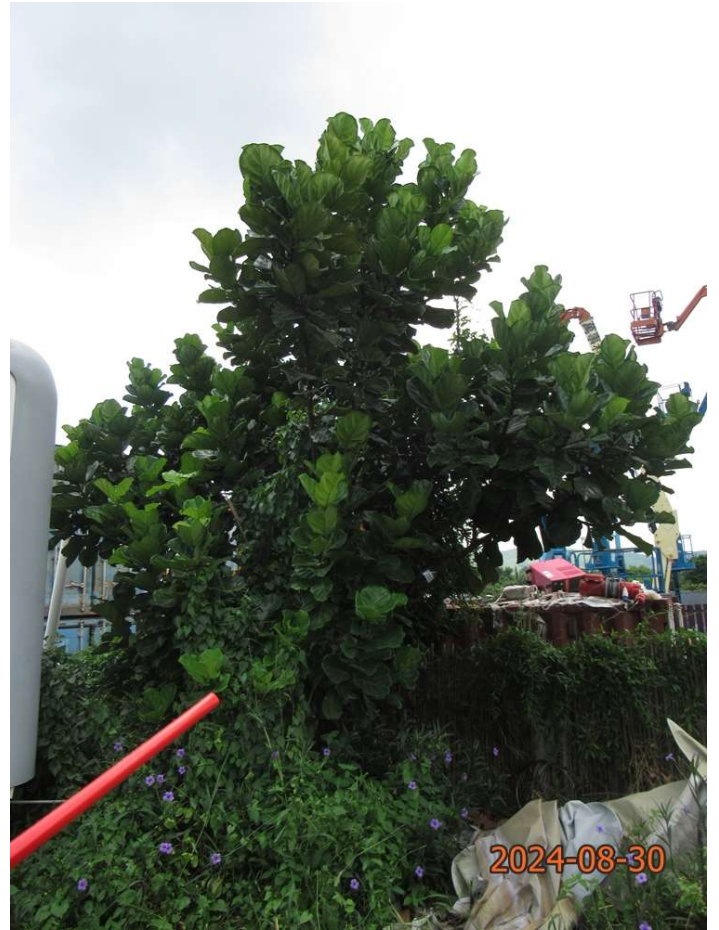
| Tree No. | Tree Species | | Tree Size Measurements | | | Amenity Value | Form | Health Condition | Structural Condition | Suitability for Transplanting | Remarks |
|---|---|---|---|---|---|---|---|---|---|---|---|
| T11 | <i>Ficus microcarpa</i> | 榕樹（細葉榕） | 4.0 | 220 | 3.0 | Low | Fair | Fair | Fair | Low | Broken branches with epicormics |

T11 Broken branches with epicormics

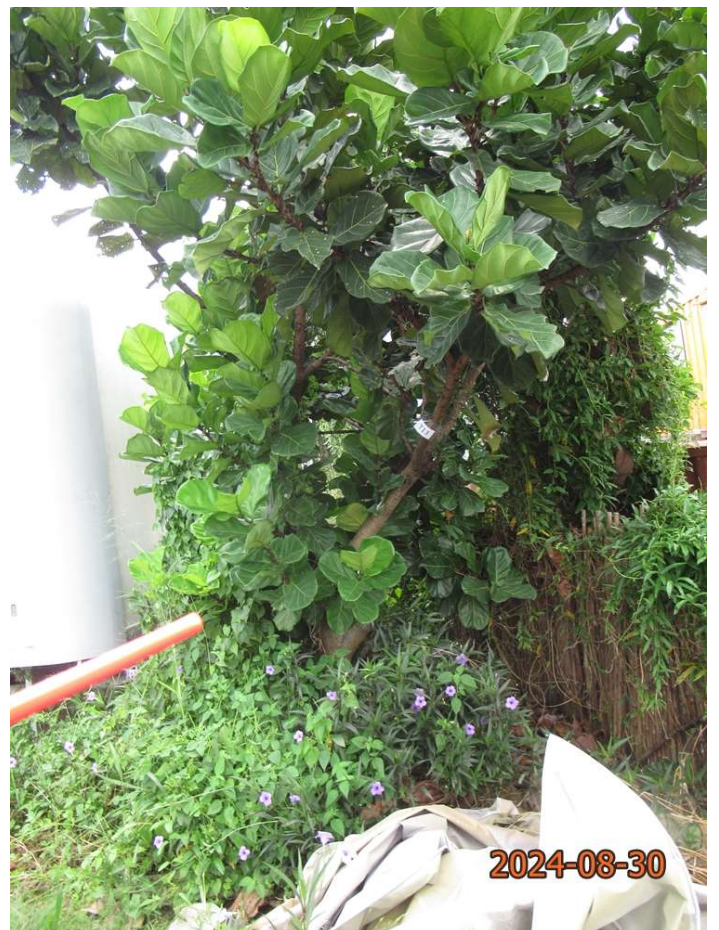
T12 (Crown condition)

| Tree No. | Tree Species | | Tree Size Measurements | | | Amenity Value | Form | Health Condition | Structural Condition | Suitability for Transplanting | Remarks |
|---|---|---|---|---|---|---|---|---|---|---|---|
| T12 | <i>Ficus lyrata</i> | 大琴葉榕 | 5.0 | 300 | 6.0 | Low | Poor | Fair | Poor | Low | Broken branch with expose dead and decayed wood, forked branch with tree wound |
