# Tree Survey Report

**Date of Survey: 25<sup>th</sup> October 2024**

**Lots 2063 And 2064 In D.D. 106 and Adjoining Government Land, Kam Tin, Yuen Long, New Territories (Former Shek Wu School)**

Registered Arborist

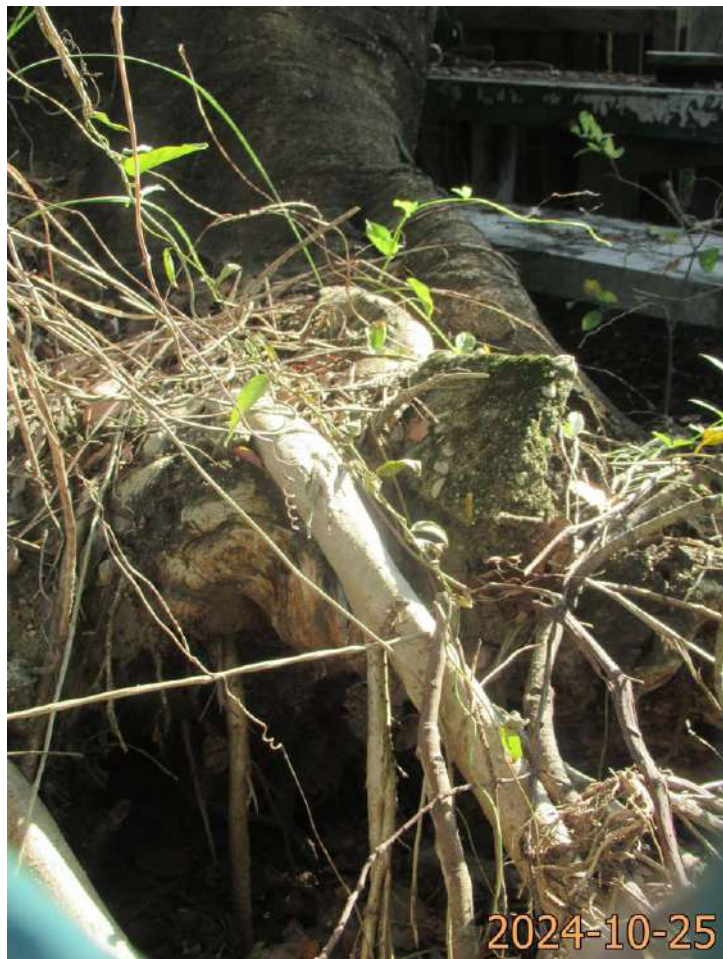
T14 Uprooted\_3

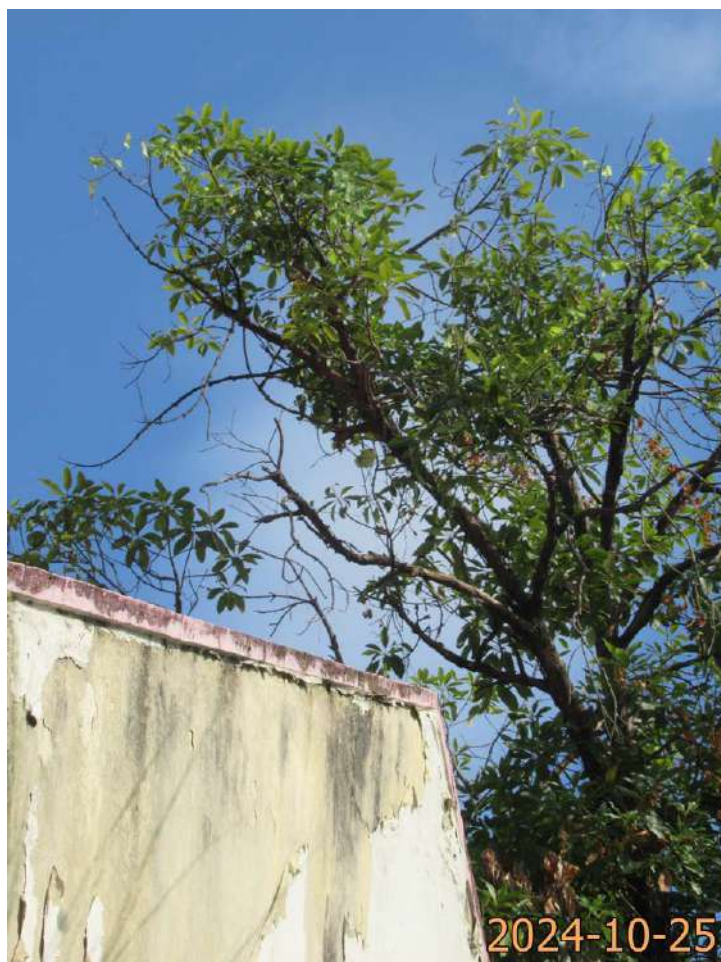
T15 Dieback twigs

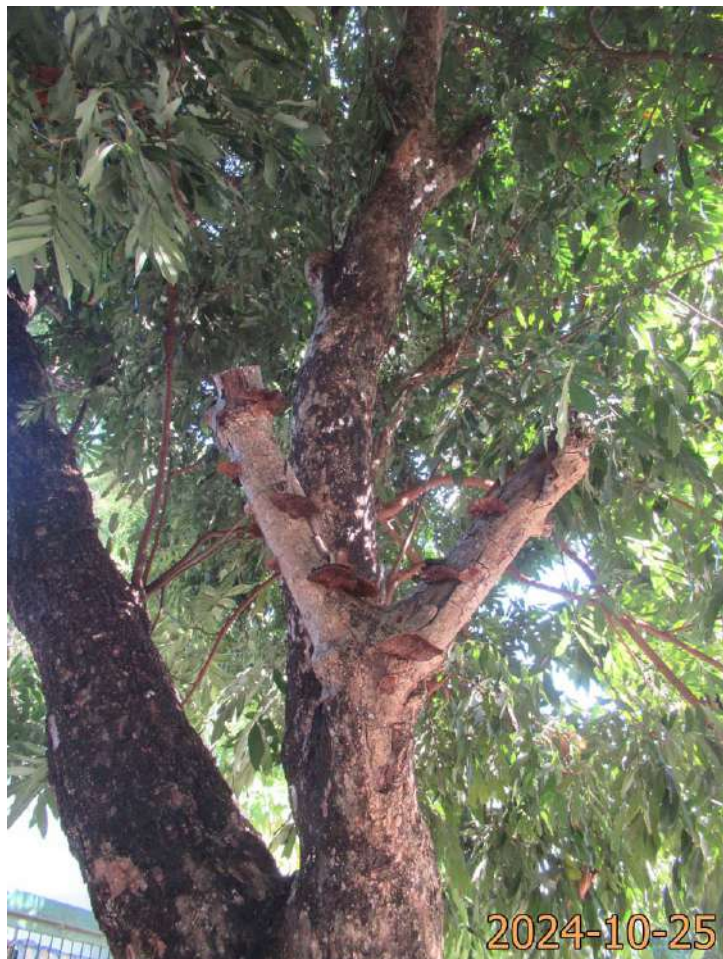
T18 Dead branch

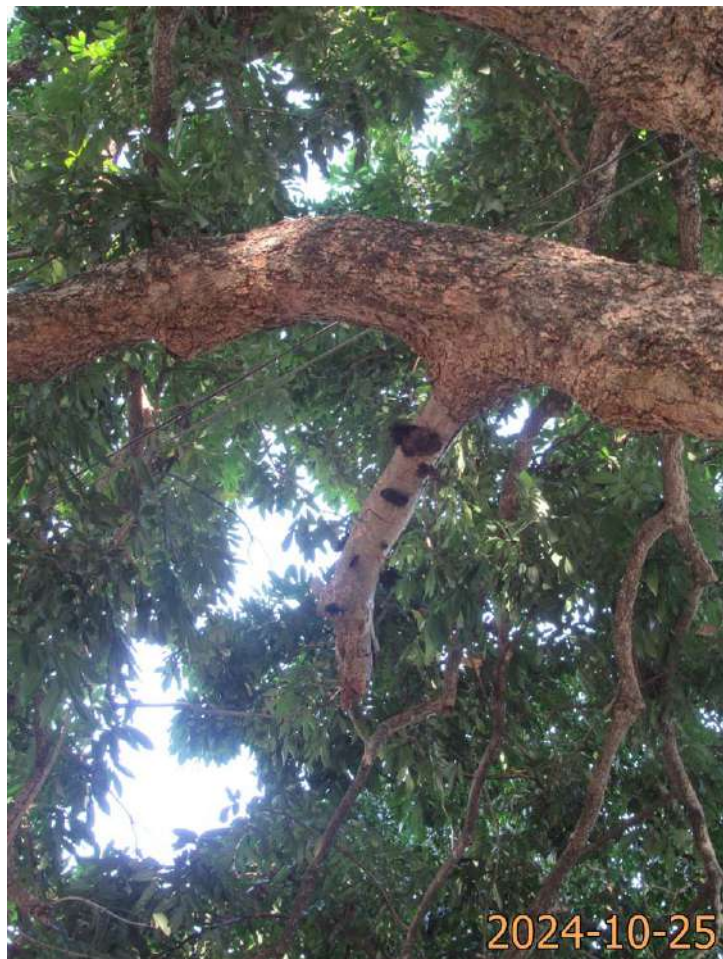
T19 Dead branch

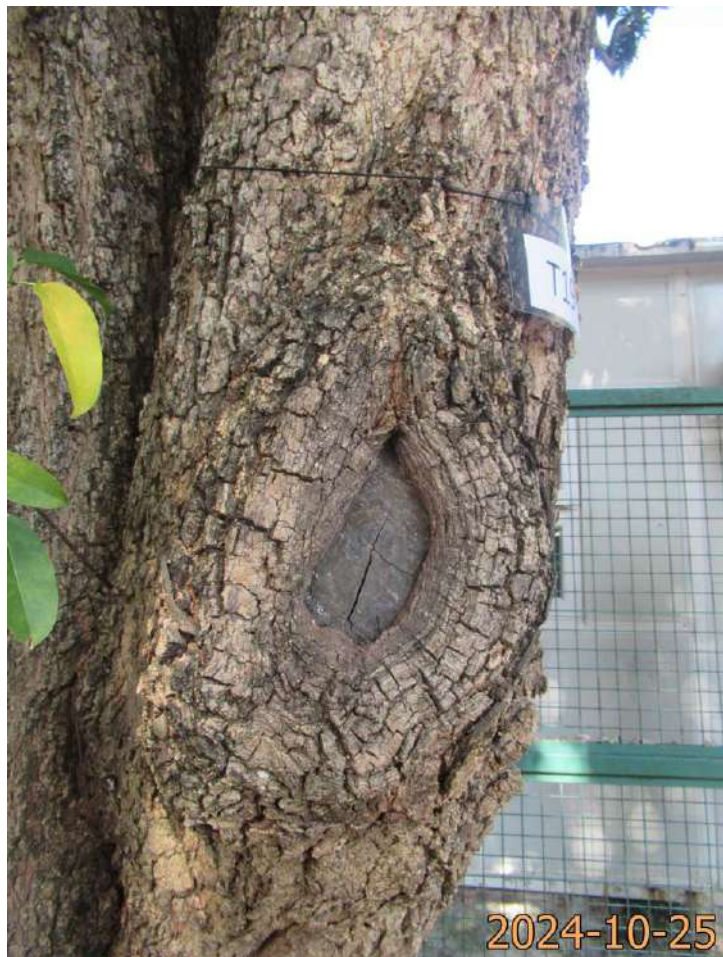
T19 Wound on trunk

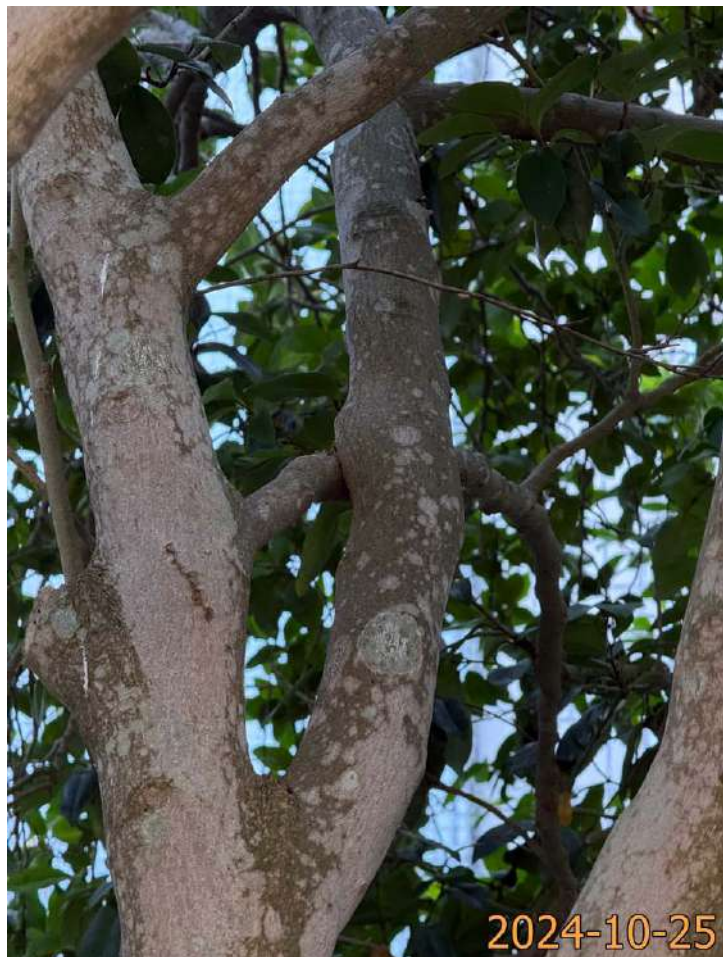
T21 Cross branches

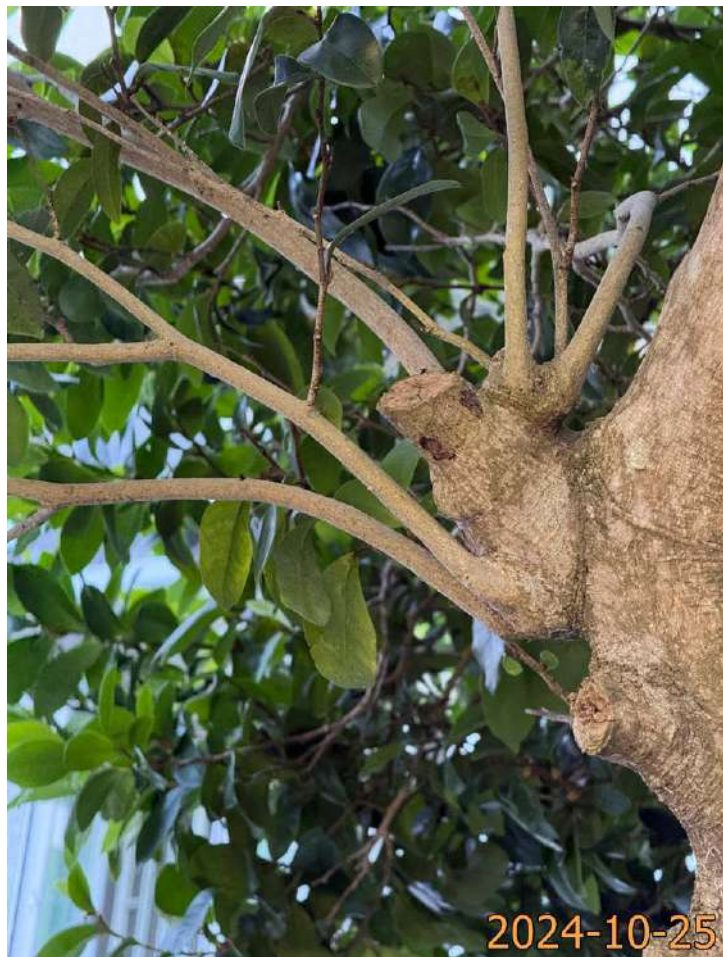
T21 Pruning wound with epicormics

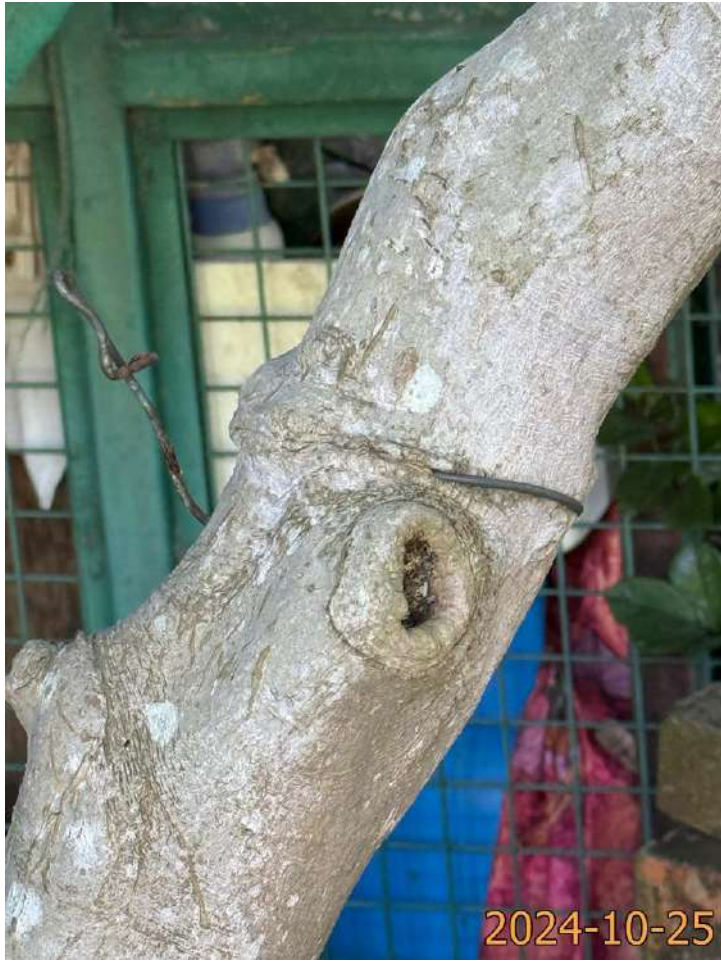
T21 Wire embedded in trunk
