**SECTION 16 PLANNING APPLICATION FOR PROPOSED RESIDENTIAL  
CARE HOMES FOR THE ELDERLY IN "VILLAGE TYPE DEVELOPMENT"  
AT LOT NO. 76 S.G. & 76 S.H. IN D.D. 101, MAI PO, YUEN LONG**

**LANDSCAPE PROPOSAL  
&  
TREE TREATMENT PROPOSAL**

**PREPARED BY  
STEPHEN LAI STUDIO LIMITED (S L S L)  
ON BEHALF OF  
GOTLAND ENTERPRISES LIMITED**

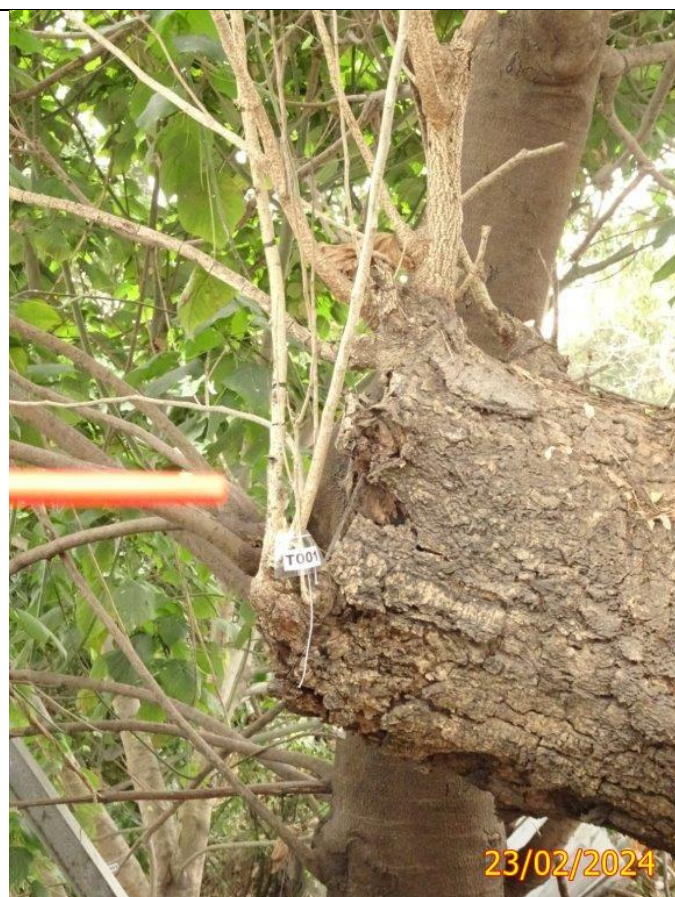
T01 | Albizia lebbeck 大葉合歡 | pruned branch with  
epicormic shoots on lower crown

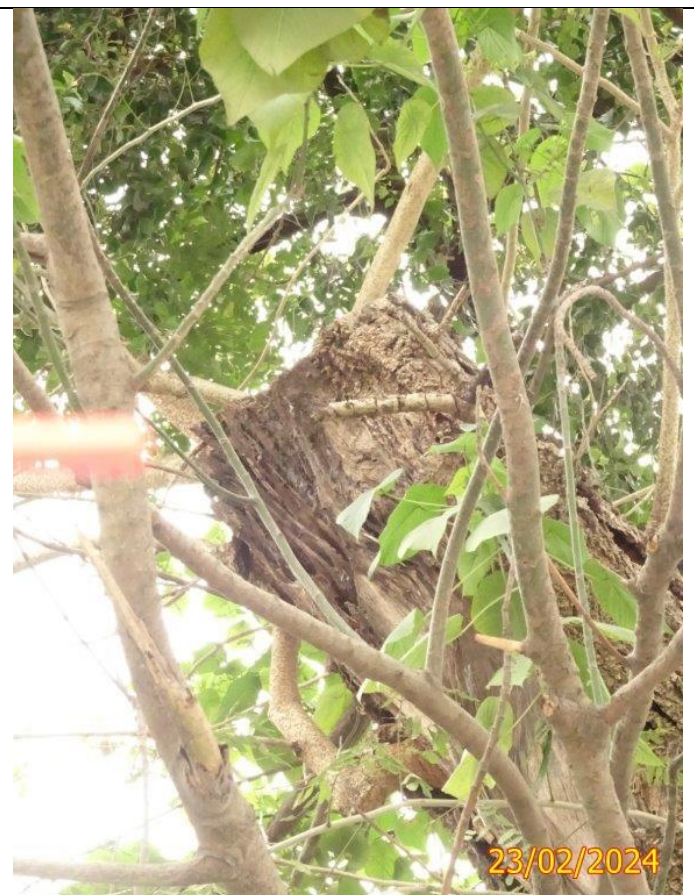
T01 | Albizia lebbeck 大葉合歡 | another pruned branch on mid crown

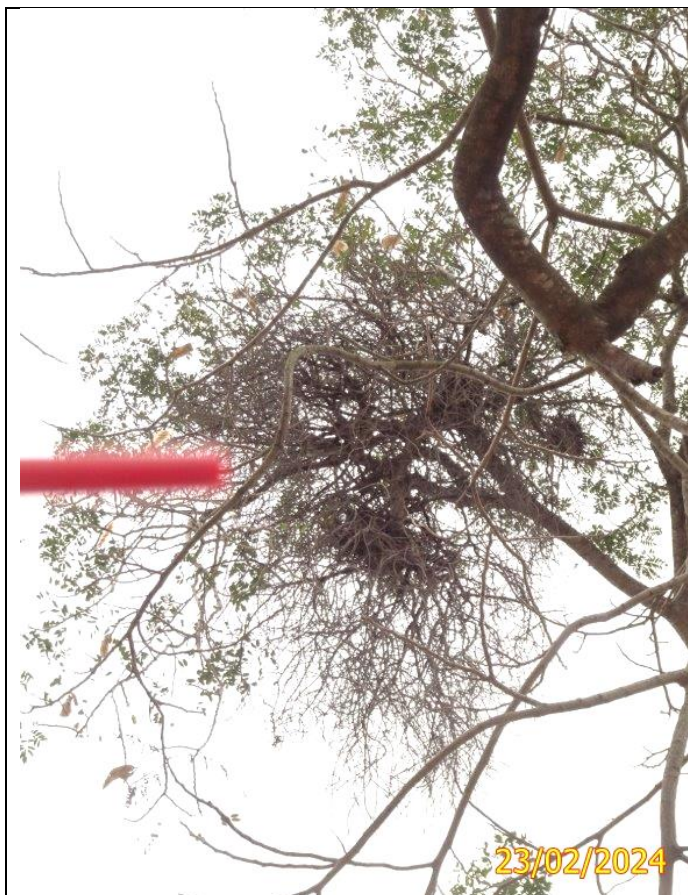
T01 | Albizia lebbeck 大葉合歡 | hemiparasite plant, *Viscum album* on upper crown

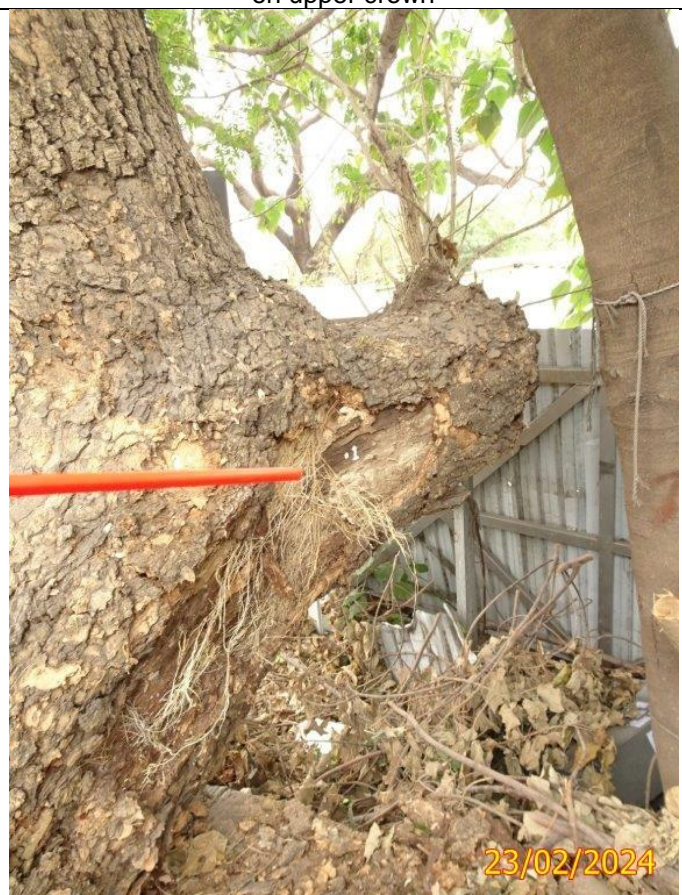
T01 | Albizia lebbeck 大葉合歡 | mechanical injury on broken branch at lower trunk

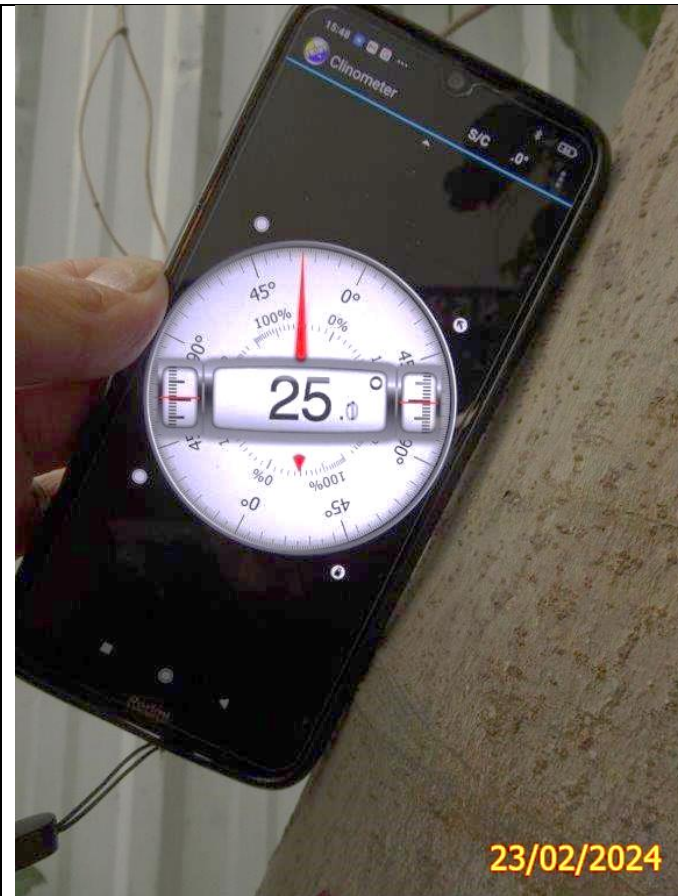
T03 | *Macaranga tanarius* var. *tomentosa* 血桐 | titled  
25°

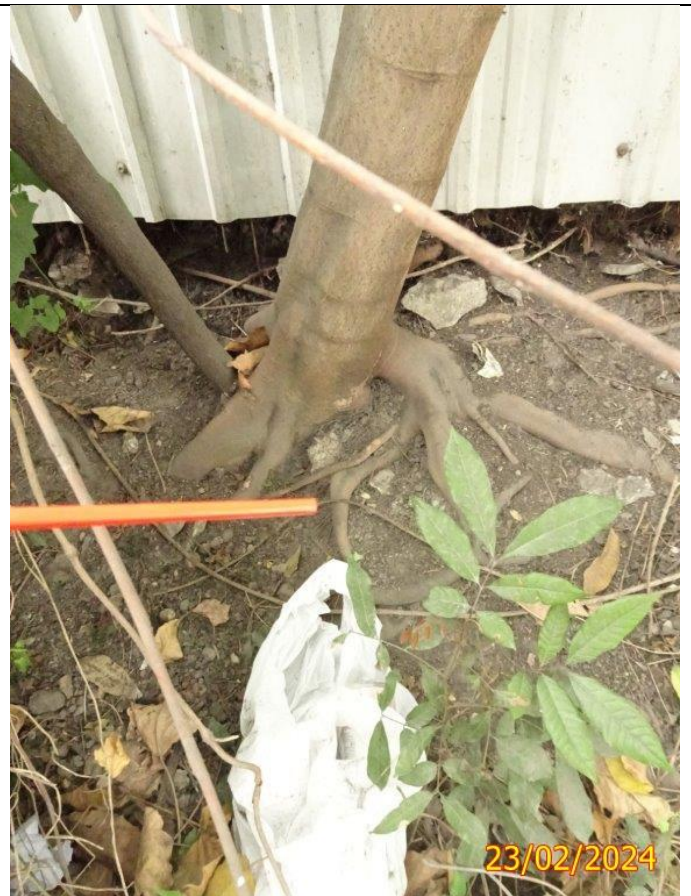
T03 | *Macaranga tanarius* var. *tomentosa* 血桐 |  
exposed root

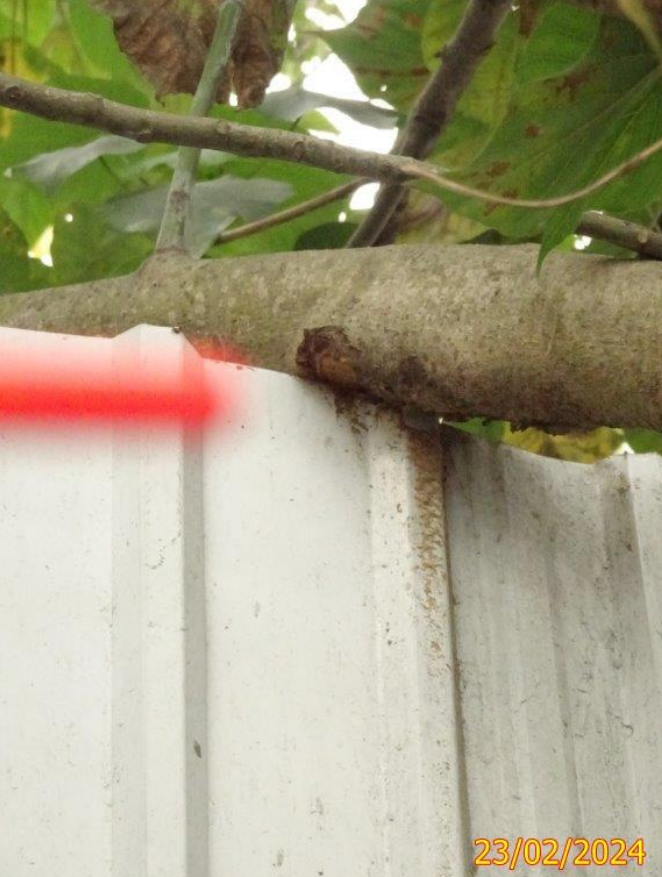
<p>23/02/2024</p>
<p>T05   <i>Macaranga tanarius</i> var. <i>tomentosa</i> 血桐   mechanical injury on mid trunk</p>	<p>T05   <i>Macaranga tanarius</i> var. <i>tomentosa</i> 血桐   branch conflict with hoarding</p>
  <p>23/02/2024</p>	<p>No Photo</p>
<p>T05   <i>Macaranga tanarius</i> var. <i>tomentosa</i> 血桐   root collar conflict with hoarding</p>

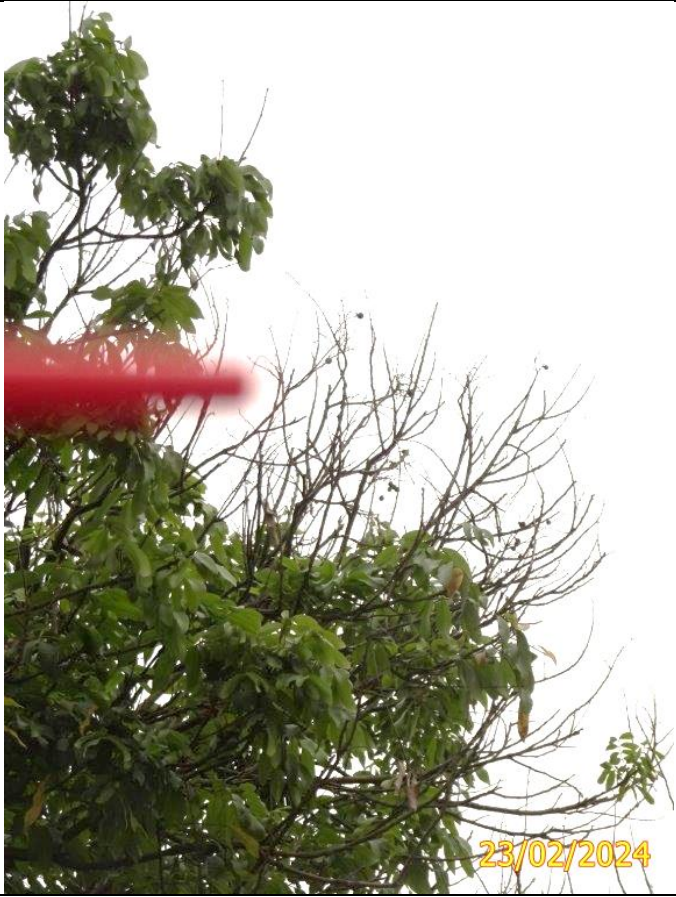
<p>No Photo</p>
<p>T09   Dimocarpus longan 龍眼   dieback twigs on upper crown</p>

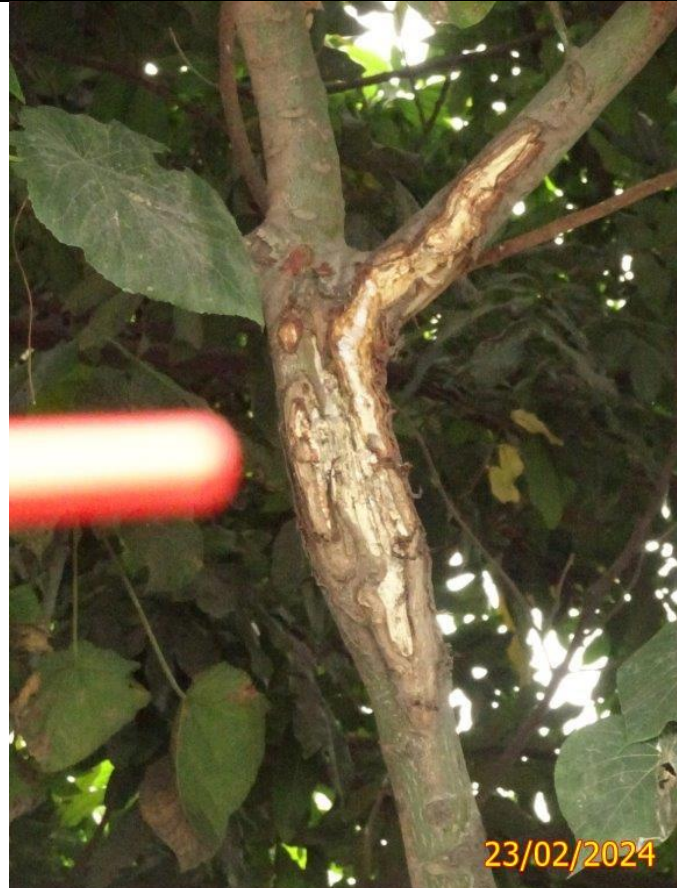
<p>No Photo</p>
<p>T10   <i>Macaranga tanarius</i> var. <i>tomentosa</i> 血桐   mechanical wound on upper trunk</p>

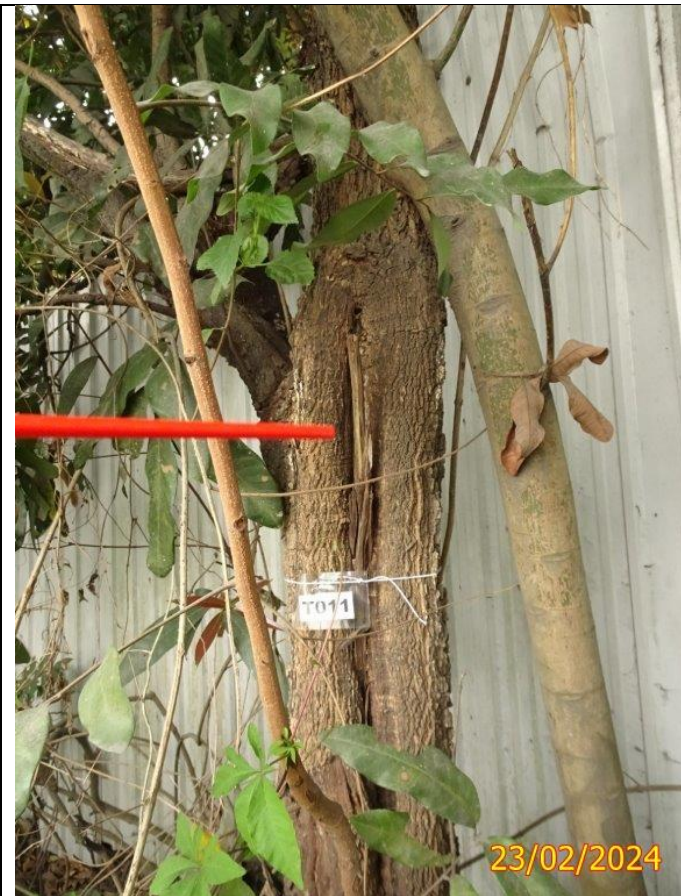
T11 | *Dimocarpus longan* 龍眼 | longitudinal wound on mid trunk

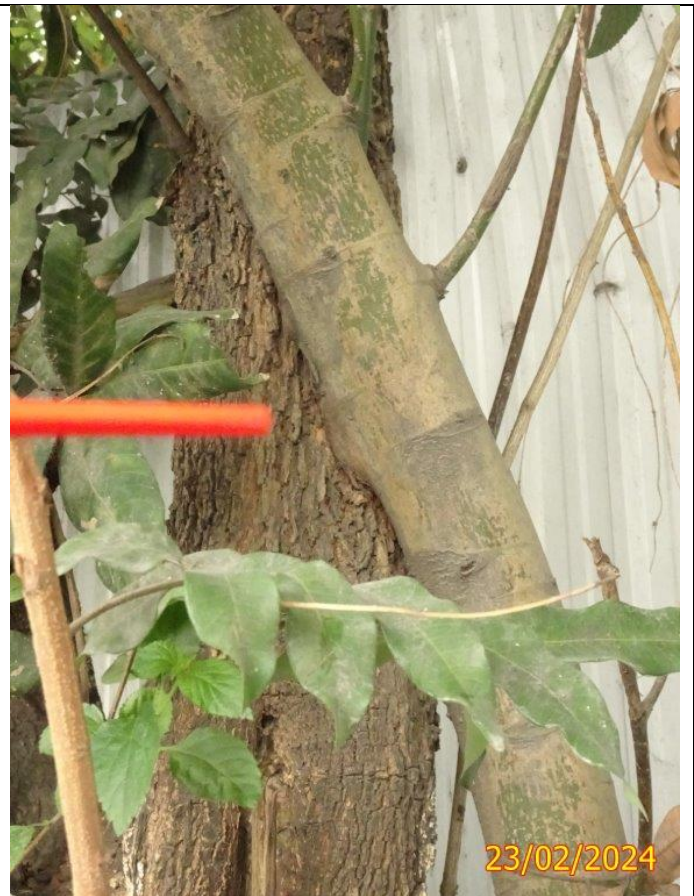
T11 | *Dimocarpus longan* 龍眼 | cross trunk

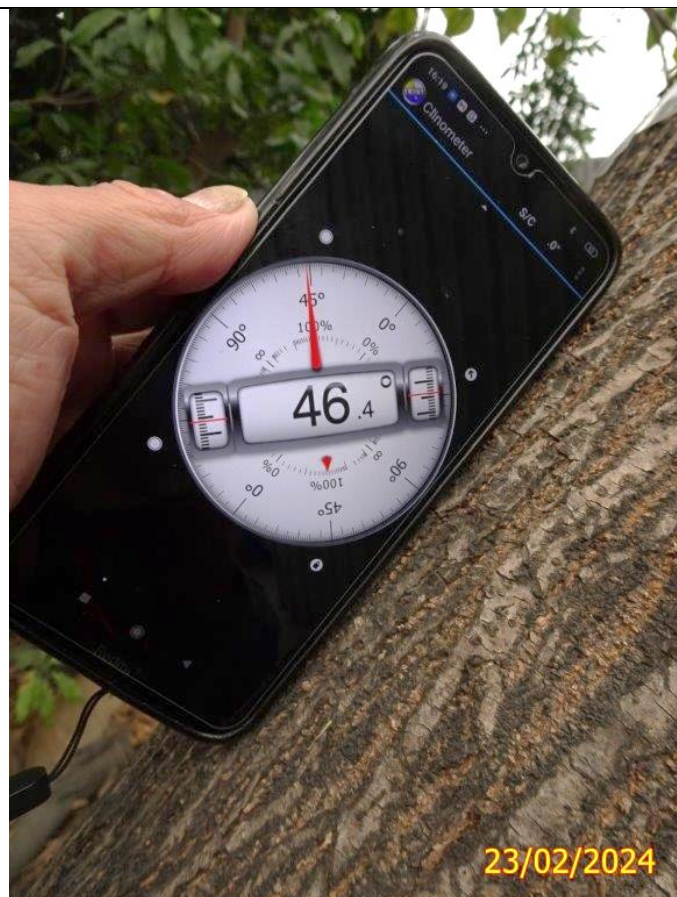
T18 | *Leucaena leucocephala* 銀合歡 | tilted 46.4°

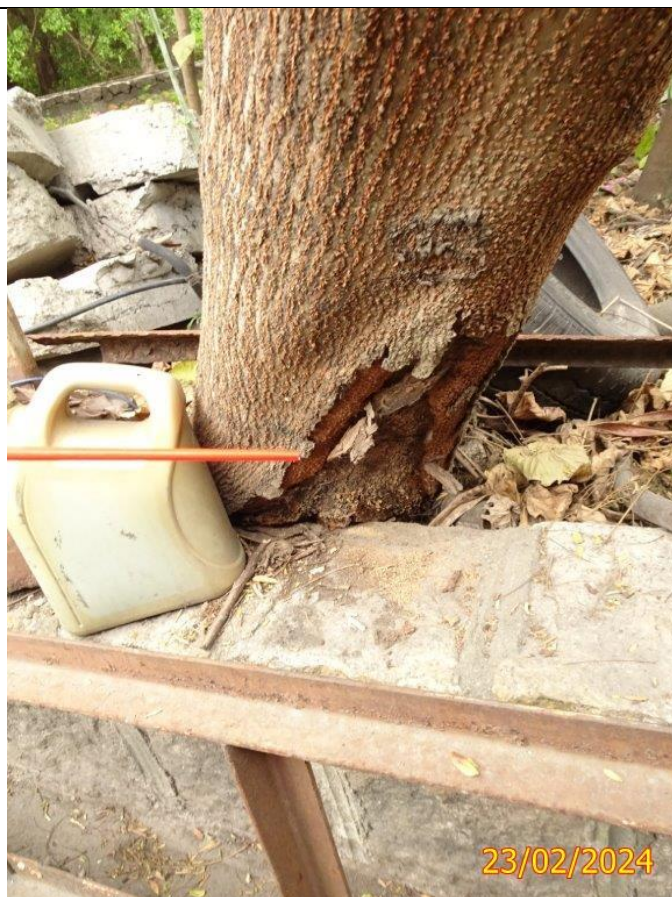
T18 | *Leucaena leucocephala* 銀合歡 | mechanical injury on root collar

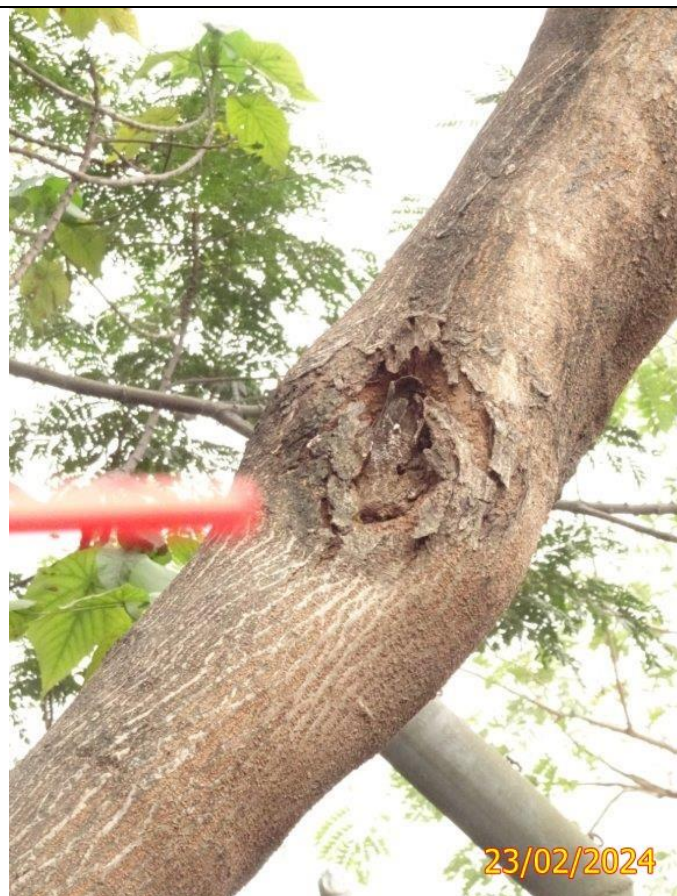
T18 | *Leucaena leucocephala* 銀合歡 | enclosed wound on mid trunk

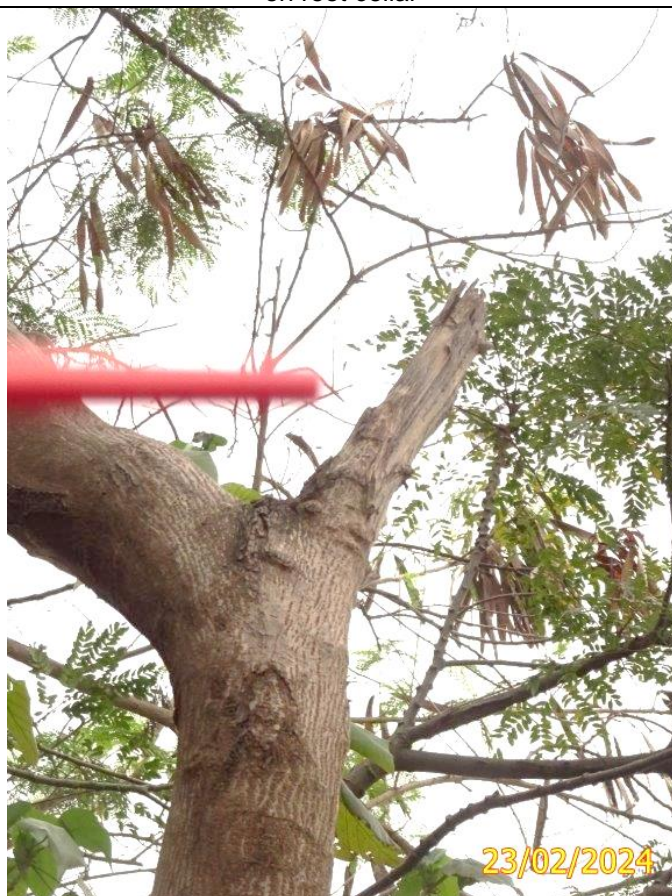
T18 | *Leucaena leucocephala* 銀合歡 | broken branch

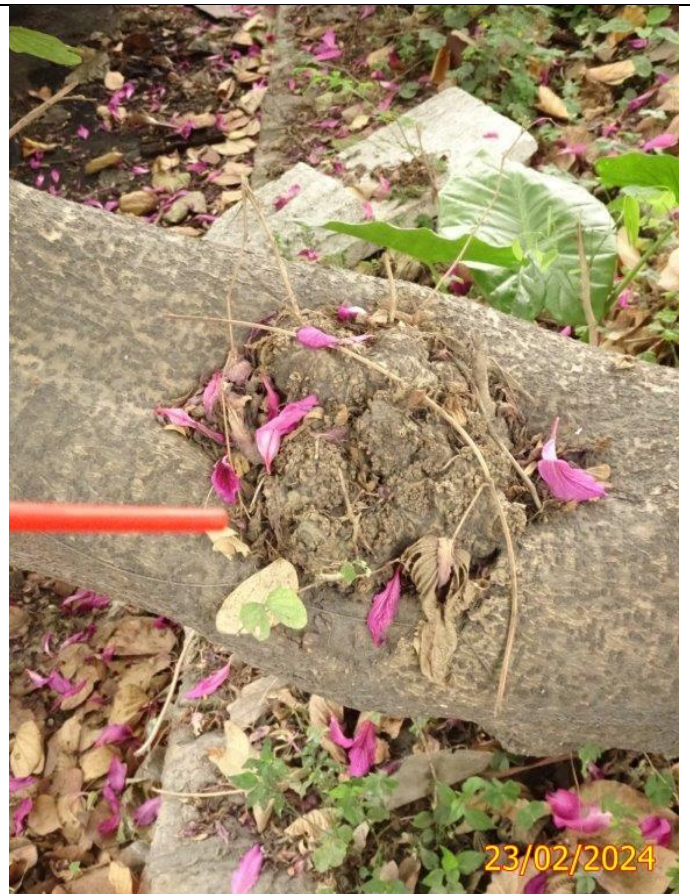
T19 | Bauhinia x blakeana 洋紫荊 | canker at lower trunk

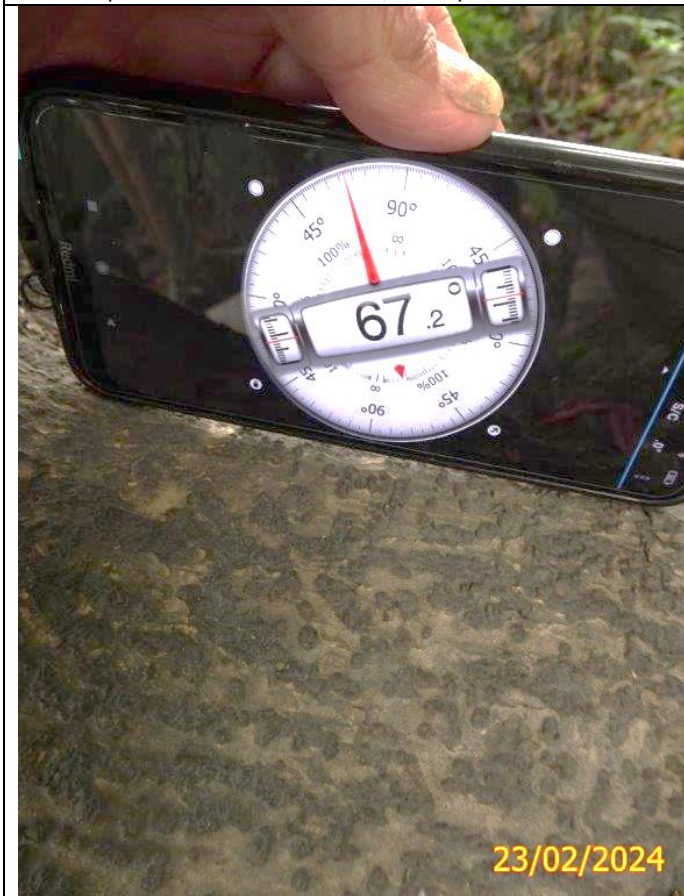
T19 | Bauhinia x blakeana 洋紫荊 | tilted 67.2°

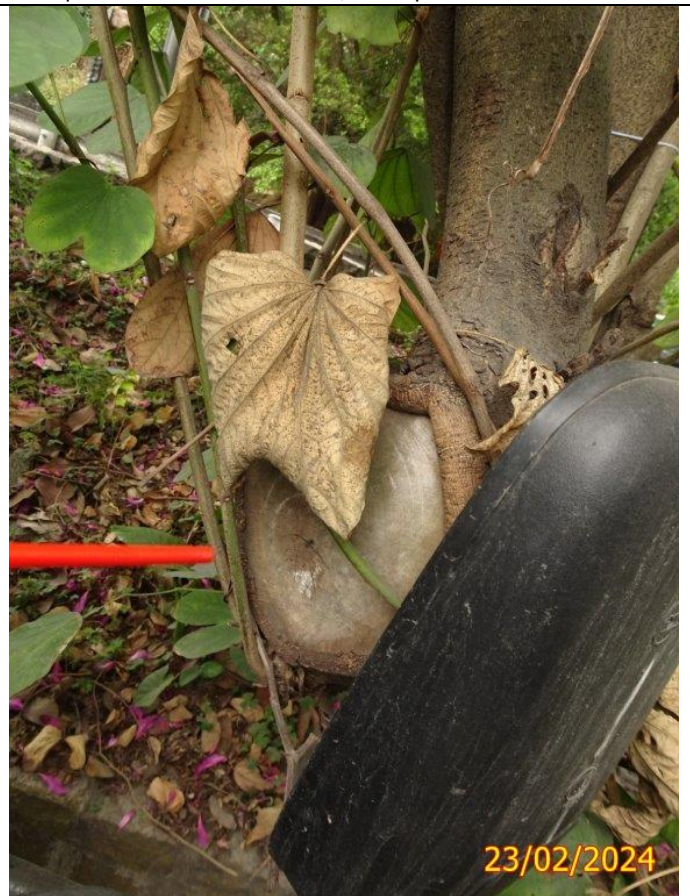
T19 | Bauhinia x blakeana 洋紫荊 | pruning wound at lower trunk

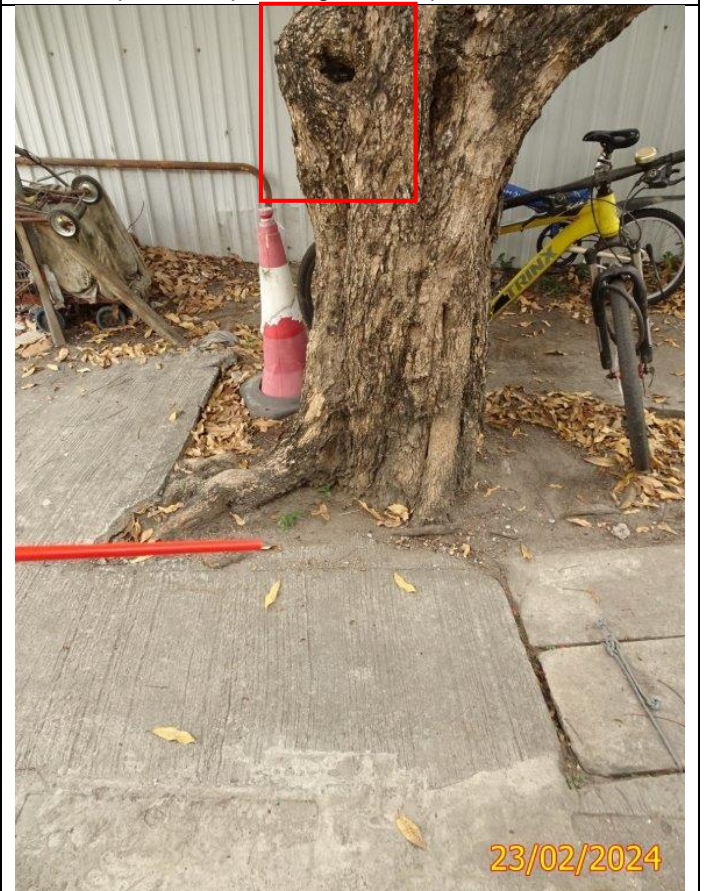
T20 | *Dimocarpus longan* 龍眼 | Root condition

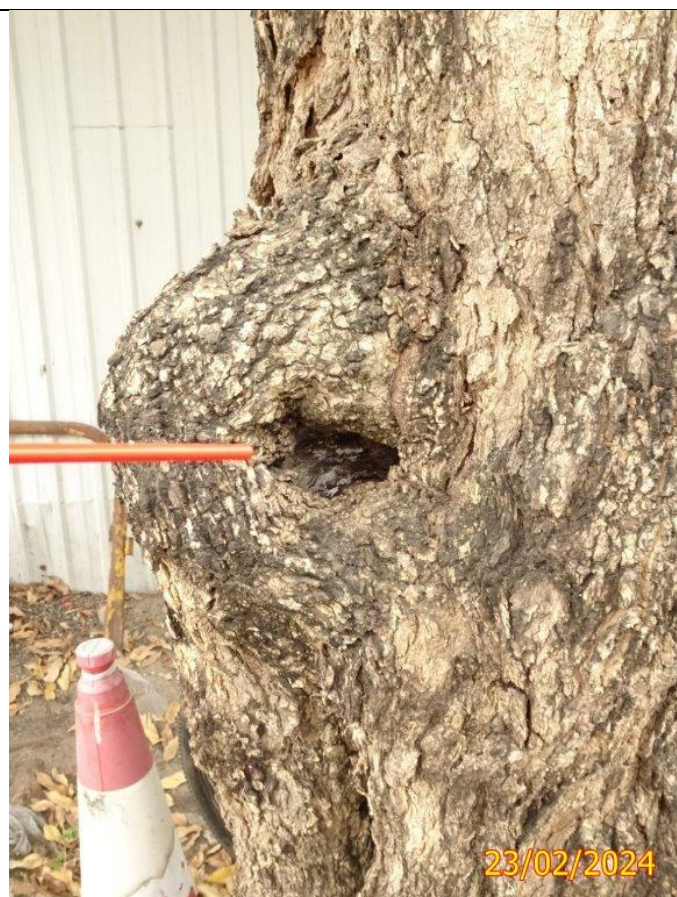
T20 | *Dimocarpus longan* 龍眼 | small open cavity at lower trunk

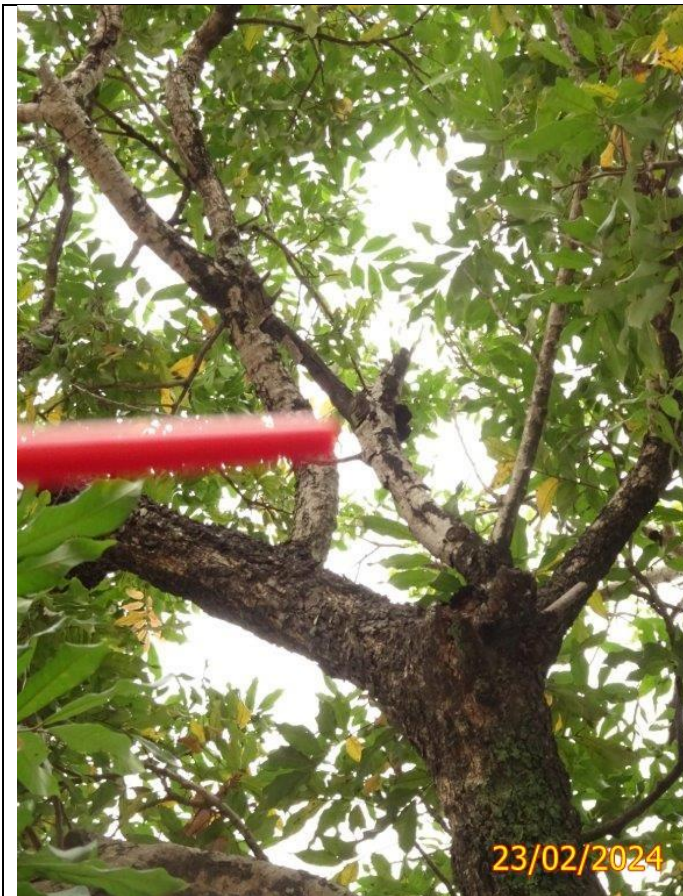
T20 | *Dimocarpus longan* 龍眼 | dead branch with fungal invasion

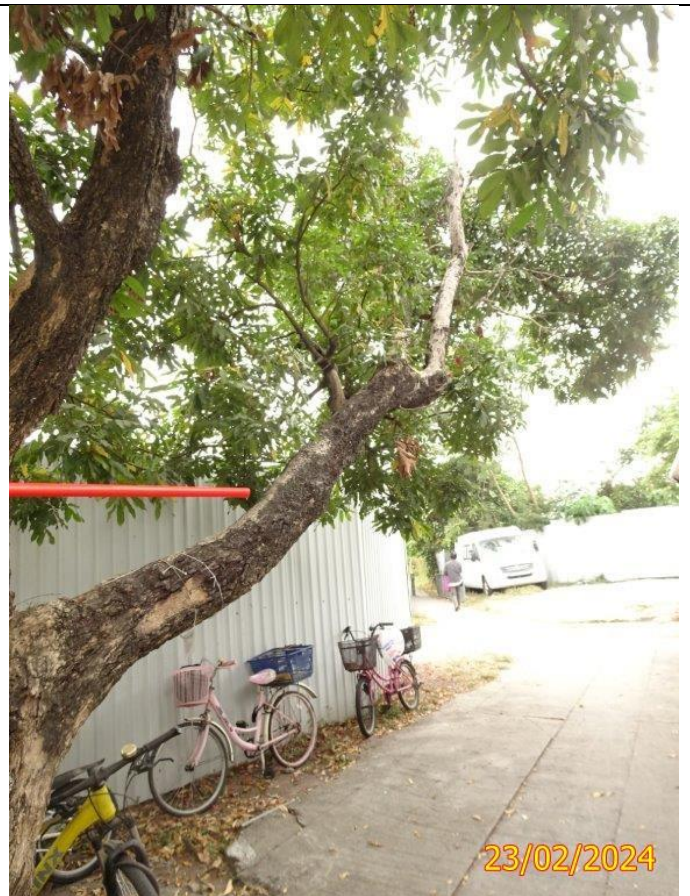
T20 | *Dimocarpus longan* 龍眼 | heavy lateral limb

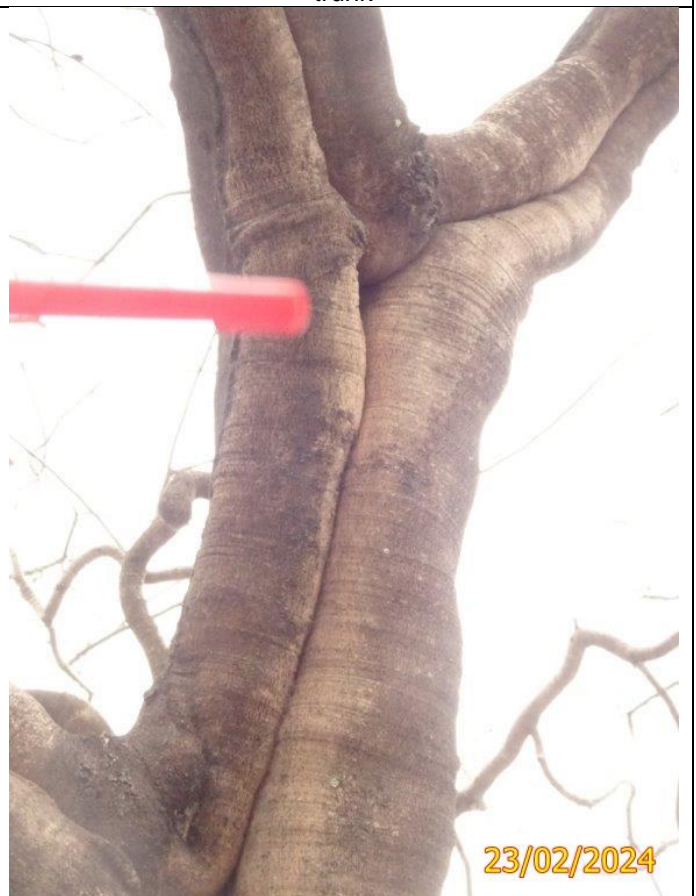
T22 | Delonix regia 鳳凰木 | small open cavity at upper trunk

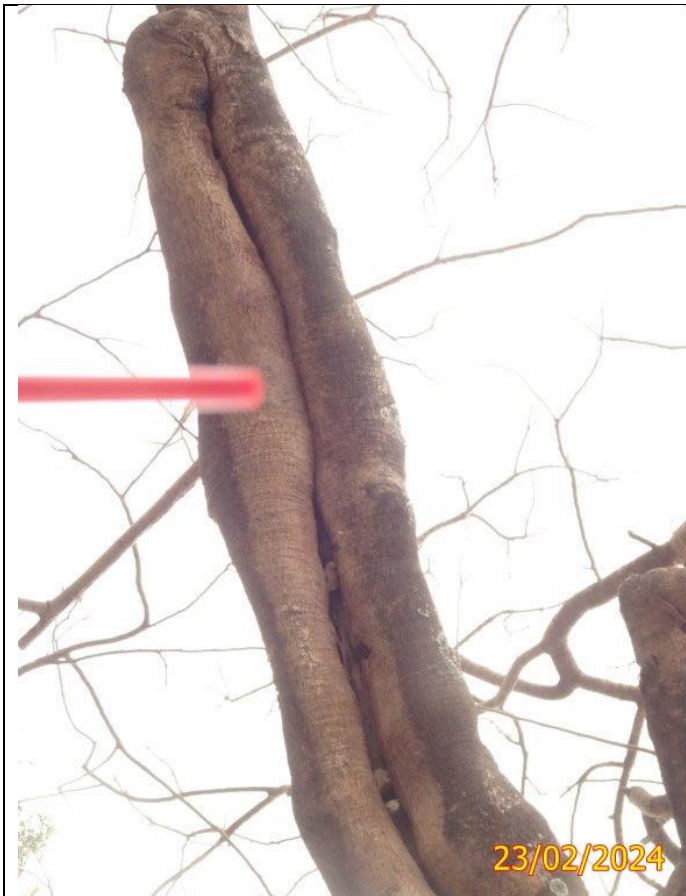
T22 | Delonix regia 鳳凰木 | longitudinal wound on mid branch

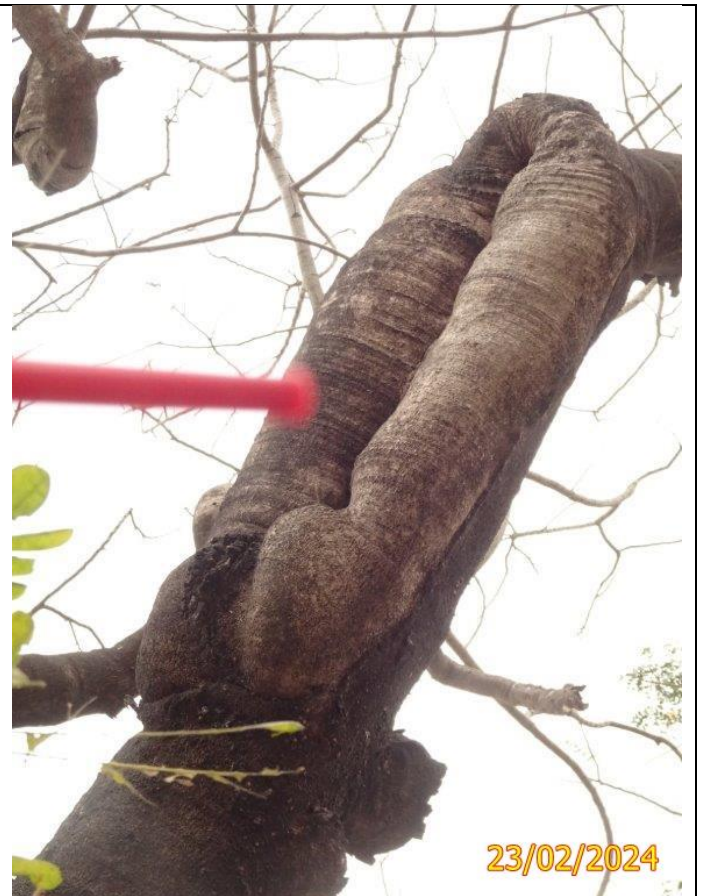
T22 | Delonix regia 鳳凰木 | abnormal longitudinal wound on upper crown

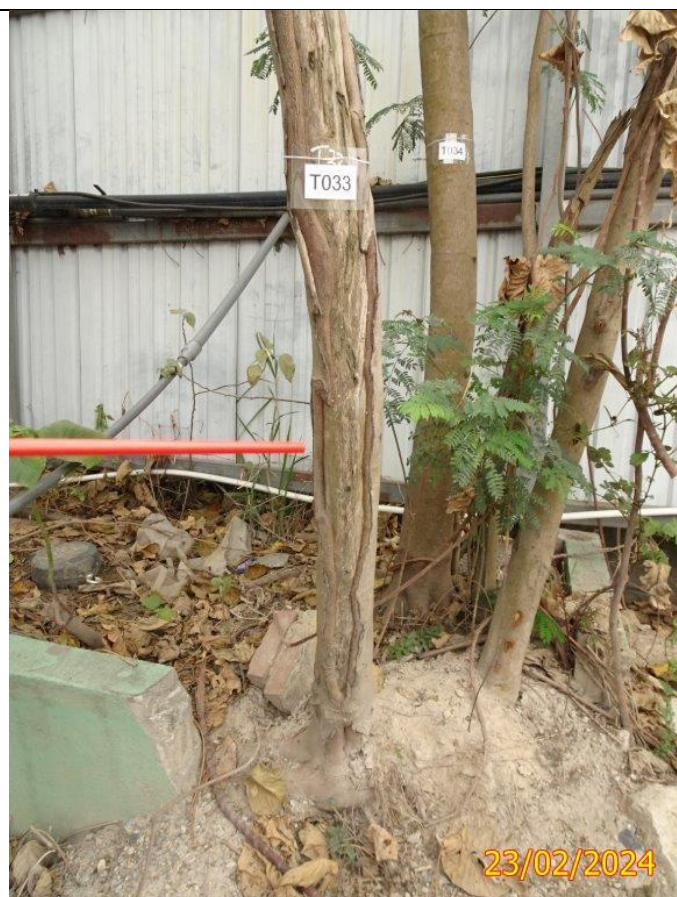
T33 | *Macaranga tanarius* var. *tomentosa* 血桐 | longitudinal bark crack at lower trunk

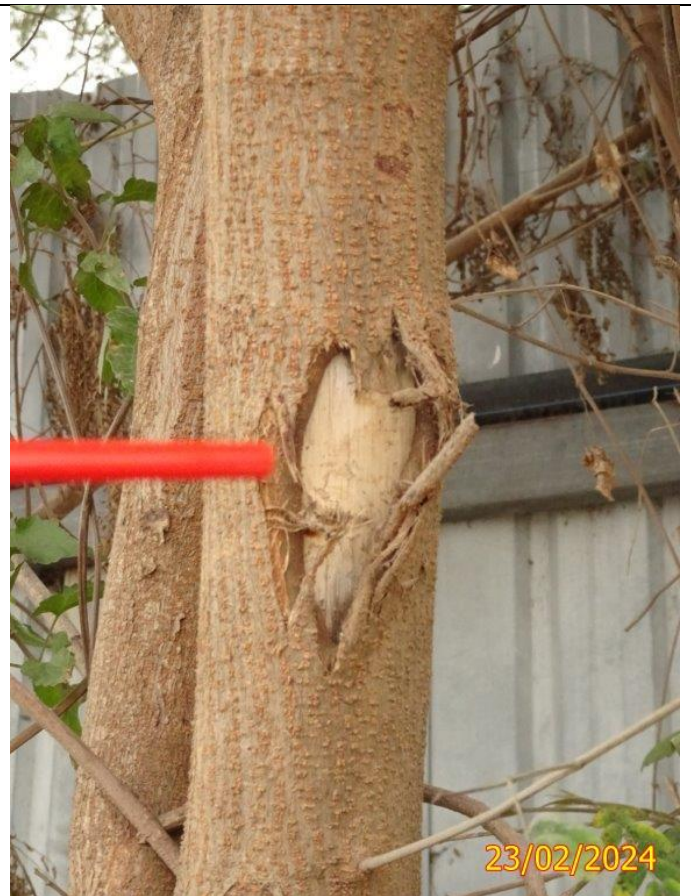
T36 | *Leucaena leucocephala* 銀合歡 | mechanical injury  
at mid trunk
