**SECTION 16 PLANNING APPLICATION FOR PROPOSED RESIDENTIAL
CARE HOMES FOR THE ELDERLY IN "VILLAGE TYPE DEVELOPMENT"
AT LOT NO. 76 S.G. & 76 S.H. IN D.D. 101, MAI PO, YUEN LONG**

**LANDSCAPE PROPOSAL
&
TREE TREATMENT PROPOSAL**

**PREPARED BY
STEPHEN LAI STUDIO LIMITED (S L S L)
ON BEHALF OF
GOTLAND ENTERPRISES LIMITED**

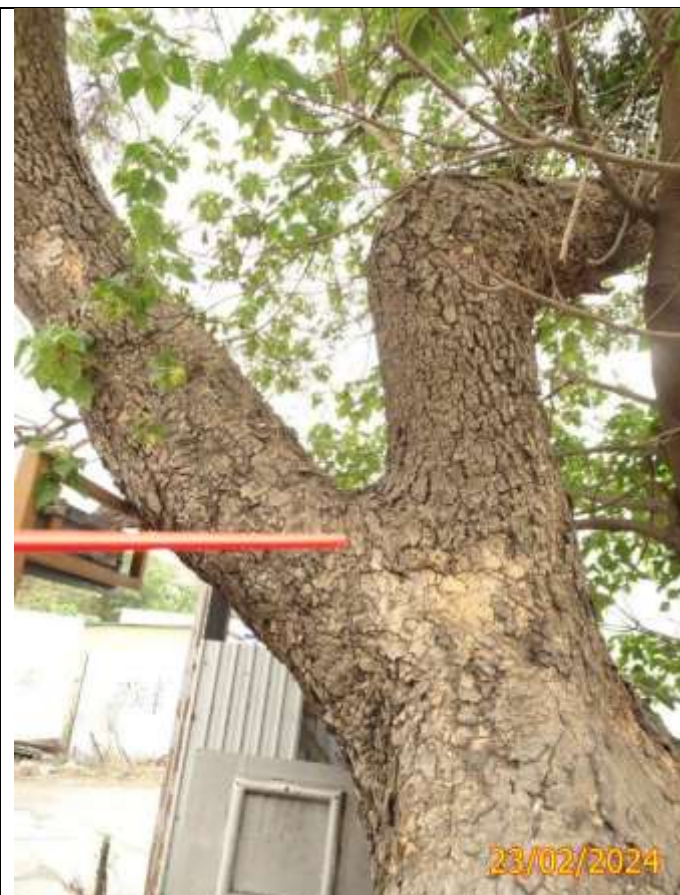
T01 | Albizia lebbeck 大葉合歡 | co-dominant branch

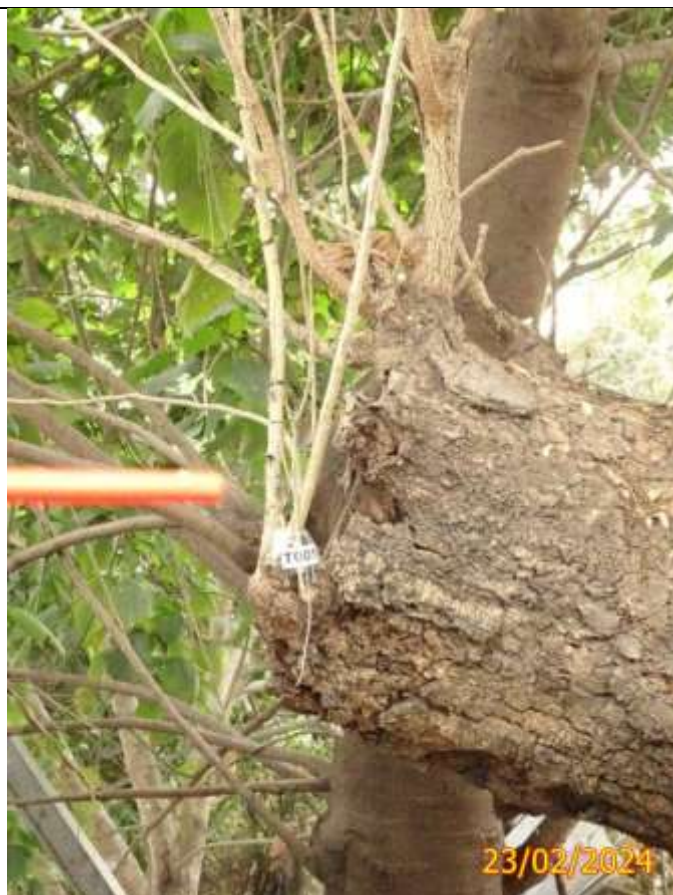
T01 | Albizia lebbeck 大葉合歡 | pruned branch with epicormic shoots on lower crown

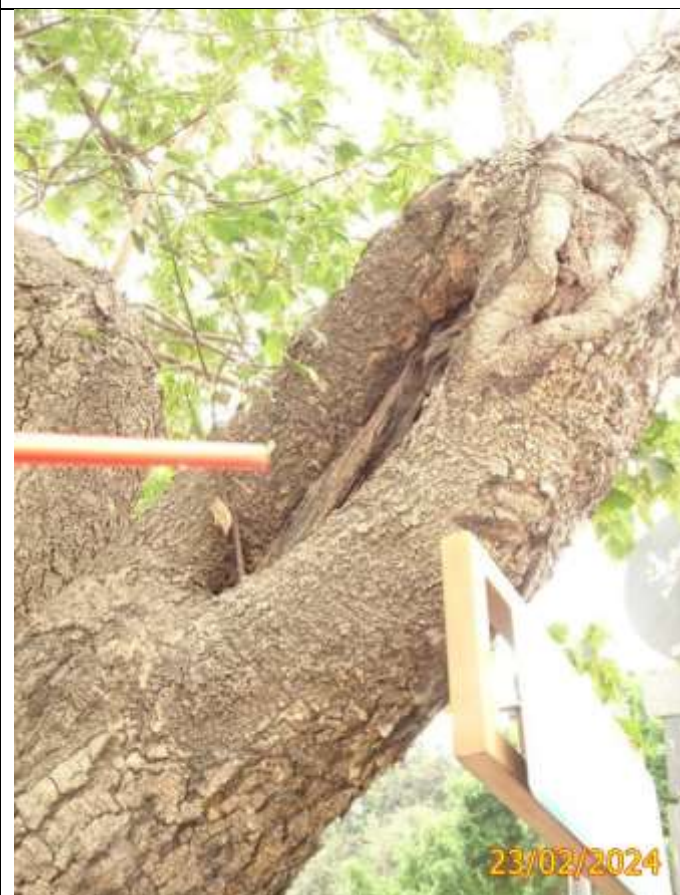
T01 | Albizia lebbeck 大葉合歡 | deadwood exposed wound on lower branch

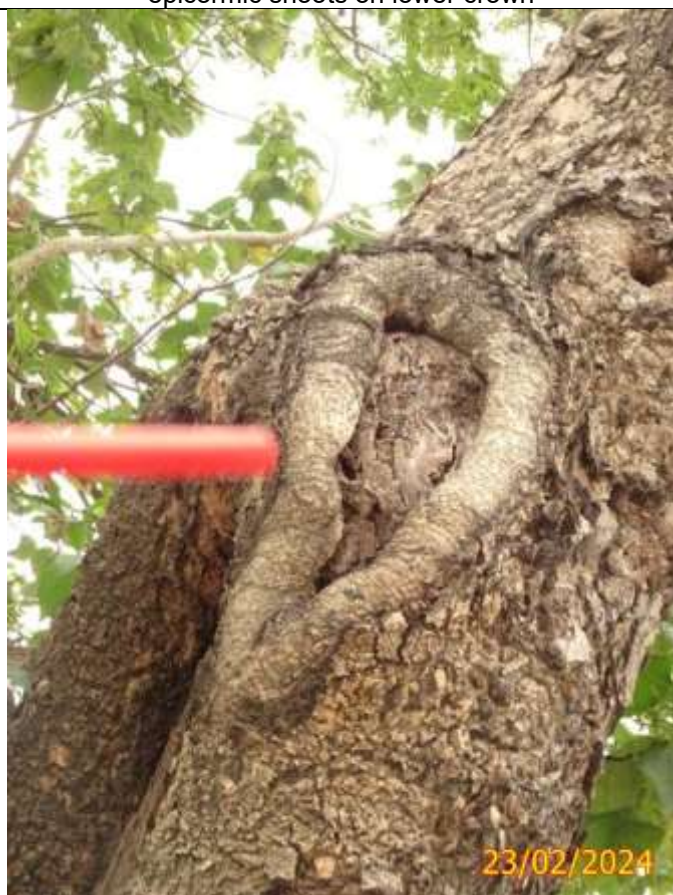
T01 | Albizia lebbeck 大葉合歡 | enclosed wound on branch

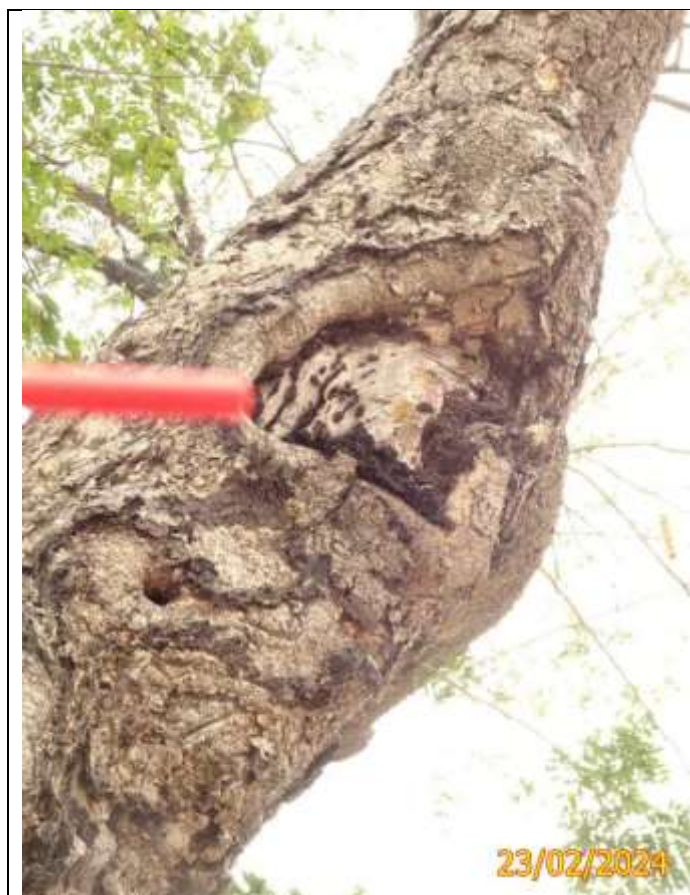
T01 | Albizia lebbeck 大葉合歡 | mechanical injury on branch

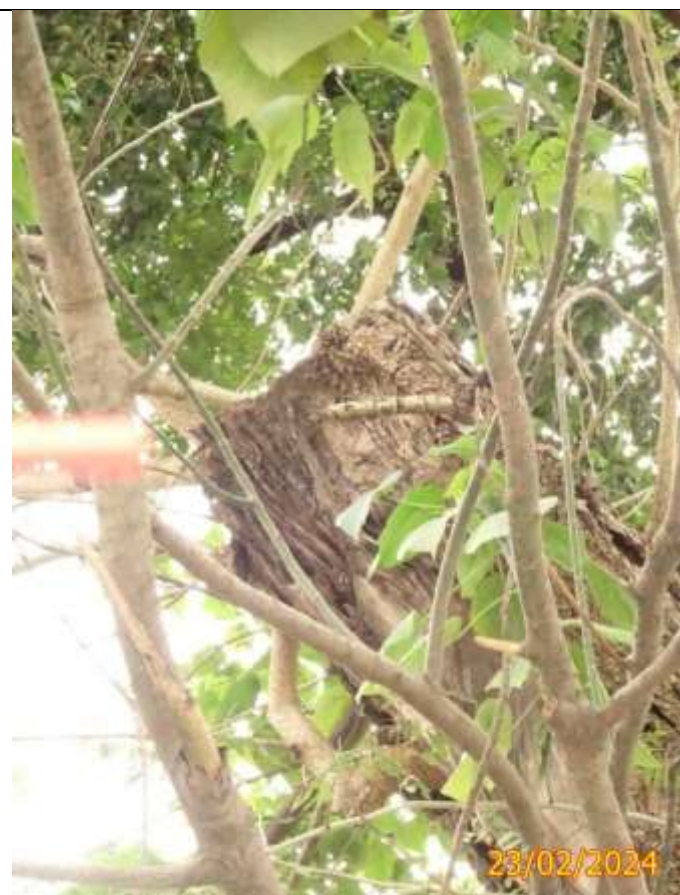
T01 | Albizia lebbeck 大葉合歡 | another pruned branch on mid crown

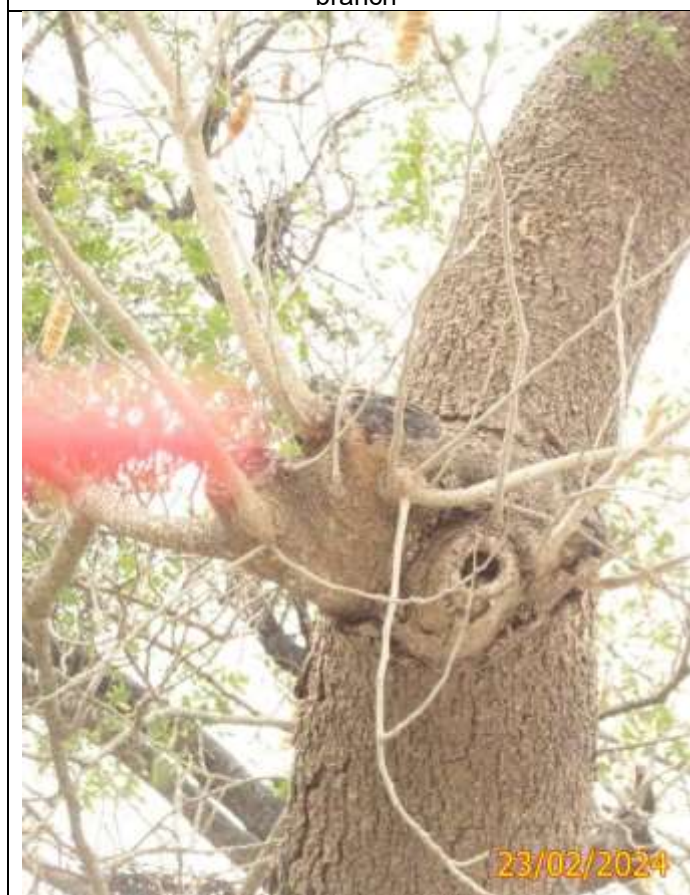
T01 | Albizia lebbeck 大葉合歡 | abnormal wound with epicormics on mid crown

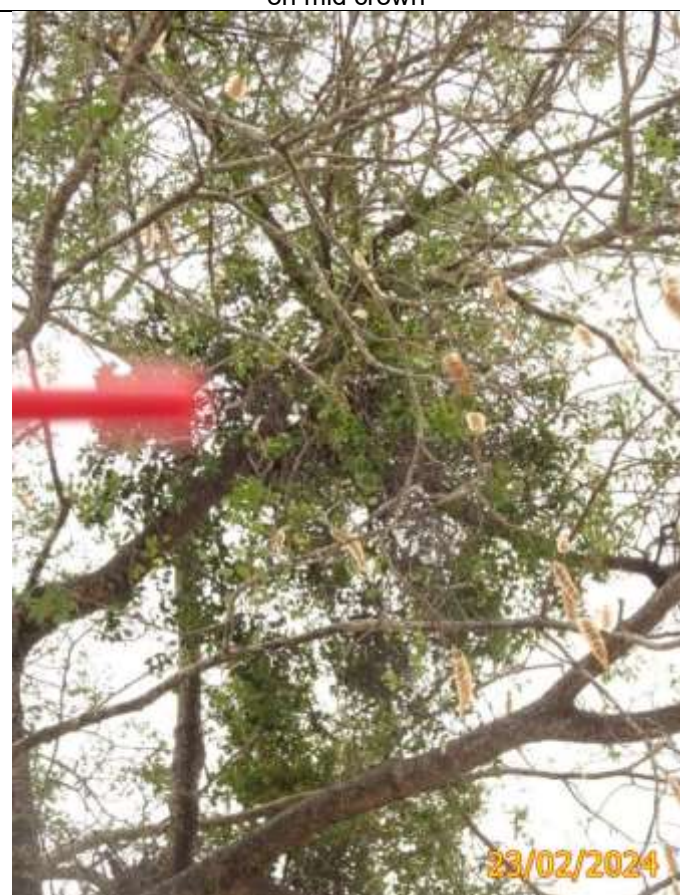
T01 | Albizia lebbeck 大葉合歡 | hemiparasite plant, *Viscum album* on mid crown

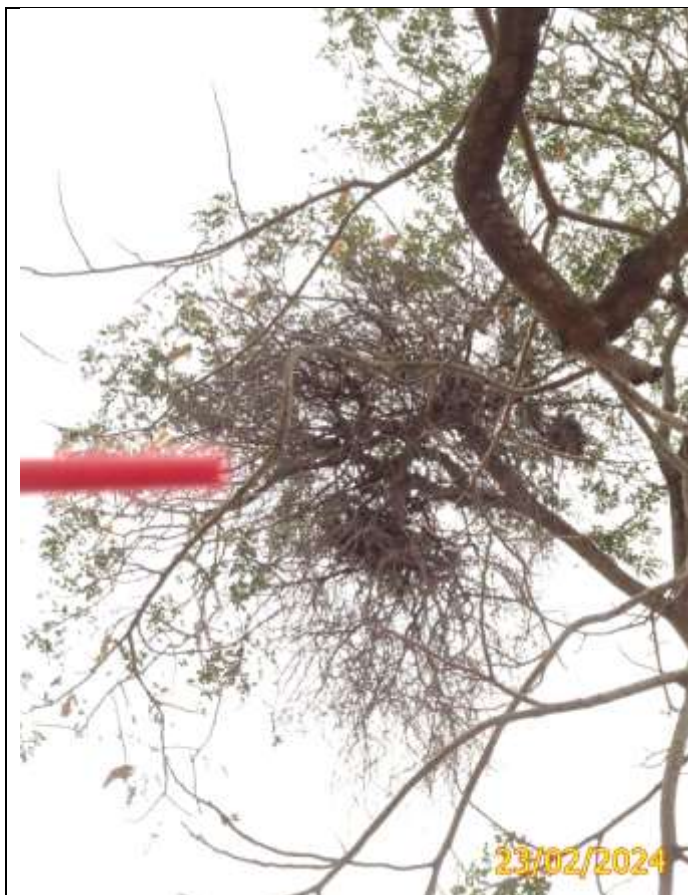
T01 | Albizia lebbeck 大葉合歡 | hemiparasite plant, *Viscum album* on upper crown

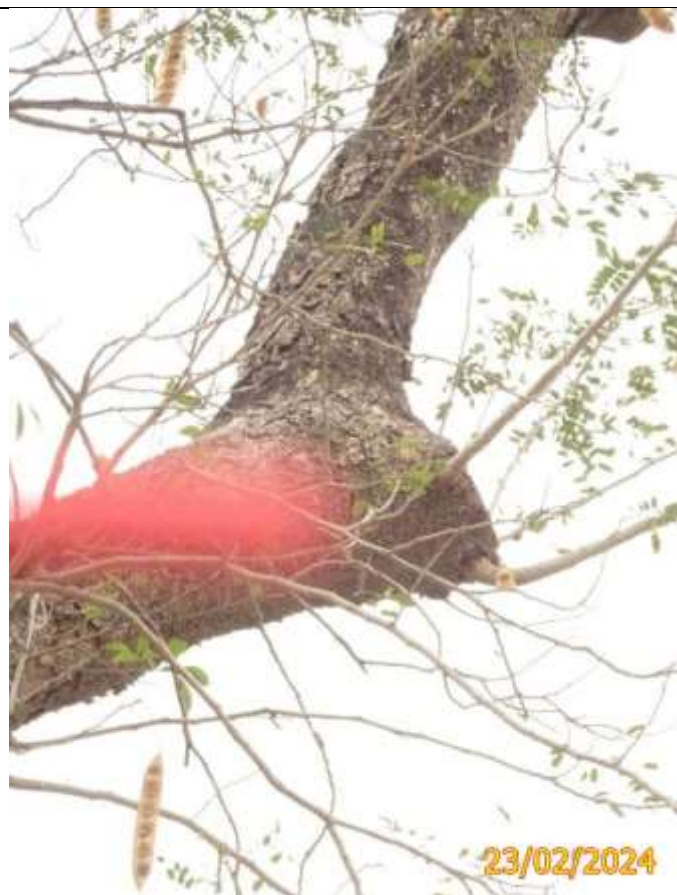
T01 | Albizia lebbeck 大葉合歡 | another pruned branch on upper crown

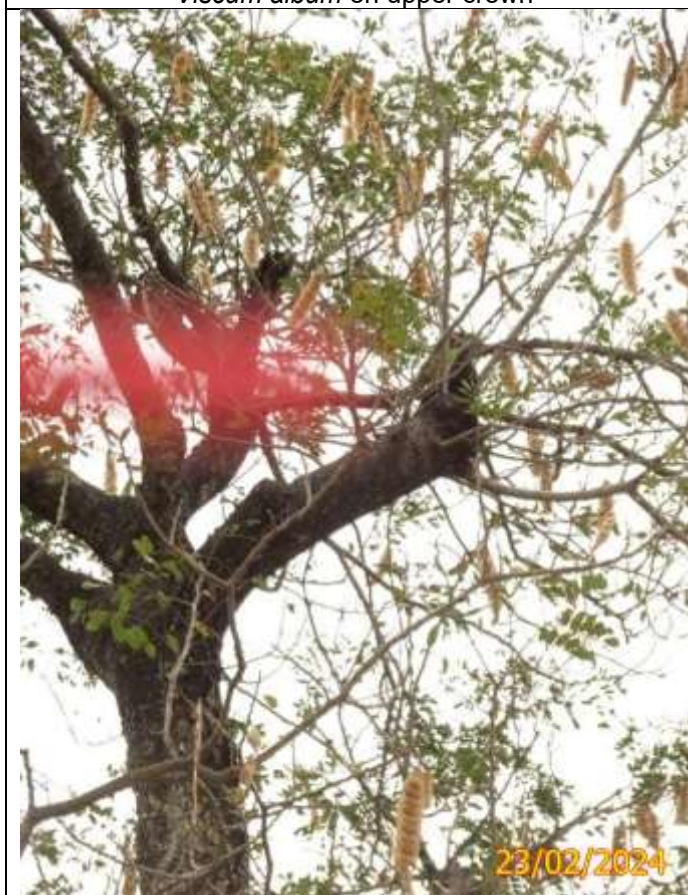
T01 | Albizia lebbeck 大葉合歡 | pruned branch with epicormic shoots on upper crown

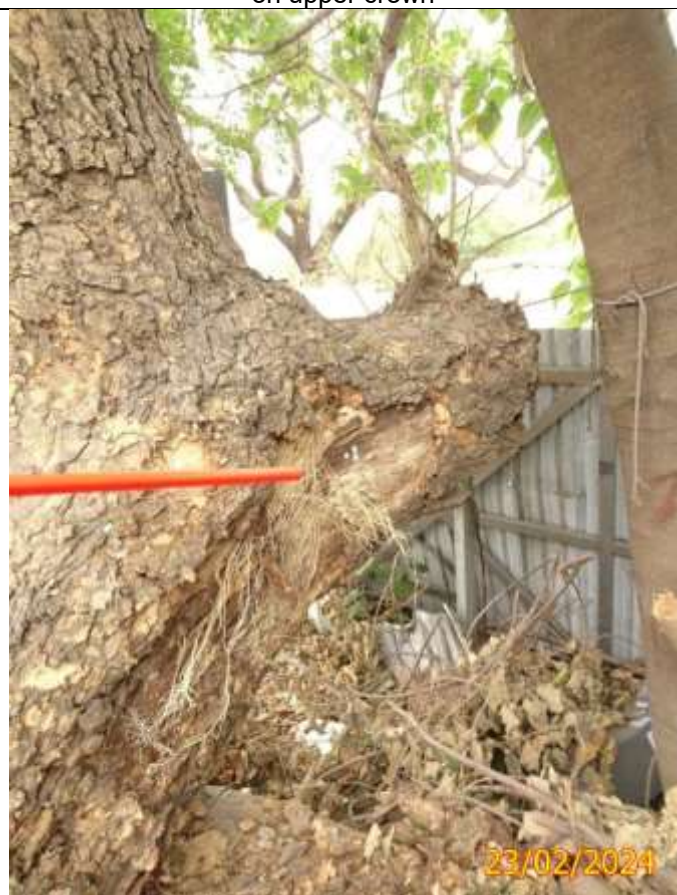
T01 | Albizia lebbeck 大葉合歡 | mechanical injury on broken branch at lower trunk

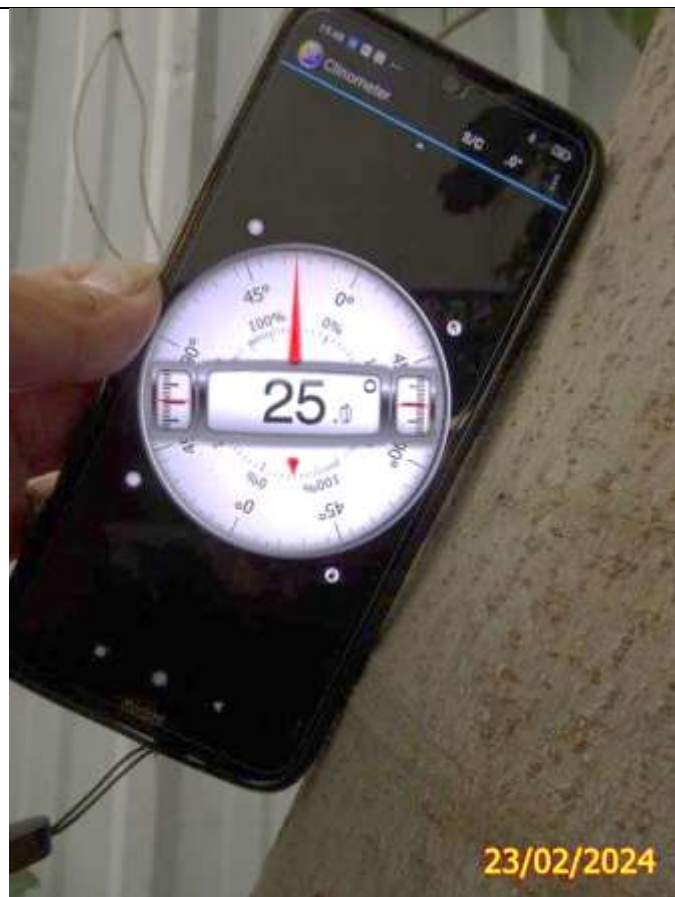
T03 | *Macaranga tanarius* var. *tomentosa* 血桐 | titled
25°

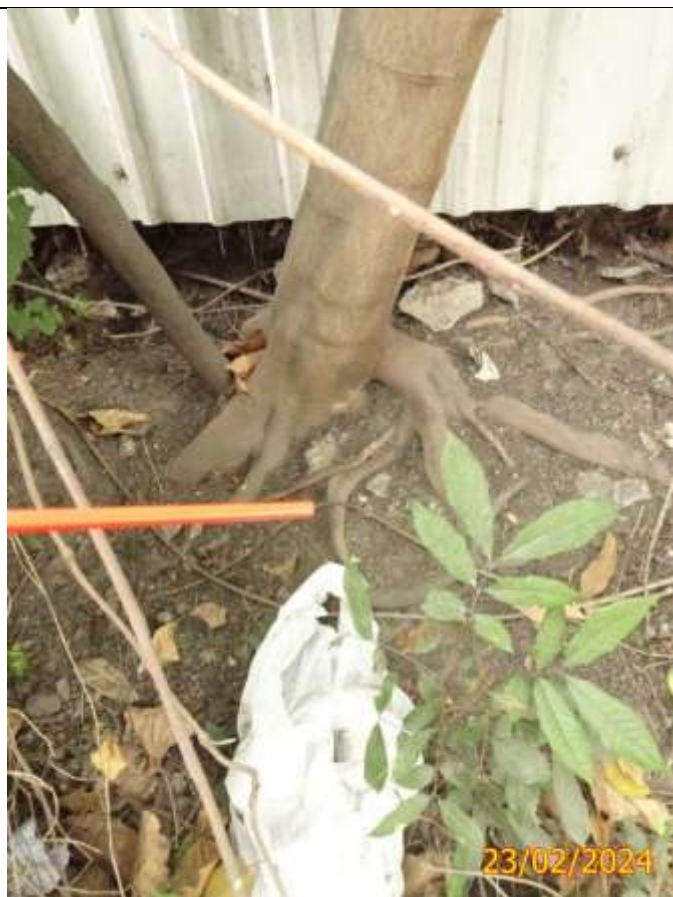
T03 | *Macaranga tanarius* var. *tomentosa* 血桐 |
exposed root

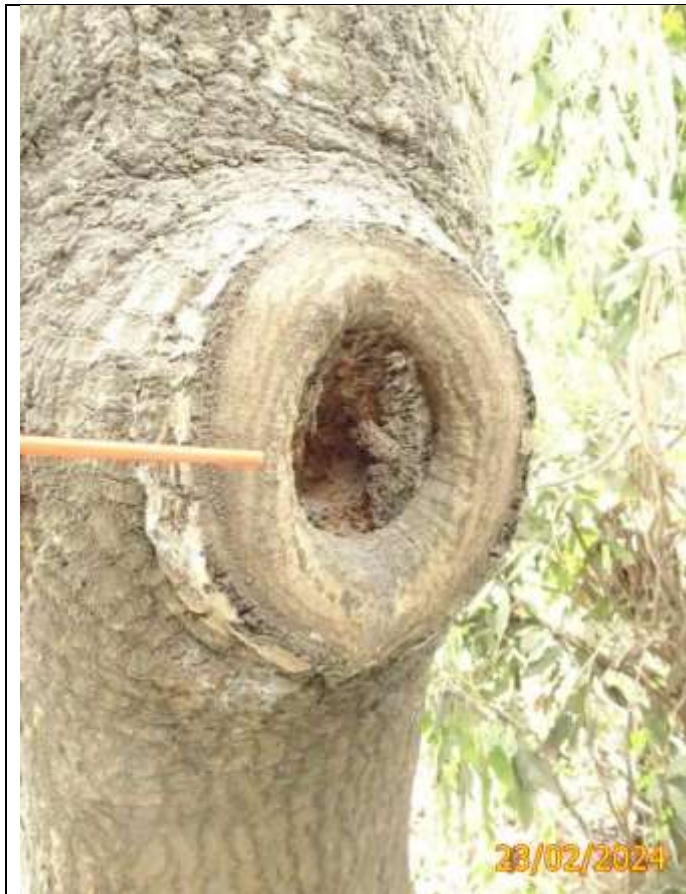
T04 | *Aleurites moluccana* 石栗 | unhealed wound on mid trunk

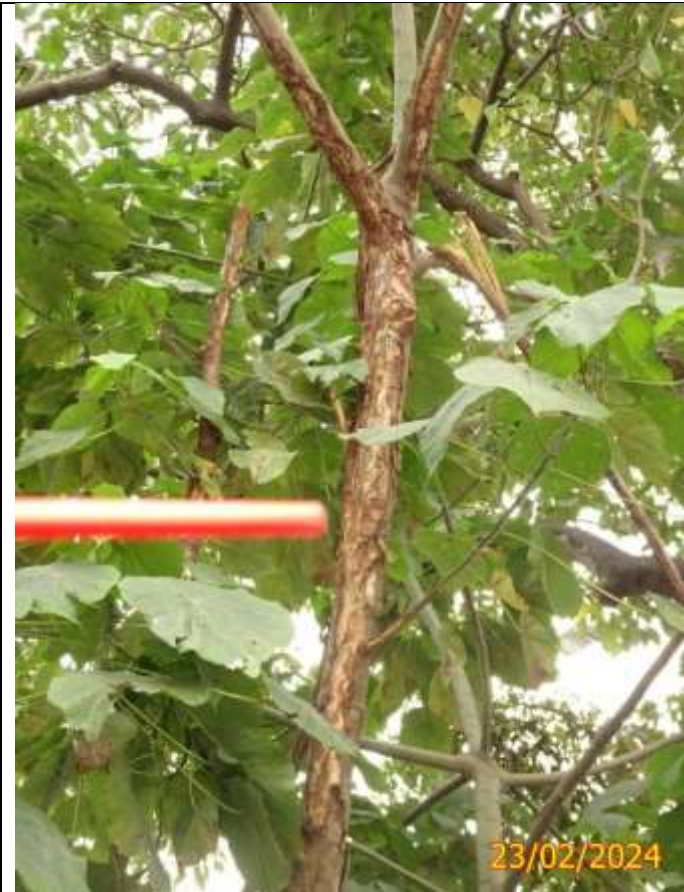
<p>T05 <i>Macaranga tanarius</i> var. <i>tomentosa</i> 血桐 mechanical injury on mid trunk</p>	<p>T05 <i>Macaranga tanarius</i> var. <i>tomentosa</i> 血桐 branch conflict with hoarding</p>

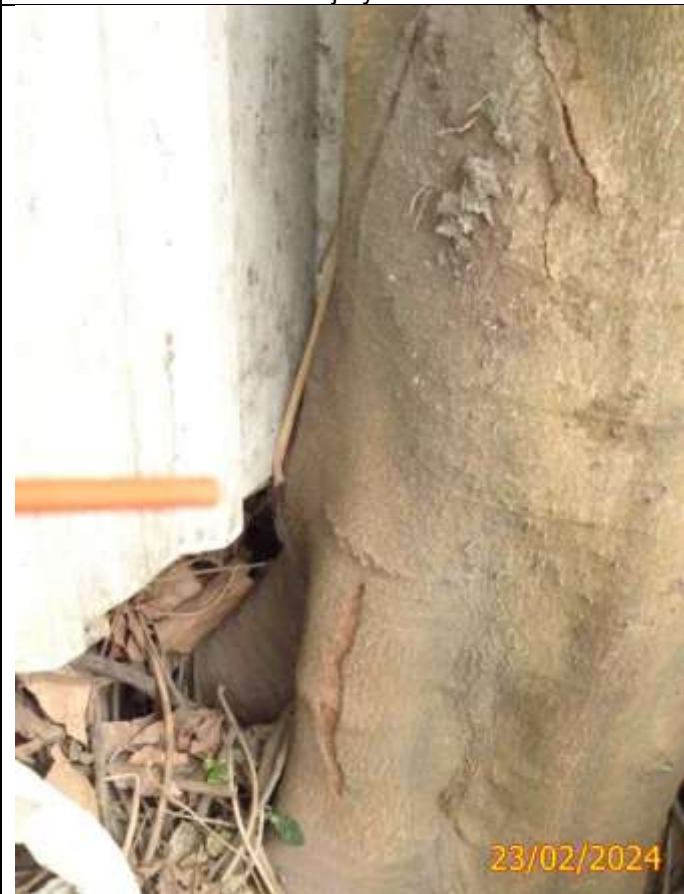
<p>No Photo</p>
<p>T05 <i>Macaranga tanarius</i> var. <i>tomentosa</i> 血桐 root collar conflict with hoarding</p>

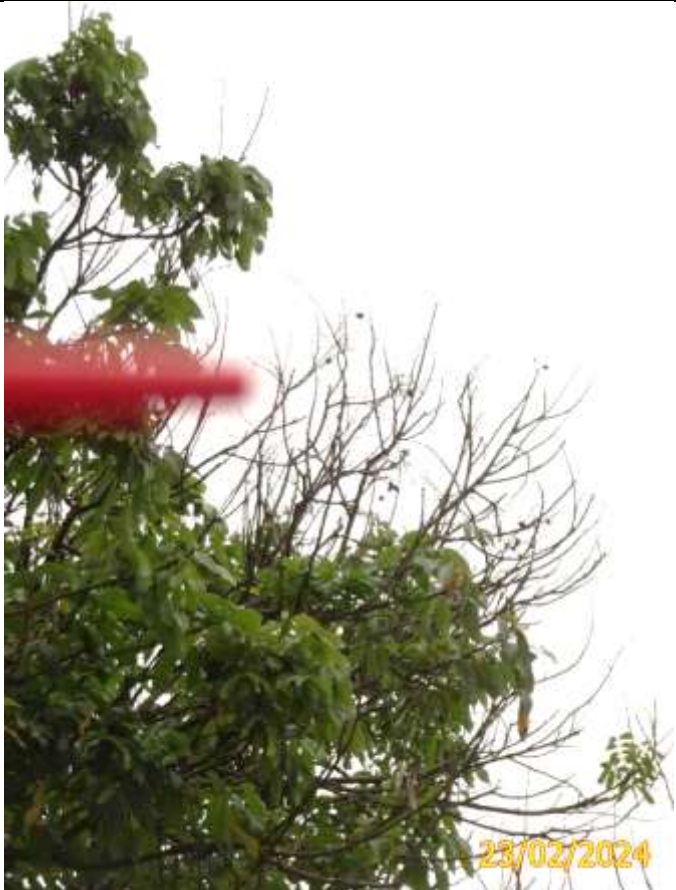
<p>No Photo</p>
<p>T09 Dimocarpus longan 龍眼 dieback twigs on upper crown</p>

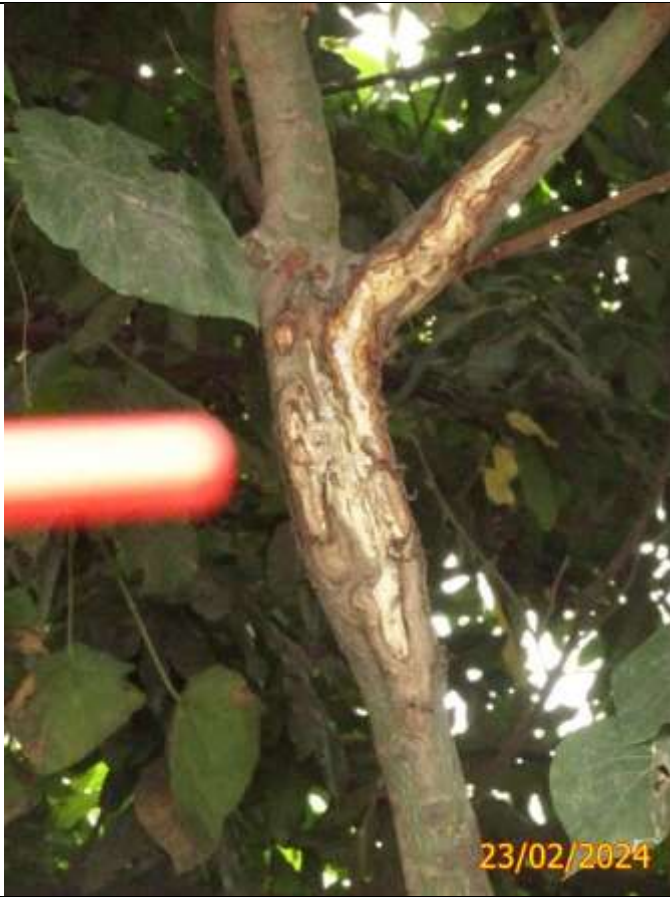
T10 | *Macaranga tanarius* var. *tomentosa* 血桐 |
mechanical wound on upper trunk

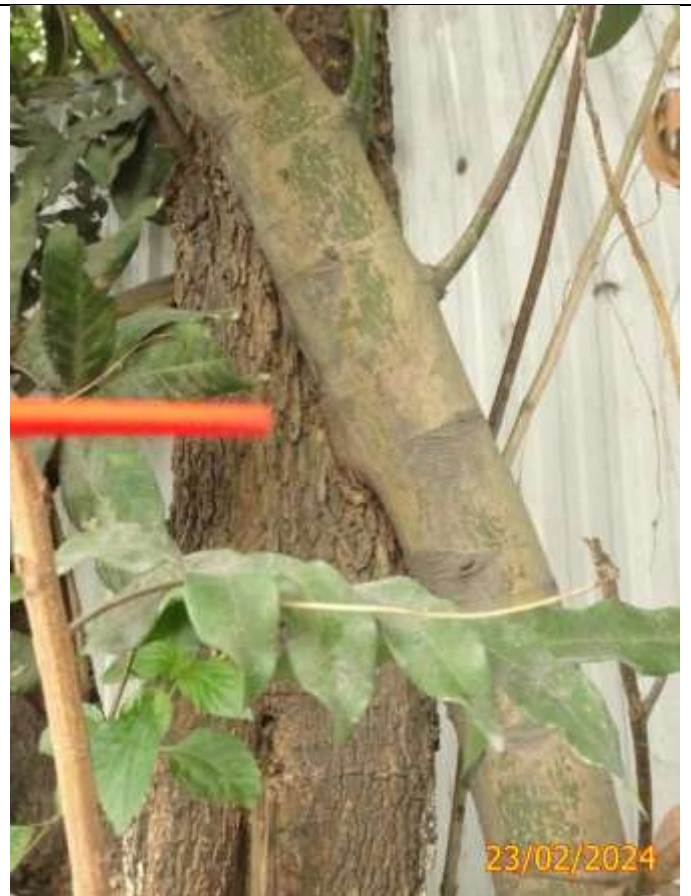
T11 | Dimocarpus longan 龍眼 | cross trunk

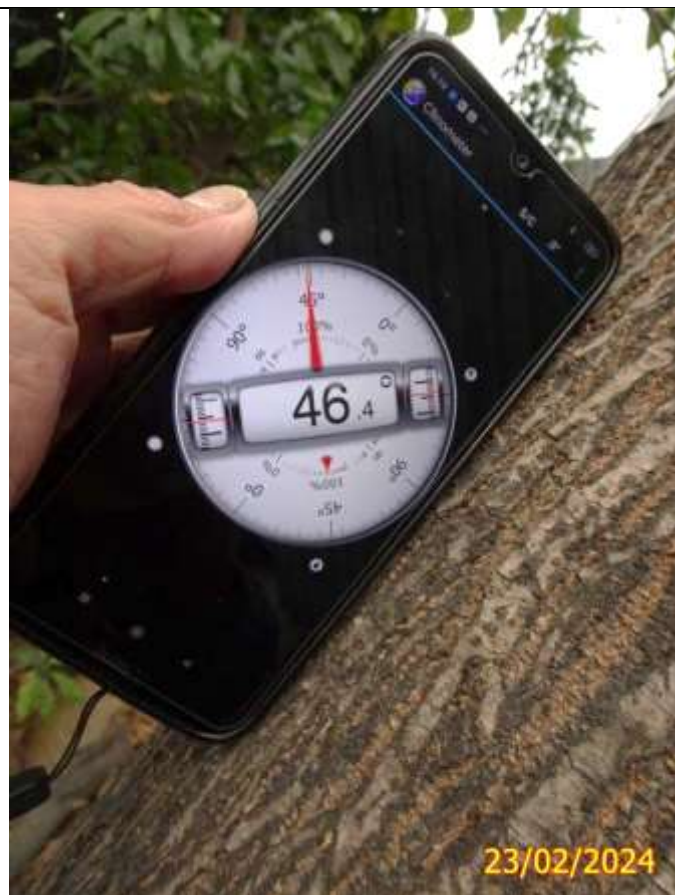
T18 | *Leucaena leucocephala* 銀合歡 | tilted 46.4°

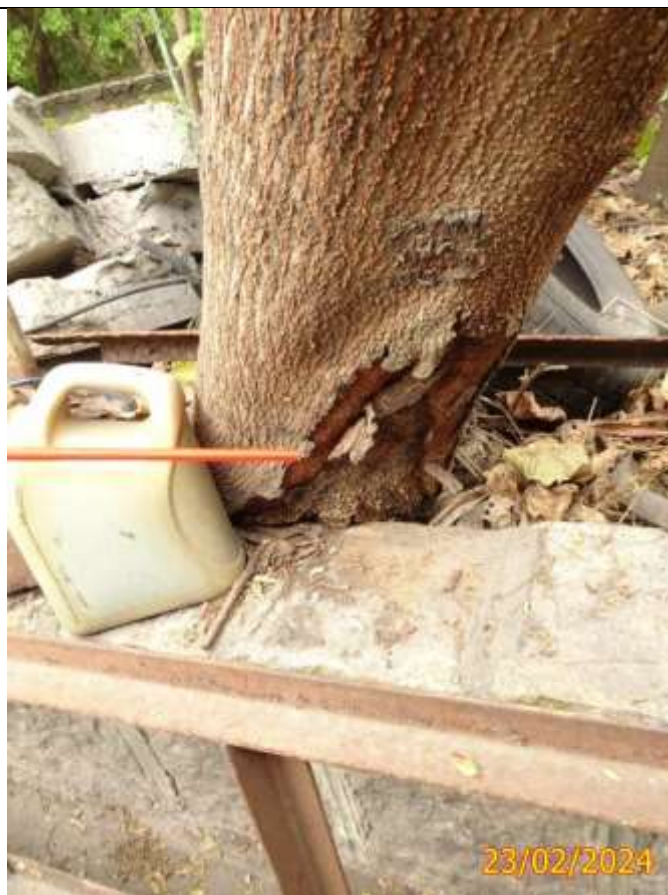
T18 | *Leucaena leucocephala* 銀合歡 | mechanical injury on root collar

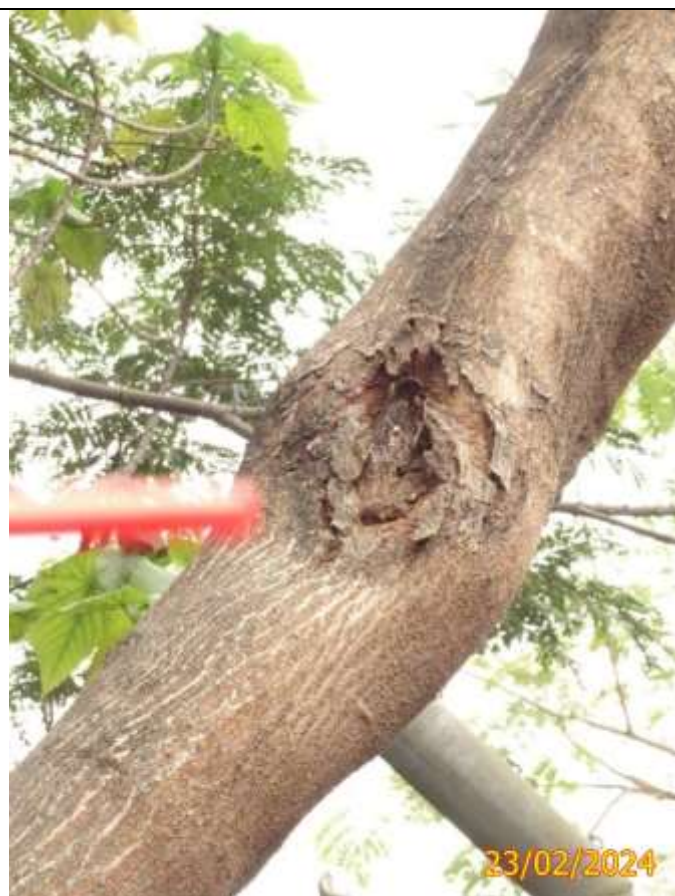
T18 | *Leucaena leucocephala* 銀合歡 | enclosed wound on mid trunk

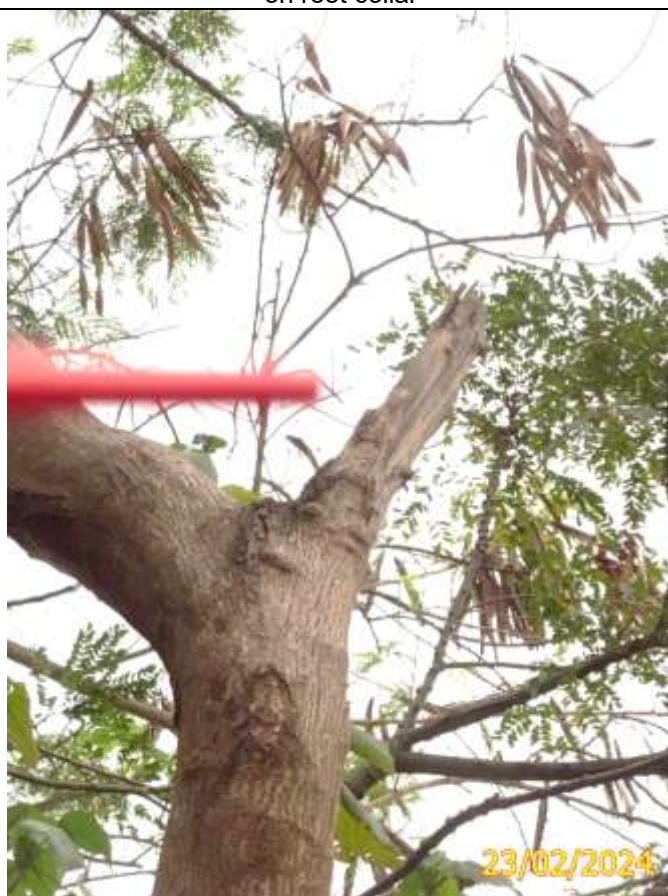
T18 | *Leucaena leucocephala* 銀合歡 | broken branch

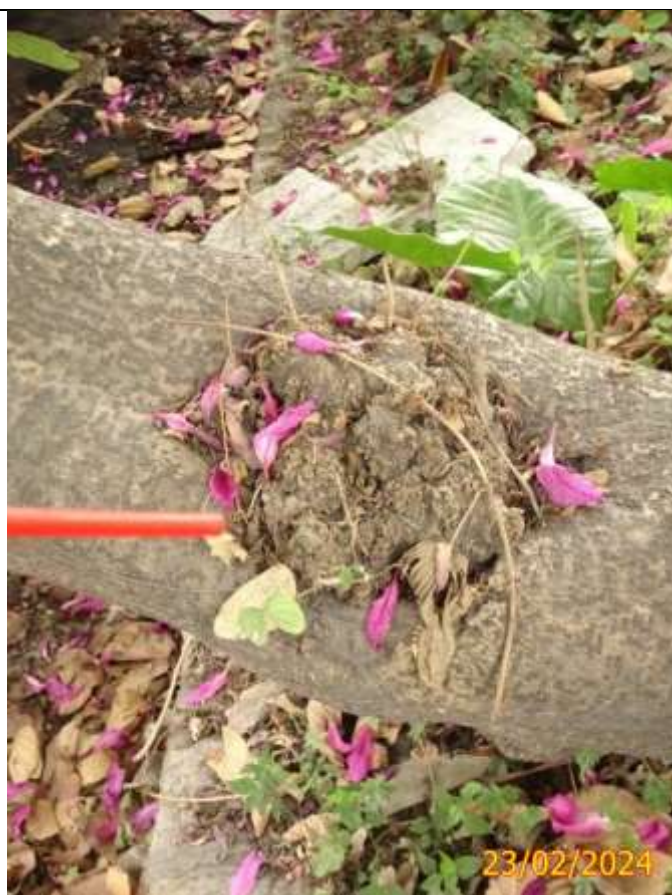
T19 | Bauhinia x blakeana 洋紫荊 | canker at lower trunk

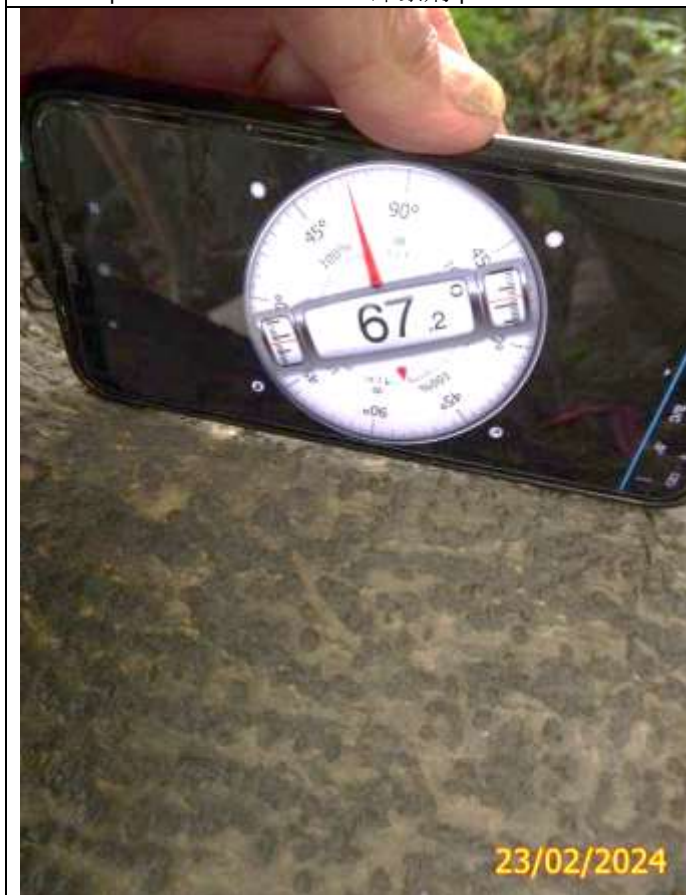
T19 | Bauhinia x blakeana 洋紫荊 | tilted 67.2°

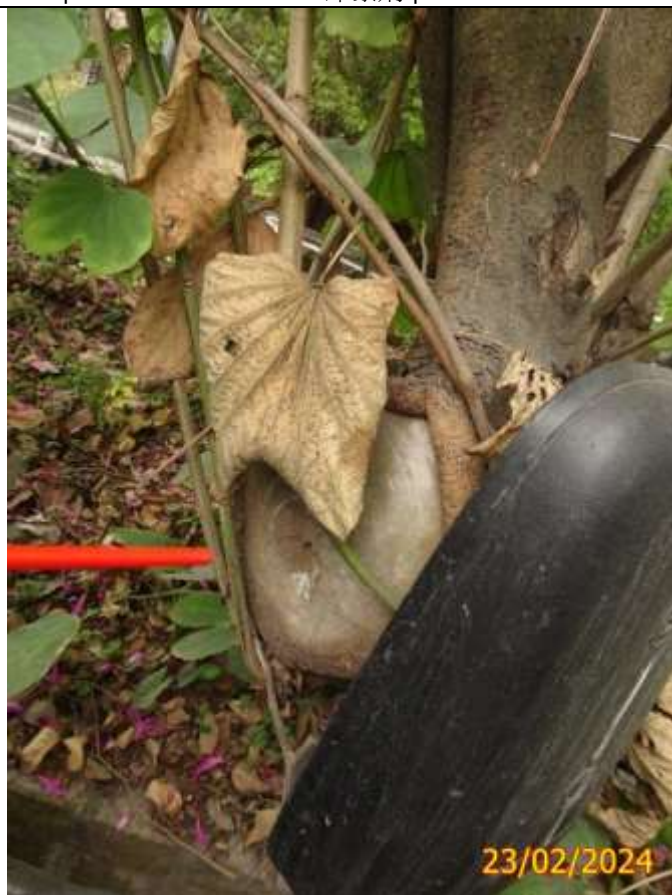
T19 | Bauhinia x blakeana 洋紫荊 | pruning wound at lower trunk

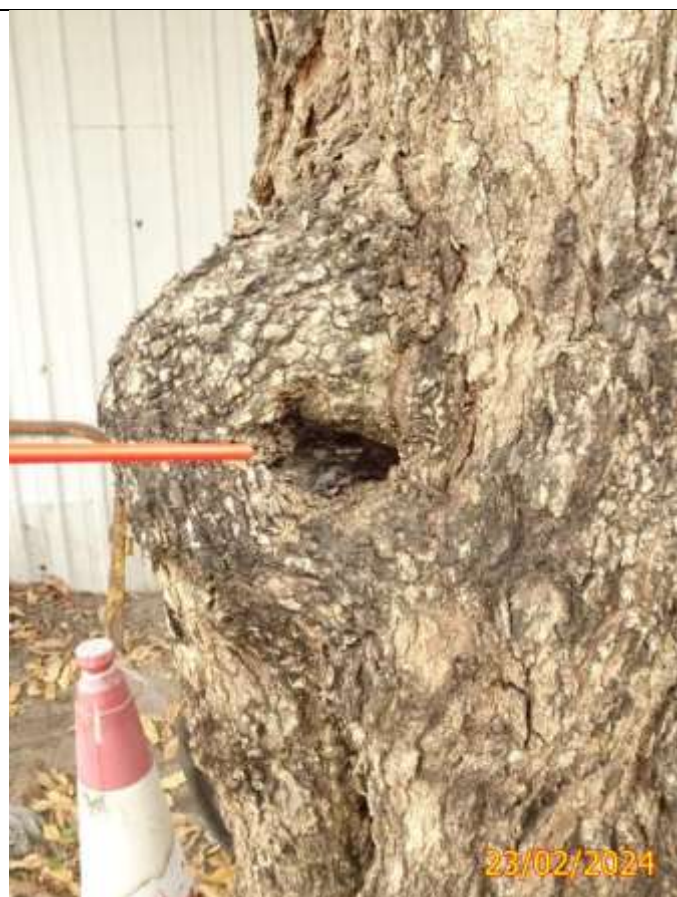
T20 | Dimocarpus longan 龍眼 | small open cavity at lower trunk

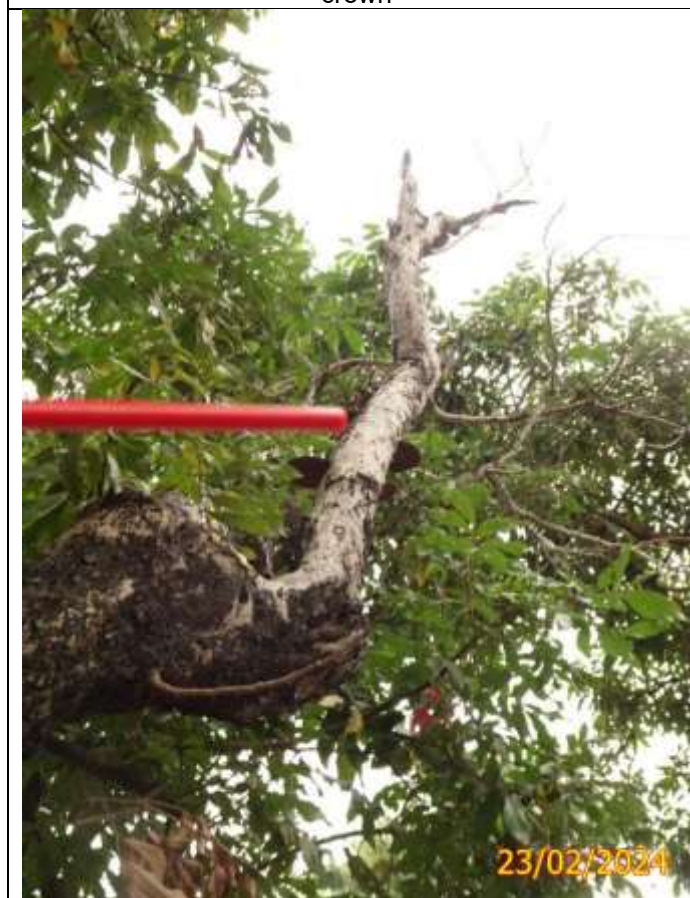
T20 | Dimocarpus longan 龍眼 | dead branch with fungal fruiting bodies

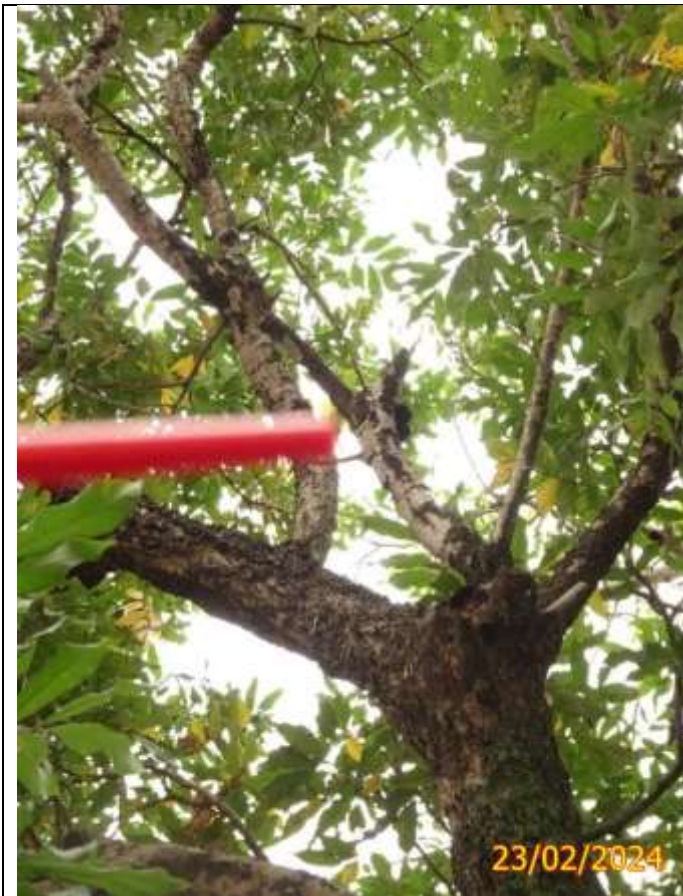
T20 | *Dimocarpus longan* 龍眼 | dead branch with fungal invasion

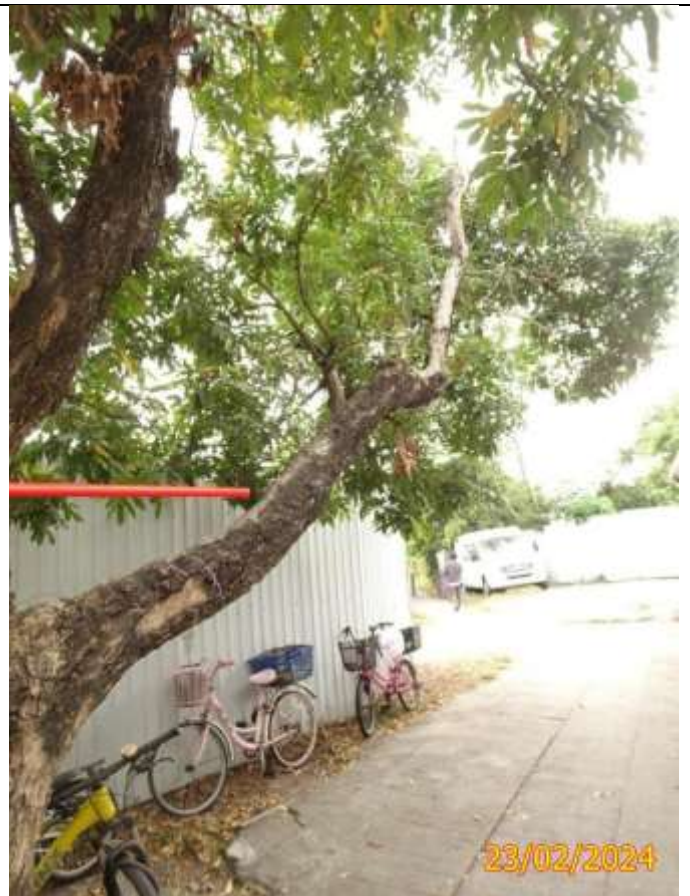
T20 | *Dimocarpus longan* 龍眼 | heavy lateral limb

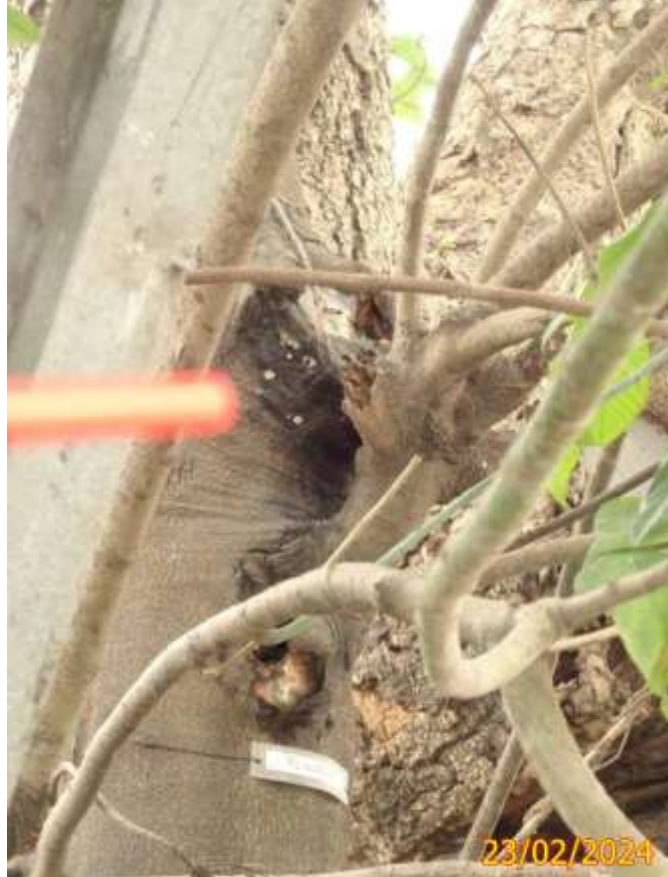
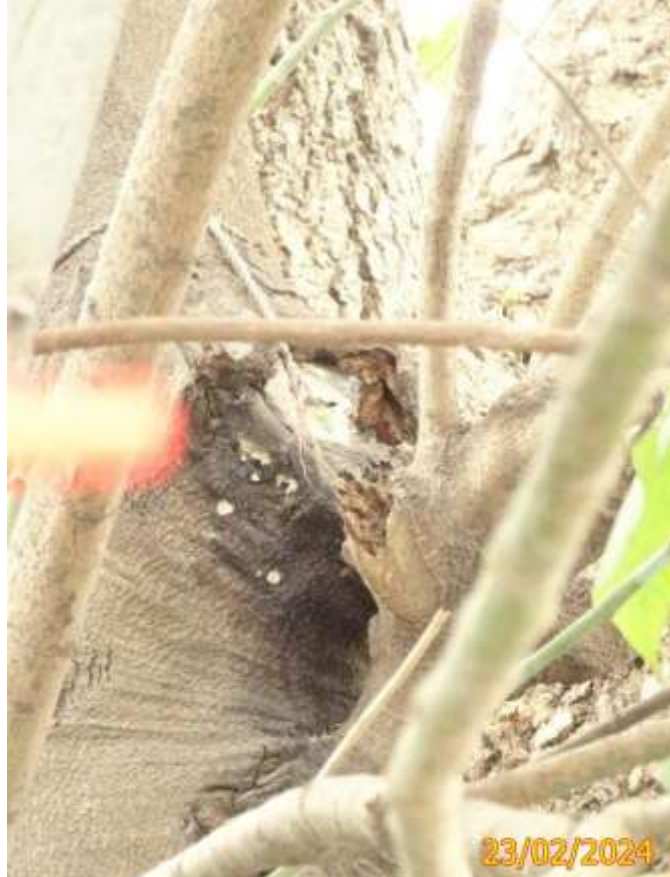
T21 | *Macaranga tanarius* var. *tomentosa* 血桐 | Root condition

<p>T21 <i>Macaranga tanarius</i> var. <i>tomentosa</i> 血桐 close up of decaying wound</p>	<p>T21 <i>Macaranga tanarius</i> var. <i>tomentosa</i> 血桐 unhealed wound at root collar</p>

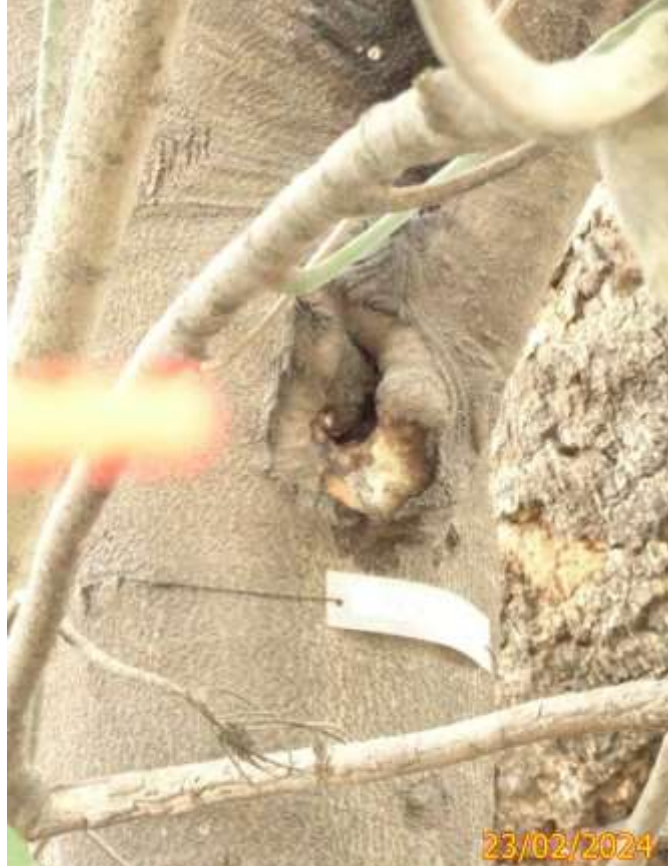
<p>No Photo</p>
<p>T21 <i>Macaranga tanarius</i> var. <i>tomentosa</i> 血桐 decaying pruning wound at lower trunk</p>

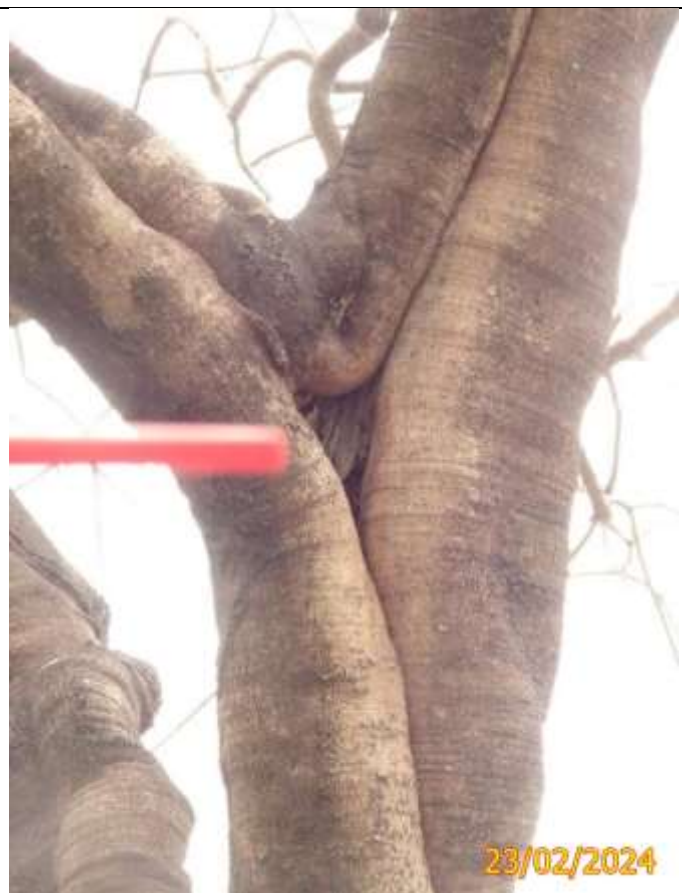
T22 | Delonix regia 鳳凰木 | deadwood wound on mid trunk

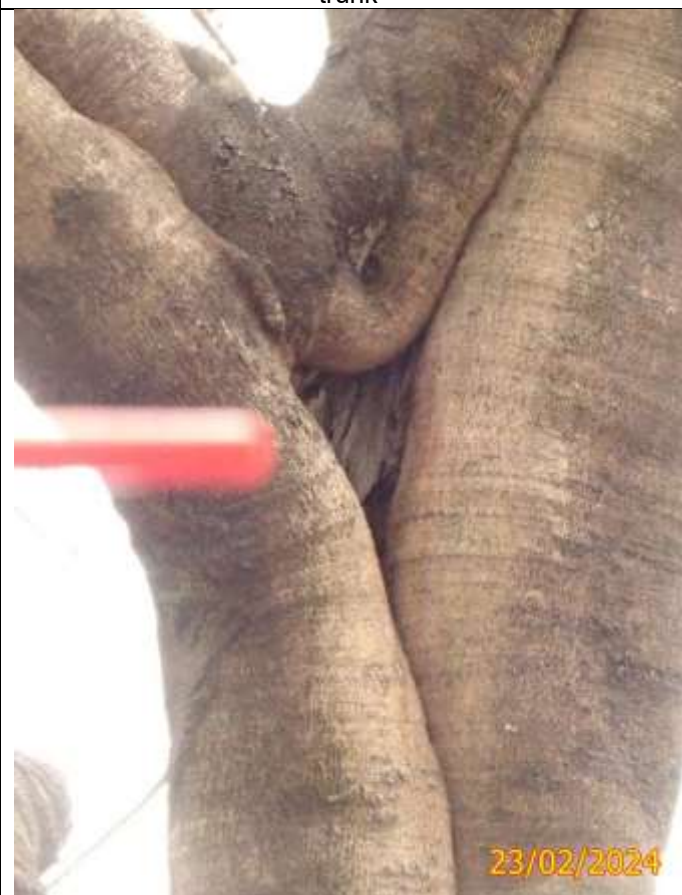
T22 | Delonix regia 鳳凰木 | close up of deadwood wound on mid trunk

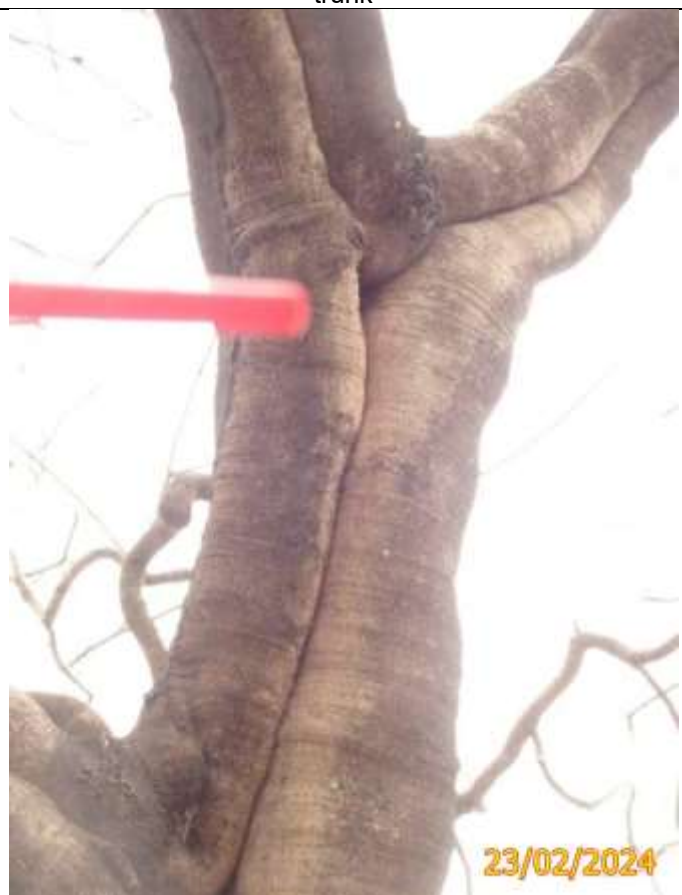
T22 | Delonix regia 鳳凰木 | small open cavity at upper trunk
