**SECTION 16 PLANNING APPLICATION FOR PROPOSED RESIDENTIAL
CARE HOMES FOR THE ELDERLY IN "VILLAGE TYPE DEVELOPMENT"
AT LOT NO. 76 S.G. & 76 S.H. IN D.D. 101, MAI PO, YUEN LONG**

**LANDSCAPE PROPOSAL
&
TREE TREATMENT PROPOSAL**

**PREPARED BY
STEPHEN LAI STUDIO LIMITED (S L S L)
ON BEHALF OF
GOTLAND ENTERPRISES LIMITED**

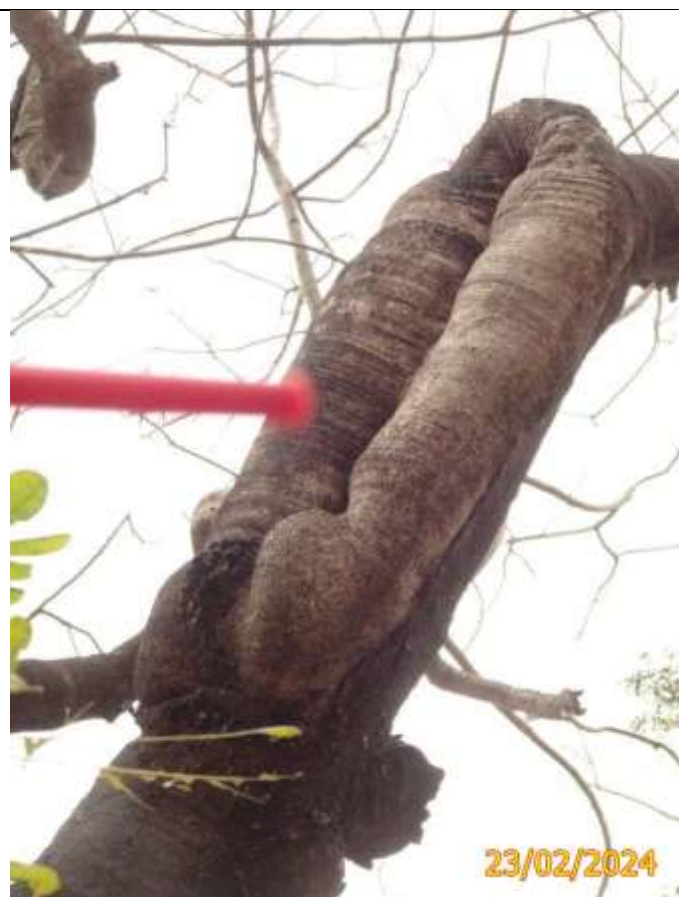
T22 | Delonix regia 鳳凰木 | abnormal longitudinal wound on upper crown
